**Kilu'ufi Hospital, Auki, Malaita Province**

**Site inspection report**

**Kilu'ufi Hospital Site Inspection Report**

**TOPOGRAPHICAL SURVEY OF KILU'UFI HOSPITAL, PARCEL 151-001-32,  
LOT 4 OF LR 544, MALAITA PROVINCE, SOLOMON ISLANDS**

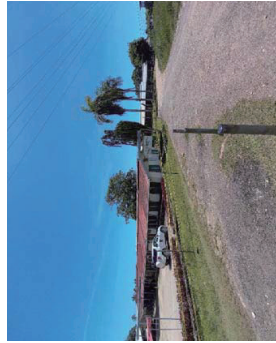
Figure 1: South east view towards hospital

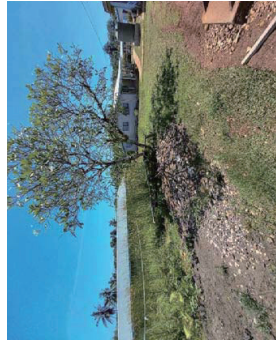
Figure 2: View of western side of hospital

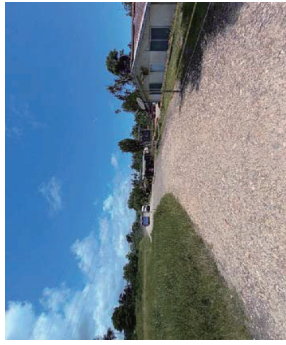
Figure 3: Access Road and main entry to KH

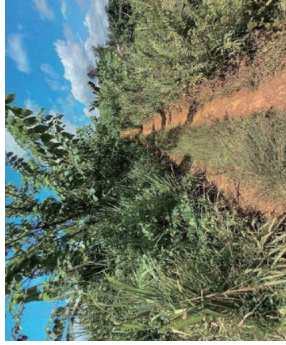
Figure 4: Access Road to western side of KH

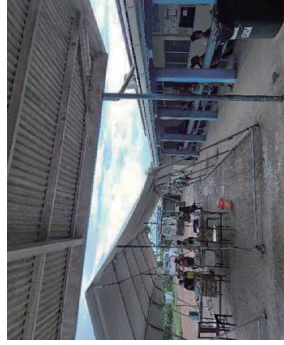
Figure 5: Out-patient waiting area

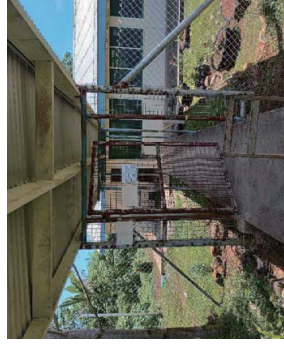
Figure 6: Typical covered walkway to Isolation ward

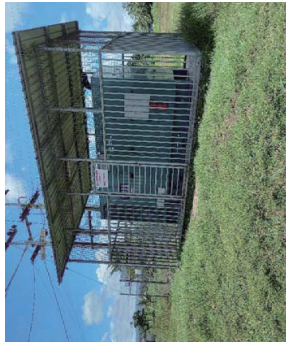
Figure 11: Backup diesel generator

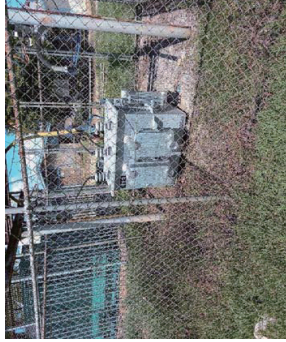
Figure 12: Transformer

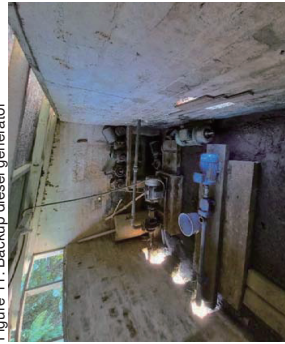
Figure 13: Borehole 1 pump room - operational

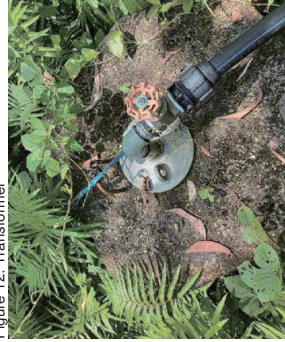
Water – KH is supplied by two water sources. Borehole 1 is pumped directly into the hospital and also supplies the staff residences after hours. Borehole 2 is pumped to a storage tank before supplying the hospital however this is no longer functional. KH experiences water shortages up to 4 hours each day. KH also relies on rainwater harvesting for drinking water. There are water tanks located along the buildings. Typically they are standalone and not pumped into the buildings.

Figure 14: Borehole 2 with internal pump – not functional

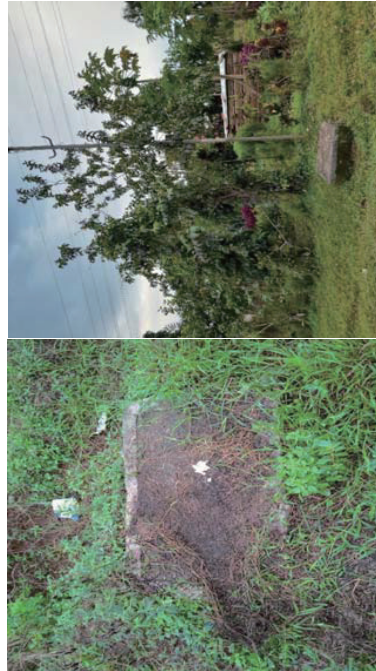
Photo 11 and 12: Telekom manholes

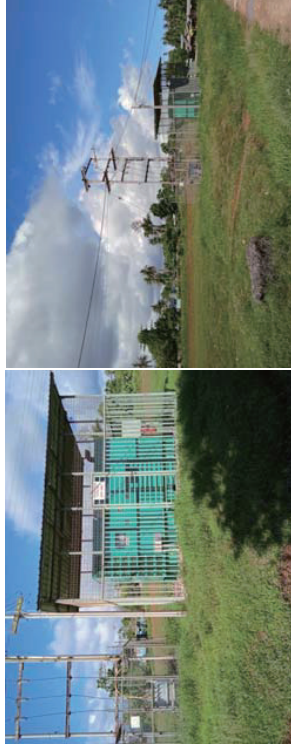
Photo 13 and 14. Transformer and the standby generator

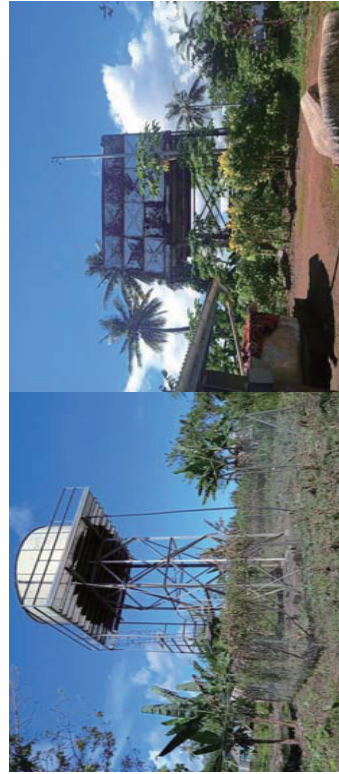
Located northeast of the hospital is the unused gravity tower tank that has a capacity of 48,000 litres, which distributes water to the hospital facilities and staff residences. The gravity storage tank has a volume of 48,000 litres with 8 m tank base height from ground level with 40 mm polyvinyl pipe sizes connected off from the borehole. Currently the borehole and pump are no longer in used because of mechanical problem and no funding to fix.

Photo 15 and 16. The two-gravity storage tank tower surveyed.
