KILU'UFI HOSPITAL GEOTECHNICAL INVESTIGATION REPORT

Consultant: Engineering Environmental Services
Limited

Report No: KH202205_GI_001
Report Status: FINAL

Kilu'ufi Hospital Improvement Project Geotechnical Investigation

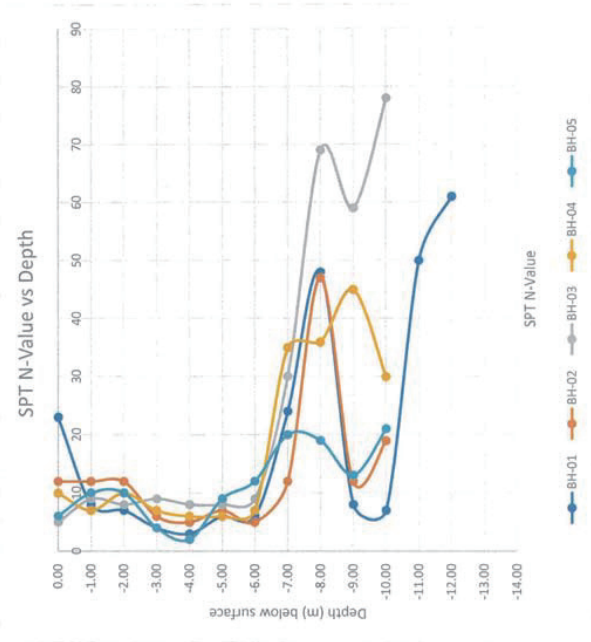
Figure 4. SPT vs Depth graph of boreholes

Results from the SPT clearly identify difference in material properties below the surface. The clay layer generally from 0 – 6m depth with an average N-value of 8 while the Alluvial gravel below the clay tends to show increasing N-value with depth, with an average N = 33. Footing shall be considered for depths between 1m and 2m.

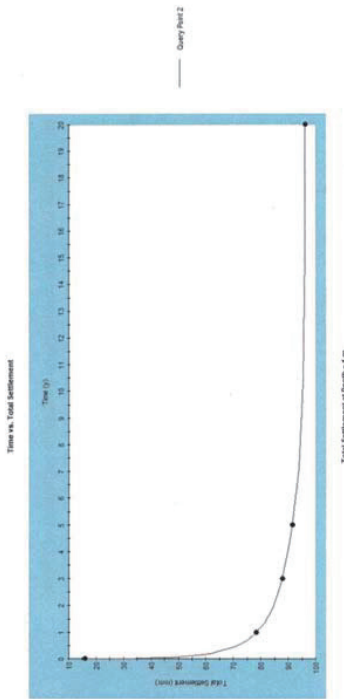
Figure 5. Graph of time vs consolidation settlement

- Immediate Settlement – 16mm -20mm
- Consolidation Settlement – 16mm to 96mm after year 10 of building service life

Final settlement estimates will be evaluated once building loads are determined.

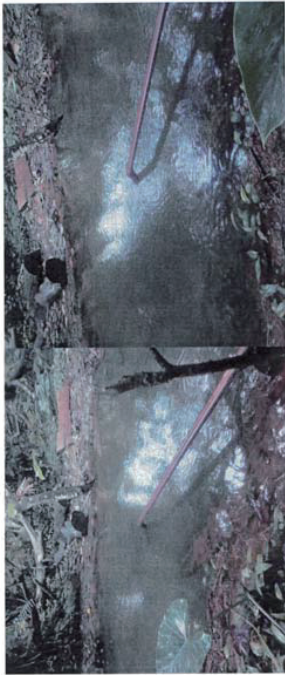
❖ Water Source

It should be noted that contamination of the water source is very likely considering that there are residential homes and villages close to the water source less than 100m away.

The microbiology test results indicate that the presence of E.Coli at the water source and in the taps is considerably higher than the recommended guideline of the WHO and is deemed unsafe for consumption. Contamination of the water source is also possible from human activities in close proximity to the water source as houses and dwellings are built around the area of the water source.

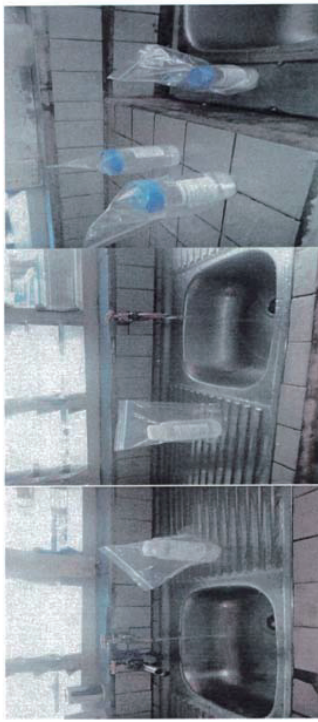
❖ Kitchen Tap Samples

E. coli is a more specific indicator of faecal contamination and is a potentially more harmful pathogen than other bacteria typically found in the total coliform group. The presence of coliform bacteria in tap water suggests that there could be a problem with existing equipment or treatment systems, contamination of the source water or a breach in the distribution system that could introduce *E. coli* contamination.

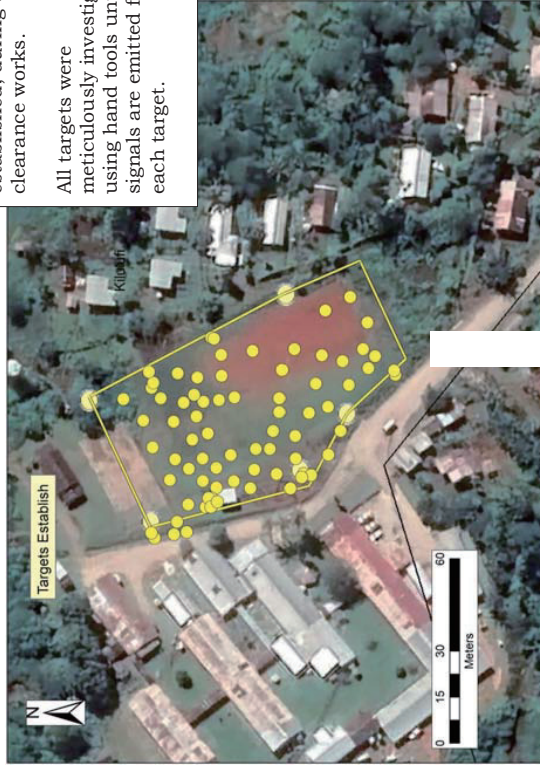
Targets Established Map

A total of 80 targets were established, during the UXO clearance works.

All targets were meticulously investigated using hand tools until no signals are emitted from each target.

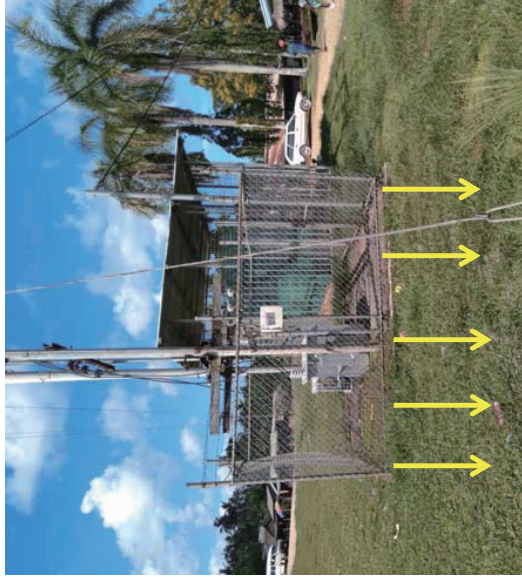
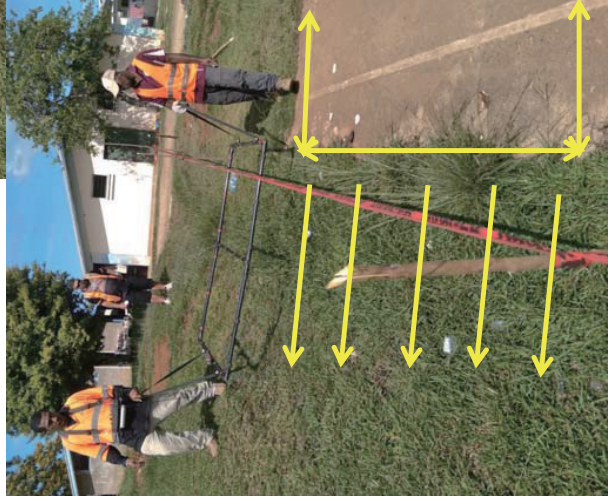
Heavy interferences from steel rods in the concrete slab
