**Republic of Indonesia, Ministry of Public Works
Directorate General of Water Resources**

**Indonesia
Expert Dispatch Scheme
Dam Design and Construction
Advisory Services**

**Completion Report
Supporting Report 3
Establishment of Risks Management System
in Dam Construction**

**Study on
"The necessity and Methods of Risk Management"
(presented in Workshop, INACOLD Seminar in 2023/2024)**

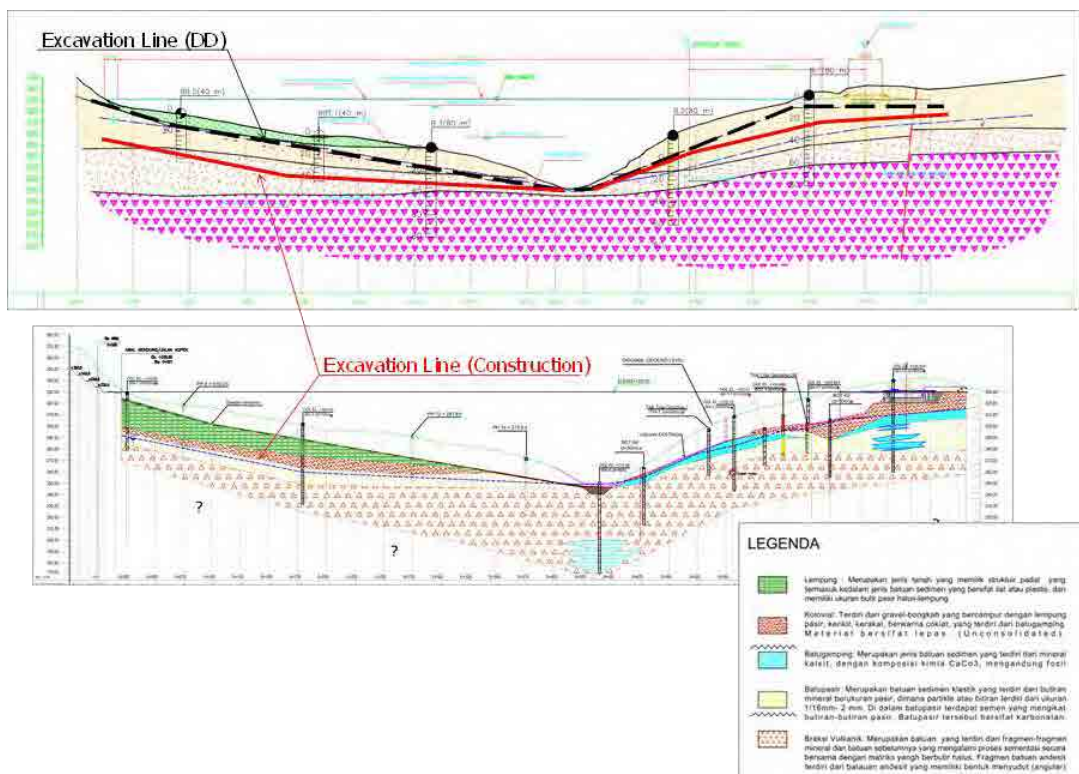
Figure 2.10 Example of Change in Foundation Excavation Line (Bagong Dam)

It is estimated that the cause of this was a lack of geological surveys and incorrect geological interpretation in design phase.

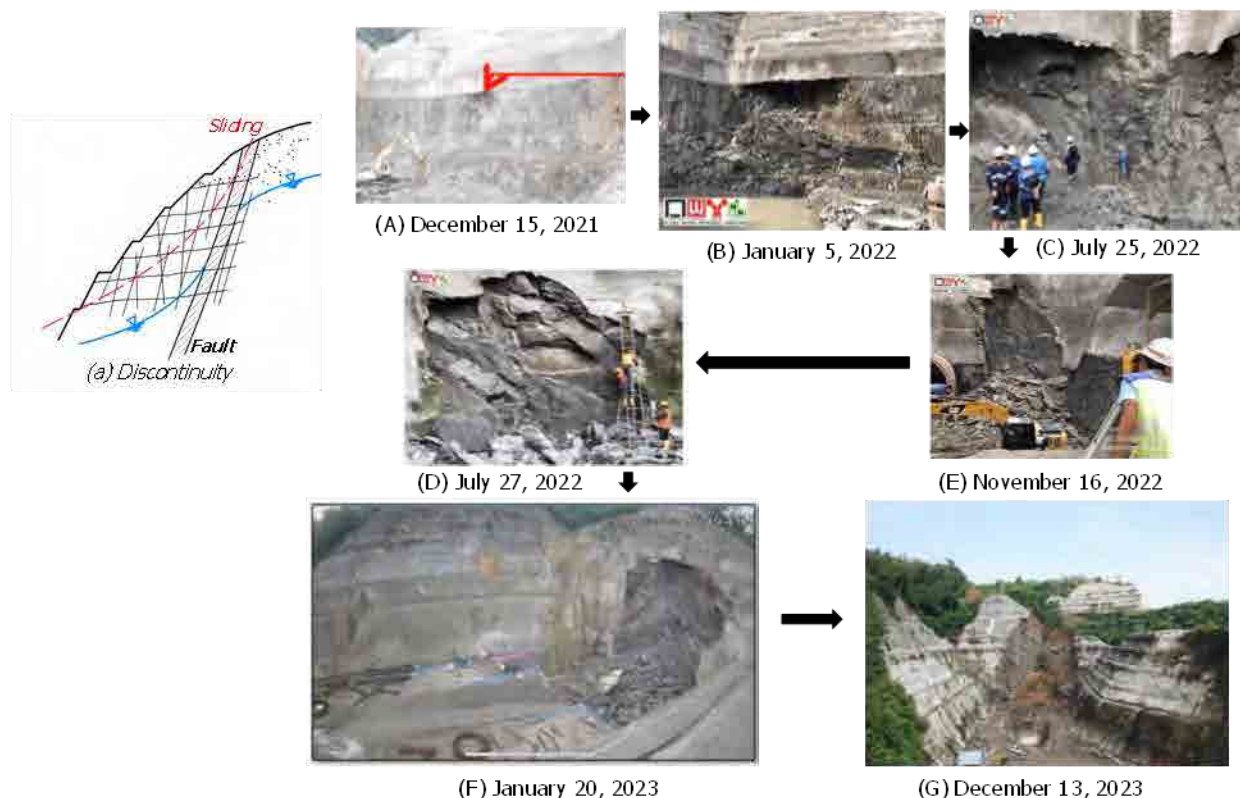
Figure 2.19 Large-scale Sliding Occurred on Cut Slope (Rukoh Dam)

Considering these geological conditions, it is necessary to change the shape of the cut slope during the excavation or measures are needed to prevent the bedrock from loosening.

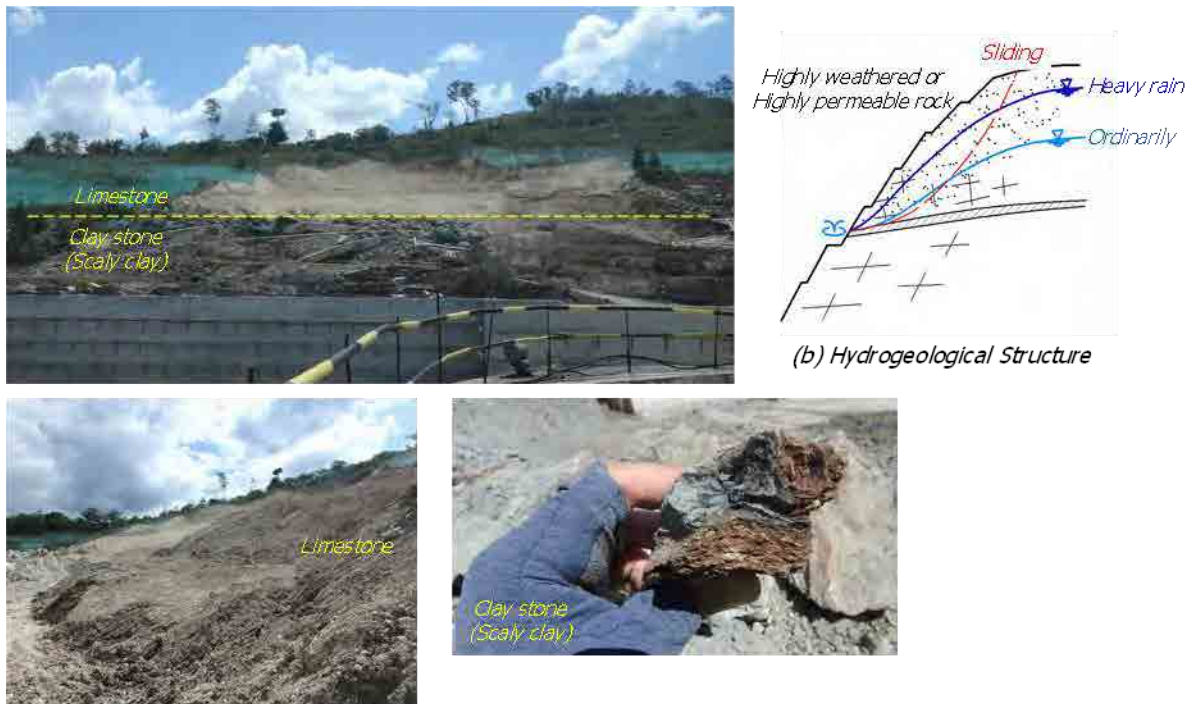
Figure 2.20 Large-scale Sliding Occurred on Cut Slope (Temef Dam)

Figure 2.20 shows a case of a landslide caused by hydrogeological structures. This landslide occurred at the spillway site of Temef Dam. The geology of the cut slope is a claystone layer with an overlying limestone layer. In addition to the hydrogeological structure, the claystone layer was also a cause of the landslide because it was scaly clay. Considering these geological conditions, measures are needed to prevent the bedrock from loosening and to remove groundwater from the slope as much as possible.

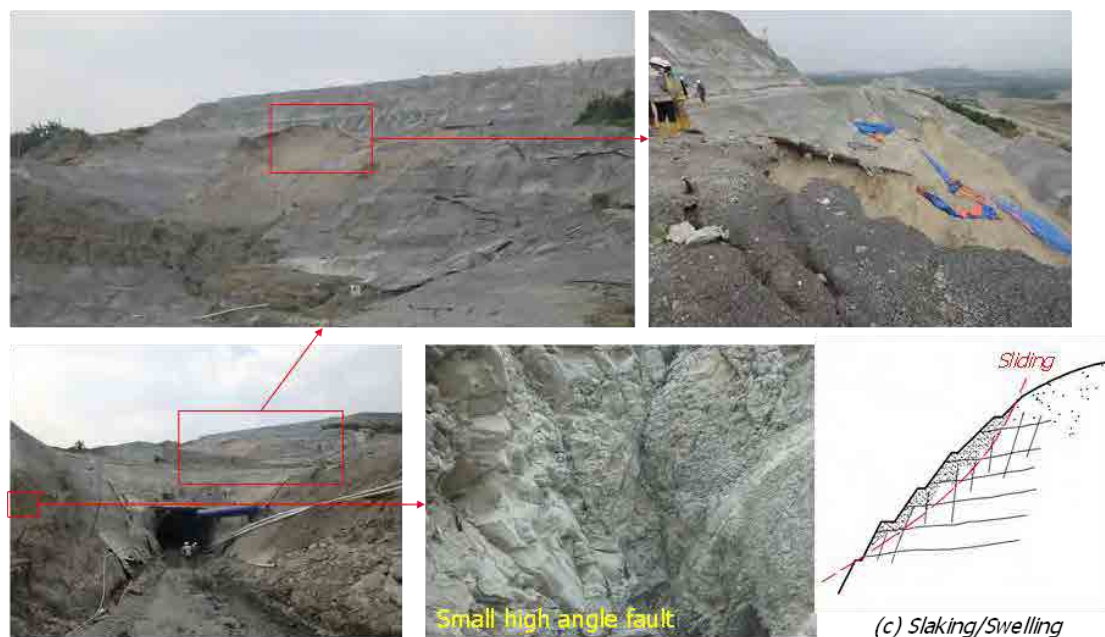
Figure 2.21 Large-scale Sliding Occurred on Cut Slope (Jragung Dam)

Figure 2.21 shows a case of a landslide caused by slaking. This landslide occurred at the intake tower site of Jragung Dam. The geology of the cut slope is claystone. There is also a folded structure around the dam site, with small high-angle faults as shown in the photo. I believe this was also a cause of the landslide. Considering these geological conditions, measures are needed to prevent deterioration of the bedrock and to prevent the infiltration of surface water into the cut slope.

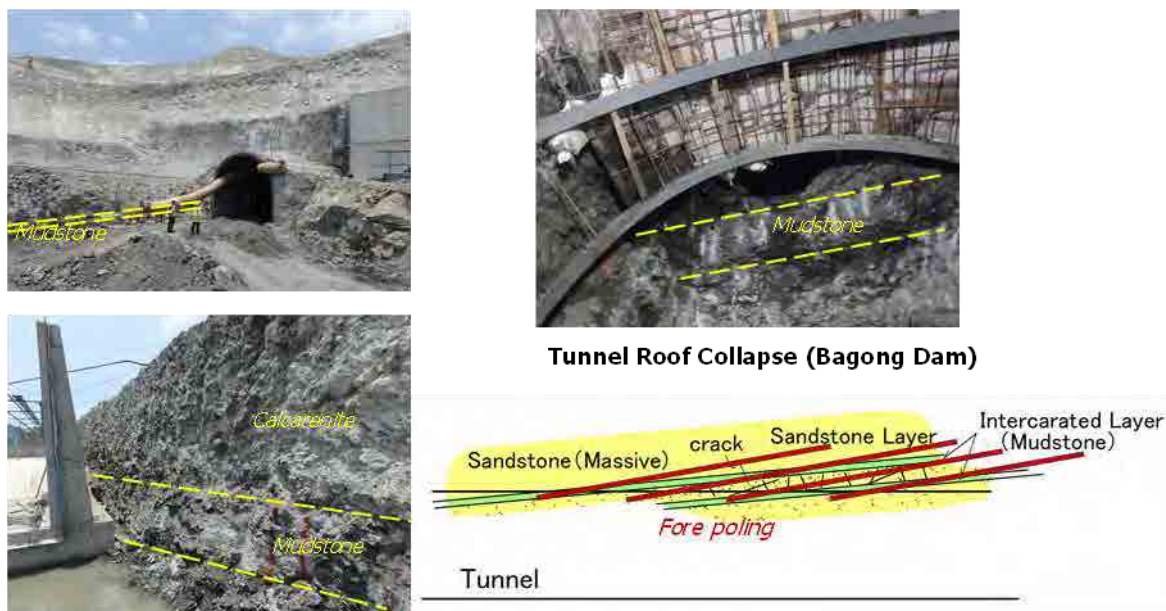
Figure 2.25 Auxiliary Construction for Tunnel Roof Collapse

Figure 2.25 shows a case of roof collapse in the diversion tunnel of Bagong Dam. The cause of the collapse, the georisk factor, was a low-angle discontinuity developed along the bedding plane. Since such geological structures can be predicted in advance, it is possible to design auxiliary works such as fore poling at the design phase.

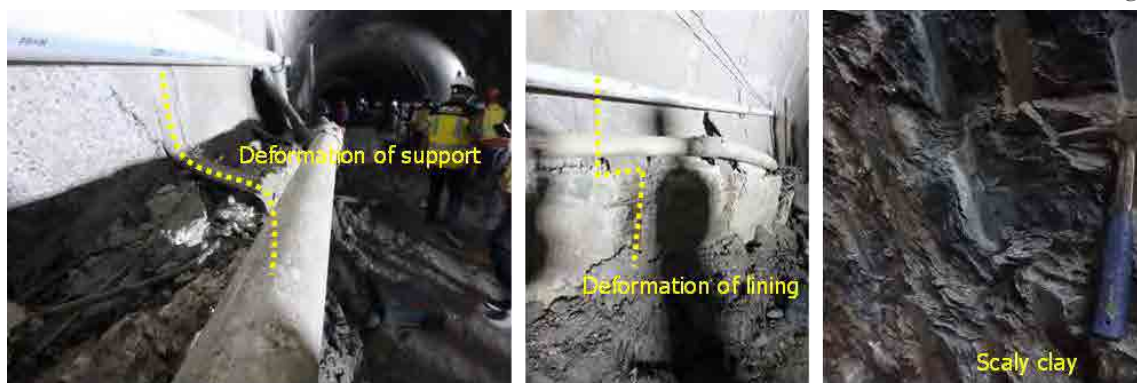
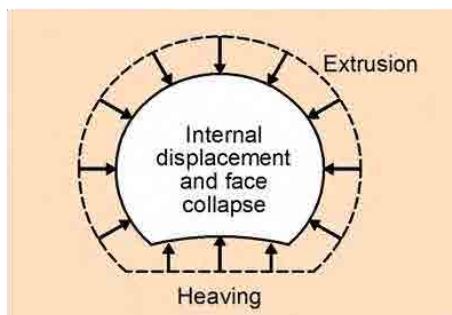
Conceptual Diagram of Tunnel Deformation due to Swelling

Figure 2.26 shows a case of the deformation in the spillway tunnel of Manikin Dam. The cause is the swelling pressure of scaly clay.

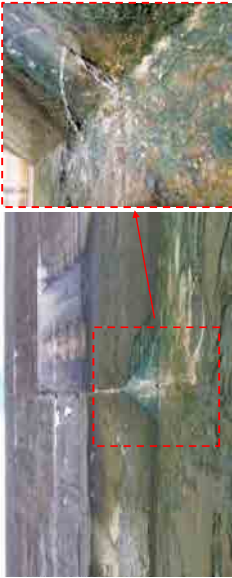
<p>Photo-1 Condition of spillway crack before improvement</p>

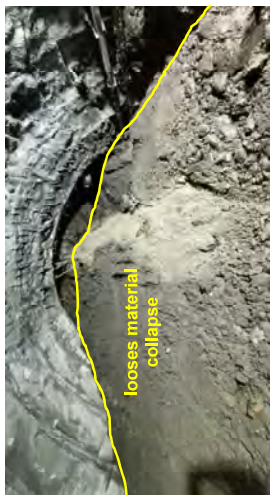
<p>looses material collapse</p> <p>Figure-2 loose material collapse from tunnel</p>

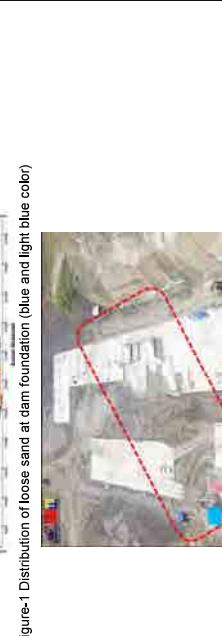
Figure-1 Distribution of loose sand at dam foundation (blue and light blue color)

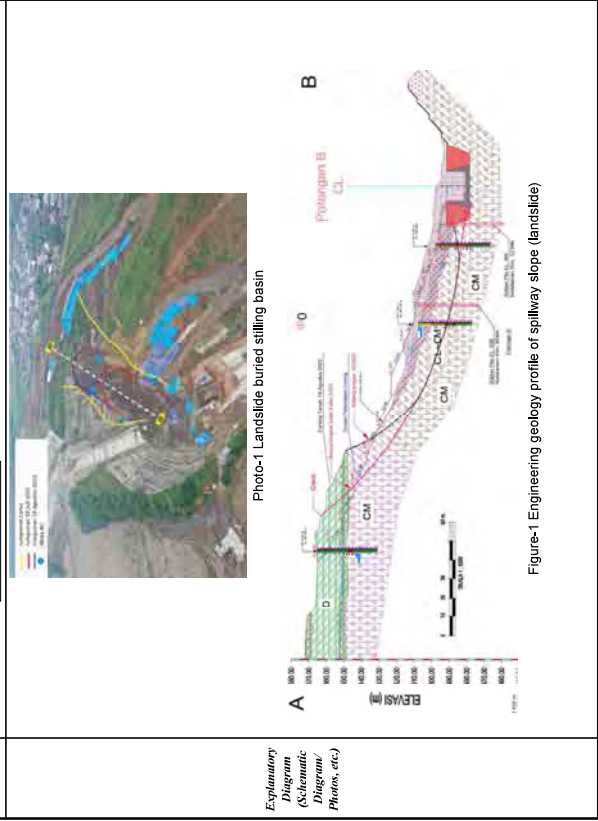
Figure-1 Engineering geology profile of spillway slope (landslide)

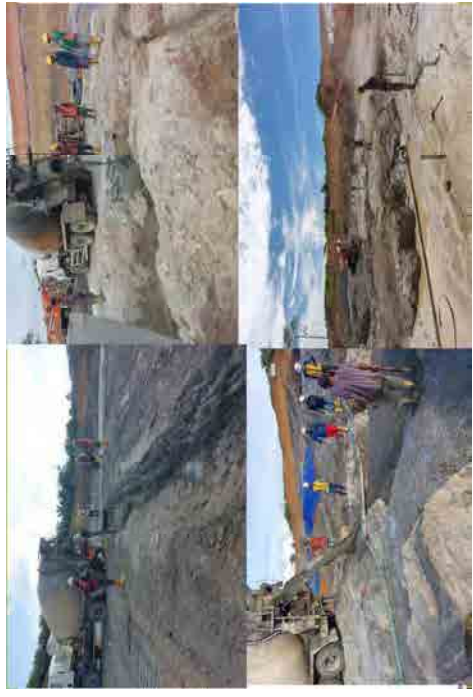
Photo-1 Rock foundation condition of Sepaku Semol Dam

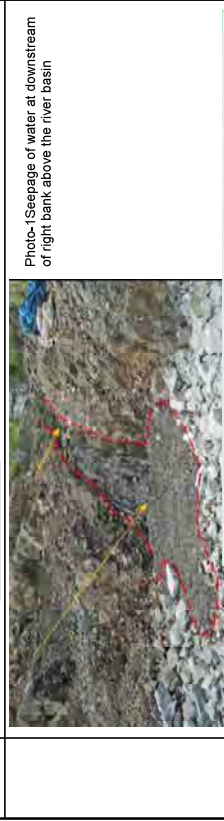
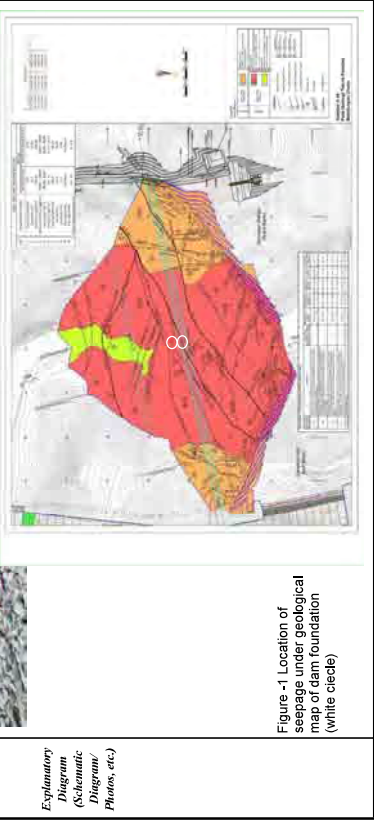
Figure -1 Location of seepage under geological map of dam foundation (white circle)
