**Indonesia  
Expert Dispatch Scheme  
Dam Design and Construction  
Advisory Services**

**Completion Report  
Data Book**

**February 2025**

# *1. Site Inspection Reports*

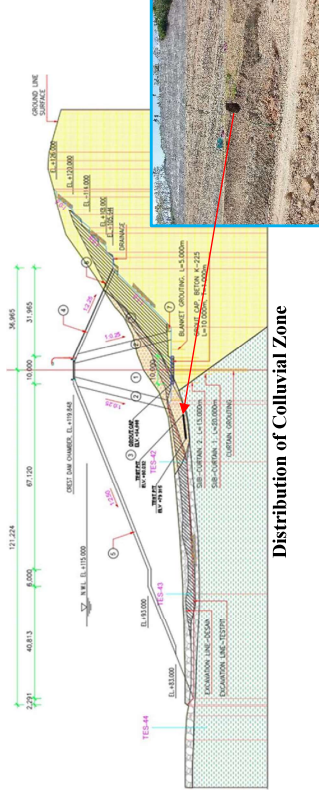
After excavation of the dam foundation on the right abutment, a colluvial zone has been observed. The Colluvial zone is judged as an unsuitable material for dam core foundation so it must be removed. In case the Colluvial zone on the foundation is removed, the shape of foundation will be inclined suddenly at around one third upstream of core foundation zone.

One of the countermeasures is to finish the foundation excavation surface smoothly so as not to leave sudden changes in the core foundation surface. However, since the Grout Cap Concrete has already been placed and the grouting has been completed, the best way at this time is to replace the excavated Colluvial zone with concrete and create a flat core foundation.

The Consultant has already conducted a structural analysis of the dam stability under the conditions of whit/without of the concrete replacement, and has confirmed that the replacement with concrete will ensure the stability of the dam.

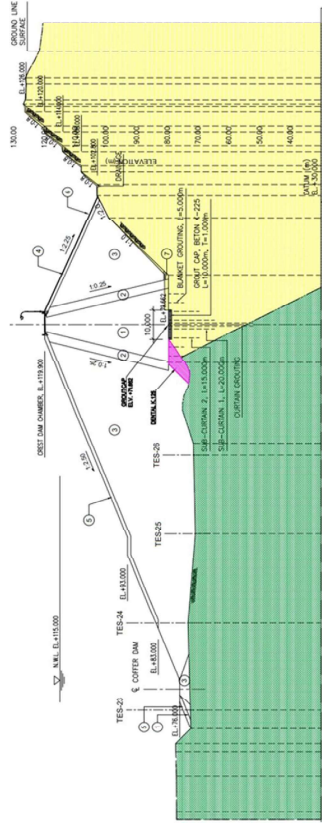
**Proposed Dental Work (Replacement with Concrete)**

In general, immediately after finishing the foundation excavation, the Site Engineers shall inspect the actual condition at site and make judgement whether the rock condition is good for dam foundation or not. In this case, before confirmation of the condition at site, the cap concrete was placed and grouting works were commenced remaining this colluvial zaon in the dam foundation.

It is essential that the engineering judgement before commencement of following works when technical issue found.

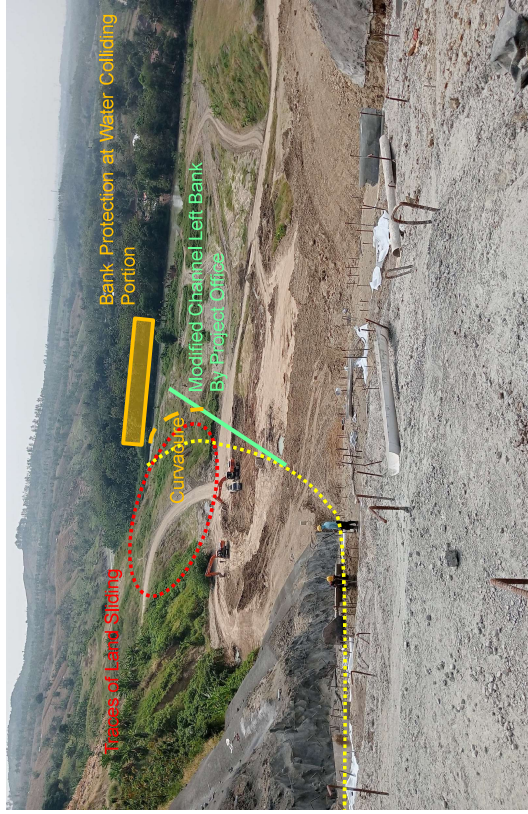
At the left bank of the river connecting channel of the spillway, trace of sliding is observed and it is anticipated that excavated slope will slide. The Site Engineer proposed straightening the channel alignment to escape the colluvial area.

For implementation of this modification, the hydraulic condition at the connection point with old river must be evaluated and some measures such as bank protection at water colliding portion or curvature of channel shall be provide, if necessary.

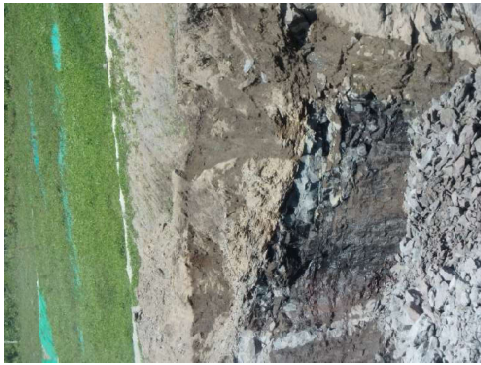
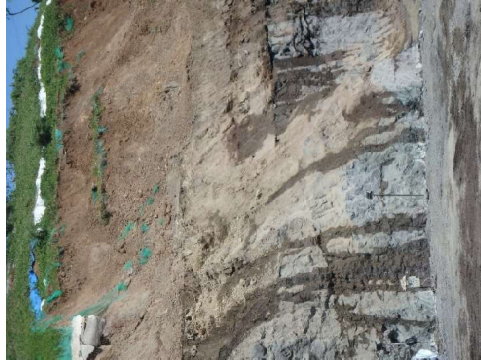
Weathered Basalt on Cut Slope and Collapse in the Soil Layer

The cut slope composed of residual soil of weathered rocks has collapsed on a small scale. In order to protect this slope, it is necessary to remake the cutting slope gentler or to provide slope protection works other than sodding or Geo-net which is proposed by site office because sliding occurred in the soil layer, not slope surface erosion.

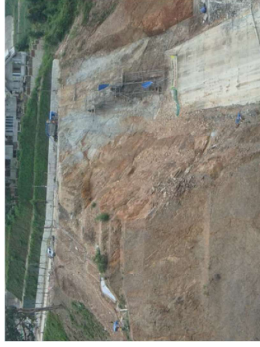
A small-scale slope failure is observed on the cut slope. As discussed above (Geological Structure), due to the cleavage developing parallel to the dam axis and tend to weathered and loosen. The weathered shale will be a cause of surface failure and small-scale collapses.

For this reason, many cut slopes are sprayed with mortar.

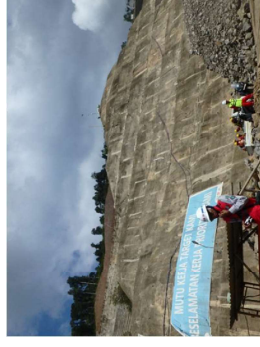
- (2) Cut-Slope at Diversion Tunnel Outlet

Cracks are observed on the shotcrete concrete of the cut-slope right bank of diversion tunnel outlet. According to the geotechnical engineer at the site, since cracks had occurred, rock bolts (3m) were installed and the deformation of the slope was being monitored. The length of the rock bolts was designed considering the surrounding geological conditions.

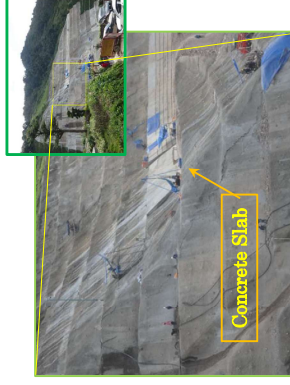
- (3) Cut Slope at Spillway

Slope stabilization works had been conducted on the cut-slope. Geo-net was installed in the upstream area where fresh rock are distributed, and at the weathered rocks area in the downstream, reinforced concrete slab (15cm thick) are overlaid after placing shotcrete (10cm thick)..

It is supposed that the applied countermeasures are probably appropriate. In case in Japan, however, "Concrete Frame Works with Rock Bolt" is supposed to be applied, judging from the geological condition at site.

Since several small slope failures have been observed at site, continuous monitoring of movement of the cracks and slope surface shall be conducted.

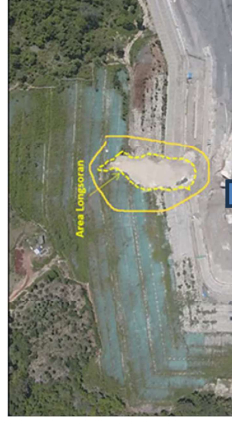
The sliding area has been expanding as shown in photos below.

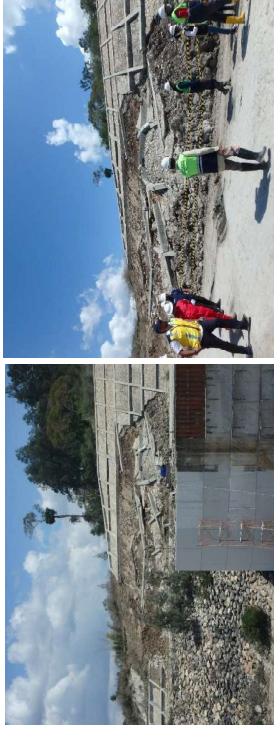
Scaly clay is observed on the slip surface.

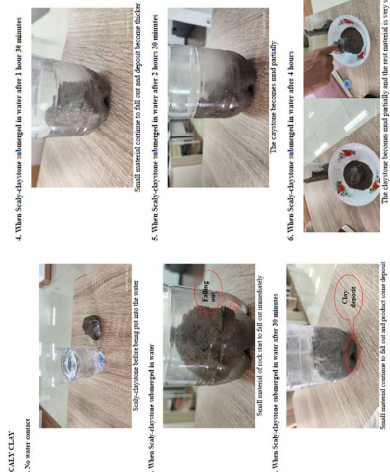
The swelling of the scaly claystone was extremely rapid, and when the sampled rock at the tunnel was soaked in water, it became completely clay in about 4 hours as shown in right figure.

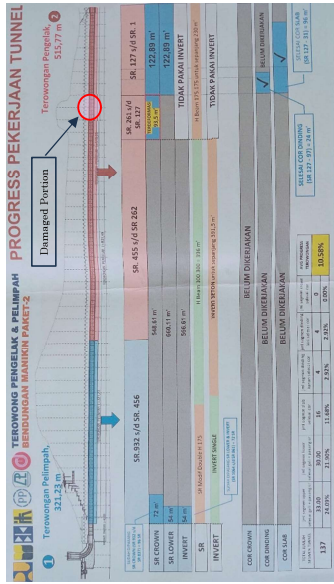
At 160 m from tunnel outlet, damage of tunnel support had occurred then the works has been stopped.

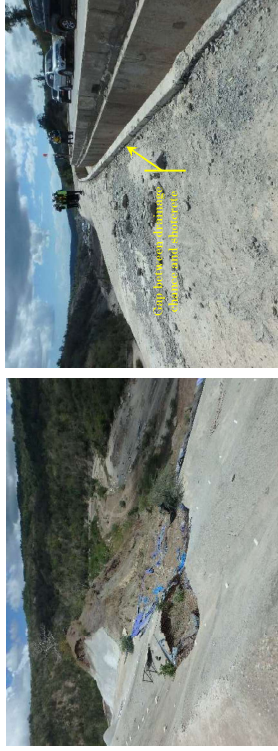
Photo 1 Access Rode on Right Abutment

As shown in Photo 1 for the first case, the roadside drainage ditches are provided at a level lower than the road surface, making it easy for rainwater to permeate behind the shotcrete. On the other hands, the deterioration of the spillway excavation slope and the development of gully, shown in Photo 2, are considered to correspond to the latter.

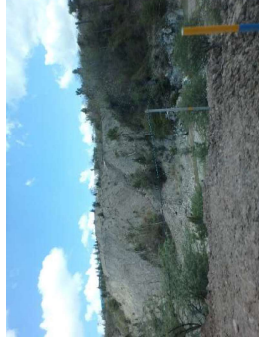
Surface failure is observed on the slope upstream of the dam site (right photo).

It is anticipated that ground water level will raise up after impounding reservoir and the surface layer of the slope around the reservoir may deteriorate due to swelling/slaking. The slope failure will occur more easily than before impounding and the collapse may expand to the upper part of the slope.

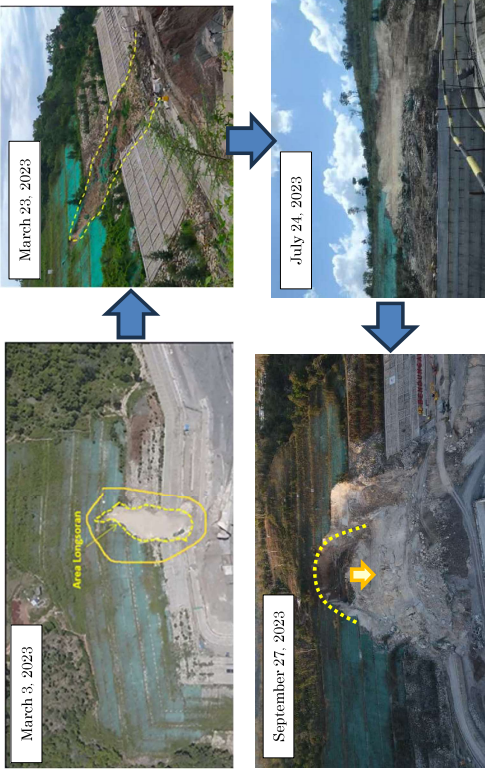
Sliding area has been developing toward upstream and upward.
