### Consideration on Geology of Bagong Damsite

## Suggestion on Treatment of Colluvium at Bagong Damsite Right Abutment and Spillway Foundation

JICA Dam Construction Advisors  
Hiroshi Shimizu  
Naoya Mizuno

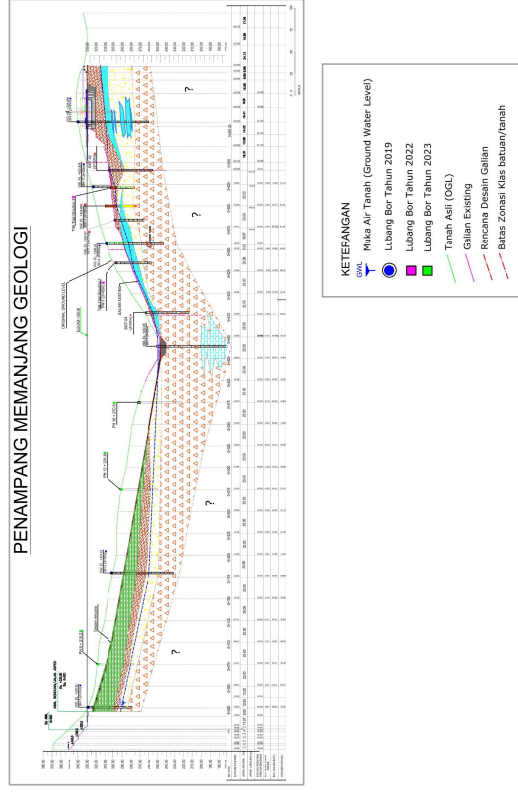
Figure-2 Geological cross section of the dam axis.

- After the start of construction, it was found that "Colluvium" was thickly distributed on the slopes on both banks of the dam site (Figure-2). However, the properties of colluvium differ between the right and left banks. The colluvium classified on the right bank is very loose rock mass, the origin of which is estimated to be creep or landslide (Photo-1, Photo-2).

- The dip of the strata observed during the field visit is almost horizontal to less than  $10^\circ$ . However, according to the geological cross section of the dam axis shown in Figure-2, the distribution altitude of limestone is slightly different between the right and left banks, which may indicate the distribution of old faults in the riverbed (which can be confirmed by excavating of the riverbed area).

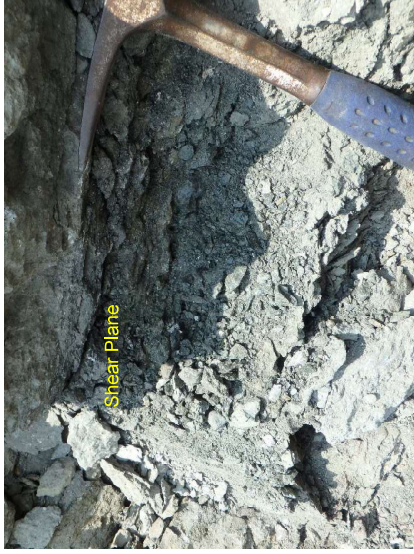
Photo-3 Claystone Layer in the Wonosari Formation.

- According to the regional geological map, several northeast-southwest and north-south faults have developed around the dam site (see Figure 1).
- High-angle fractures have developed in the limestone and sandstone in the Wonosari Formation distributed at the dam site. Fractures are developed in the thin claystone layers, which have partial slickensides (Photo-3).

Fine fissures are developed and partially fissure surfaces have slickensides.

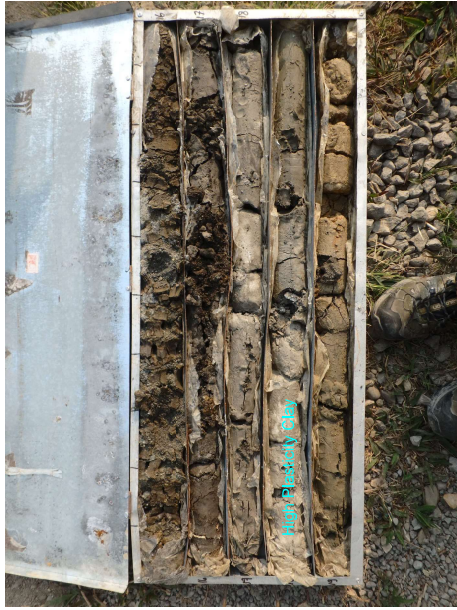
- In general, the slip layer consists of highly plastic clay. Due to the shear surfaces (foliation) caused by creep and sliding, they are anisotropic in strength and have a lower strength than normal clays. During the site inspection, highly plastic clay was observed at a depth of 17-19 m in borehole BGT-5 (Photo-5).

**Photo-5 Core samples from borehole BGT-5 at depths of 15-20 m**  
Highly plastic clays are recognized at depths of 17-19m.

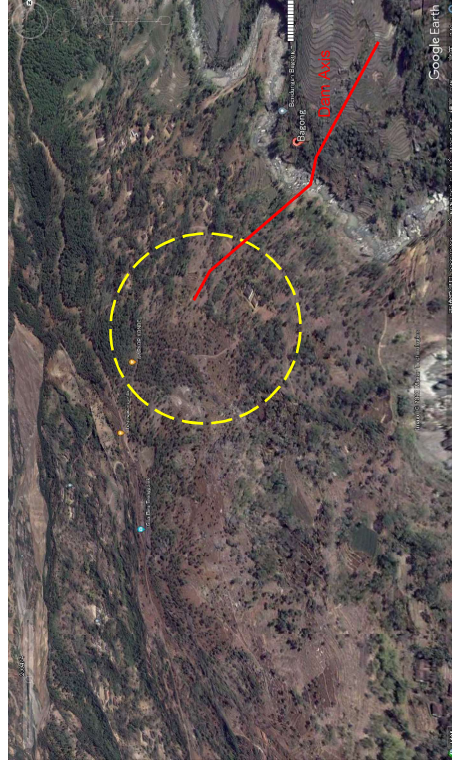
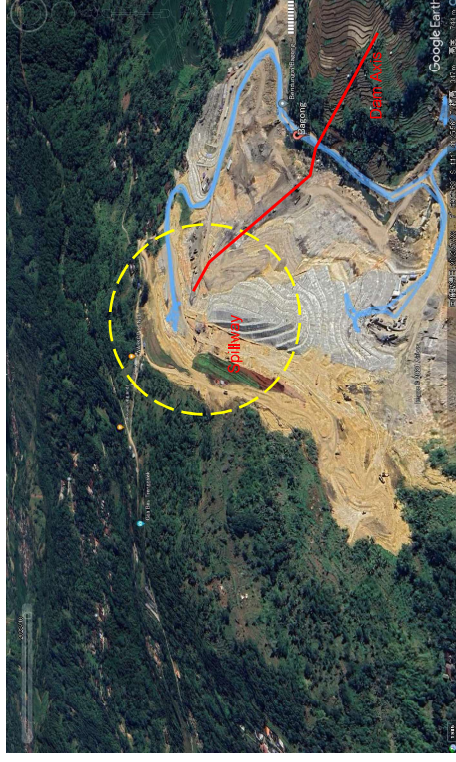
**Photo-4 Satellite image of the left bank of the dam site.**

**a) Satellite image taken on 29 August 2003**

**b) Satellite image taken on 22 July 2023.**

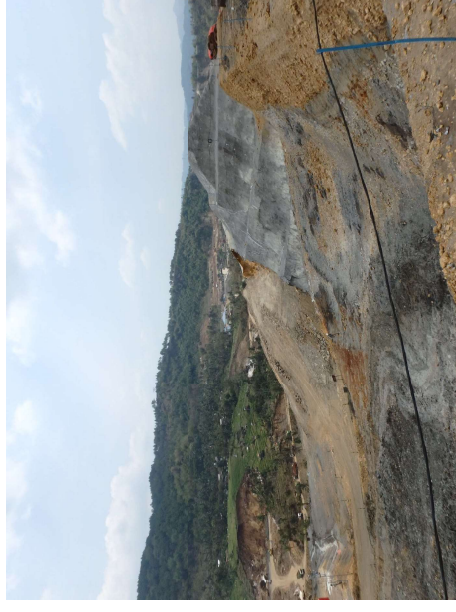
**Photo-6: Slope left between the spillway and the embankment.**

The slope of the cut is 1:2.0 and soil nails have been used.

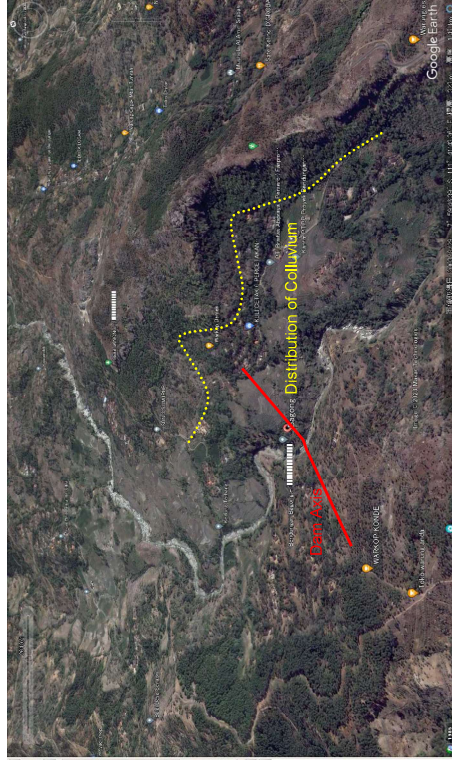
- According to Google Earth satellite imagery, steep slopes or cliffs can be seen above the left bank slope (Photo-7). It is estimated that the sediment generated by the slope failure near the summit has repeatedly moved and accumulated due to colluvium and debris flows, forming a thick layer of colluvium below the slope, and the area where colluvium is distributed forms a gentle slope.
- The above colluvium is covered with volcanic ash. According to the geological cross section of the dam axis in Figure-2, the distribution of the layer is thicker upslope and reaches more than 20 meters.

Photo-7 Satellite image of the right bank of the dam site, 29 August 2003.

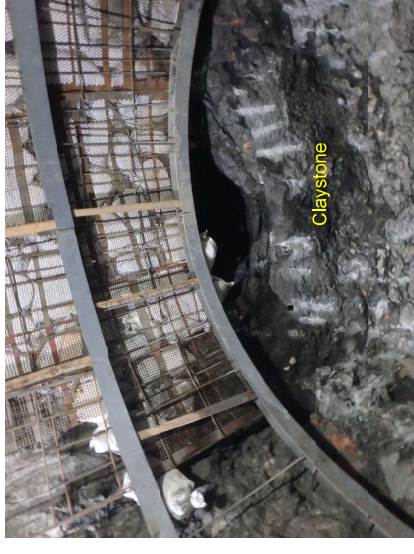
- A ceiling collapse occurred during the construction of the diversion tunnel (Photo-8). The strata observed at the outlet of the diversion works tunnel were calcareous sandstone (calcareenite), partially intercalated with thin layers of claystone (Photo-9).
- The geological structure is almost horizontal and the claystone layer above is brittle with well-developed shear planes (see Photo-3, Photo-10). The collapse points inspected on site show the distribution of a thin layer of claystone layers, which is estimated to be the cause of the ceiling collapse. Due to the relationship between the height of the tunnel and the geological structure, the claystone layer is distributed just near the ceiling.

Photo-8: Collapsed portion at the ceiling of the diversion tunnel.

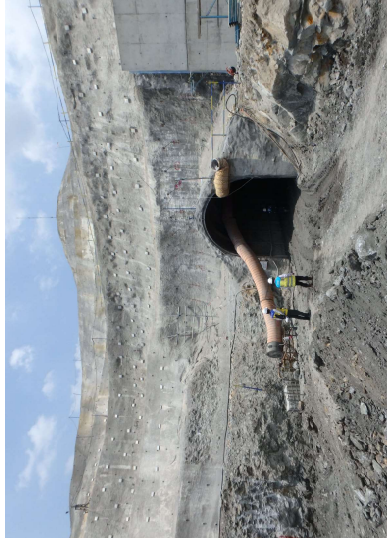
Photo-9 Rock mass conditions near the outlet of the diversion tunnel (1).

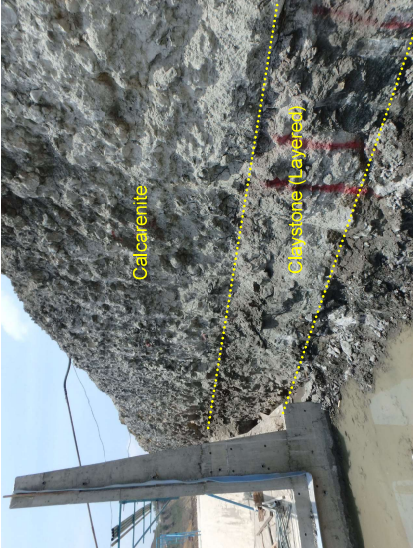
Photo-10 Rock conditions near the outlet of the diversion tunnel (2)

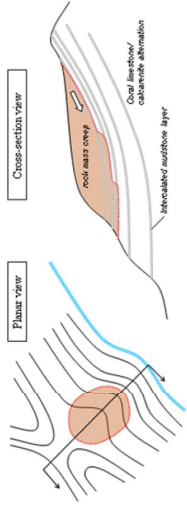
- Several thin clay layer is confirmed in the boring photos of GBT-05 and GBT-02 (see Photo 1 & 2 in annex 1 (A1)), and the lowest layer is probably distributes as shown in Figure A1.
- The upper layer of the thin clay layer is obviously loosened and showing characters of colluvium (eg. distribution of open cracks, weathering condition and remaining of geological structure in the sliding mass), and,
- No topography suggestive of land sliding around the right bank slope (e.g. slip cliffs, gentle gradients at the head and the short distance of movement, etc.) (by reading of Google Earth satellite image).

**Schematic diagram of rock creep on the right bank**

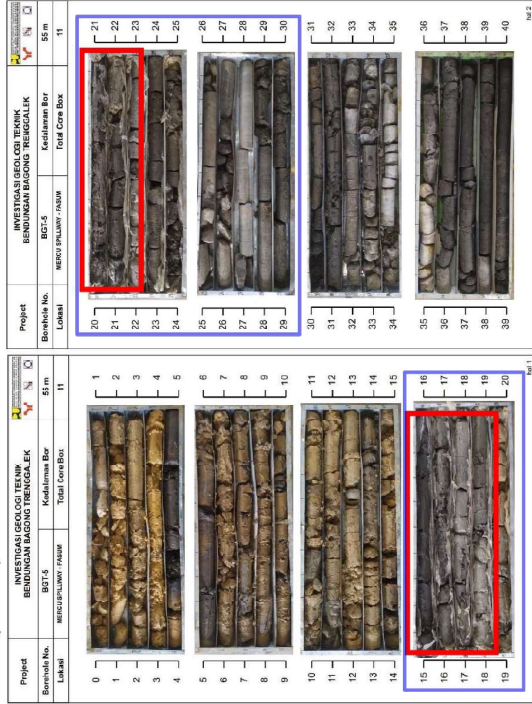
Phot 1

- BGT-5 (55/75 m)

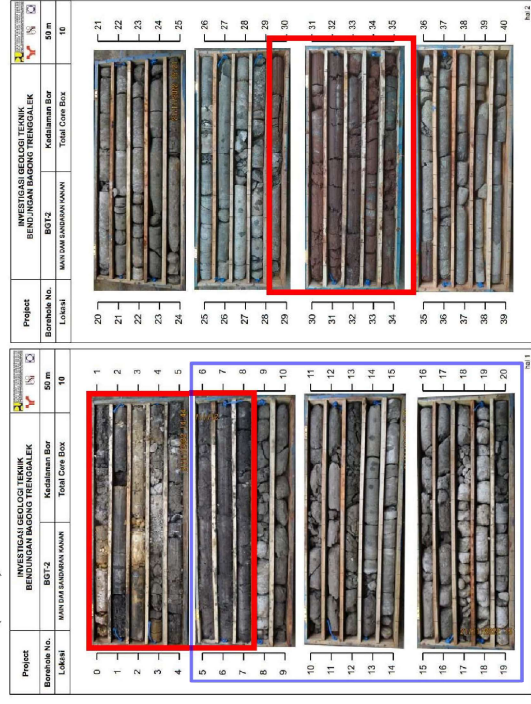
Phot 2

- BGT-2 (50 m)

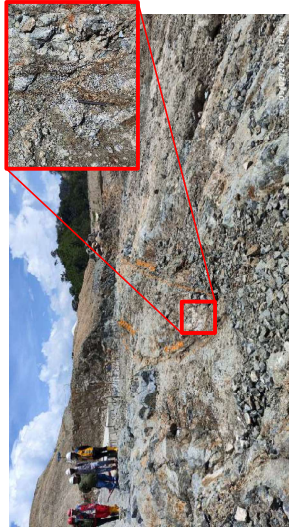
At present, although the details of them are not confirmed because the foundation excavation has not been completed, it is supposed that these issues will not be a critical problems considering the scale of fault.

**Figure 2** Fault Crossing Core Foundation

Since the core foundation of Bulango Ulu Dam will be covered with grout cap concrete, it is recommended that to conduct a trench excavation and replace it with concrete along the fault at the core foundation area, if necessary.

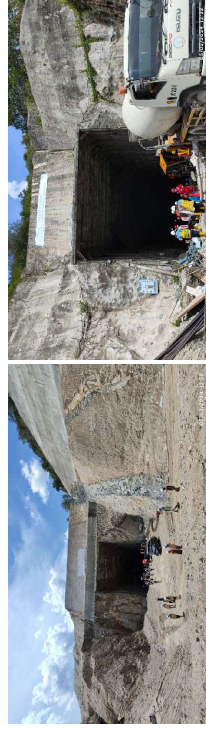
The spillway of Bulango ulu dam is tunnel spillway with Faults and Intrusion were observed around the spillway excavation.

Surrounding intrusion rock (dike), the base rock (Granodiorite) has been weathered and decompressed then It's like sand. It is necessary to protect the excavated surface not to develop the weathering.

**Figure 3** Inlet (left) and Outlet (right) of Spillway of Bulango Ulu Dam

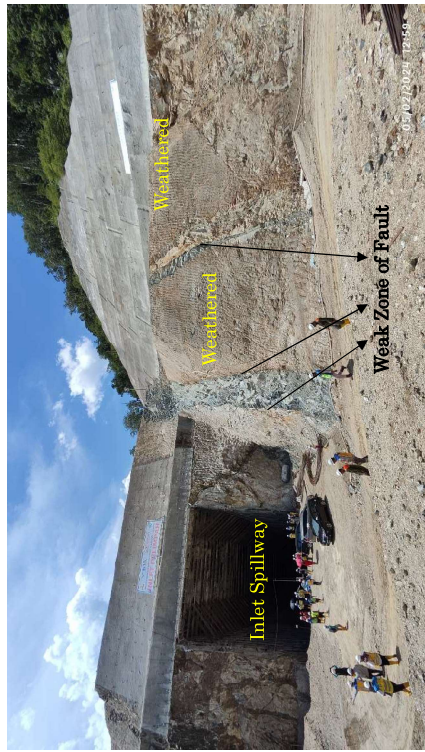
- (2) Spillway Inlet and Outlet
- Surrounding intrusion rock (dike), the base rock (Granodiorite) has been weathered and decompressed then it's like sand. It is necessary to protect the excavated surface not to develop the weathering.
- At the inlet of the tunnel, a fault in the granitic rock is clearly visible. Although the fault has been backfilled by the intrusion of more alkaline rocks, the boundary between the two rocks appears to have a fracture that becomes a weak zone. Improvements to the location are required by grouting to minimize the permeability value of the rock to prevent side seepage through the weak zone.

**Weathered and fault at the inlet of spillway tunnel**

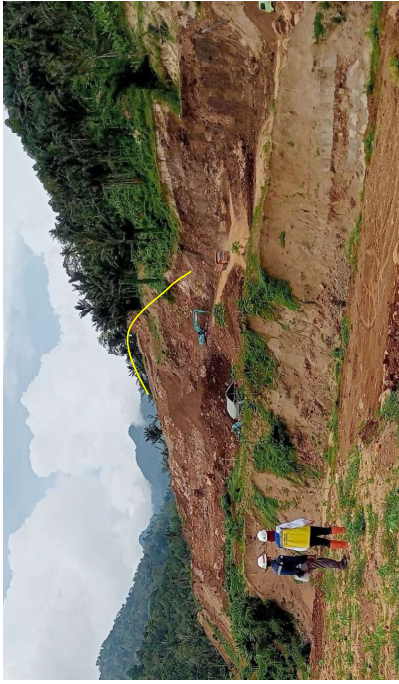
Sliding has occurred at the excavation slope of borrow pits.

The development plan of borrow pit was not established and the Contractor collecting materials from the toe of the area. The excavation surface is steep and there is a high risk of collapse.

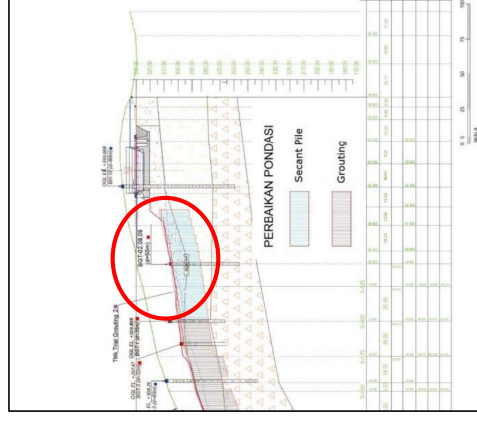
Figure 2 Colluvium at right abutment foundation

(4) at the right abutment near the spillway, the dam foundation is still on colluvium. It recommended that all colluvium deposits should be removed and replaced with dental concrete or all replaced with core fill material completely (removing the installed secant piles as well).

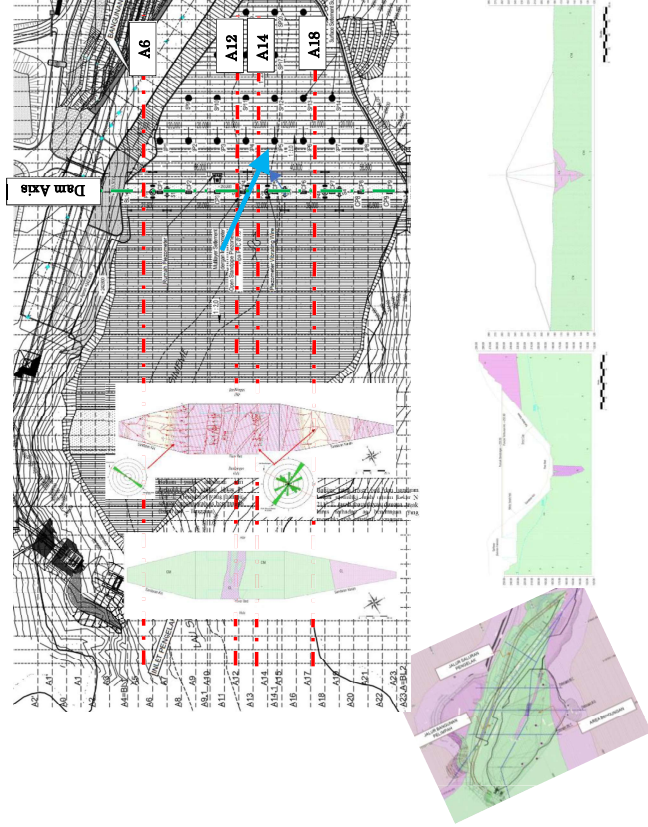
Distribution of Weak Zone in Core Foundation

Before impounding the reservoir, it is necessary to clarify the cause of sudden change of pore water pressure and consider measures to be taken in the event of excessive leakage after impounding reservoir.

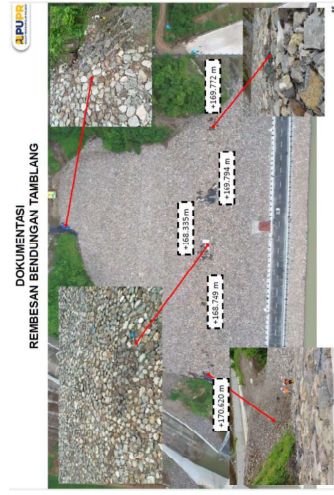
### Location of Leakage from Dam Body

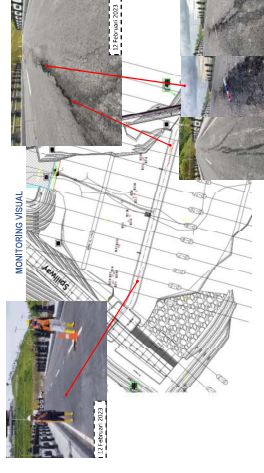
Figure 1 Crack on the Dam Crest Road

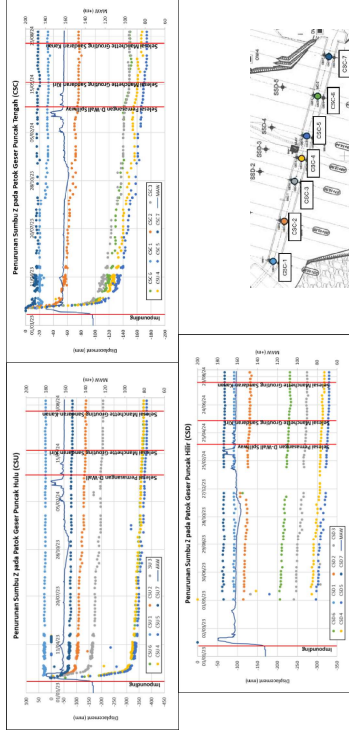
Figure 2 Settlement at the Dam Crest
