1. Minutes of Meetings

Dam Discussion by Balai Teknik Bendungan

**TECHNICAL DISCUSSION ON THE CONSTRUCTION OF THE TEMEF DAM, TIMOR
TENGGAH SELATAN AND MANIKIN DAM, KUPANG REGENCY, EAST NUSA
TENGGARARA PROVINCE**

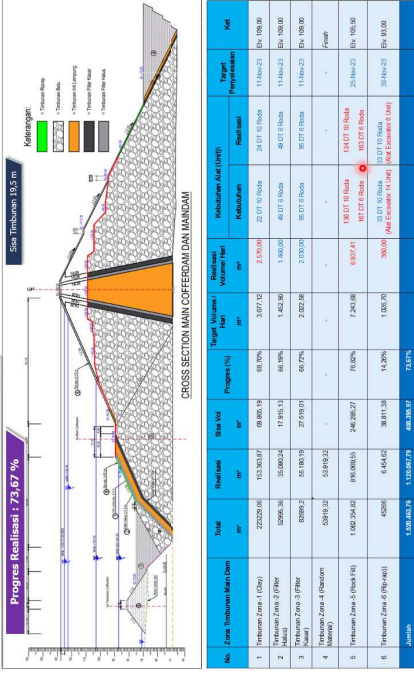
1. It was reported that the realization of the volume/day of embankment work did not reach the target.
 - a. In order for the initial filling of the reservoir to be carried out according to the planned schedule, an acceleration plan should be drawn up to achieve the target, for example by adding human resources and heavy equipment.
 - b. In achieving the target of the filling work, supervision should be carried out and it should be ensured that the filling results meet the required technical specifications by carrying out strict quality control in accordance with the work instructions (IK) that have been determined by the contractor and consultant.

Figure 4: Realization of dam body work has reached 73.67%

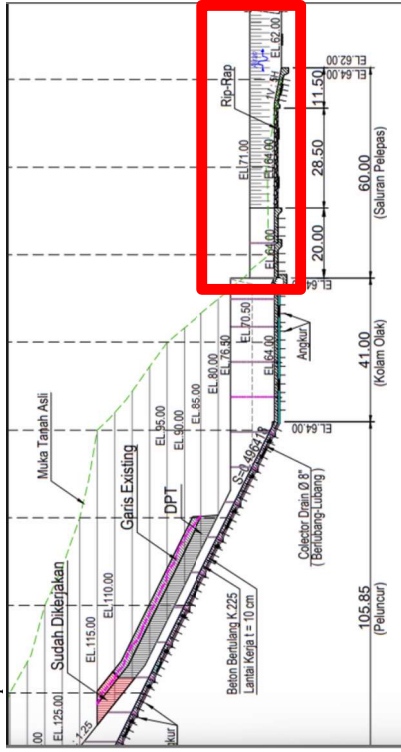
Figure 5: Longitudinal cross-section of the spillway structure

2. With the design of the spillway structure presented, it appears that there is no stilling basin, so it is estimated that the energy of the water flow from the launch channel when it reaches the end sill is still high.
 - a. If possible, consider having the end sill upstream equipped with groundills or concrete blocks.
 - b. In the longitudinal cross-section of the spillway structure, the water flow profile should be depicted based on the results of the test model.
 - c. It is reported that the spillway construction has reached the end sill, so to increase energy absorption, a 3-5 m high embankment/revetment construction will be added

downstream of the end sill. To evaluate the safety of the structure, the connection details between the existing structure and the structure to be added should be reported.

- It is reported that the physical hydraulic modeling of the spillway structure was only carried out up to the Q5 return flood. In accordance with the Guidelines for Designing Embankment Dams Volume IV (1999), physical hydraulic modeling should be carried out up to Q100 in the stilling basin and Q1000 in the launch channel, so that areas in the spillway structure that have the potential to experience cavitation can be evaluated, so that they can be anticipated with design changes or reinforcement.

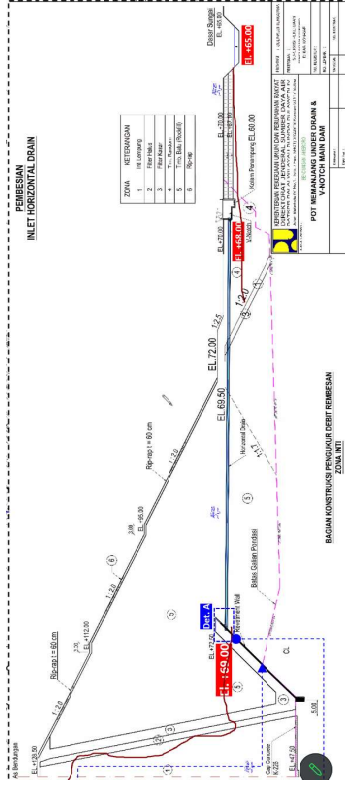
Figure 6: Cross-section of the v-notch design of the Ameroro Dam

- In the v-notch image presented, it can be seen that downstream of the seepage reservoir before the river, a fill construction has been made which is intended to prevent backwater from the river towards the v-notch.
 - Check the design considerations considering that the river elevation is below the elevation of the reservoir, which is feared to cause seepage to not be able to flow from the reservoir to the river.
 - The influence of embankments downstream of the seepage reservoir on the phreatic water conditions in the downstream rockfill zone should be analyzed. In this case, a comparison should be made between the safety factors in conditions with and without embankments downstream of the seepage reservoir.

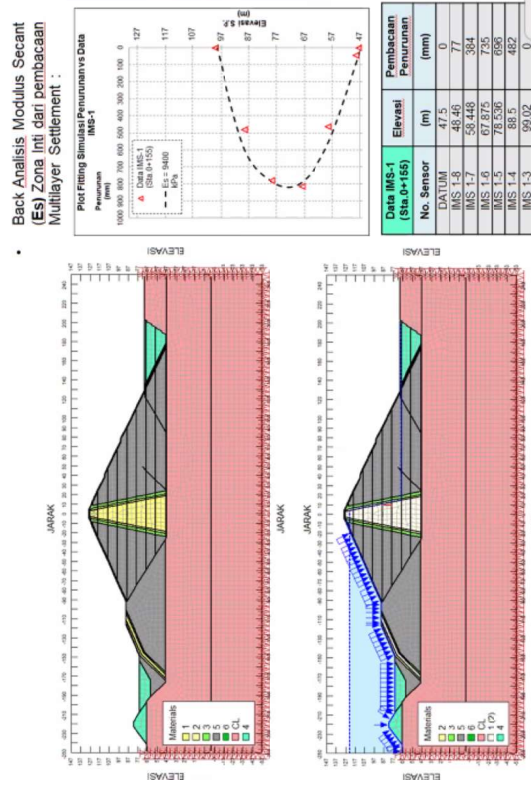
Figure 7: Results of back analysis in determining the secant modulus value of the Ameroro Dam

1. In the Ameroro Dam rockfill parameters used in the analysis model, the consultant used correlation parameters that were back analyzed and obtained the secant modulus (ES) value. A large scale triaxial test should be carried out to obtain the secant modulus (ES) value according to field conditions. Then, compare the secant modulus (ES) value and determine the results.

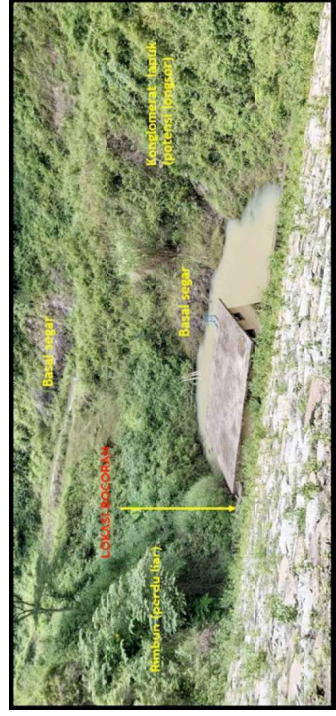
- Observations show leaks around the V-notch and on the right abutment of the dam.
- Action Required: A detailed analysis of seepage conditions supported by data needs to be conducted. It is also necessary to determine whether this seepage poses a safety risk to the dam structure.
-

Figure 1: Seepage near V-notch.

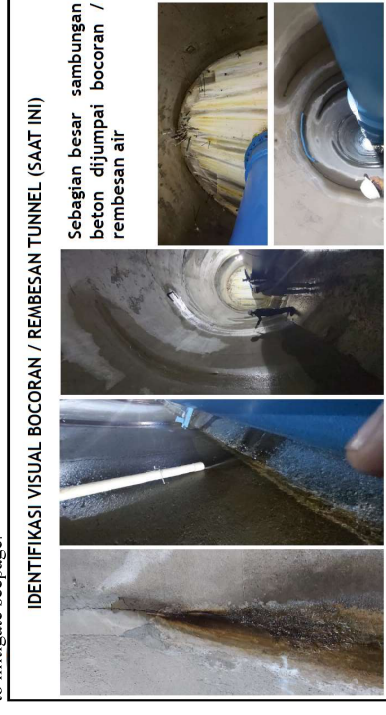
- Observations indicate seepage at the joint structure inside the tunnel as well as at the tunnel crown.
- Action Required: A thorough inspection and repair plan need to be implemented to mitigate seepage.

Figure 2: Water leakage at tunnel.

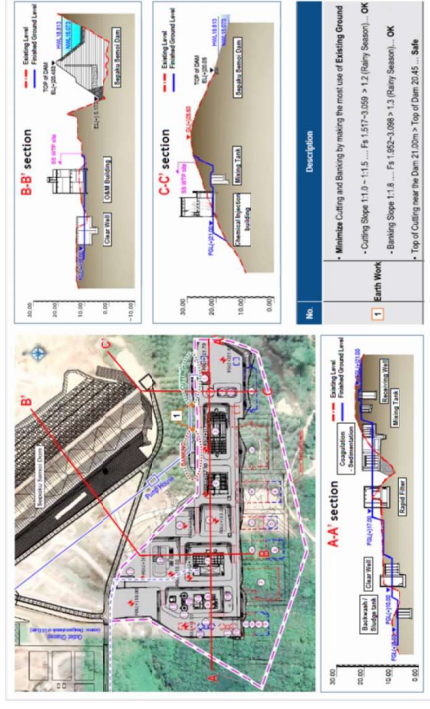
Figure 2. Layout of WTP Plan and Deductions A-A', B-B' and C-C'

- 3.
4. Below is the planning layout for the Water Treatment Plant (WTP) on the left side of the Sepaku Semoi Dam.
- To facilitate the evaluation of WTP designs, design drawings should be drawn at a normal scale of 1:1 for vertical and horizontal comparisons and equipped with distances and dimensions.

- The WTP is designed to be on the left abutment of the dam, with the distance between the mixing tank (nearest building) to the body of the Sepaku Semoi dam being ± 50 m, and the mixing tank depth is 3.8 m. This distance is considered too close to the dam body, which is feared could compromise the safety of the dam. Apart from that, the left support appears to be a thin hill. For this reason, consider shifting the overall WTP further downstream to ensure it does not affect dam safety. In determining the location of the WTP, you should coordinate with the Kalimantan IV River Regional Office as the Dam Manager.

- In designing the distance of the WTP to the dam body, a seepage analysis should be carried out to ensure the safety of the dam against piping or reed erosion.

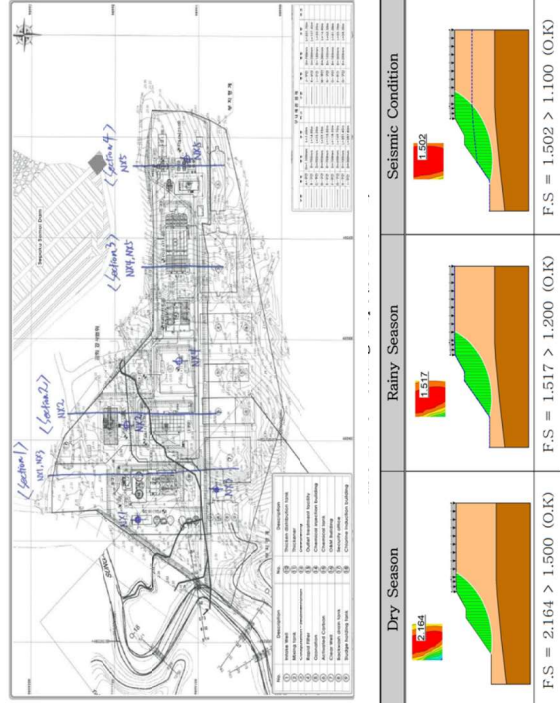
Figure 3. Results of Slope Stability Analysis on Section 4 of the WTP Plan

6. The following is Figure 4 and the results of the slope stability analysis of the excavation plan in the Sepaku Semoi Dam WTP planning.
- In the analysis of the slope stability of the excavation plan, it can be seen that the safety factor values obtained are relatively small during the rainy season and during seismic conditions. Detailed calculations for each condition should be provided, both for the stability of the excavation slope and the stability of the embankment slope.

- If the WTP is designed close to the dam body, which is feared to be dangerous to the stability of the dam, dam stability analysis should be carried out by adapting the standards applicable to dams in Indonesia, namely based on effective stress conditions and carried out under several loading conditions including rapid drawdown conditions. Meanwhile, if the WTP is shifted further downstream so that there is no fear of disrupting the safety of the dam, discussions on the WTP design can be continued with the Kalimantan IV River Basin Center as the Dam Manager only, and do not require a recommendation from the Dam Safety Commission.

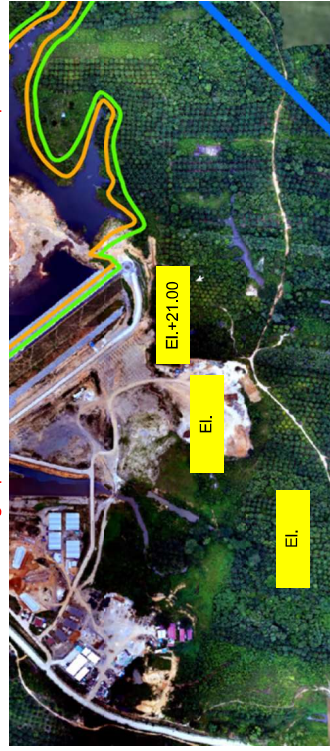
- c. Analysis needs to be carried out in accordance with actual conditions in the field. For this reason, the engineering parameters (engineering properties) used in the analysis should be based on field tests, and the depiction of the groundwater phreatic line used in the analysis should be presented based on assumptions about normal water conditions, bearing in mind that data regarding the amount of water pressure was not obtained at the time of design, pores in the field are used to delineate the phreatic line.

Figure 4. Aerial Photo of the Condition of the Left Support of the Sepaku Semoi Dam

7. In designing the Sepaku Semoi Dam WTP, the consultant should consider the technical suggestions mentioned above and suggestions from the Directorate General of Human Settlements which recommends that the position of the prospective WTP be placed further
