| No | URAIAN/SARAN | TINDAK LANJUT OLEH PEMRAKARSA BENDUNGAN/ KONSULTAN SUPERVISI | TANGGAPAN KAJIAN BALAI TEKNIK BENDUNGAN |

1. Discussion on RCC Foundation
2. Quarry Material Evaluation

DAM ISSUES & RECOMMENDATIONS

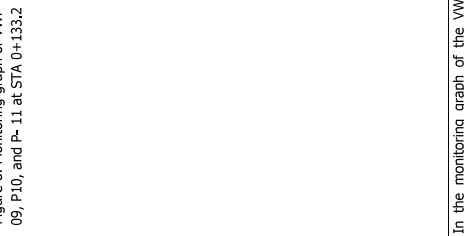
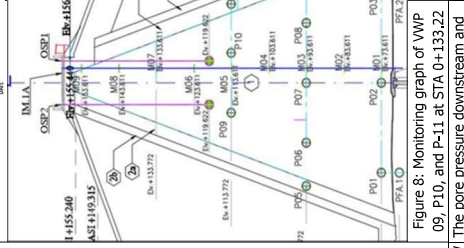
| No | DESCRIPTION/SUGGESTIONS | FOLLOW-UP BY DAM INITIATOR/SUPERVISION CONSULTANT | RESPONSE TO THE CENTER OF DAM ENGINEERING STUDY |
|---|---|---|--|
| 3 | <p>VW piezometer readings P09, P10, and P-11 at STA 0+133.22 show less responsive results. The cause of less responsive results should be evaluated and the response of the</p> | <p>Monitoring graph P.37 position at random downstream, semi-light after installing the piezometer, it functions well. Vibrating Wire is an electrical device assuming a break, to detect breaks at the position where the break in the cable has been embedded and efforts have been made to make it work again.</p> | <p>Suggestions should be heeded and acted upon.</p> |

| No | DESCRIPTION/SUGGESTIONS | FOLLOW-UP BY DAM INITIATOR/SUPERVISION CONSULTANT | RESPONSE TO THE CENTER OF DAM ENGINEERING STUDY |
|---|---|---|--|
| 4 | <p>In the monitoring graph of the VWP</p> <p>Figure 8: Monitoring graph of VWP 09, P10, and P-11 at STA 0+133.22</p> <p>The pore pressure downstream and</p> | <p>Figure 8: Monitoring graph of VWP 09, P10, and P-11 at STA 0+133.22</p> | <p>Suggestions</p> |

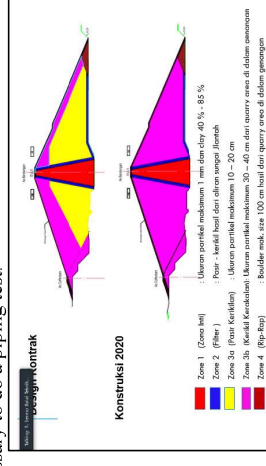
• Figure 1 comparison dam typical design and construction

- Some agricultural land has not yet been acquired, causing delays in work (especially for the bottom outlet).
- The embankment is still 36 meters short. The embankment material on the dam body still remains 36 meters. The total physical work has reached 85.27%. The initial plan is to impound the reservoir at the end of July or early August, but seeing the progress, it is likely to be delayed.
- There was a design change in the construction. During construction, the zone 3a parameter was tested, which has smaller parameters than the design, and then all of zone 3a was replaced with zone 3b, considering the availability of zone 3b is sufficient for use. By replacing zone 3a with a coarser material, there is a possibility that filter material will enter the random zone; if that happens, it is necessary to do a piping test.

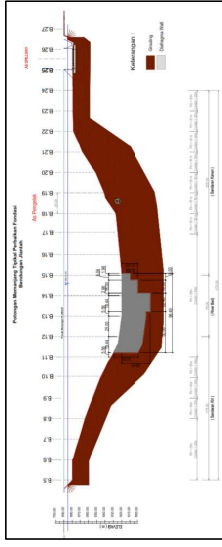
Figure 2 foundation improvement on dam foundation using diaphragm walls and grouting

10. Dam foundation improvement was carried out using two methods: grouting and diaphragm wall. At the design stage, no recommendation was made to use a diaphragm wall. When construction is done at the riverbed location, grouting is not effective because the grouting test has been carried out at a distance of 25 cm and has not shown good grouting effectiveness.

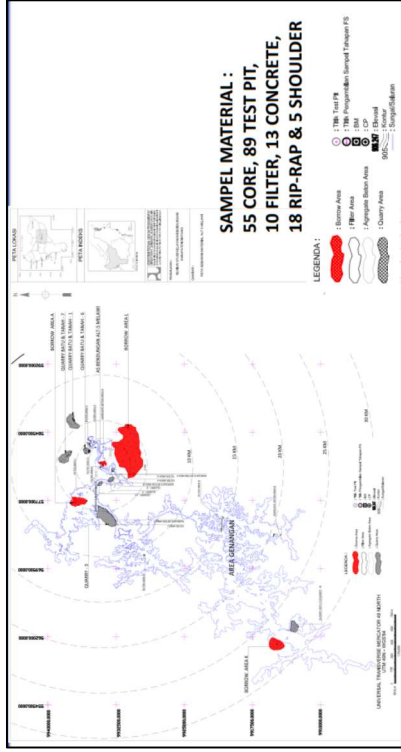
Figure 7. Map of Availability of Melawi Dam Materials

1. The material availability map should be improved,
 - a. The map scale should be enlarged so that the area on the map can be seen clearly.
 - b. At the quarry location, color information should be differentiated, for example: red for stone material, brown for soil material, and yellow for sand material.

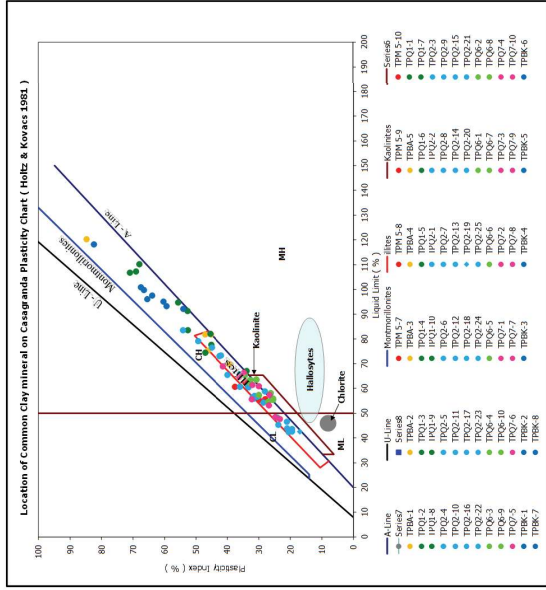
Figure 8 Plasticity Index Test Value

5. The consultant stated that out of 25 pit tests conducted, only 7 met the requirements, resulting in a total core zone material volume of 3.3 million m³ with an area of 1.3 million m² and a material thickness of 2.4 m. The volume comes from the spillway abutment excavation, borrow area L, and rock and soil quarry 1.
 - a. The consultant should explain in more detail the volume of each borrow area.
 - b. The consultant stated that the pit test was conducted at a distance of 500 m. To increase accuracy, the consultant can complete the pit test with a hand drill at a minimum distance of 100-150 m.
 - c. Consultants should ensure the borrower's exemption status, yes/L, to avoid difficulties in land availability during the construction period, because in the area is a location that meets the requirements.

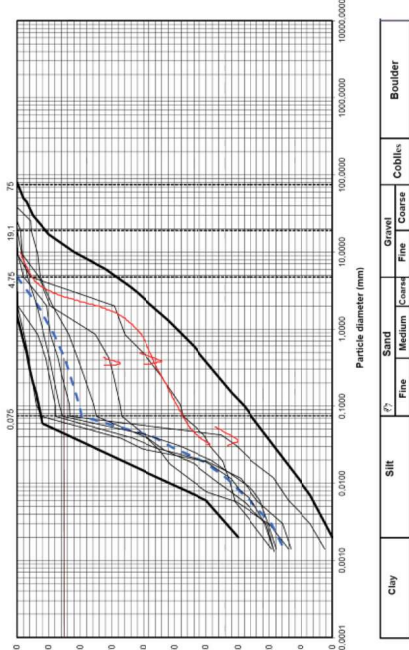
Figure 9. Grain Size Test Results Graph

- c. In the gradation graph image (Figure 9), it appears that the largest portion of the core material is silt and the clay content is almost non-existent. This is inconsistent with the results of the Atterberg limit test, so it needs to be reviewed again.

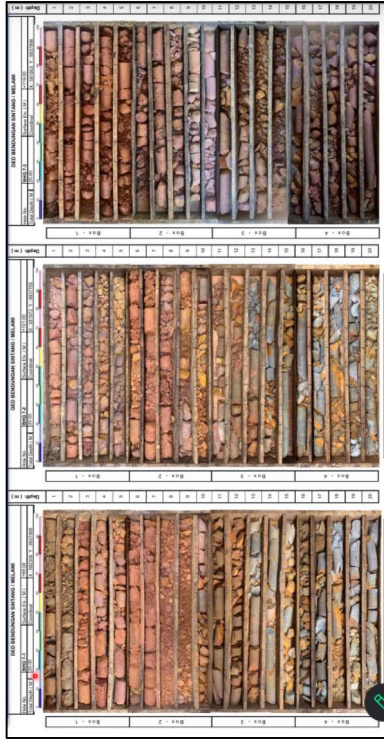
Figure 10. Core Box Quarry 7 Stone and Soil Material

9. The consultant stated that the material used for rockfill is at a depth of 17 m below the overburden layer and has a rock compressive strength of 500 kg/cm². However, based on the core drilling sample (in the core box) it shows a small RQD value (the sample has many fractures). The value RQD can affect slake durability and rock strength. It should be re-checked the conformity between the drilling core sample and the physical and mechanical properties data (slake durability, compressive strength, soundness, relative density, etc.) of the test results that have been carried out.

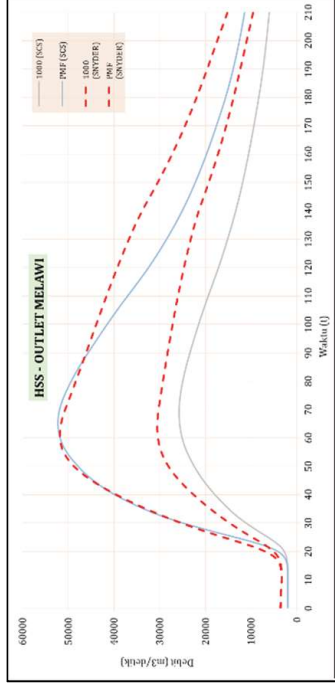
Figure 12. Flood Graph of Melawai Outlet Design

- Comparison of the design flood hydrograph (QPMF and annual Q1000 or Q1/2PMP) between the 2 (two) methods is the basis for selecting the initial abstraction. Figure 12 still does not represent the closeness between the two methods, so to change the initial content of Green and Ampt, the peaking coefficient value of the Snyder method can be adjusted. If this method cannot be achieved, it can be tried by changing the initial abstraction of the SCS.

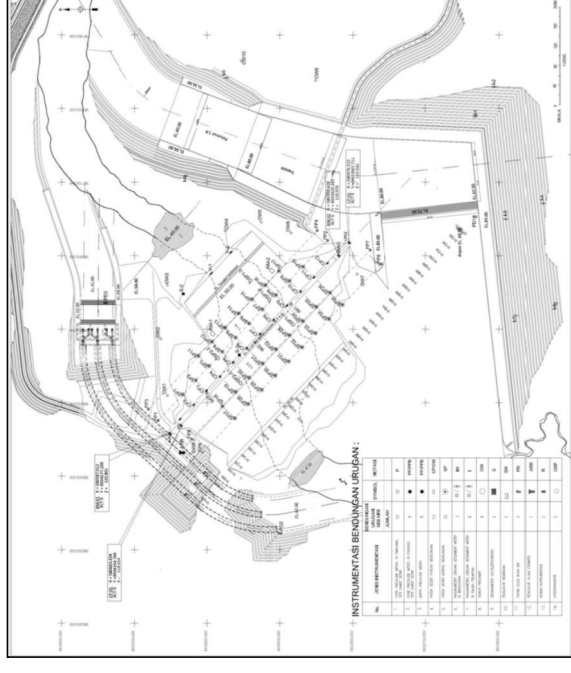
Figure 14. Melawi Dam Instrumentation Plan

1. To observe earthquake behavior in the dam, a seismograph will be installed.
 - a. It should be ensured that the type of earthquake monitoring instrumentation to be installed is a seismograph or strong motion accelerometer.
 - b. Considering that the dam height is 68 m from the planned base of the foundation excavation, consideration should be given to installing a Strong Motion Accelerograph (SMA) instrument in the bedrock at 2 (two) embankment points.

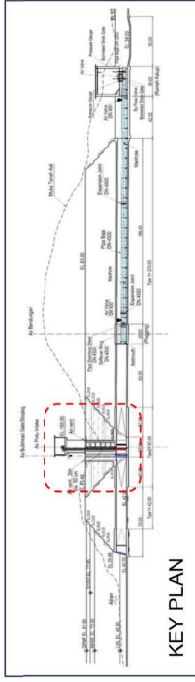
Figure 15. Melawi Dam Intake Tower

- c. Because there is a control valve at the bottom outlet, the distance of the trashrack grid should be reconsidered, so that the control valve is not disturbed by trash entering the penstock.
3. It was conveyed that the working floor of the intake house was at EL +103 and a ladder would be installed to go up to the working floor of the intake house.
- a. To make it easier during operation and maintenance, please reconsider that the working floor of the intake house is at an elevation of +83.
 - b. If the intake house remains at an elevation of +103, consider providing road access in the form of a bridge so that operational vehicles can enter during operations or maintenance.

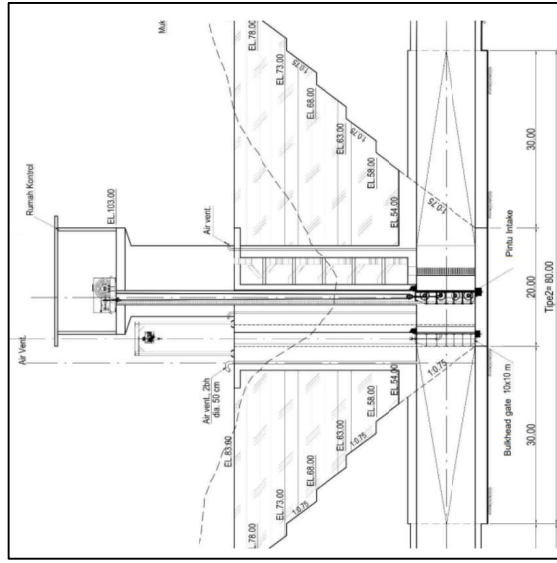
Figure 16. Intake House

4. It was stated that there were only maintenance stairs in the intake house, to facilitate operations and maintenance as well as the safety of OP officers, the stair access should be replaced with a lift (gondola).

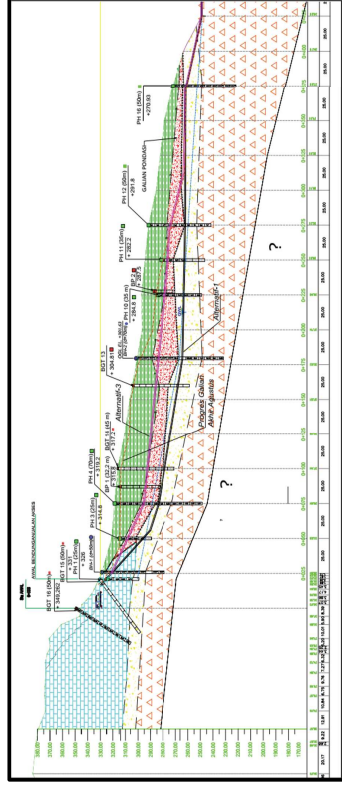
Figure 4. Longitudinal Geological Cross Section of the Left Abutment of Bagong Dam
 During the implementation of dam construction, the geological conditions of the left abutment of the dam were found to be in the form of a colluvial layer that was much thicker than the design estimate, namely with the deepest layer ranging from 25-35 m from the original ground level (OGL) to reaching the hard rock layer, so it was necessary to make changes to the excavation design and repair the foundation.

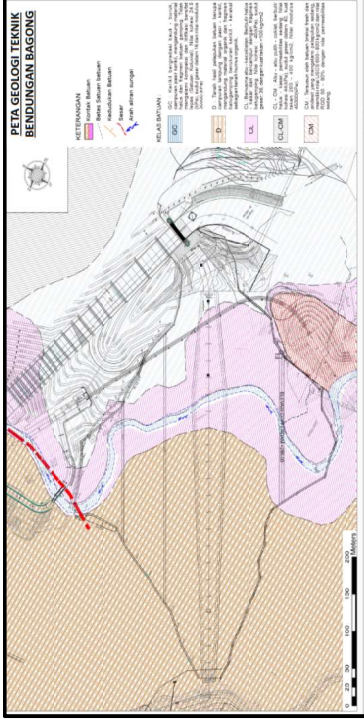
Figure 5. Engineering geological map of Bagong Dam

1. As conveyed by the consultant on the engineering geological map of Bagong Dam, the left abutment is colluvial but on the map it appears to be rock class D. Rock class D and colluvial have different engineering properties. If the rock class is colluvial, it should be included in the Colluvial (Col) class in the engineering geological map depiction.

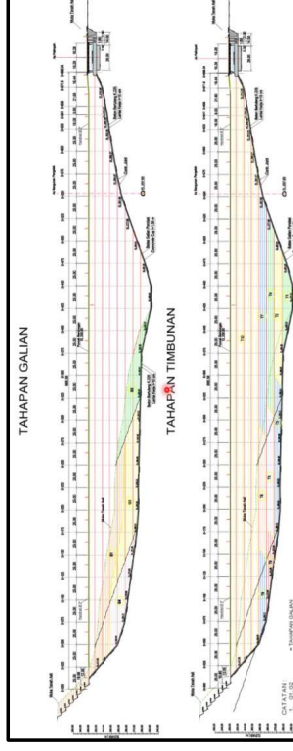
Figure 6. Excavation and Backfilling Method

2. The excavation of the foundation slope is carried out with a slope of the excavation slope designed at 1:1.5 with the target of the core zone foundation reaching the top of the bedrock. The consultant should consider the following suggestions:
