マーシャル諸島共和国
マジュロ病院整備計画
フォローアップ協力調査報告書

2023年4月

独立行政法人
国際協力機構（JICA）

株式会社 梓設計

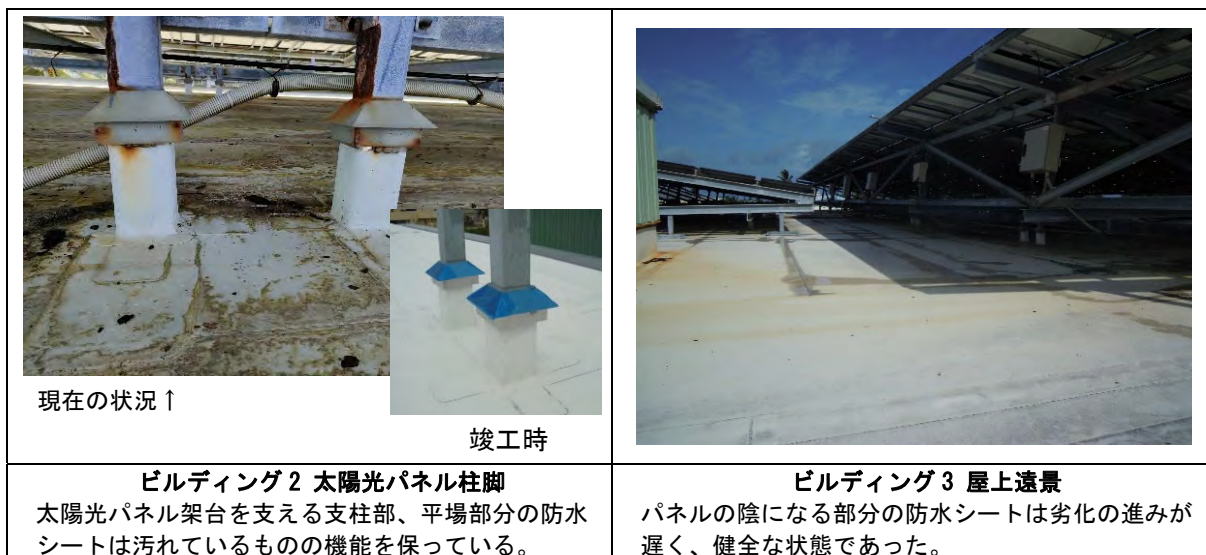
図 2-4 ビルディング 2 及びビルディング 3 屋根からの雨漏り写真

ビルディング 2 及びビルディング 3 の漏水箇所は外周面に集中している。ビルディング 1 と同様に、外周部の軒先雨水排水溝部分の防水層の劣化が激しく、軒先雨水排水溝部分に接する梁と立上り壁の間から屋内への雨水の進入が見られた。軒先雨水排水溝の一部は先方がメタルシートで改修しているが、メタルシートの継ぎ目処理が不完全であり、端部から雨水が侵入していると考えられる。

<p>ビルディング 2 軒先雨水排水溝部分 シートの劣化が顕著である。防水性能が失われている。</p>	<p>ビルディング 2 軒先雨水排水溝側面 側面の既存防水シートは内部の繊維が現れており防水性能が失われている。</p>

<p>ビルディング 2 梁接合部 ビルディング 1 と同様に複数の箇所では梁と立上りの壁の間から雨水進入の痕跡があった。</p>	<p>ビルディング 3 梁接合部 同左天井内でコンクリート立上壁と梁の間から雨水の侵入跡が見られた。</p>

軒先雨水排水溝の防水シートは笠木内部に巻き込むため、笠木を一度取り外す必要がある。笠木の損傷を極力抑え、既存の笠木を活用する方針とする。笠木を固定するビスの頭は、シーリング材で止水する。また、ビルディング 2 及びビルディング 3 においては、既存平場の防水層と軒先雨水排水溝部分の改修部分の取り合いにおいて、アルミ製の水切り等を設置し、取り合い部からの漏水を防ぐ。

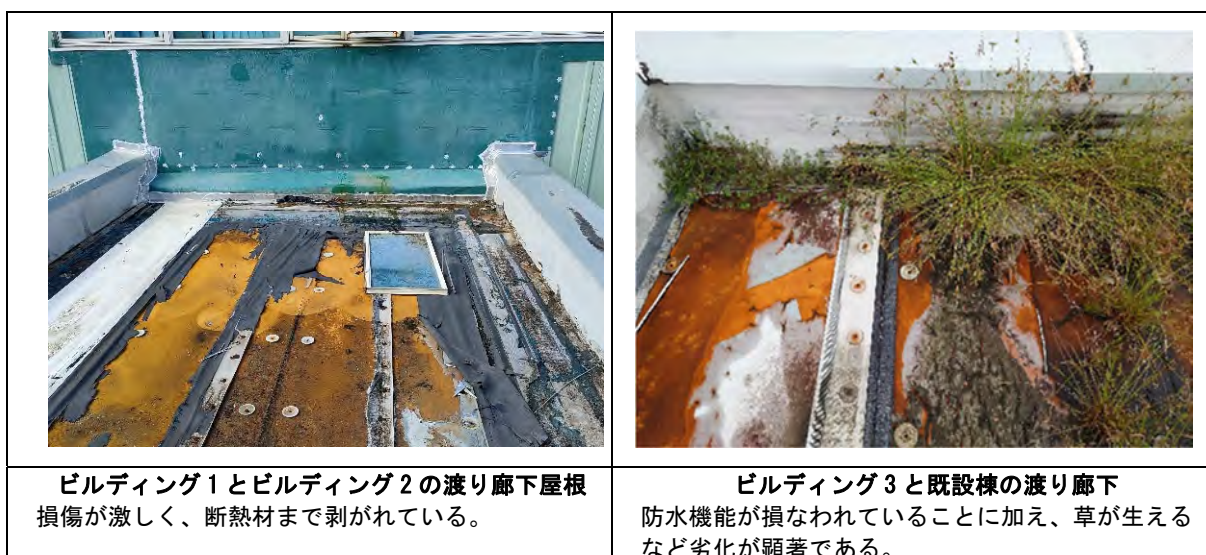
図 2-5 渡り廊下 屋根からの雨漏り写真

ビルディング 1 及びビルディング 2 の渡り廊下、ビルディング 2 及びビルディング 3 の渡り廊下、ビルディング 3 と既設棟（協力対象外）の渡り廊下の屋上防水の劣化状況を確認したところ、各建物と廊下の取合い部分に漏水跡が見られた。渡り廊下屋上の雨水は各建物の雨水排水溝を通じてルーフトレーンにて排水する仕組みとなっているが、雨水排水溝の漏水補修のために病院側で設置したメタルシートが、渡り廊下の防水シートとの連続性を保っていないため、渡り廊下からの雨水がメタルシートの下に流れ込む状況が見受けられた。

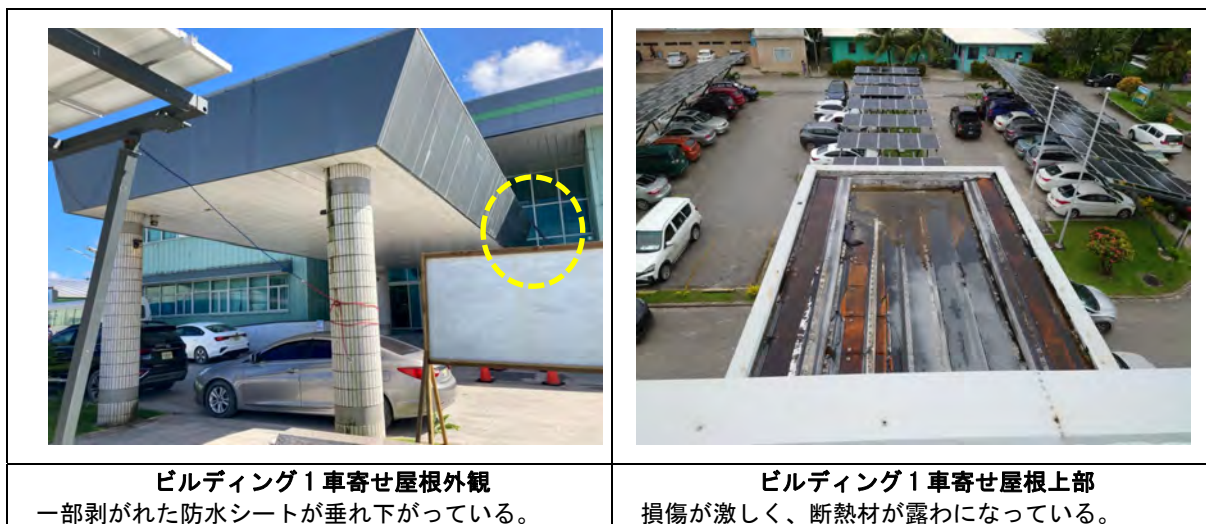
図 2-6 ビルディング1車寄せ 屋根からの雨漏り写真

ビルディング 1 の車寄せ屋上部分に関しては、防水シートがほぼ全面的に剥がれており、修繕が必要である。また車寄せはメインエントランスに位置しているが、剥がれた防水シートが垂れ下がっていた。

ビルディング 1 においては、既存の断熱ボードは損傷がなく、乾燥状態を保っており、問題ないことを確認した。このため、断熱材の交換は必須ではないと考えられる。防水層を撤去しないオーバーレイ工法となる場合は、防水層よりも下層となる断熱材の交換は行わないが、一方で渡り廊下やビルディング 1 の車寄せ庇は断熱材まで剥がれている部分が散見されており、交換が必要である。

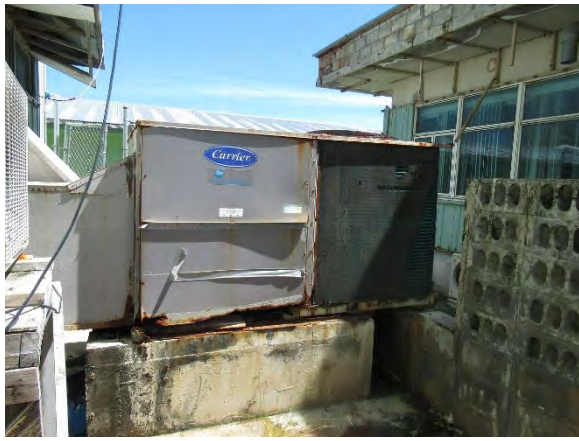
ビルディング 1 大型パッケージ
 ビルディング-1には1階空調用として2台の大型パッケージ(2代目)が設置されているが、かなり腐食が進んでいる。

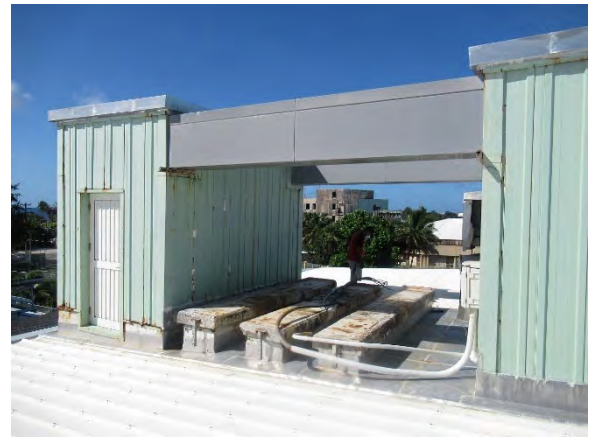
ビルディング-1 大型パッケージ撤去跡
 修繕要請があった時にはビルディング 1の屋上に2階用の大型パッケージ(2代目)が2台設置されていたが、現在は撤去されている。

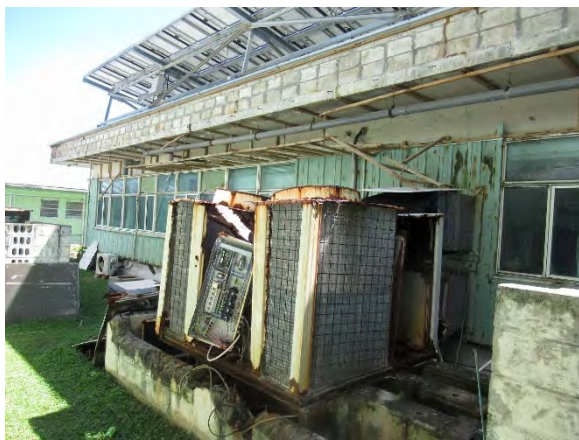
ビルディング 2 大型パッケージ
 ビルディング 2とビルディング 3用の3台の2代目大型パッケージがあるが、故障して放置されている。これらのエリアでは病院側が設置したルームエアコンによって空調が行われている。

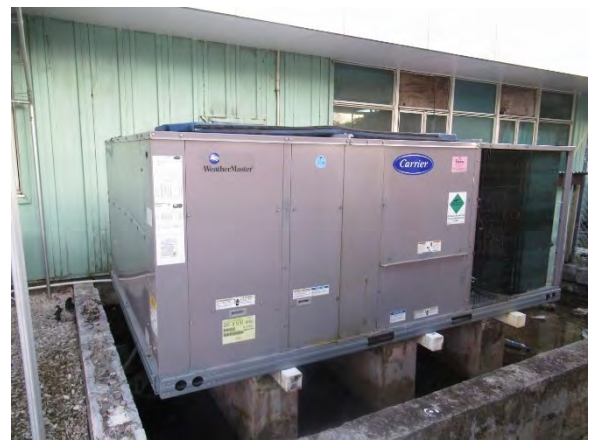
ビルディング 3 大型パッケージ
 ビルディング 3には4台の大型パッケージが設置されており、うち3台は2022年初頭に病院側の工事により更新されている。この機器は3代目である。

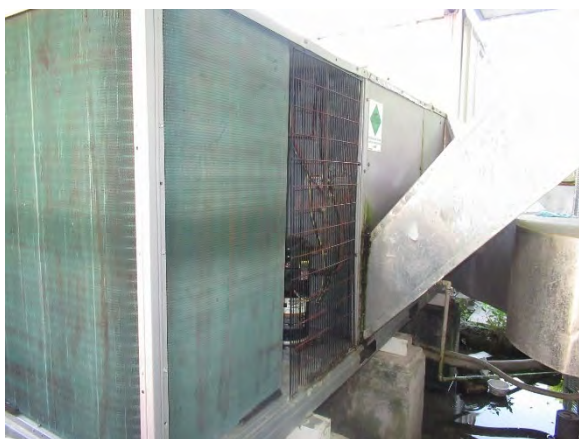
ビルディング 3 大型パッケージの腐食
 新設大型パッケージは設置後1年が経過していてもかかわらず、すでに熱交換フィンや保護ガード、コーキング部分に腐食が見られる。

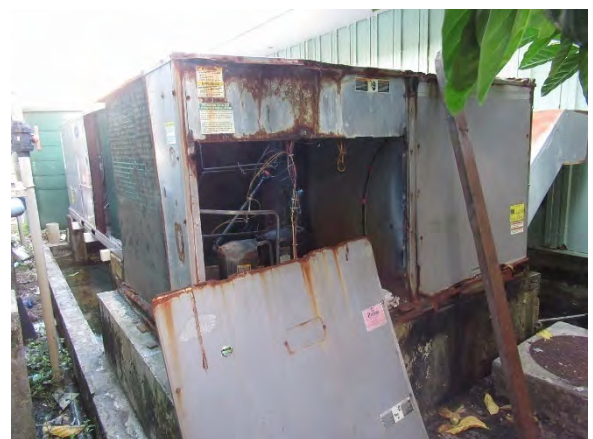
ビルディング 3 2代目大型パッケージ
 ビルディング 3の残りの1台は手術室用の大型パッケージで、2代目の機器である。外観上はほとんど朽ち果てているが、何とか稼働している。

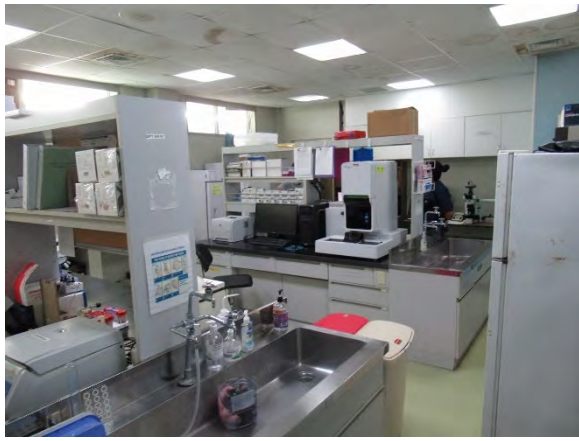
HEMATOLOGY & BIOCHEMISTRY

ラボ諸室は病院側で設置した大型パッケージによって空調されている。天井面に設けた吹出口・吸込口から給気、還気が行われている。

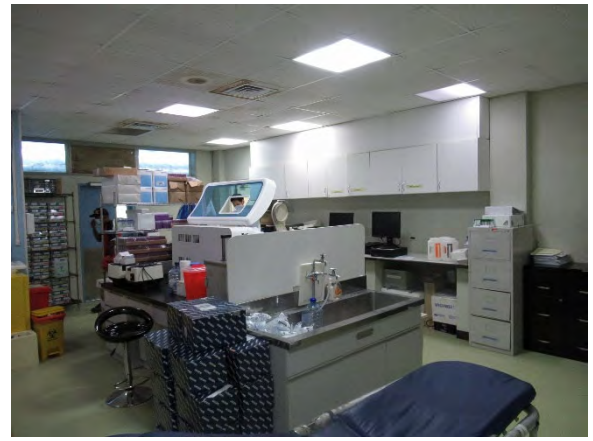
PATHOLOGY & CYTOLOGY

天井面に汚れがあるものの、空調機能そのものには問題はない。

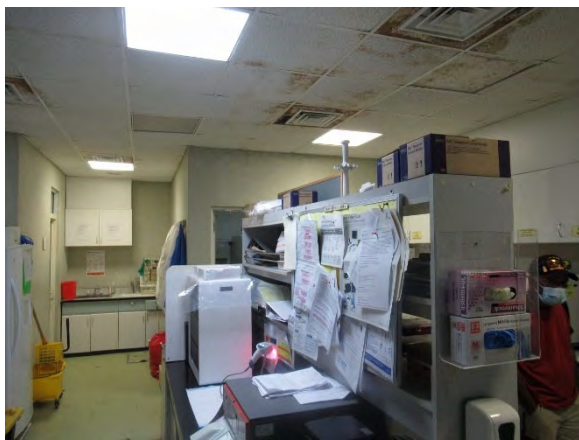
MICROBIOLOGY

当室も天井に汚れが多いものの、空調機能そのものには問題はない。

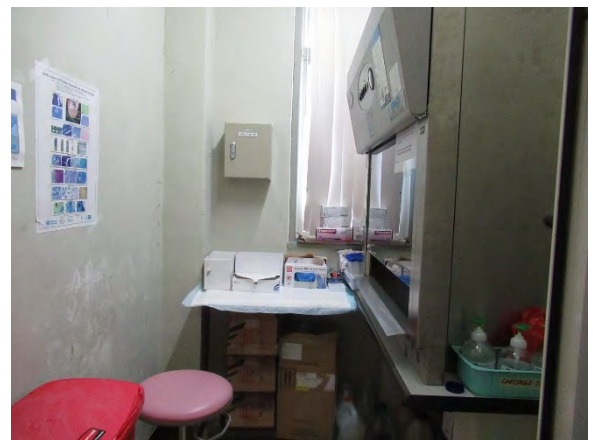
安全キャビネット

安全キャビネットは専用室に設置されている。循環型であるが、機器本体には問題はない。

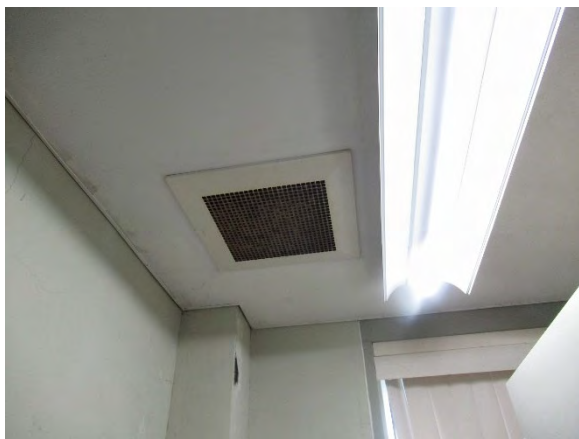
安全キャビネット設置室の換気

安全キャビネットは専用室に設置されているが、天井扇が設置され、稼働が確認できる。当該室の陰圧としては確保できていると考えられる。

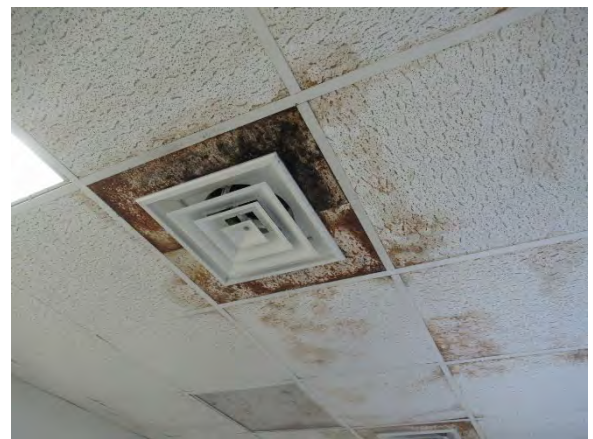
ラボ空調吹出口

ラボ諸室の天井が汚れている主な要因は空調吹出口の結露水が天井材に広がり、それがカビの発生などを引き起こしていると思われる。

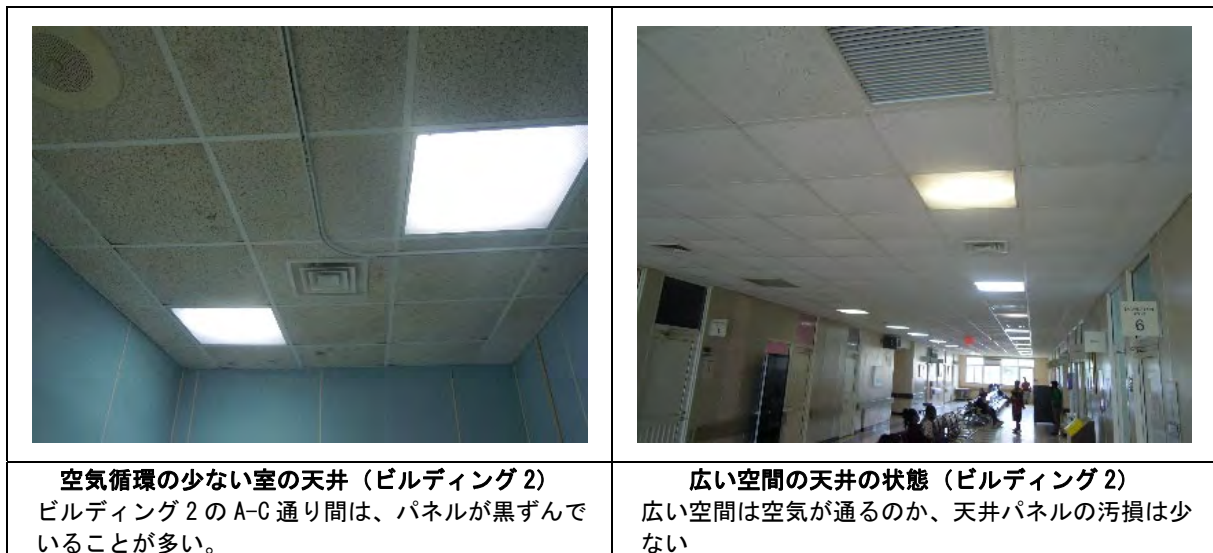
図 2-9 天井の状況 写真

天井パネルの損傷箇所は、建物外周部と空調機の排気口及びダクトの位置に集中している。

建物外周部の損傷は、前述の軒先雨水排水溝部分からの雨水の進入が原因となっており、パネル交換などの回収をする場合にはまず原因である雨漏りを修繕する必要がある。空調機の排気口及びダクトにおいては、結露した水が天井内の岩綿吸音板に滴り落ち、錆や水染み等の汚れが広がっているところが散見された。マーシャルの気候は温暖かつ湿潤であり、湿度が高いため結露が発生しやすい。空気中の水蒸気は、空気中に含むことが出来る限界量があり、温度が低いほどその量が低下する。湿度が高く、室温と外気温との温度差が大きいほど結露が発生しやすい。

<p align="center">天井の状態</p> <p>空調機の排気口及びダクトの位置で天井パネルが汚損している箇所が多い。</p>	<p align="center">建物外周部付近の天井汚損箇所</p> <p>雨漏りにより天井が破損している場所もある。</p>

<p align="center">天井内部の排気口の状態</p> <p>排気口の結露水等で天井パネルに汚損が発生しており、ダクトから水滴が滴る様子が確認された。天井下地はあまり傷んでいない。</p>	<p align="center">天井内部の状態</p> <p>天井下地はあまり傷んでおらず、そのまま利用可能である。</p>

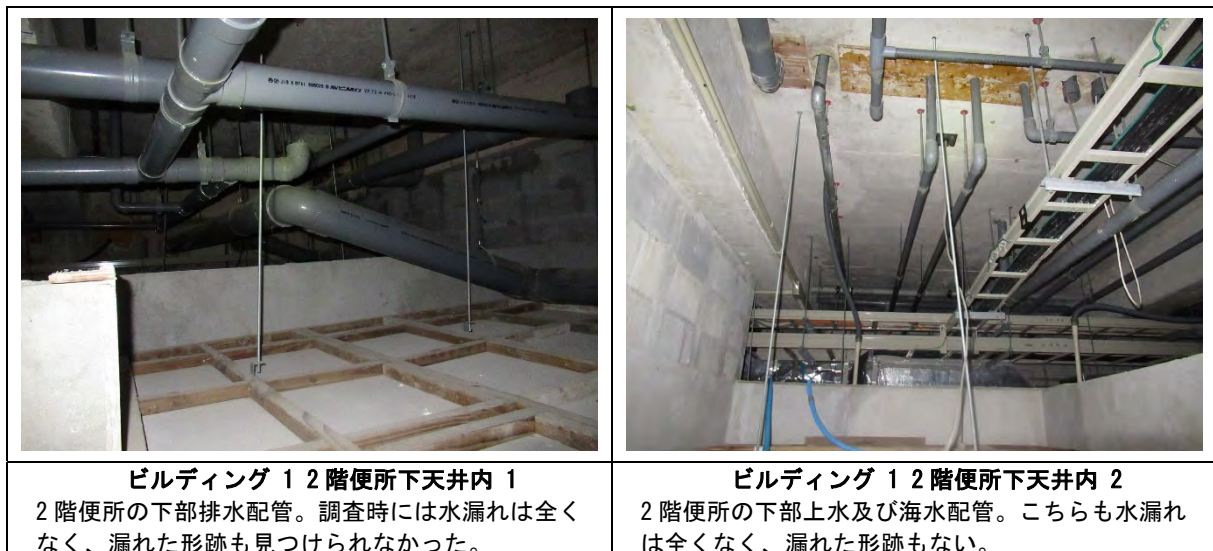
現地調査時のヒヤリングでは、病院側は排水ではなく、給水に問題があるとのことだった。この点に関し調査をしたところ、ビルディング1に限らずほとんどの便所において洗浄水が断水していることがわかった。一方、手洗器や掃除流し、ステンレス流しなどの水栓からは問題なく水が出ている。水栓に給水する上水と、便所の洗浄水に使用する海水の2系統があり、このうち海水系統の水圧が低いため、ほとんどの便所で水が出ないということが原因である。上水も海水も公共水道から直結給水されているが、上水系統は十分な水圧がある一方で、海水系統は水圧が非常に弱いため、断水状態が発生している。

上水も海水も竣工時点では受水槽+加压ポンプにて給水が行われていたが、ポンプ故障によりこれらの機器はバイパスされ、水道管直結方式に変更されている。断水が発生してしまう要因のひとつは給水方式を変更してしまったことにあるが、上水さえ給水されていれば、その水をバケツで汲んで便器に流すことができるため、現地では問題なく運用されている。

<p>ビルディング 1 2 階便所内 1 男子便所。洗面器からは水が出るが、小便器は給水接続口が取り外され、使用禁止になっている。</p>	<p>ビルディング 1 2 階便所内 2 大便器のロータンク内は水が全くなく、しばらく断水が続いていると想定できる。</p>

<p>上水加圧給水ポンプ 上水加圧給水ポンプが故障し、モーター部分が分解されたまま放置されている。現在は受水槽と加圧ポンプは使用せず、水道直結方式に変更されている。</p>	<p>上水受水槽 上水受水槽は外観上、フレームに錆びが出ているが貯水性能には問題はなさそうであるが、給水ポンプが故障したため、使用されていない。</p>

<p>海水加圧給水ポンプ 病院側で設置した海水加圧給水ポンプがこの小屋内に設置されているということであるが、故障して稼働していないとのこと。</p>	<p>海水受水槽 ポンプが故障してしまっているため、受水槽も使用されず、水道引込管直結で建物内に給水しているということであるが、水圧不足から断水している。</p>

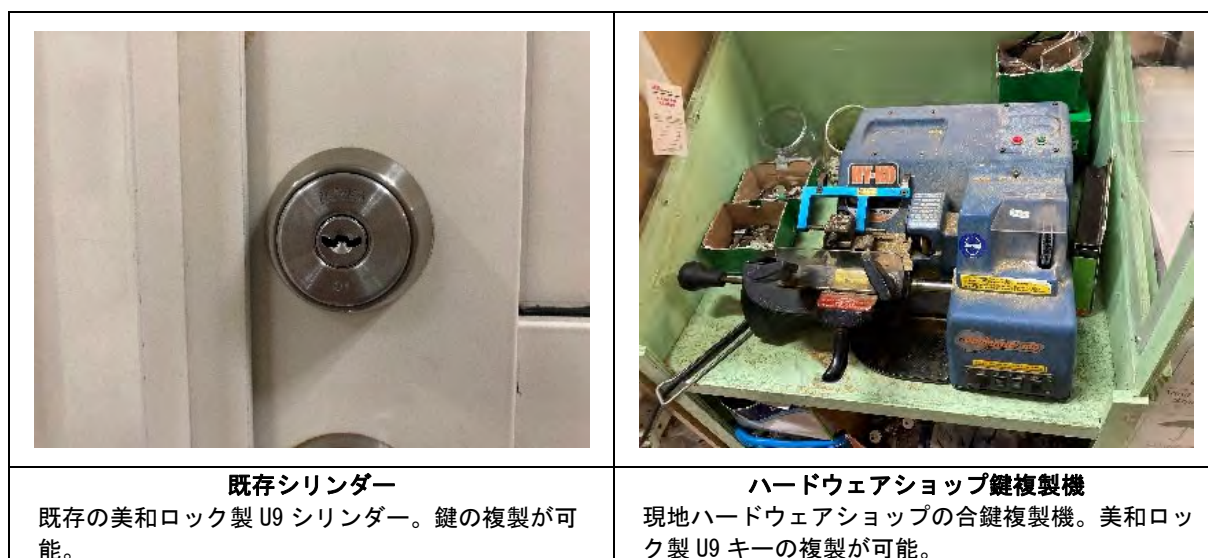
図 2-11 鍵の不具合にかかる写真

竣工時に納入した鍵の大半を利用者が紛失しており、現状ではスペアキーの調達方法が確立されていないため、レバーハンドル上部に南京錠を設置し、ドアの施錠を行っている。

扉のシリンダー錠は鍵の複製が可能な美和ロックのU9シリンダーが使われており、「blankキーの調達」と「鍵を削ることのできる機械・技術サービス」の条件が揃えばスペアキーの作成が可能である。マーシャルには、マジュロ病院の新築時に鍵金物を含めて建具を調達した日系の商社がある。現地調査において当該商社と面談し、美和ロックのU9キーのblankキーを問題なく調達できることを確認した。また、マーシャルの複数のハードウェアショップにおいて、美和ロックの鍵を持ち込み、blankキーのストックの有無と研削が可能か確認したところ、blankキーのストックはないものの、所持している研削機械で問題なくスペアキーの製作が可能であることを確認した。このように、スペアキー制作に必要な条件は揃っている。なお、マスターキーは2本現存していた。

現地調査において判明した、破損したシリンダー、ハンドル、サムターン、ロックケース、ヒンジ、フラッシュボルト、ドアストッパーは新しいものに交換する。その他、必要に応じて扉の調整を行う。

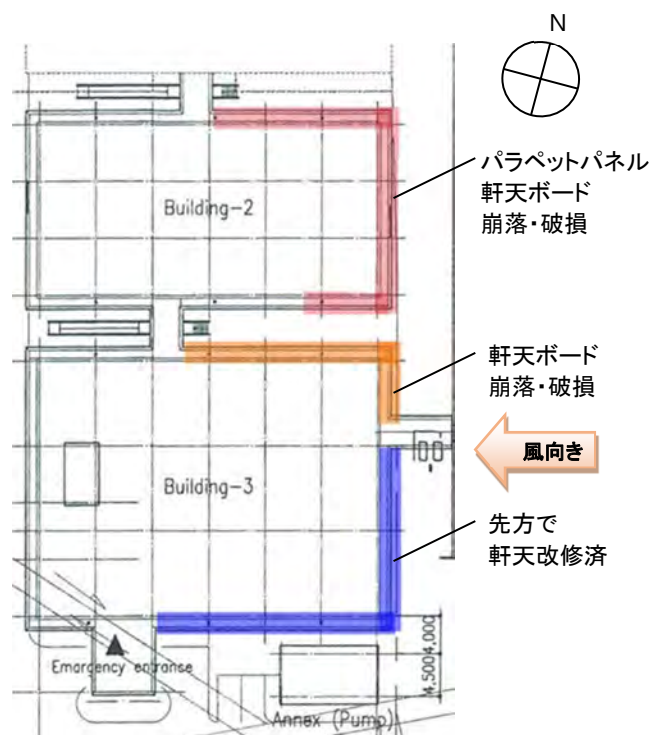
図 2-12 パラペット及び軒天の損傷範囲

ビルディング 2 の東面を中心にパラペットアルミパネルの崩落及びパネル取り付け下地の破損が多数みられた。

またビルディング 3 はパラペットアルミパネルの崩落は無いものの、東面北側を中心に軒天井のボードの損傷、落下が多数見られた。東面南側については、病院が軒天井の補修を行っており、仕上がり状態は良好である。パラペットはコンクリートブロック積の壁に木製下地を組み、その上に外装仕上げとしてアルミ曲げパネルをビスで固定する仕様である。軒天井は野地板（ケイ酸カルシウム板）を木軸に釘止め、塗装仕上げとしている。

- ① 東からの潮風で樋の吊り金具が錆で劣化
- ② 吊り金具が樋を支えられず、ルーフトレインから樋が脱落して漏水、軒天に滞水
- ③ 漏水等で湿気た軒天内にシロアリが巣くい、食したことで木製下地が損傷し、パラペットパネル及び軒天が脱落した

2-3-7 で示したとおり、パラペットのアルミパネルと軒天ボードが一部脱落している。漏水の直接的原因とはなっていないが、笠木の木下地やパラペットを構成するブロック等の耐久性を低下させる可能性があるため、早急に脱落したアルミパネルや軒天ボードを修繕することが望ましい。試算においては、直接工事費のみで 83,000USD 程度であり、25,000USD を超えるため公共事業省の管轄と想定される。

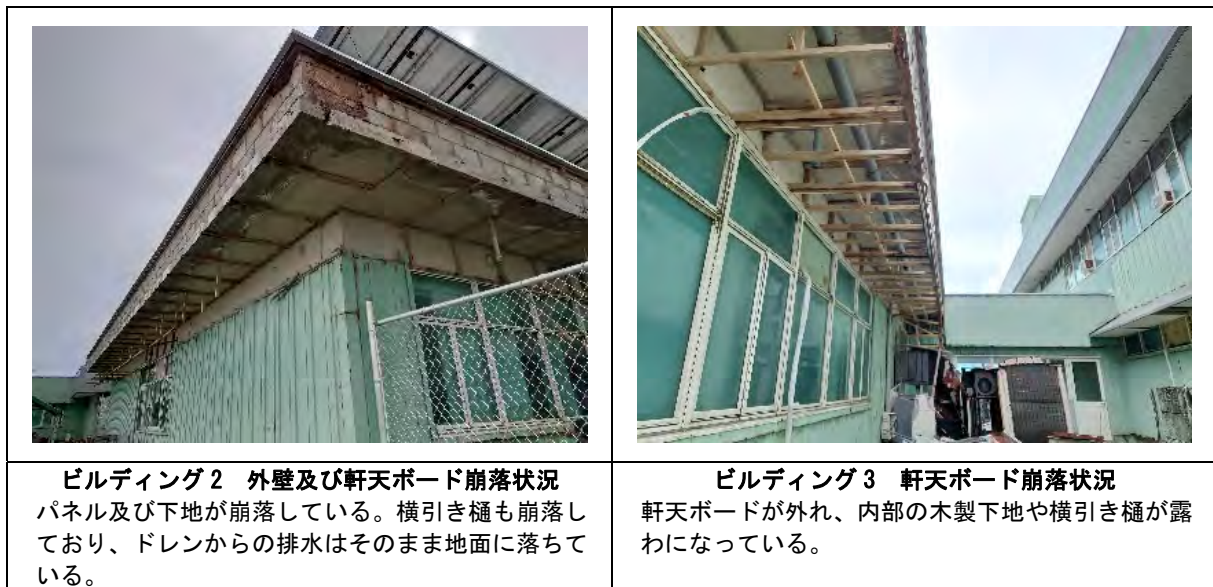
図 2-13 外壁パネルおよび軒天の劣化・落下 写真

パラペットアルミパネル及び軒天の崩落は、以下のような順番で劣化が進んだ結果発生したと考えられる。

なお、パラペットアルミパネルの崩落は、屋内への雨水侵入の直接的な原因にはなっていない。

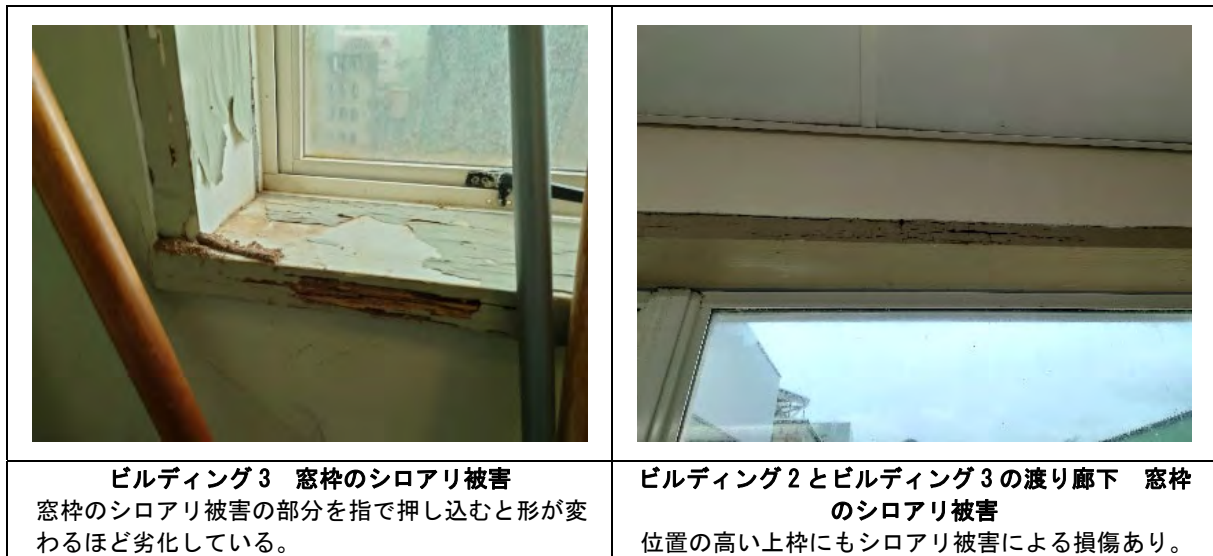
図 2-14 シロアリ被害 写真

ビルディング 2、ビルディング 3、及び渡り廊下において、シロアリによる窓枠の被害がみられた。雨漏りや湿度の高さにより湿潤状態になった木製窓枠にシロアリが寄ってきて食したたものと推察される。

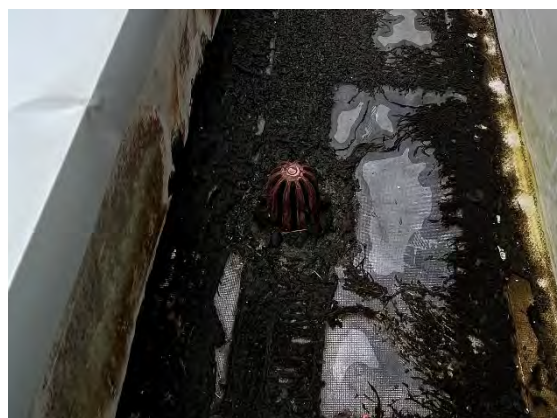
既存ルーフトレンの状態

清掃を行っていただければルーフトレンが一斉に詰まるという事態は避けられることや、過去 50 年間の最大 1 日雨量が 1 時間に集中して降り、かつ一定の時間降り続ける確立は低いと考えられる。また、現地調査で長年清掃されていない屋上を確認したところ、劣化した防水シートの繊維に植物（藻やコケのようなもの）等がからんだものがルーフトレンのストレーナーキャップに絡まっていたが、ルーフトレンが完全に詰まっている状態は見受けられなかった。そのため、オーバーフロー管の設置は必須ではないと考えられる。

また、各建物のルーフドレンのストレーナーキャップが清掃されておらず、軒先雨水排水溝に水が溜まっている状況である。ドレンは水が流れるよう清掃し、劣化した表面にエポキシ塗料を塗布する。

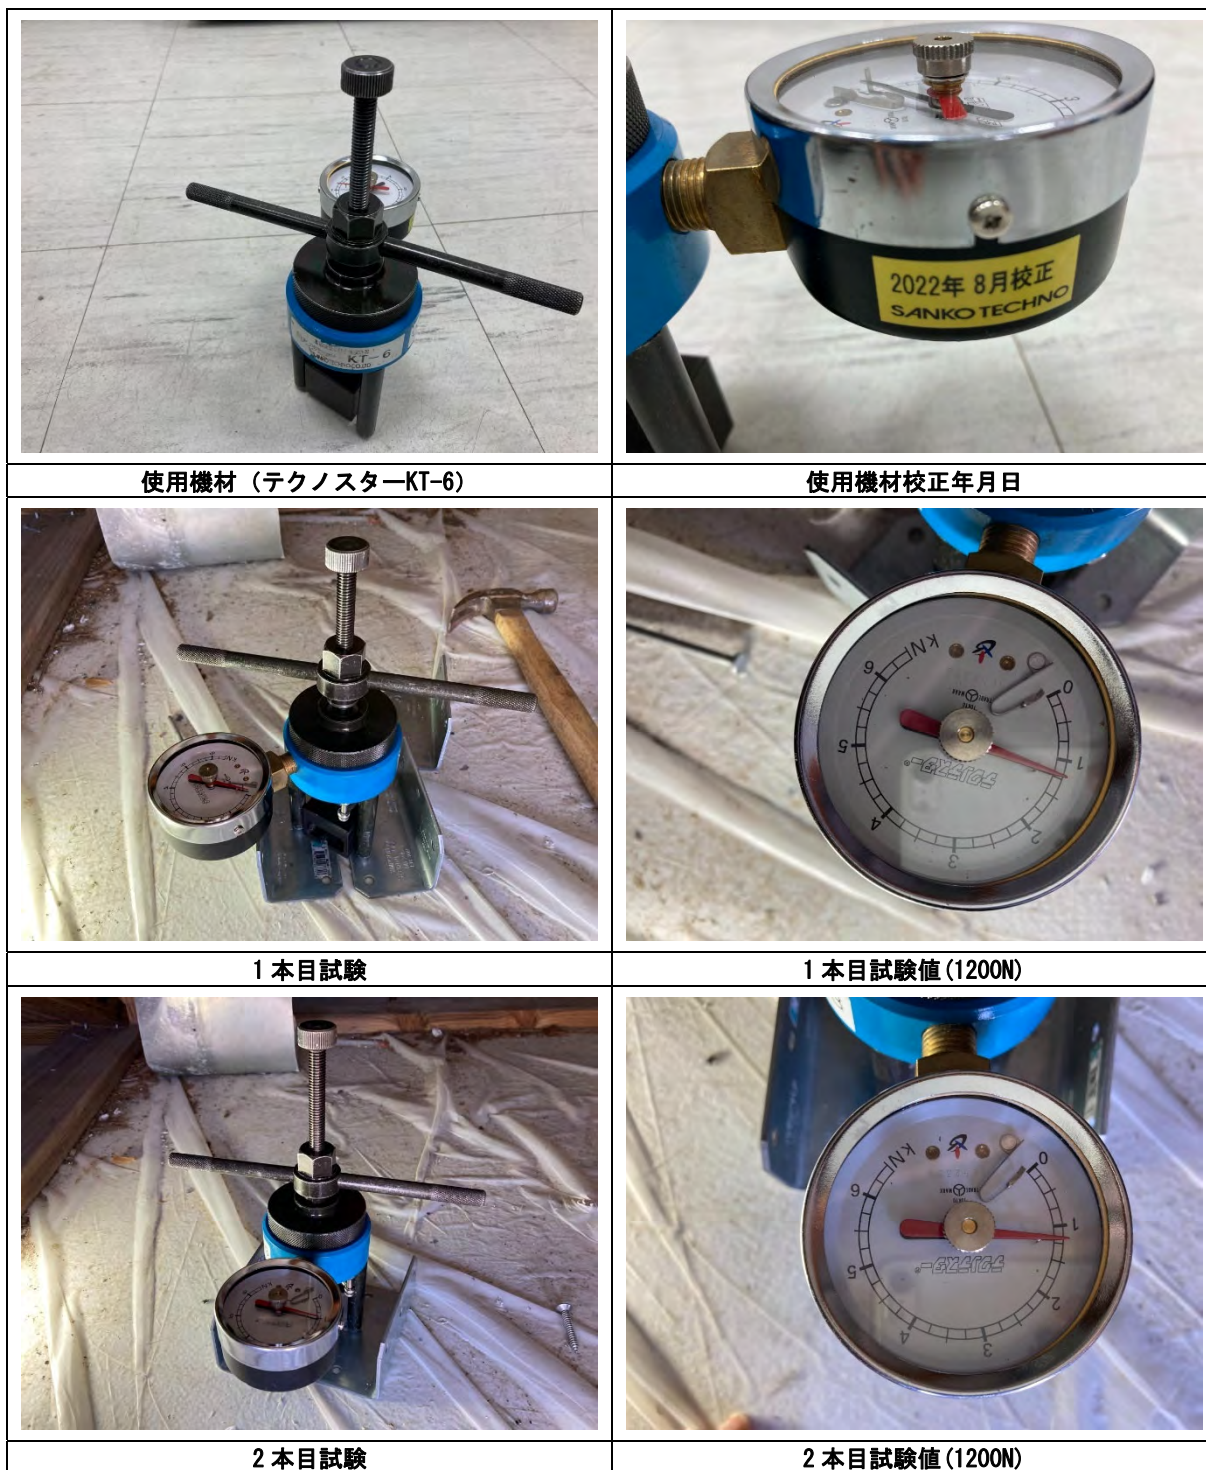
図 3-1 デッキプレートの引き抜き耐力試験 写真

デッキプレートに4mmの下穴を空け、5mmのネジを挿入の上、試験機で引っ張り引き抜き強度を確認する。

想定するシート防水工法の 1 本あたりの設計引き抜き強度は 600N であるため、倍の値である 1200N を確認したところで負荷を止め、試験を終了した。試験の結果、デッキプレートの引き抜き体力は充分確保されていることを確認した。
