**The Republic of the Marshall Islands
Ministry of Health and Human Services**

**Follow-up Cooperation Survey Report
on
The Project for Improvement of
the Majuro Hospital
in
The Republic of The Marshall Islands**

April, 2023

**Japan International Cooperation Agency
(JICA)**

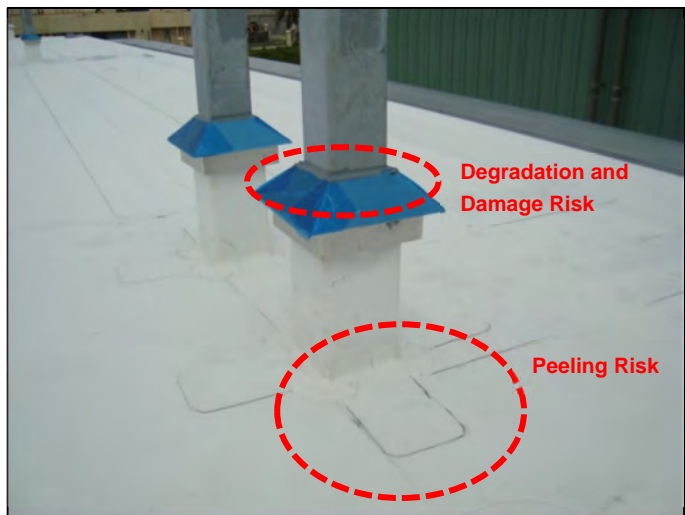
Figure 1-4: Photo of Pillar Construction

The waterproofing method for the supports involved covering the supports with stainless steel tubes where they penetrate through the roof, wrapping them in waterproofing sheets, using stainless steel plates to fix the upper edges of the sheet risers, and installing stainless steel drain covers and applying sealant on the top. This is considered to be a sufficient measure for preventing leaks. However, as years pass after the construction, the penetrations should be checked because the waterproofing sheets may crack, or peel away due to deterioration of the adhesive, or the sealant on the top covers of the sheet risers may have deteriorated over time.

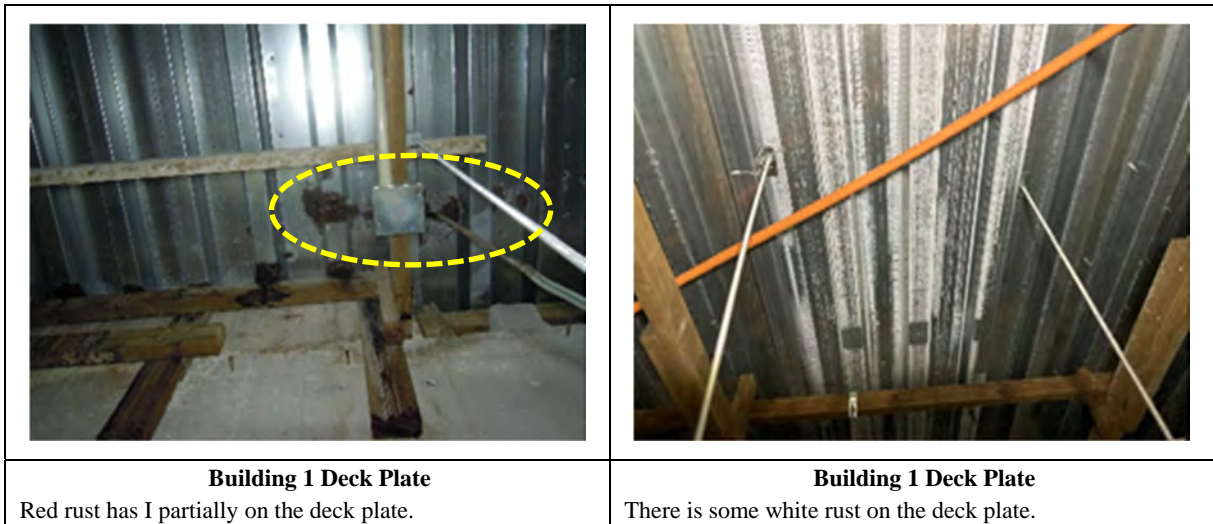
Figure 2-3: Building 1, Photographs concern with Roof Leaks

In Building 1, leaks were reported mainly from the perimeter of the second floor, and also from the center of the building on part of that floor. There was no evidence of leaks on the first floor.

Leakage was also found at the joints of the folded-plate roof installed by the RMI, confirming that it is not completely watertight. Additionally, although vinyl sheets have been installed on top of the existing waterproofing sheets under the wooden supports on the folded-plate roof, the waterproofing layer is somewhat deficient because the mounts are bolted (nailed in some places) to the deck slabs, and the bolts (nails) penetrate the waterproofing layer.

A thin layer of white rust has formed on the surfaces of the deck plates, but it is due to zinc oxides in the plating layer and does not compromise the structural resistance. Localized red rust was observed in some areas, but only in a limited number of places. The copings are well fixed and the joint sealant is in good shape, and although some of the sealant of the screw heads on the top of the coping has deteriorated, no major problems were found at this time.

<p style="text-align: center;">Building 1 Folded-Plate Roof</p> <p>Folded-plate roof installed by the RMI. Jointed in the center, and rainwater was entering the joints.</p>	<p style="text-align: center;">Building 1 Eave Rainwater Drainage Trench Area</p> <p>The waterproofing sheet is noticeably degraded. Dirt was accumulating in the drain.</p>

<p style="text-align: center;">Building 1 Joint of Girder</p> <p>There were traces of rainwater intrusion between the girder and the rising wall at several locations.</p>	<p style="text-align: center;">Building 1 Method of Roof Truss Installation</p> <p>For the installation of the roof truss, bolts were used in the waterproof layer.</p>

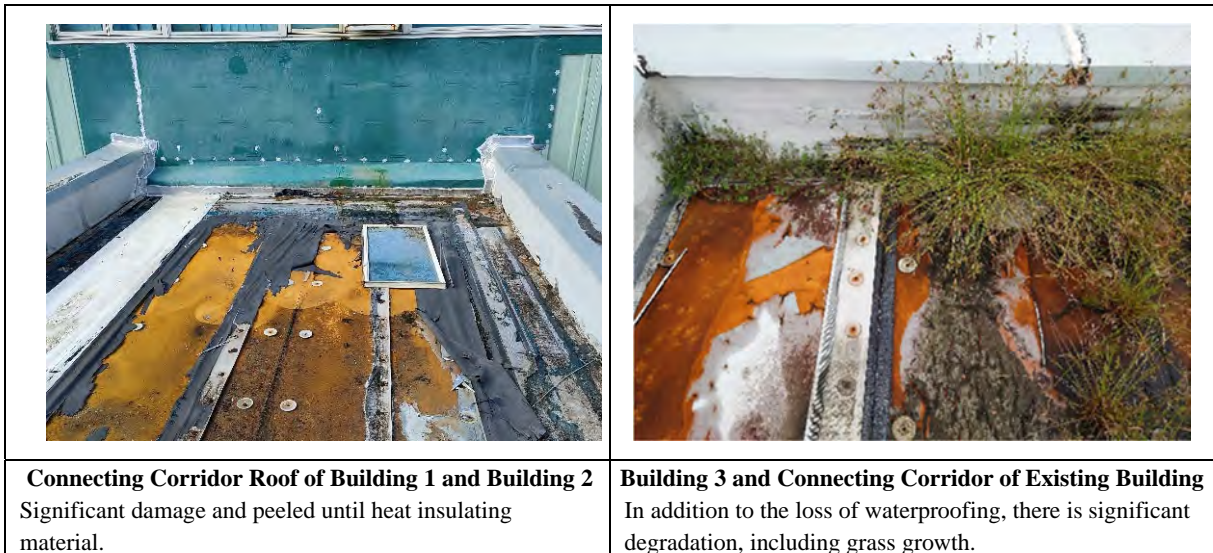
Figure 2-5: Corridors, Photographs concern with Roof Leaks

The deterioration of waterproofing on the roofs of the corridors between Buildings 1 and 2, Buildings 2 and 3, and Building 3 and an existing building (outside the scope of the Project) was checked, and evidence of leaks were found at the joints between the corridors and each building. The drainage system is designed so that rain drains from the corridor roofs to the roof drains via the rain gutters; however, the metal sheets installed by the hospital to repair leaks in the rain gutters interrupt the waterproofing sheets on the corridor roofs, resulting in rainwater flowing under the sheets.

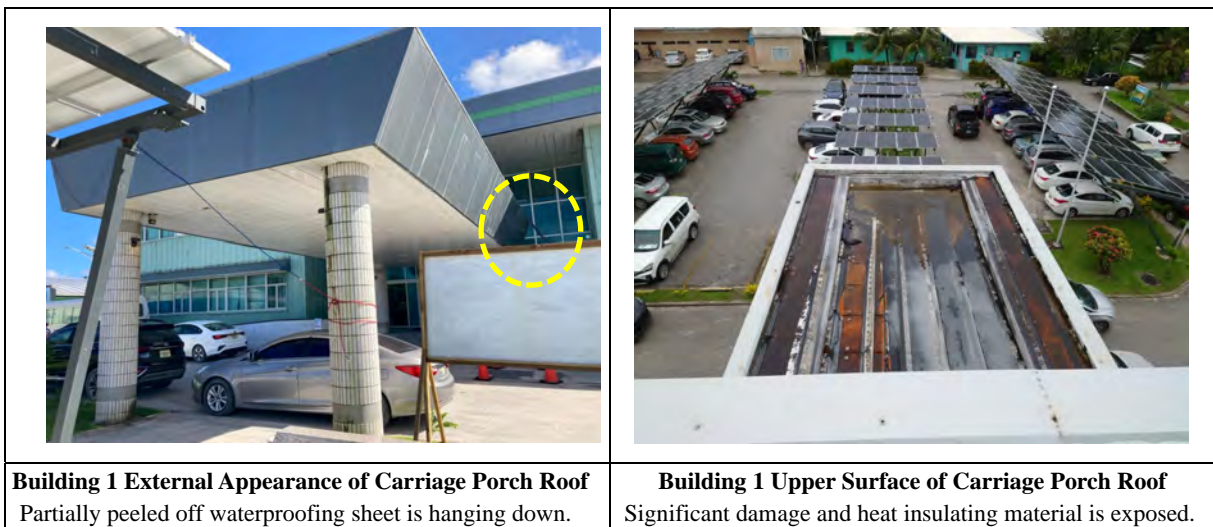
Figure 2-6: Building 1 Carriage Porch, Photographs concern with Roof Leaks

The waterproofing sheets on the carriage porch roof of Building 1 are nearly all peeling away and must be repaired. The sheets are hanging down over the main entrance where the carriage porch is located.

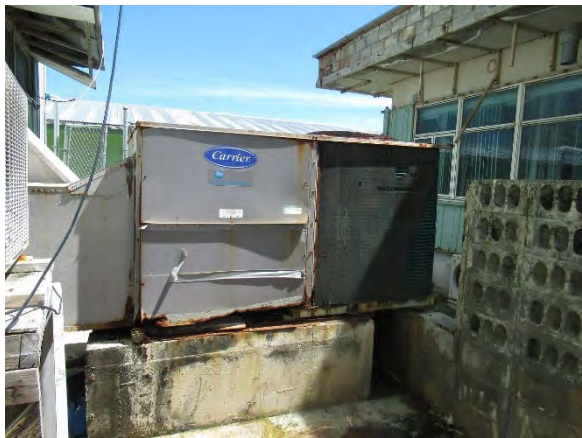
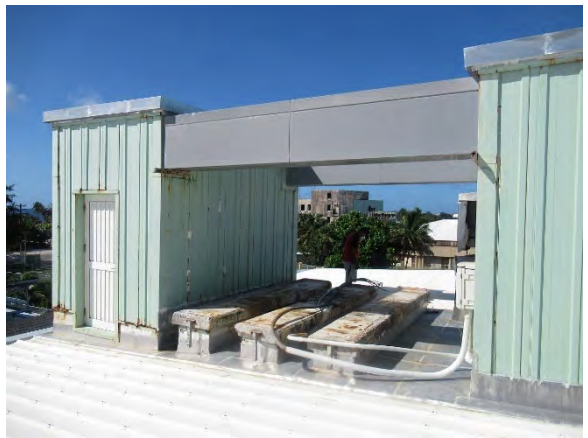
<p>Building 1 Large Package Building 1 has two large packages (second generation) installed for first floor air conditioning, but they are quite corroded.</p>	<p>Building 1 Large Package Removal Site At the time of the repair request, two large packages (second generation) for the second floor were installed on the roof of Building 1, but they have now been removed.</p>

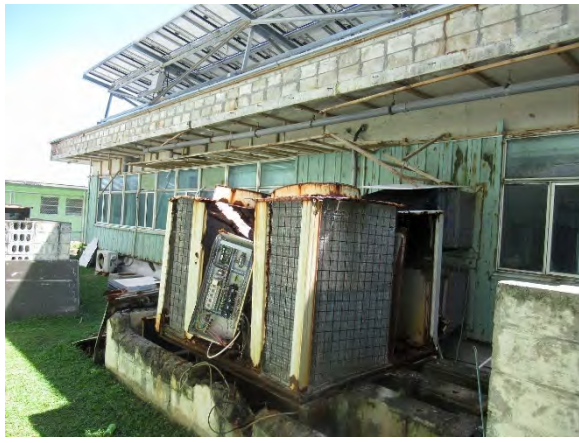
Building 2 Large Package

There are three second-generation large packages for Building 2 and Building 3, but they are broken and abandoned. These areas are air-conditioned by room air conditioners installed by the hospital.

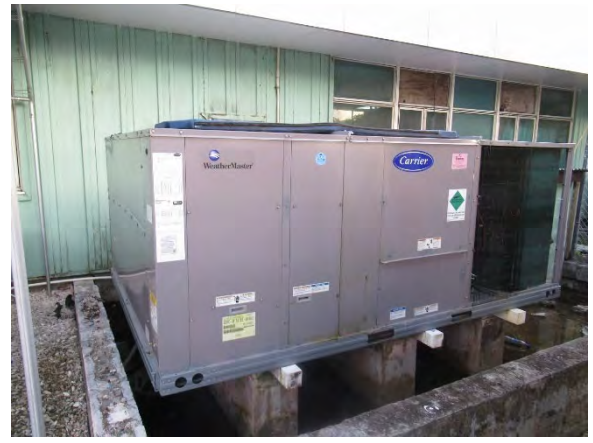
Building 3 Large Package

Building 3 has four large packages, three of which are being upgraded by the hospital in early 2022. This equipment is the third generation.

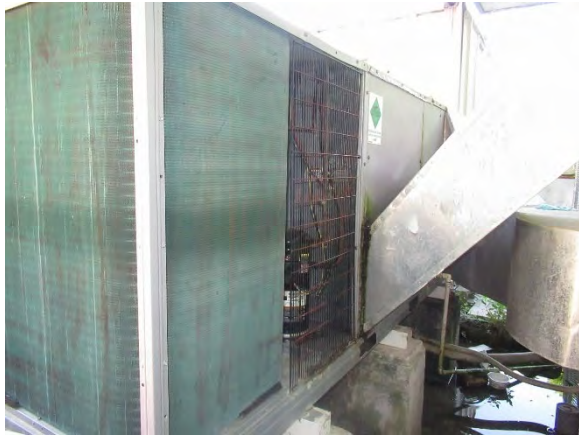
Building 3 Corrosion of Large Package

Even though the new large package has been installed for less than one year, corrosion is already visible on the heat exchange fins, protective guards, and caulking areas.

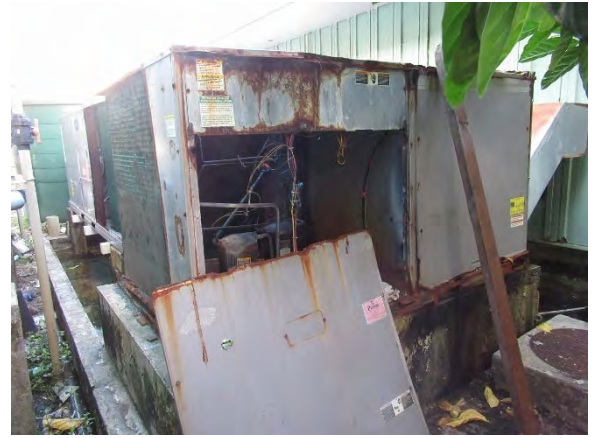
Building 3 Second-Generation Large Package

The remaining one for Building 3 is a large package for an operating room and is the second generation of equipment. It is almost externally dilapidated, but it is somehow operational.

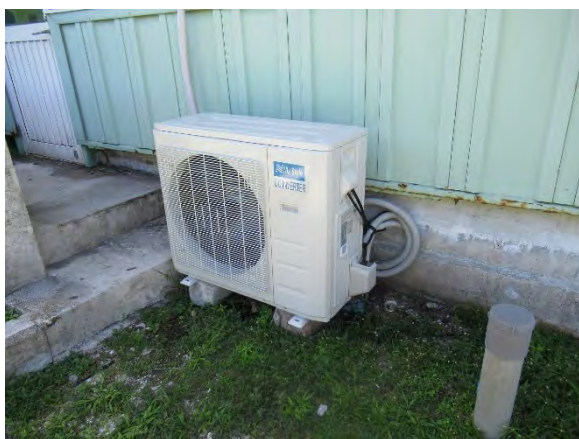
Outdoor Unit of Newly Installed Room Air Conditioner
Many of the small rooms have room air conditioners installed by the hospital.

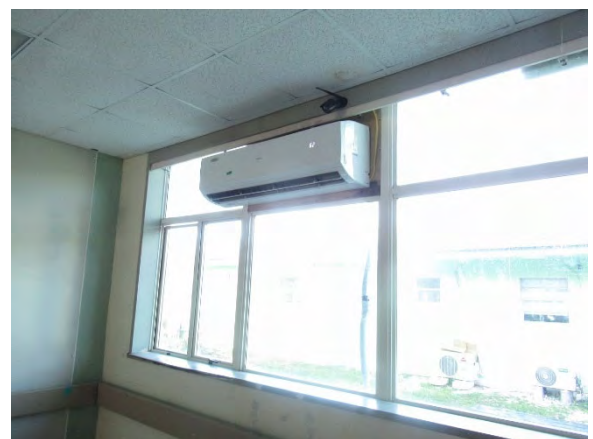
Indoor Unit of Newly Installed Room Air Conditioner
Condition of indoor unit of room air conditioner.

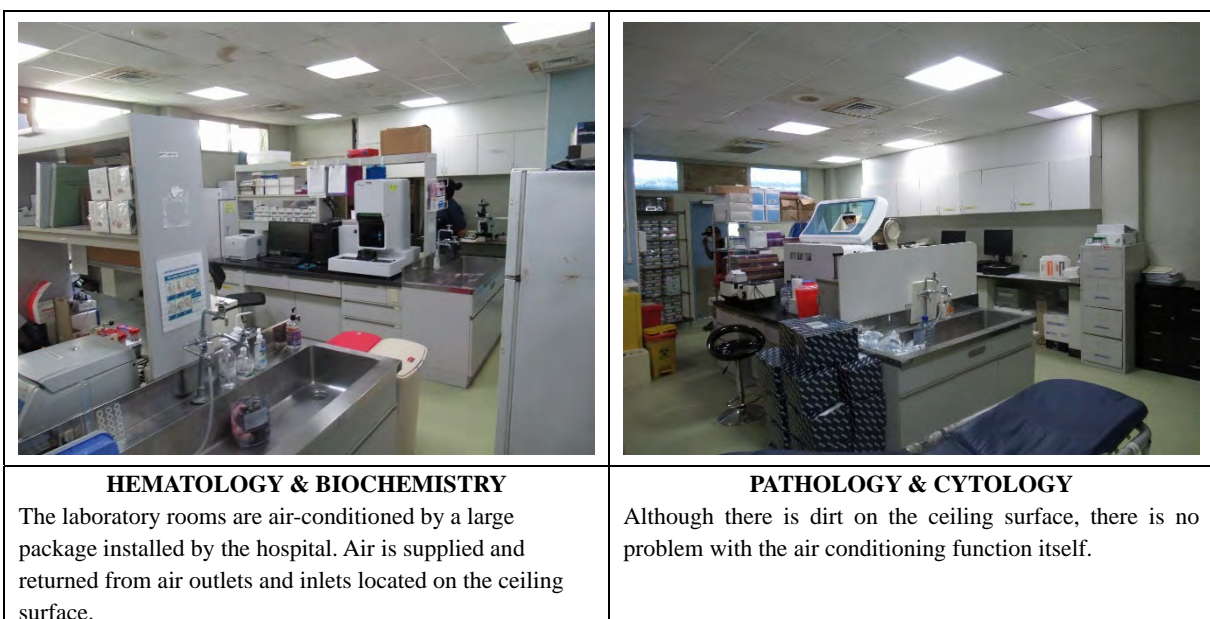
Figure 2-8: Photographs concern with Air Conditioning and Ventilation System in Laboratory

<p style="text-align: center;">MICROBIOLOGY</p> <p>Although this room also has many stains on the ceiling, there is no problem with the air conditioning function itself.</p>	<p style="text-align: center;">Safety Cabinet</p> <p>Safety cabinet is located in a dedicated room. Although the equipment is circulation type, there is no problem with the equipment itself.</p>

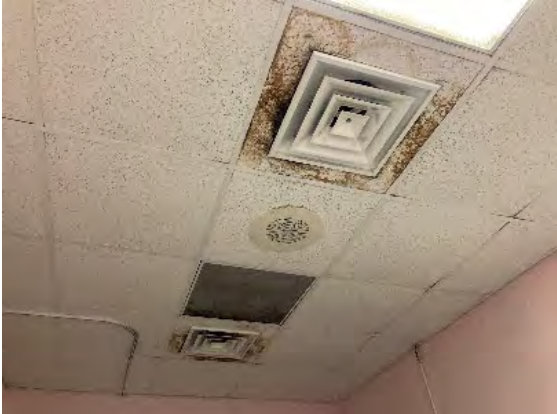
<p style="text-align: center;">Ceiling Condition</p> <p>Many areas of the ceiling panels are stained at the location of the air conditioner exhaust outlets and ducts.</p>	<p style="text-align: center;">Stained Ceiling Near Building Perimeter</p> <p>The ceiling is damaged in some areas due to roof leaks.</p>

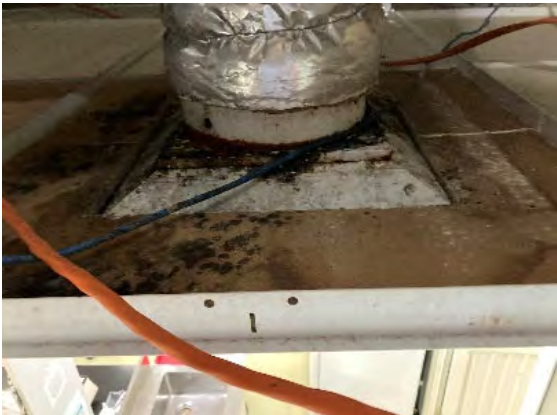
<p style="text-align: center;">Condition of the Exhaust Vent Inside the Ceiling</p> <p>The ceiling panel was confirmed to be stained by condensation water from the exhaust port, etc., and water drops were observed dripping from the duct. The ceiling backing structure is not damaged much.</p>	<p style="text-align: center;">Condition of the Inside of the Ceiling</p> <p>The ceiling backing structure is not damaged much and can be used as is.</p>

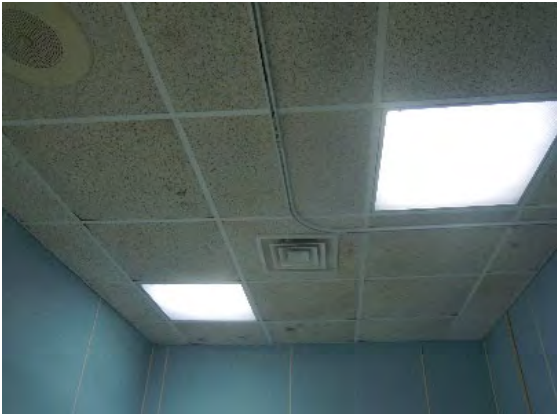
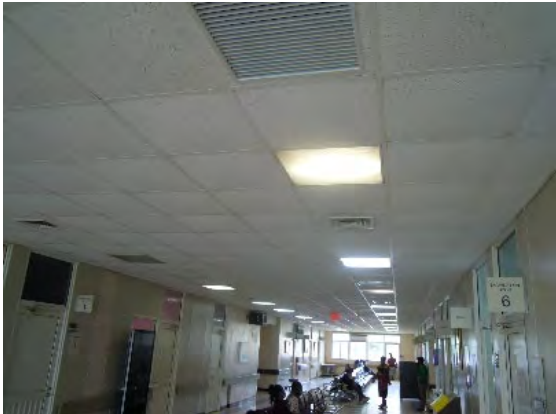
<p style="text-align: center;">Ceiling of Room with Low Air Circulation (Building 2)</p> <p>Between A and C grid line in Building 2, the panels are often blackened.</p>	<p style="text-align: center;">Condition of the Ceiling in Large Space (Building 2)</p> <p>Large space has better ventilation and there is less staining of the ceiling panels.</p>

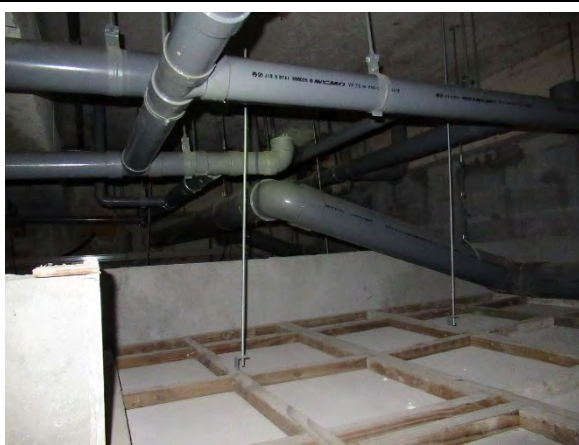
Building 1 In the ceiling under the lavatory on the 2nd floor (1)

Lower drainage piping for second floor lavatory. At the time of the survey, there was no water leakage at all and no trace of leakage could be found.

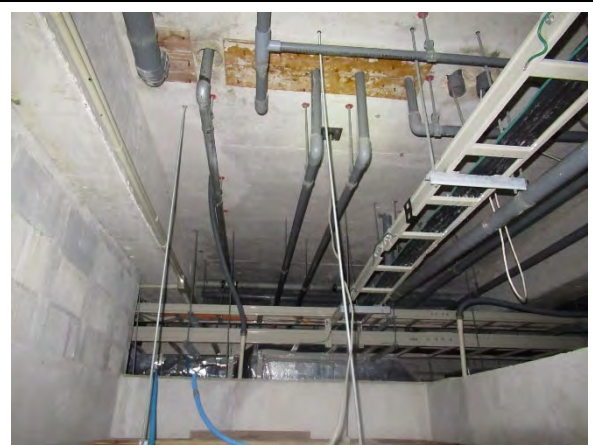
Building 1 In the ceiling under the lavatory on the 2nd floor (2)

Lower water and seawater piping for 2nd floor lavatory. There is no water leakage at all here either, and no trace of leakage.

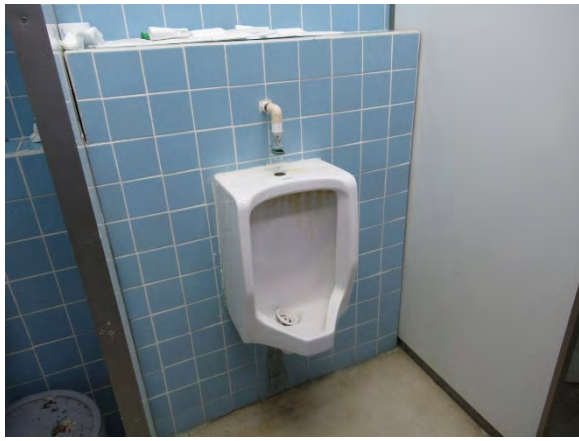
Building 1 In the lavatory on the 2nd floor (1)
Men's lavatory. The washbasin provides water, but the urinal has the water supply connection removed and is unavailable.

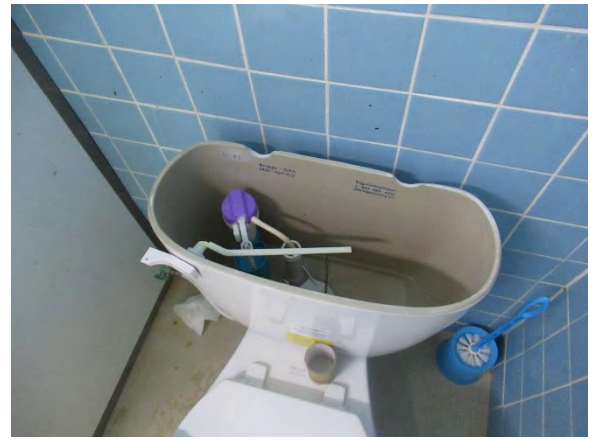
Building 1 In the lavatory on the 2nd floor (2)
There is no water at all in the low tank of the closet bowl, and it can be assumed that the water has been cut off for some time.

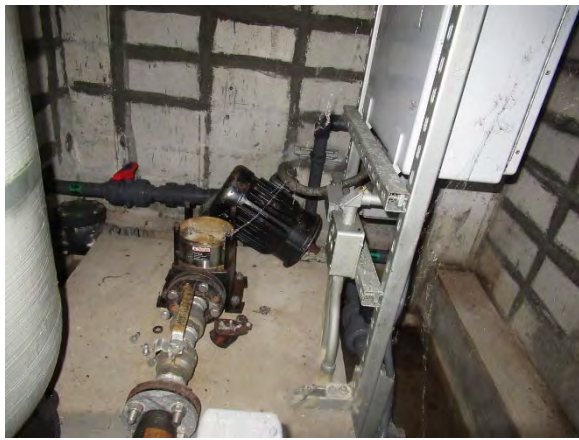
Water Supply Pressurized Water Pump
The water supply pressurized water pump is failed and the motor section has been left disassembled. Currently, the system has been converted to a direct water supply system, instead of using a receiver tank and pressurized pump.

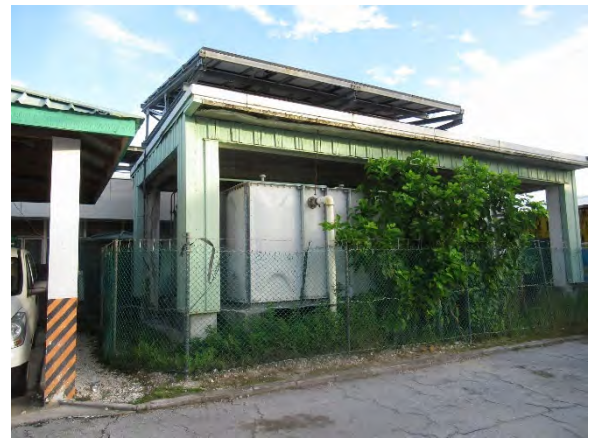
Water Supply Receiving Tank
The water supply receiver tank has rust on the frame externally, but appears to have no problem with water storage performance. However the water supply pump has failed and is not in use.

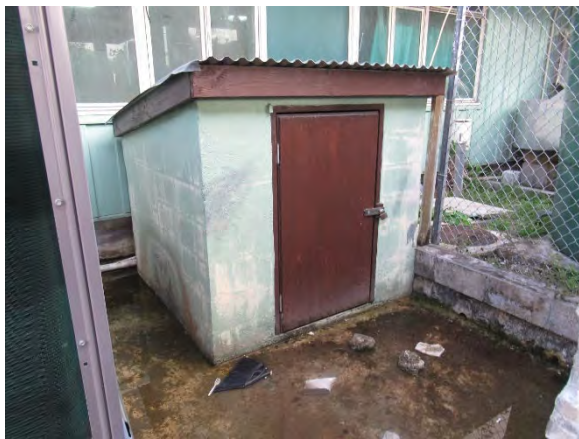
Seawater Pressurized Feed Pump
The hospital reported that a seawater pressurized water supply pump installed by the hospital is located in this shed, but it has failed and is not in use.

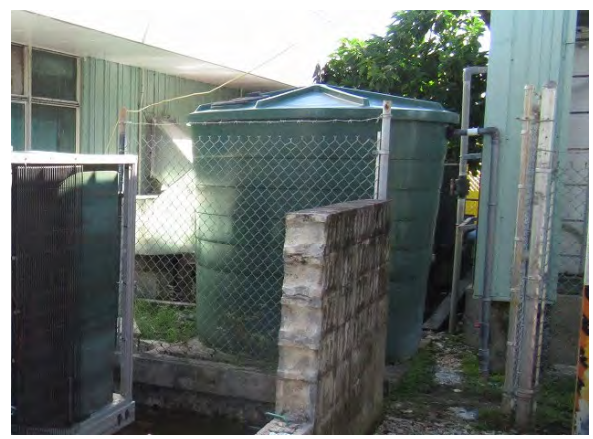
Seawater Receiver Tank
The pump has failed, so the receiver tank is not in use, and the water is being supplied to the building via a direct connection to the water supply pipe, but the water is cut off due to a lack of water pressure.

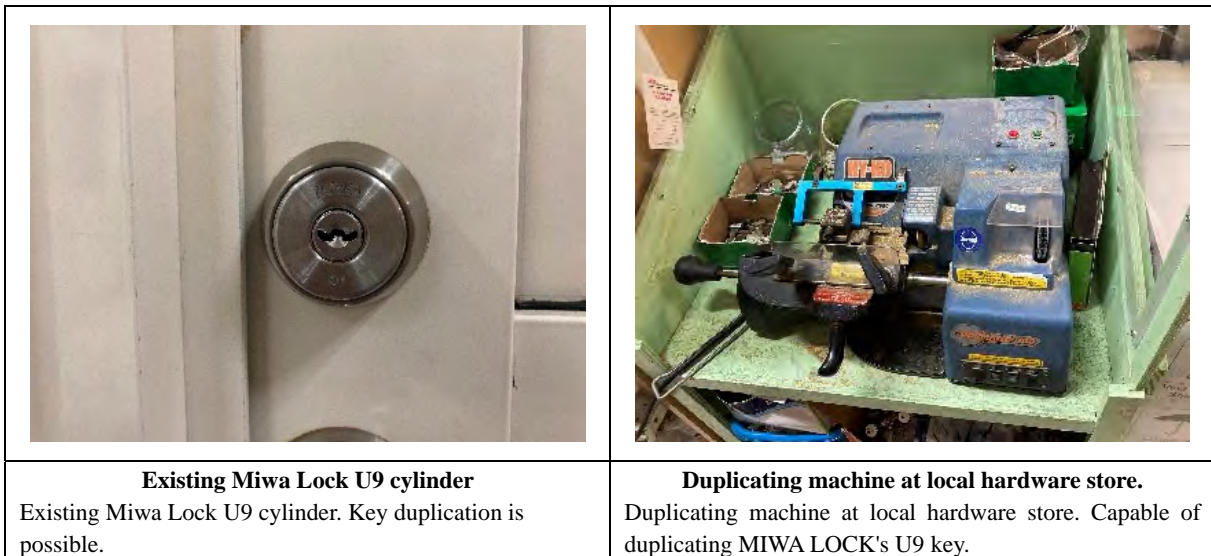
Figure 2-11: Photographs concern with Problems with Keys and Door hardware

Notably, two master keys were extant at the hospital.

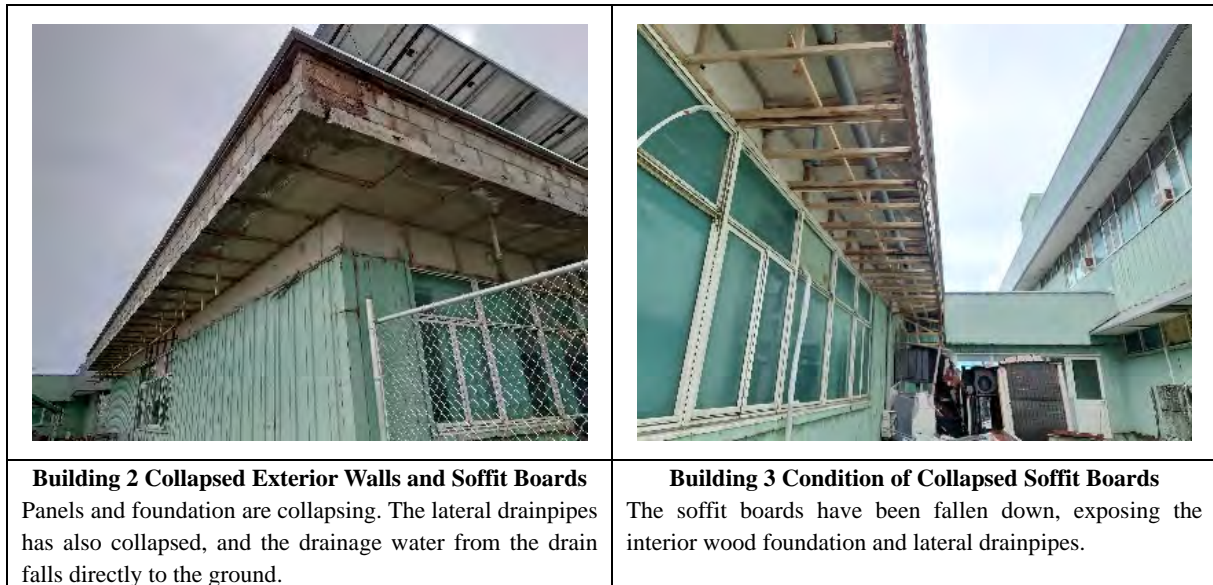
Figure 2-13: Photographs of Exterior Wall Panels and Soffits Deteriorating and Falling Off

Notably, The collapse of the aluminum parapet wall panels is not a direct reason of rain seeping inside the building..

As indicated in 2.3.7, some of the aluminum panels and eave boards of the parapet are collapsed. Although this is not a direct reason of leakage, it is desirable to reinstall the aluminum panels and eave boards that have collapsed at the earliest possible stage, as it may reduce the durability of the wooden base of the shade trees and the blocks and other components of the parapet. In the estimation, the direct cost is about 83,000USD, which is assumed to be under the jurisdiction of the Ministry of Public Works because it exceeds 25,000USD.

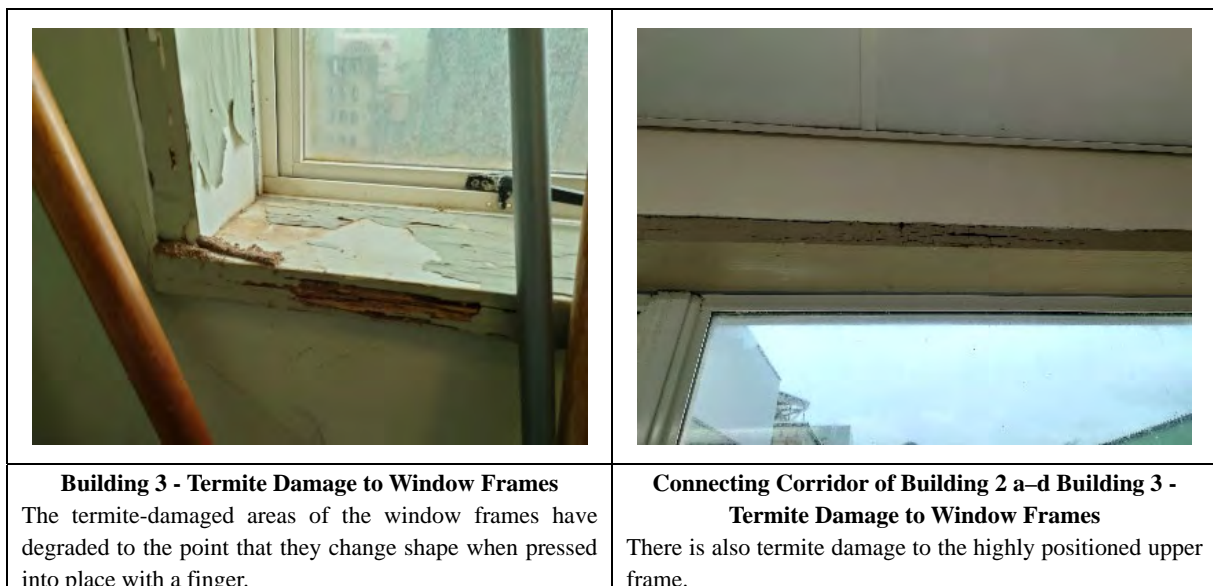
Figure 2-14: Photographs of Termite Damage

Termite damage was observed on window frames in Buildings 2 and 3 and in the corridors. It is presumed that the termites came to feed on the wooden window frames, which were made moist by leaks and high humidity.

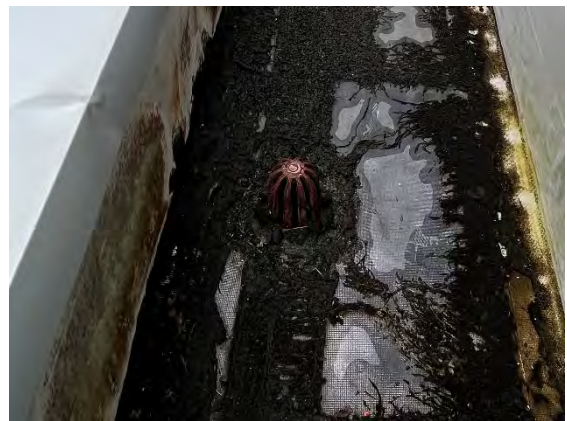
Condition of Existing Roof Drain

If the roof drains are cleaned, it should be possible to avoid having them all clog at once; also, it is unlikely that the maximum daily rainfall over the past 50 years will fall in one hour or continuously over a defined period of time. Additionally, during the field survey, rooftops that had not been cleaned in many years were checked, and although vegetation (algae- and moss-like growths) and other matter growing from deteriorating waterproofing sheet fibers are entangled in the strainer caps of the roof drains, the drains themselves are not completely clogged. Therefore, installation of overflow pipes is not considered necessary.
