エチオピア連邦民主共和国  
エチオピア道路公社（ERA）  
アジスアベバ市道路公社（AACRA）

エチオピア国  
道路アセットマネジメント技術アドバイザー業務

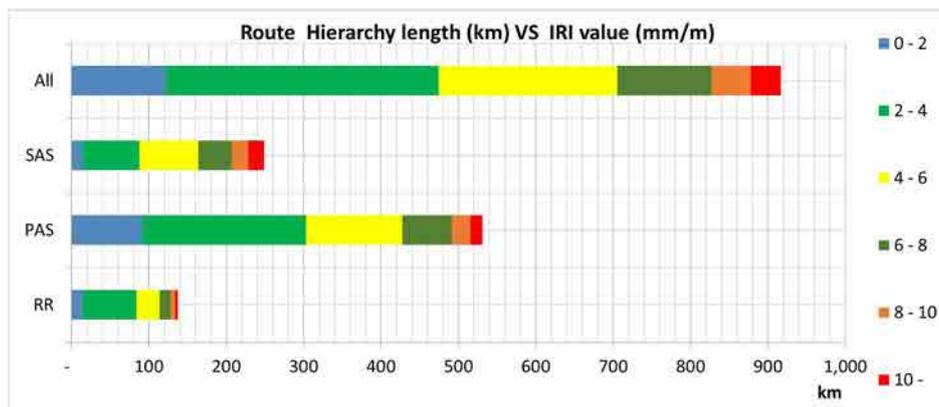
IRI について、環状道路、一次幹線道路、二次幹線道路、接続道路について計測している。未舗装道路は計測していない。2018 年のデータを見る限り、50%以上が問題なく（IRI4 未満）、補修が必要な範囲は 10%程度（IRI8 以上）であることから、アジスアベバ市内の舗装道路については比較的良好な状態が保たれているように見える。現状では補修範囲を判断する明確な IRI 値の基準は設けられていない。IRI の値よりも、予算額や路線の重要度によって補修範囲は決定されるとの事である。

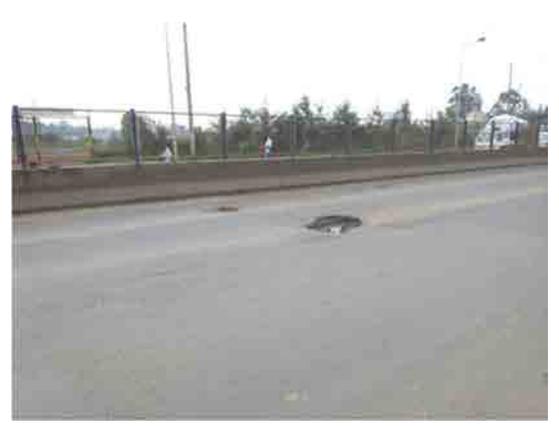
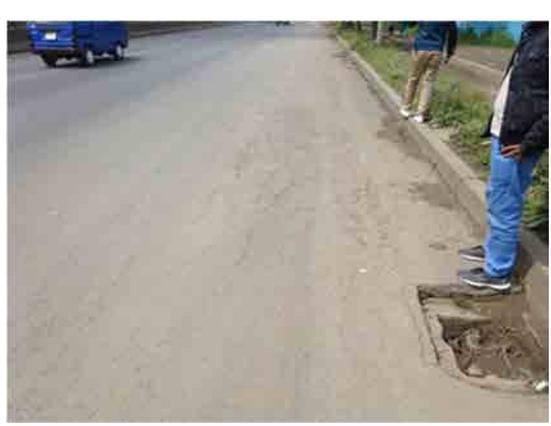
破損形態	ポットホール	破損形態	・亀甲クラック
位置	ガブリエル橋アプローチ上流部	位置	ガブリエル橋アプローチ下流部
考えられる要因	・部分的な施工不良（舗装厚さ不足）が考えられる。 ・交通荷重	考えられる要因	・路面排水不良 ・交通荷重
状況	単独であり、かつ荷重がかかる車輪軌道上のみの破損であることから部分的な出来形（舗装厚さ）不	状況	滞水によって舗装がぜい弱化し、繰り返し荷重によって亀甲クラックが発生したものと考えられ

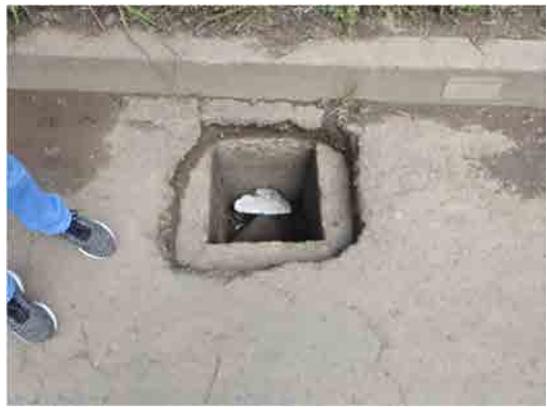
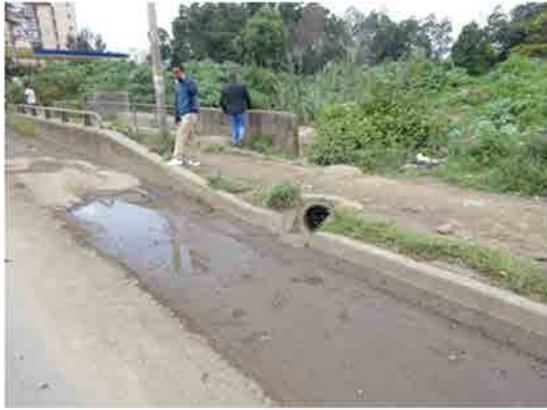
破損形態	排水ます内に異物	破損形態	土砂堆積
位置	ガブリエル橋アプローチ下流部	位置	同左の最下流の呑み口
考えられる要因	・雨水による異物流入	考えられる要因	・出来形不良（仕上がり高さ）
状況	前頁右の位置の近傍である。放置すれば、同じように土砂で埋まると予想される。	状況	写真中央に流末への呑み口が確認できるが、路面の方が低いため土砂が堆積している。常態的に滞水していることが推察できる。
推奨される対策	・日常管理による排水ますの清掃	推奨される対策	・オーバーレイなどによる路面高さの嵩上げ

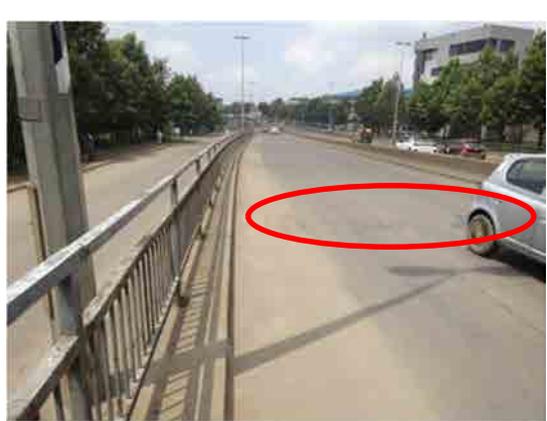
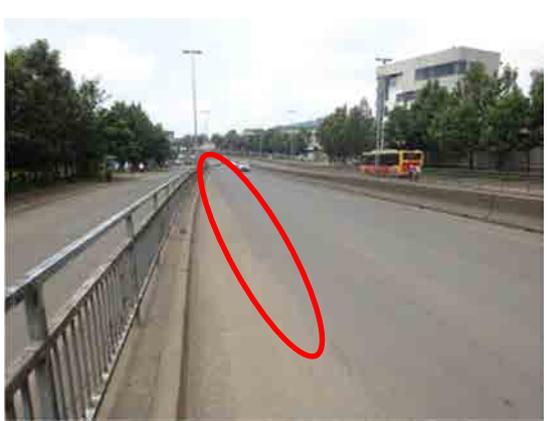
破損形態	ブリージング	破損形態	軽度な側方流動（こぶ）
位置	Lebu 交差点付近	位置	同左
考えられる要因	・プラントの品質管理	考えられる要因	・表層材料の不適合
状況	当該箇所はおそらく施工ジョイントである。プラントにおける当日の混合物製造開始直後のバッチが配合不良（アスファルト量過多）であったと考えられる。軽度なわだち掘れを伴っており、経過観察が必要である。	状況	アスファルト量過多または細骨材量過多（配合の不適合）が考えられる。左記の例と合わせて考察すると、施工当日の混合物製造工程に何らかのミス（アスファルトの計量ミスなど）が疑われる。
推奨される対策	・表層部分打ち換え	推奨される対策	・経過観察（軽度であるため応急処置などは不要）

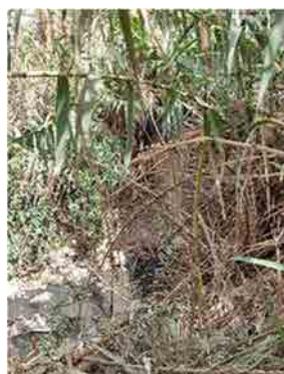
結論：上流側、下流側共に河川へのアクセスは容易ではないが、梯子などを使えば河床にアクセスが可能。河床からの点検を実施することが望ましい。下流側からの遠方目視で、床版側面でのコンクリート剥離、鉄筋露出／腐食を確認。早急な対処が望ましい。

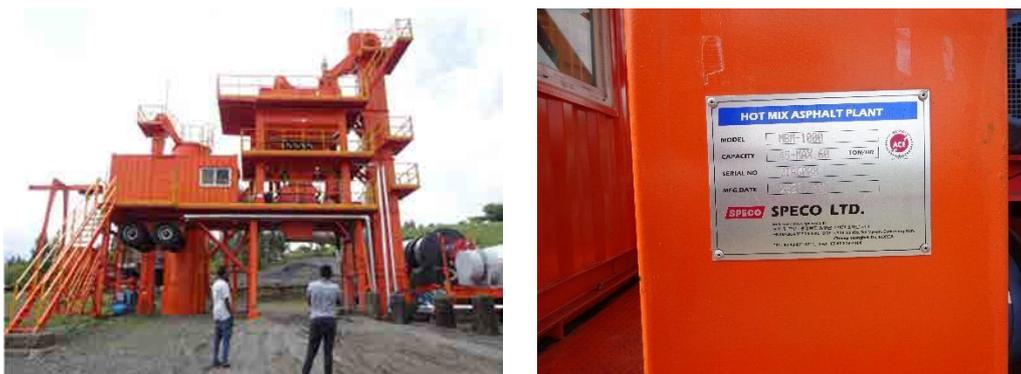
A D保有のアスファルトプラント (Sebeta)

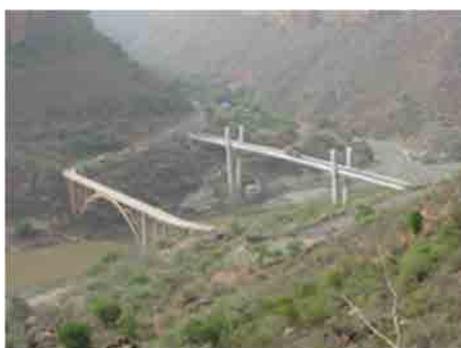
- ・ 提供された点検及び維持管理マニュアルにはケーブル及び関連部品を詳細に点検する方法が含まれていない。また、具体的にどのように活用したらよいか理解できておらず、活用できていない。
  - ・ 損傷が確認されてからの対応について記述があるマニュアルがない。
3. その他の橋梁
- ・ 現在施工中の BAHIRDAR ABAY RIVER BRIDGE（自国資金）は2橋目のエクストラードズド橋が2023年に開通する予定である。ERAは、この橋梁の維持管理もBMSを利用して総合的に行いたいと考えている。

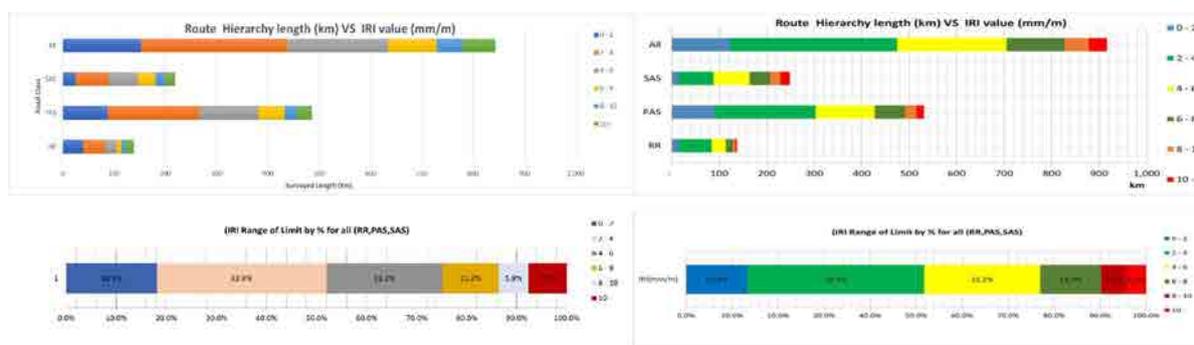
IRIについて、2018年度～2021年度までの3年間のデータを受領した。毎年1回の計測が順調に実施されていることがうかがえる。2021年度と2018年度のデータを比較すると、問題のない区間（IRI4未満）は50%程度と2018年度から変化はないが、補修が必要な区間（IRI8以上）が10%程度から13%程度に増加した。アジスアベバ市内の舗装道路については比較的良好な状態が保たれているが、若干劣化が進んでいるように見受けられる。現在は前述の通り PCSV が故障しているため、2022年度のデータ収集は出来ていない。この装置は、5m ピッチで画像をとらえることで路面状態を診断するシステムである。また、レーザーにより路面の凹凸をプロファイルする。雨天や曇天では、計測精度が下がるため、AACRA では2023年度の計測は雨季が明ける9月以降から開始する計画である。

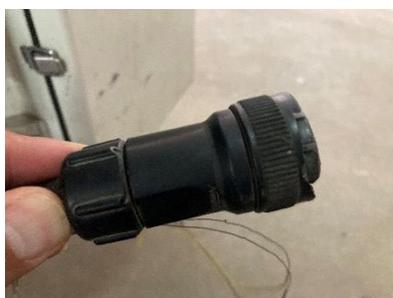
変位計センサー用 ケーブルコネクタ  
(軽微な破損、稼働に現状問題なし)

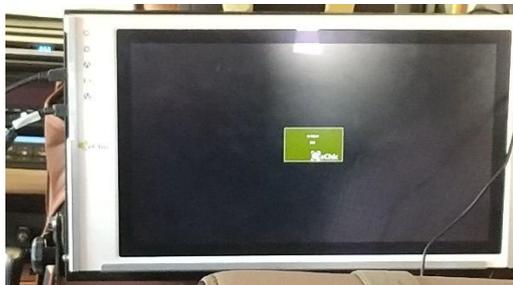
2022年12月に修理を実施したPCSVの状態を確認したところ、再度計測機材が故障し使用できない状態であった。モニタに「No signal」が表示され、システムが稼働しない現象が発生していた。

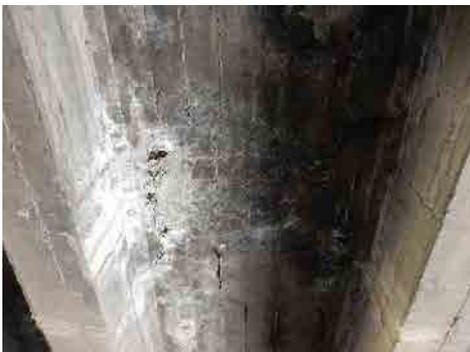
RC床版下面(密度低下) 橋台基礎部 (洗堀)

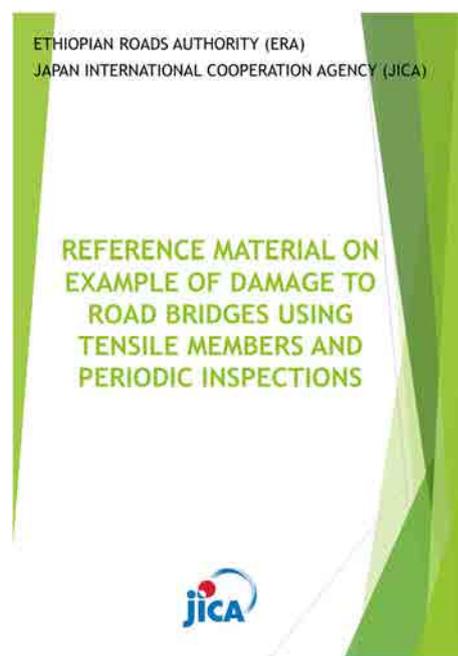
を有する橋梁点検の一助になることが期待される。

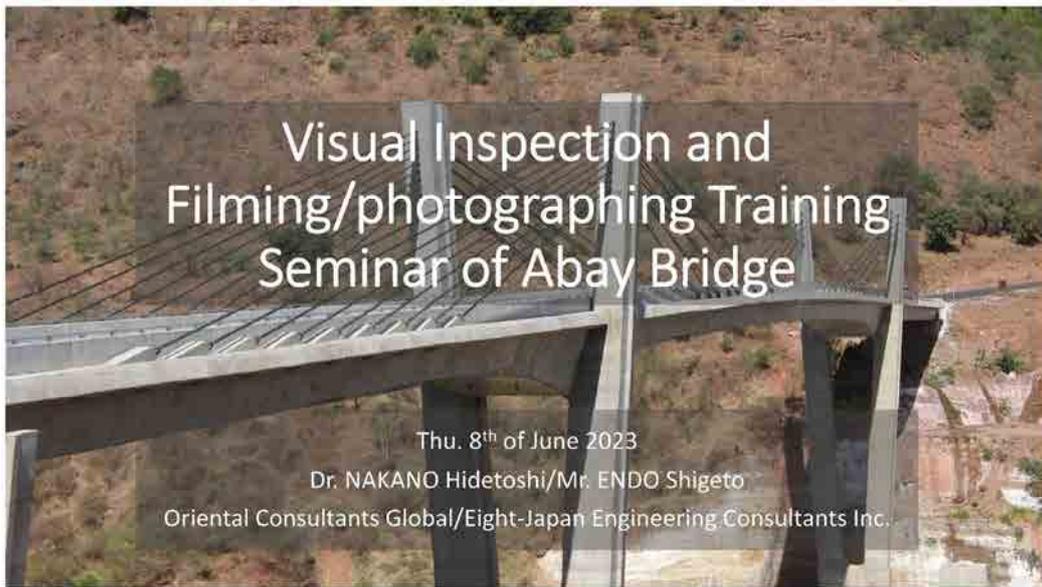
9. Schedule for the Abay Bridge Inspection

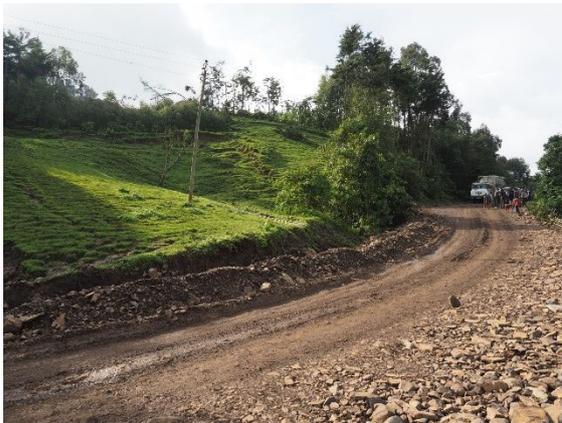
地すべり頭部と道路の状況。頭部には滑落崖と引張亀裂が、道路には押し出されたことによる屈曲が明瞭である。

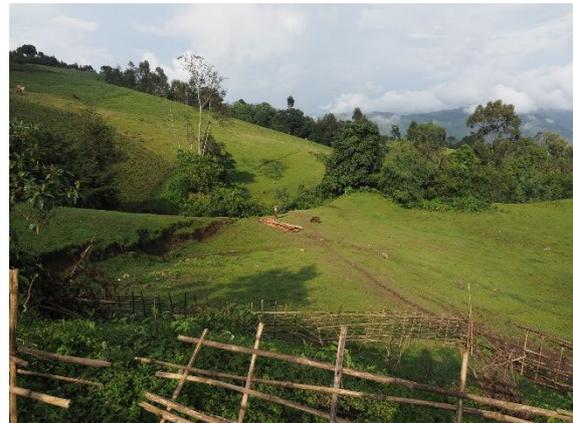
側部から末端の状況。側部には明瞭な段差を伴う亀裂が発達するが、表流水によりさらに浸食されている。

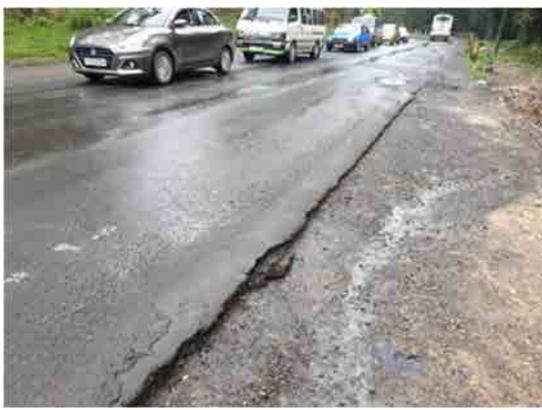
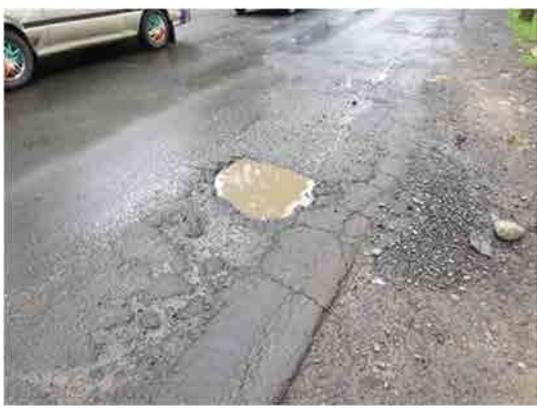
破損形態	舗装縁端（エッジ）の破損	破損形態	<ul style="list-style-type: none"> <li>・ポットホール</li> <li>・こぶ（押し出し Shoving）</li> </ul>
位置	起点から600m 森林地帯	位置	同左
考えられる要因	<ul style="list-style-type: none"> <li>・舗装縁端処理の不備</li> <li>・路面排水機能不全</li> </ul>	考えられる要因	<ul style="list-style-type: none"> <li>・舗装縁端処理の不備</li> <li>・アスファルト層下層への雨水の浸入</li> </ul>
状況	路肩が未舗装で雨水によるエロージョン（洗堀）を起こしているため、舗装の弱点であるエッジから破壊している。	状況	舗装端部が交通荷重により車輪軌道外側に押し出しによるこぶが形成され、車輪軌道には引っ張りによる縦断方向に線上クラックが発生している。さらに線状クラックが成長し、亀甲クラックを経てポットホールを形成した。
推奨される対策	<ul style="list-style-type: none"> <li>・舗装縁端に縁石や排水溝などの構造物の設置</li> <li>・未舗装路肩のキャッピング（As 簡易舗装、コンクリートシール、石張りなど）</li> </ul>	推奨される対策	<ul style="list-style-type: none"> <li>・舗装縁端に縁石や排水溝などの構造物の設置</li> <li>・未舗装路肩のキャッピング（As 簡易舗装、コンクリートシール、石張りなど）</li> </ul>

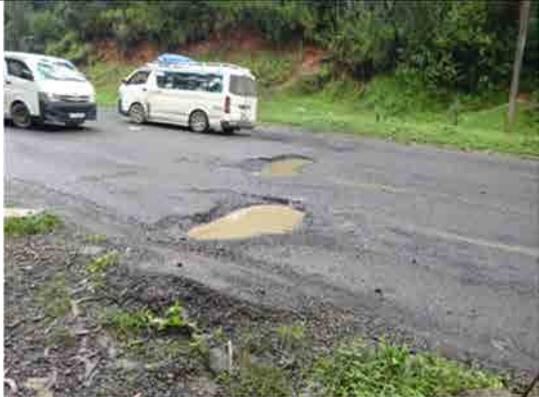
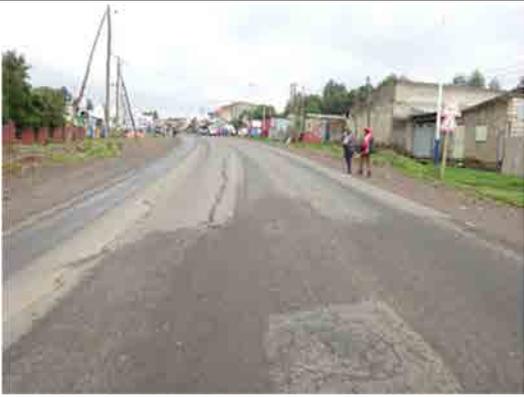
破損形態	深刻なポットホール	破損形態	・流動わだち ・こぶ (Shoving)
位置	起点から 700m 森林地帯	位置	起点より約 7 km (Shufune)
考えられる要因	<ul style="list-style-type: none"> <li>・路面排水機能不全</li> <li>・経年劣化</li> <li>・施工不良 (出来形不足)</li> </ul>	考えられる要因	・表層材料の品質不良
状況	アスファルト層 (厚さ 7 cm) が完全に消失し、路盤が飛散している。穴の深さは 20 cmあり、通過車両は十分にスピードを落とし、恐る恐る通過している状態である。直近でアジス市に向かう通行の検問を実施しており、相乗効果で南向き交通は深刻な渋滞を引き起こしている。	状況	約 200m にわたり、深刻な流動わだち掘れが形成されている。最大深さは 8 cmである。視察した区間の中では、これほど明確なわだち掘れはこの区間のみであり、表層材料の品質不良が考えられる (原料のばらつき、混合物製造時の品質管理)。
推奨される対策	<ul style="list-style-type: none"> <li>・ポットホールの穴埋めまたはパッチング</li> <li>・部分打ち換え</li> </ul>	推奨される対策	・切削オーバーレイ

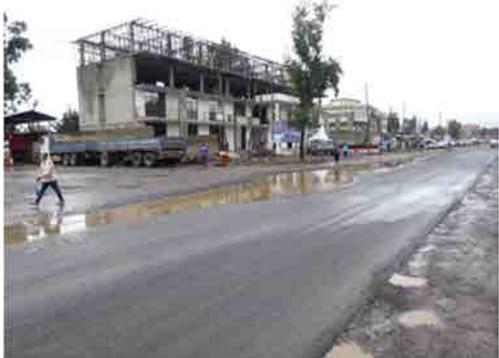
破損形態	路肩の滞水 (水たまり)		
位置	起点より約 7 km (Shufune)		
考えられる要因	・路面排水機能不全		
状況	路肩に排水構造物が全くなく、自然排水状態であるが流末がないため雨季には常時滞水している状態である。		
推奨される対策	・舗装縁端に縁石や排水溝などの構造物の設置

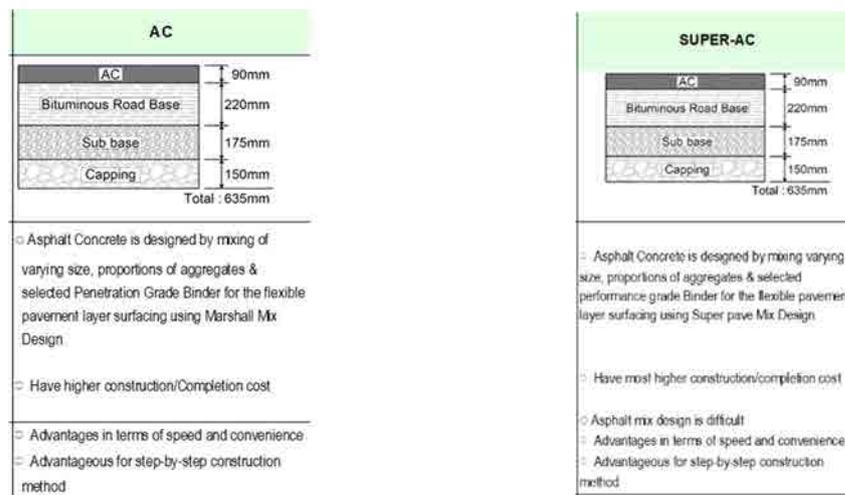
出典：ERA “Consultancy Service of Concept Design, Detail Landslide Mitigation Measures and Preparation of Tender Document through OPRC Delivery Method for Gotsion – Dejan Rehabilitation and Improvement of the Abey Gorge Road Condition”

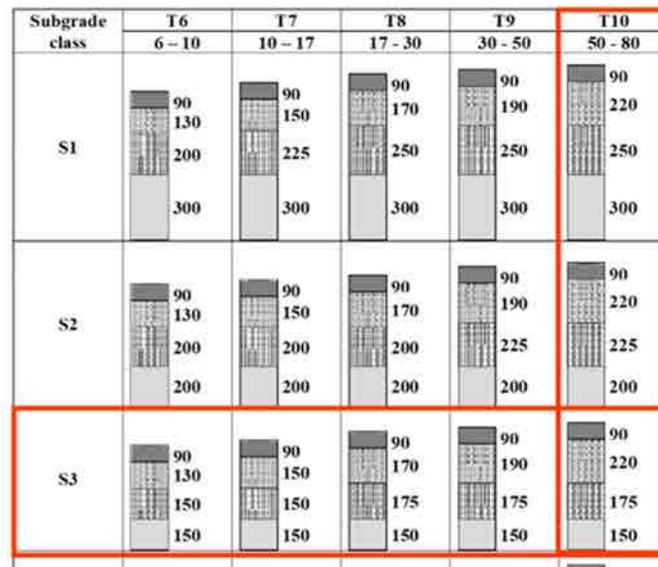
出典 : ERA “Flexible Pavement Design Manual Final Nov 2013”

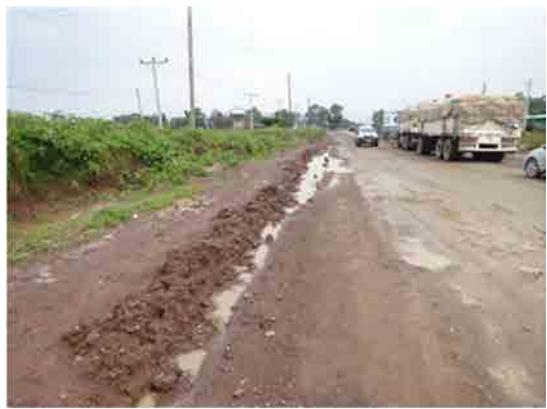
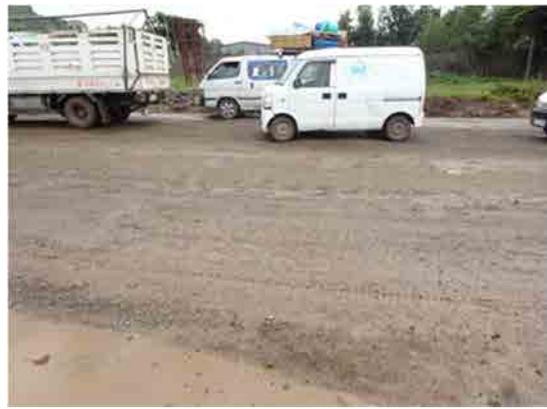
破損形態	排水不良	破損形態	・舗装版の消失
位置	起点から約800m	位置	起点から約1.2km
考えられる要因	・排水設備の未整備	考えられる要因	・路面排水不良 ・アスファルト層下層への雨水の浸入
状況	自然排水を見込んだ土側溝が設けられているが、流末が設けられていない。溢れた雨水が路面に悪影響を及ぼしている。	状況	地形的にサグ点でもあることから、特に雨水の影響を受けやすい場所で、舗装版が完全に消失している。
推奨される対策	・排水設備の整備	推奨される対策	・排水設備の整備

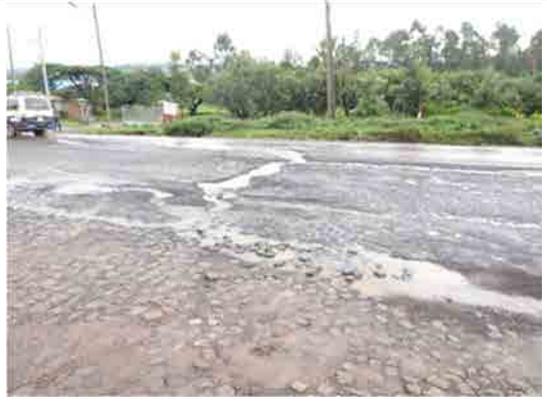
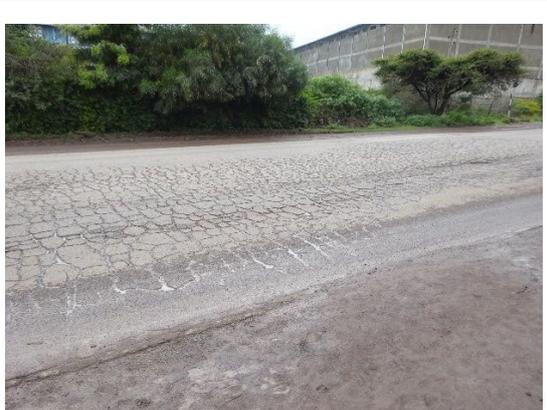
破損形態	横断方向に舗装版消失	破損形態	アリゲータ（亀甲）クラック
位置	起点より約2.3km	位置	起点より約6km
考えられる要因	・路面排水機能不全 ・交差点部	考えられる要因	・経年劣化
状況	当地点は交差点部である。交差点支線側が上流であり、流入する雨水によって横断方向に水道が形成されている。通過する車両が急激に速度を落とすため渋滞の要因となっている。	状況	路面全体に重度の亀甲クラックが発生している。舗装耐用年数を経過した経年劣化によるものと考えられる。
推奨される対策	・交差点横断部の横断排水（暗渠）などの構造物の設置	推奨される対策	・表層打ち換え

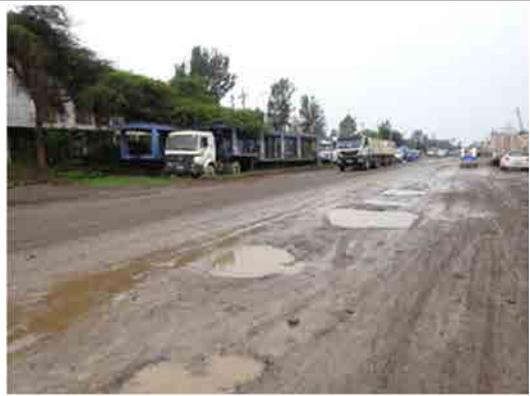
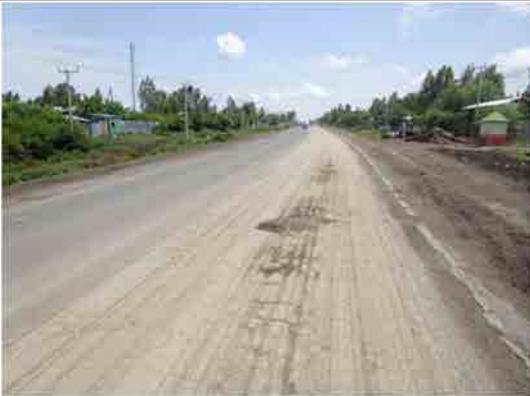
破損形態	舗装版消失および不陸	破損形態	表層切削後、未舗装のまま存置
位置	起点より約8km	位置	起点より約12km
考えられる要因	<ul style="list-style-type: none"> <li>路面排水機能不全</li> <li>サグ点</li> </ul>	考えられる要因	<ul style="list-style-type: none"> <li>舗装用材料（アスファルト材料）の不足</li> </ul>
状況	既設の舗装版が消失し、路盤が露出しており不陸を形成している。	状況	改修工事が開始されたが、切削まで完了して中断している状態である。表層用材料（アスファルト）の不足が要因。
推奨される対策	<ul style="list-style-type: none"> <li>舗装縁端に縁石や排水溝などの構造物の設置</li> </ul>	推奨される対策	<ul style="list-style-type: none"> <li>早急にオーバーレイの施工が望まれるほか、部分打ち換えが必要</li> </ul>

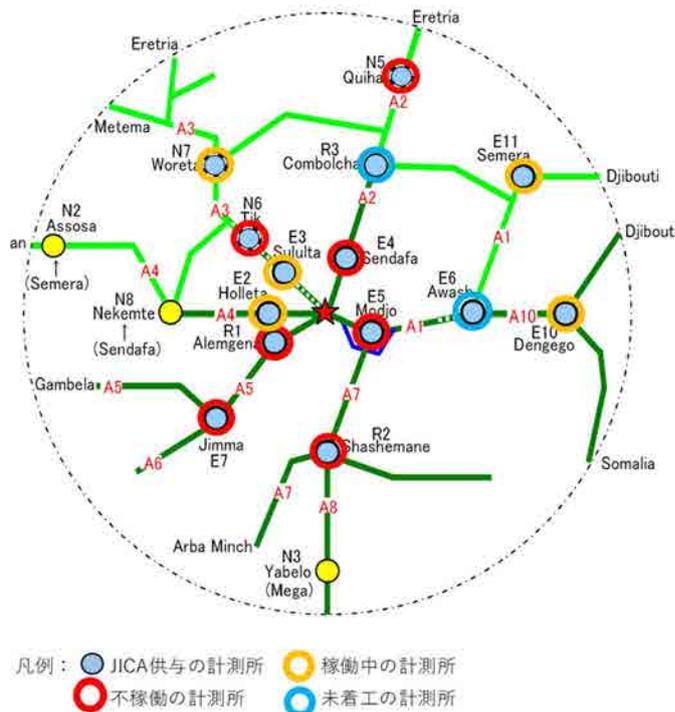
No.	台数	設置場所	状況	稼働状況
E2	1	Hollela	調査済み	○
E3	1	Sululta	調査済み	○
E4	1	Sendafa	調査済み	×
E5	1	Modjo	調査済み	×
E7	1	Jimma	調査済み	×
R1	1	Alemgena	調査済み	×
R2	1	Shashemane	調査済み	×
N6	1	Tik	調査済み	×
E10	1	Dengego	未調査	○
E11	1	Semera	未調査	○
N7	1	Woreta	調査済み	○
E6	1	Awash	工事未着手	×
R3	1	Combolcha	工事未着手	×
N5	1	Quiha	進入不可	×

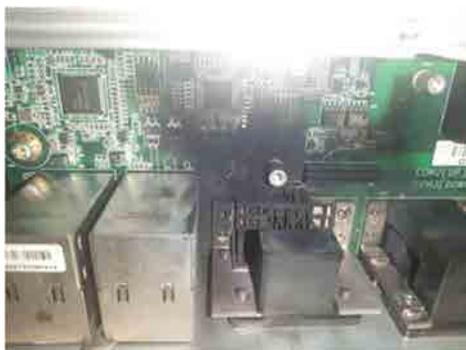
以下に ERA から入手した保守状況の写真を添付する。複数のサイトで同じ故障が発生している。

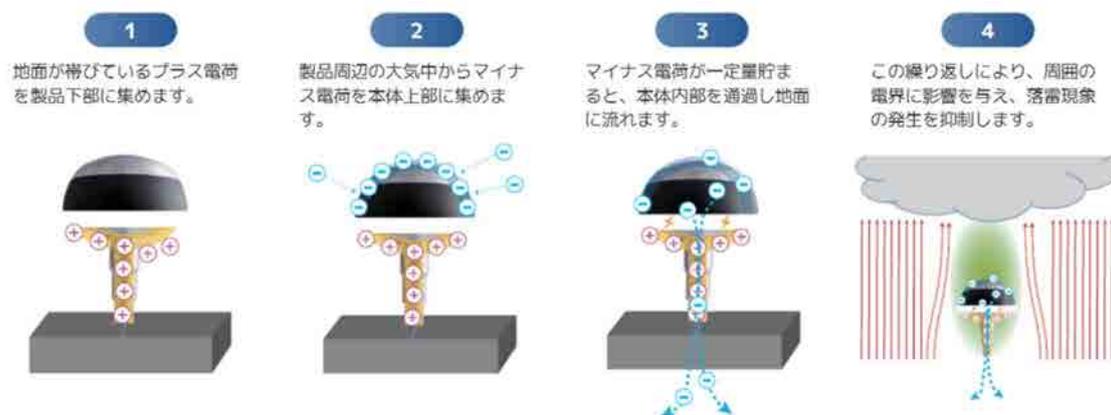
DDCEの設置は一般的な避雷針と同様の材料、工法で設置する。設置高さ25m、半径約63mの保護半径の例を示した。例えば、計測所の中心にDDCE\_100\_Plus を高さ約15mに設置することで、半径約50mのエリアが保護される。

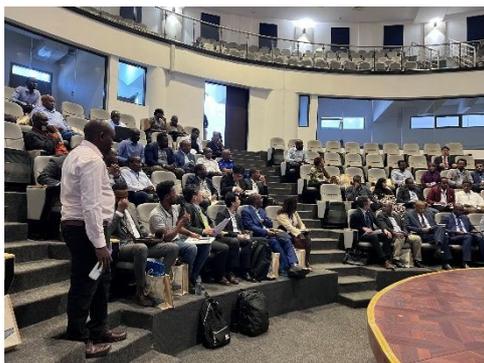
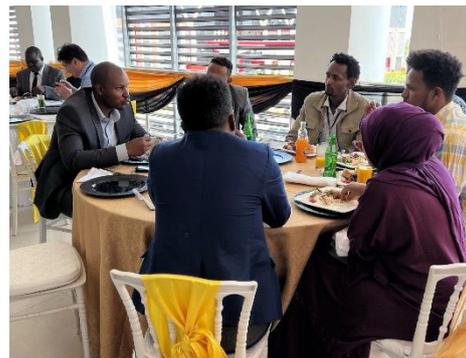
研修実施機関である KeNHA からは、「軸重超過は東アフリカ地域一丸となって取り組むべき課題であるため、このようなトレーニングは非常に有用であり、引き続き各国間の協力を続けていきたい。トラックの荷重管理は、機器だけでなくソフトスキルが重要であり、ステークホルダーのエンゲージメント、運送会社や警察との協力関係構築に継続的な努力をすることが不可欠である。ケニアにおける次の課題は裁判所とのさらなる関係の構築と法制度の適正化である。」と総括があった。

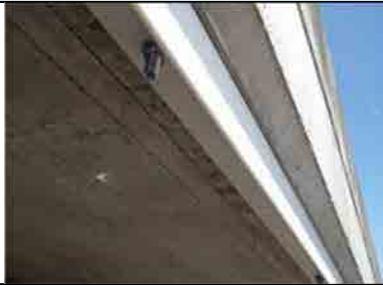
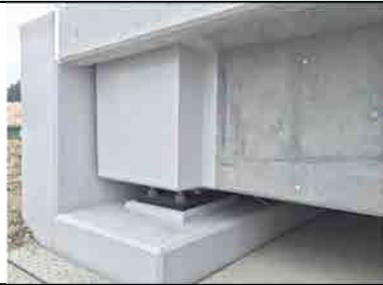
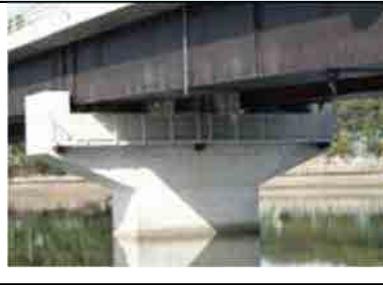
床版端部で雨水をシャットアウトすることで、上部構造等への雨水侵入を低減する。湿潤状態では、乾燥状態に比べて 100～300 倍の速さで床版が破壊に至ったことが明らかになっている。	桁端部は伸縮装置からの漏水により常時ウェットな状態になりやすいため、桁端部のコンクリート塗装を施すことにより、コンクリート内部に雨水が侵入するのを低減できる。	定期的な点検が円滑に行えるように、点検用検査路を設置する。やむを得ず検査路が設置できない場合でも、点検方法の代替案を考えておくことは道路管理者の責務である。
橋座等での水処理

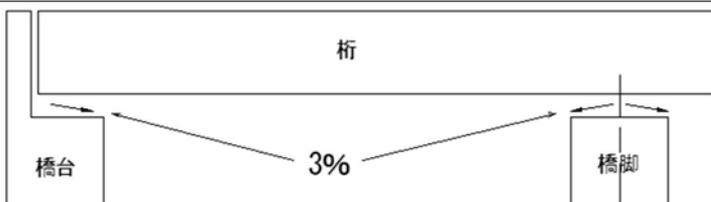
下部構造頂部は、伸縮装置からの漏水の他、支承部廻りは一般に風通しが悪く、塵芥や湿気が溜まるなど腐食・劣化しやすい環境にある。このため、水が溜まらないように橋軸方向に下図のような 3% の勾配をつける対策を講じる。

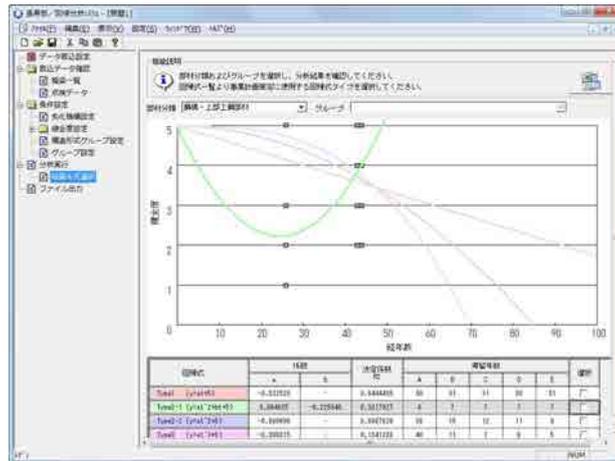
出典：JIPテクノサイエンス株式会社 HP

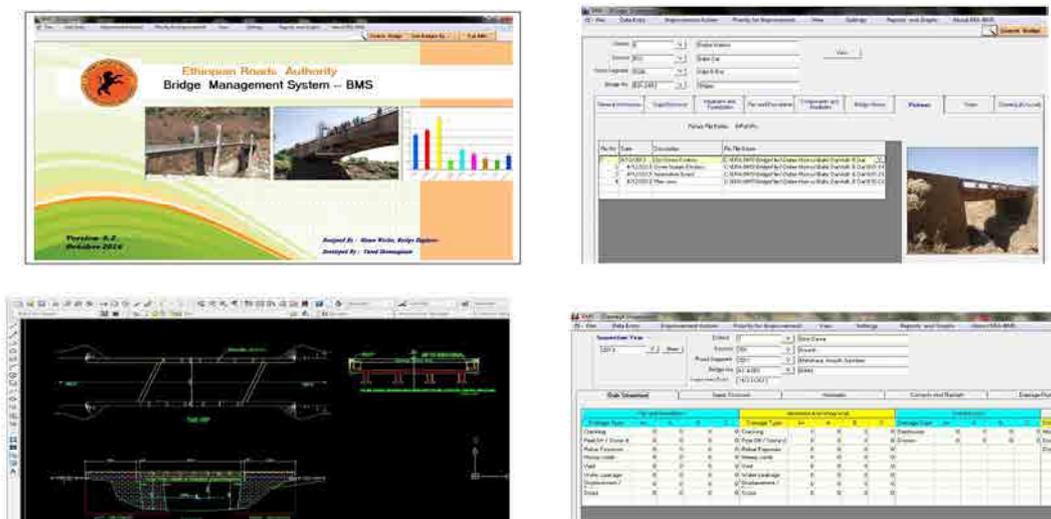
出典：ERA BMS ユーザーマニュアル

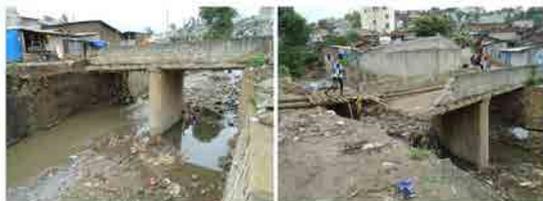
Item No.	Bridge Name	Span Length	Co-Ordinates		Year of Collapse/damage	Remark
			X-Coordinate	Y-Coordinate		
2.	Goto-2	16 m	480974	994954	August, 2022	The flood is overtopped on the bridge & it has many other defects. It need replace. It was given the services for both vehicles & pedestrian.

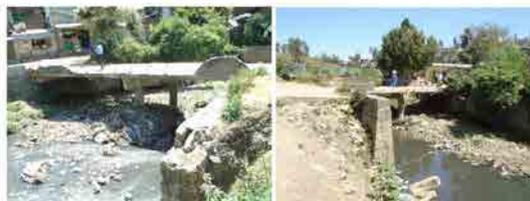
Item No.	Bridge Name	Span Length	Co-Ordinates		Year of Collapse/damage	Remark
			X-Coordinate	Y-Coordinate		
3.	Goto-3	30 m	481057	995343	August, 2022	The bridge is totally washed away by flood. It need replace. It was given the services for both vehicles & pedestrian.

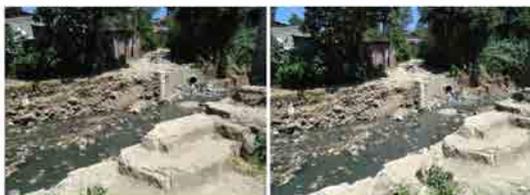
Item No.	Bridge Name	Span Length	Co-Ordinates		Year of Collapse/damage	Remark
			X-Coordinate	Y-Coordinate		
4.	Talossa Sefer	11 m	470360	997850	2016.	Abutment scoured & then Deformed. It need replace. It was given the services for both vehicles & pedestrian.

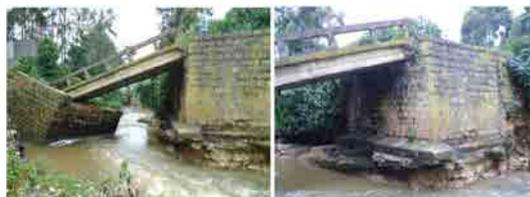
Item No.	Bridge Name	Span Length	Co-Ordinates		Year of Collapse/damage	Remark
			X-Coordinate	Y-Coordinate		
5.	Bulgariya Tabot Maderiya	15 m	472178	993802	2018.	Bending to collapses. In the previous time this bridge was used for passing bajaj & Motor Cycle, but now it uses only for Pedestrian. It need replace.

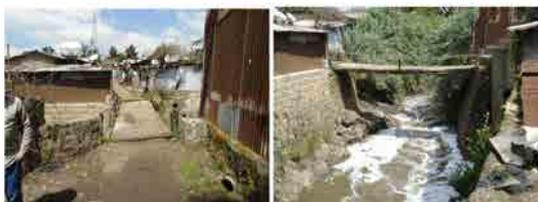
Item No.	Bridge Name	Span Length	Co-Ordinates		Year of Collapse/damage	Remark
			X-Coordinate	Y-Coordinate		
6.	Ayer Tena Processing area	Wood 6 m	467237	992193	2018.	It was a mistake during bridge construction, as a result of shortening the span. This causes for scour the abutment repeatedly. It was given the services for both vehicles & pedestrian.

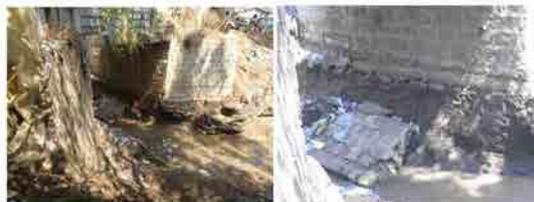
Item No.	Bridge Name	Span Length	Co-Ordinates X-Coordinate Y-Coordinate	Year of Collapse/damage	Remark
7	Mother Teresa	5 m	474165 999154	2015	It is a Culvert, But One side of abutment defomed and only pedestrian uses now. It was given the services for both vehicles & pedestrian.

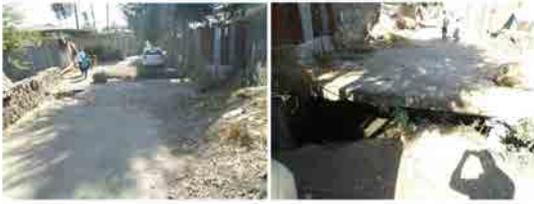
Item No.	Bridge Name	Span Length	Co-Ordinates X-Coordinate Y-Coordinate	Year of Collapse/damage	Remark
8	Addis Kejema	6 m	471000 998871	2012	The Slab is much Deteriorated At the moment it Uses for Pedestrians only. We want to replace the bridge based on the defect. In the future we want to the bridge gives the services for both vehicles & pedestrian.

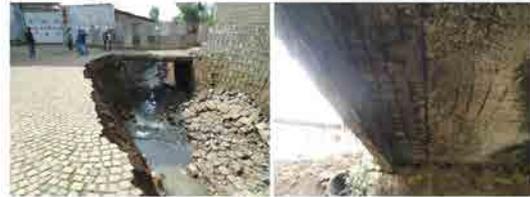
Item No.	Bridge Name	Span Length	Co-Ordinates X-Coordinate Y-Coordinate	Year of Collapse/damage	Remark
9	Abinet Clinic	4 m	469995 997156	2017	Both Abutments is highly scored. It needed to replacement. It was given the services for both vehicles & pedestrian.

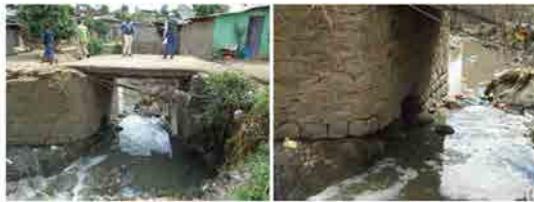
Item No.	Bridge Name	Span Length	Co-Ordinates X-Coordinate Y-Coordinate	Year of Collapse/damage	Remark
10	Genji Giorgis	34 m	479638 994561	August, 2022	Steel Pedestrian Bridge. The bridge is totally washed away by flood during the rainy season. It need replace. It was given the services for pedestrian only.

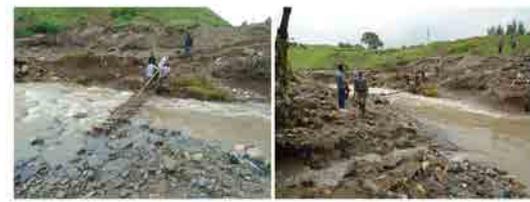
Item No.	Bridge Name	Span Length	Co-Ordinates X-Coordinate Y-Coordinate	Year of Collapse/damage	Remark
11	Genji Wefcho Bat	27 m	479762 994792		It is Wood Bridge. It should Replace by Either Bailey or any adequate structure. But not Safe.

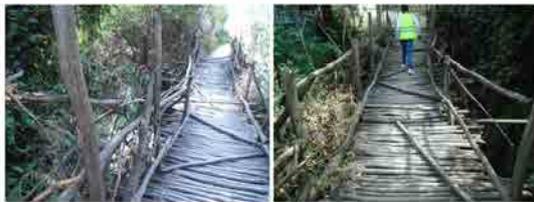
Item No.	Bridge Name	Span Length	Co-Ordinates X-Coordinate Y-Coordinate	Year of Collapse/damage	Remark
12	Ayer Tena Wood Process area	30 m	467239 992197		It gives Service, But not Safe. It is Wood Bridge. It should Replace by Either Bailey or any adequate structure. It was given the services for pedestrian only.

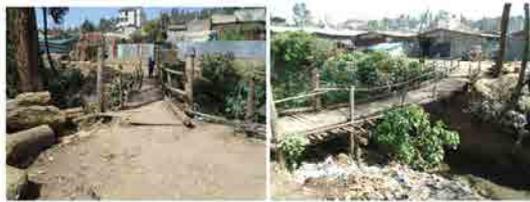
Item No.	Bridge Name	Span Length	Co-Ordinates X-Coordinate Y-Coordinate	Year of Collapse/damage	Remark
13	Around Zambiya Embassy- Kulan/Molmer	8 m	471294 992727	Not Good Condition	It gives the service for both vehicle & Pedestrian.

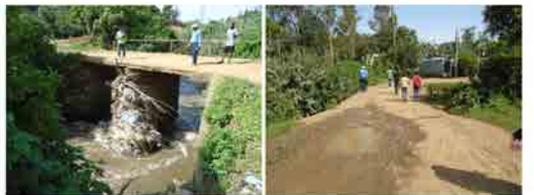
Item No.	Bridge Name	Span Length	Co-Ordinates X-Coordinate Y-Coordinate	Year of Collapse/damage	Remark
14	Ayer Tena Rufael Church	12 m	466046 992469		It gives Service, But not Safe. It is Wood Bridge. It should Replace by Either Bailey or any adequate structure. It was given the services for pedestrian only.

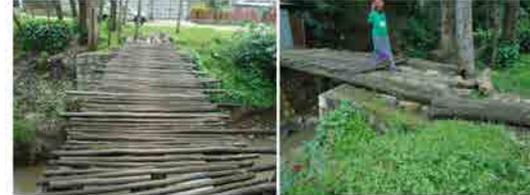
Item No.	Bridge Name	Span Length	Co-Ordinates X-Coordinate Y-Coordinate	Year of Collapse/damage	Remark
15	Ayer Tena Gebreal Belekristan	8 m	466565 992477		It gives the service for both vehicles & Pedestrian. The superstructure is highly deteriorated. It needs replacement. Damaged railing. It was given the services for both vehicles & pedestrian.

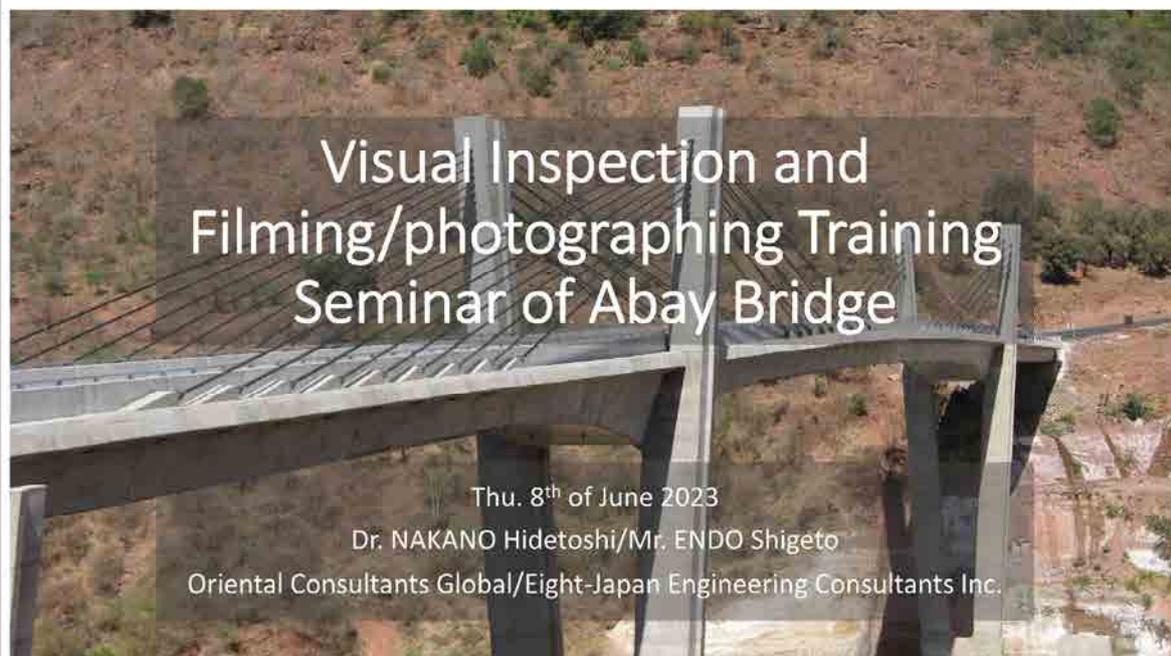
## OUTLINE of the Training Seminar

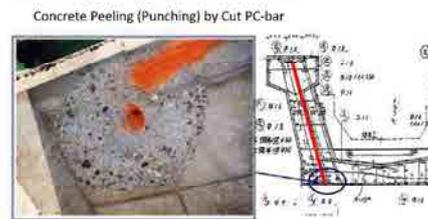
Concrete Peeling (Punching) by Cut PC-bar

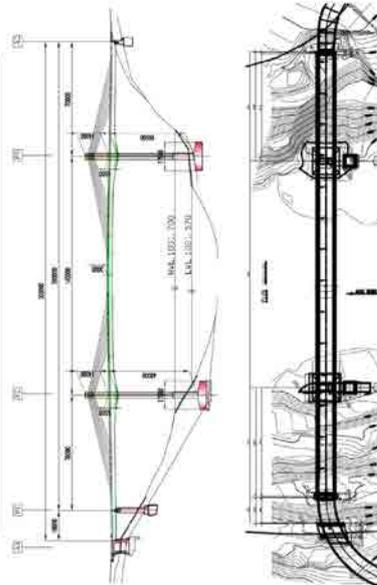
Fig. 1 General View and Overview Photo of the New Abay Bridge

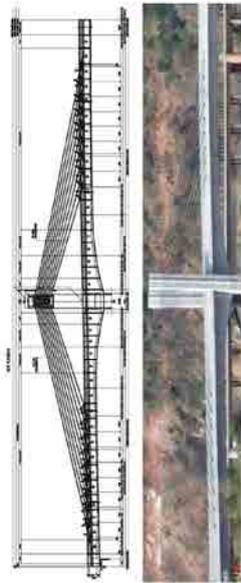
Fig. 5 Outer Cable Arrangement (P2-Center)

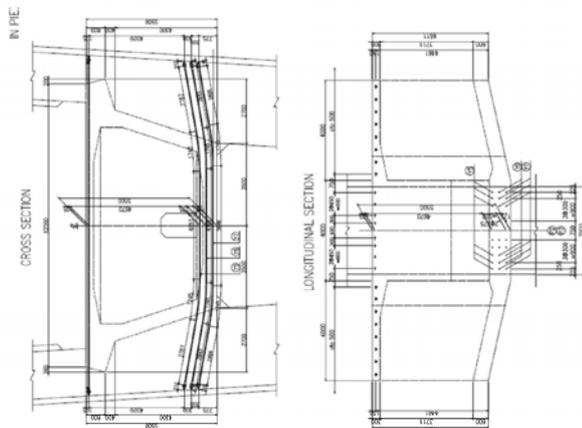
**Fig. 20 Cross-section wise Cable Arrangement of the Cross Beam (above P2)**  
PC-bars inside web is located in the 36 segments of the PC-girder. Each segment has 4 PC-bars in both webs (right/left web). Therefore, there are 2\*4\*36=288 PC-bars in the webs of PC-box girder. The function of these cables is to improve the rigidity of PC-box girder. It improves the connectivity of top slab and bottom slab in the center section of span.

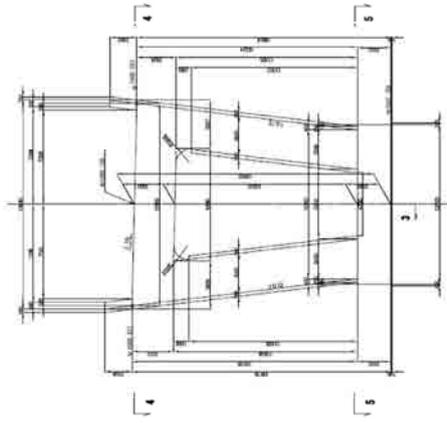
A1 is a box type abutment which allows the local traffic to cross the bridge through the box culvert-shaped section of the abutment. Therefore, the size of the abutment increased than that of the ordinary Reverse T-shaped abutment. However, it can reduce the length of the superstructure considering securing the pass to the local traffic under the superstructure. The foundation is spread foundation. It is the beginning point of the bridge and has 2 rubber bearings to support RC-box girder.

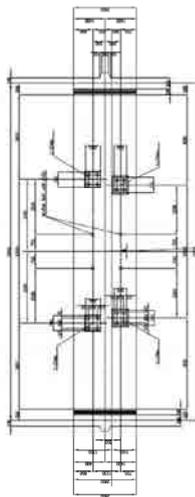
P2 is the beginning point of the extra-towered bridge. It is very high structure with 48.0m height columns. The foundation is spread foundation and supported by Man-made Rock with 1.5 to 3.0m of thickness. The columns continuously form towers for the outer cables, and they are connected rigidly with PC-box girder.

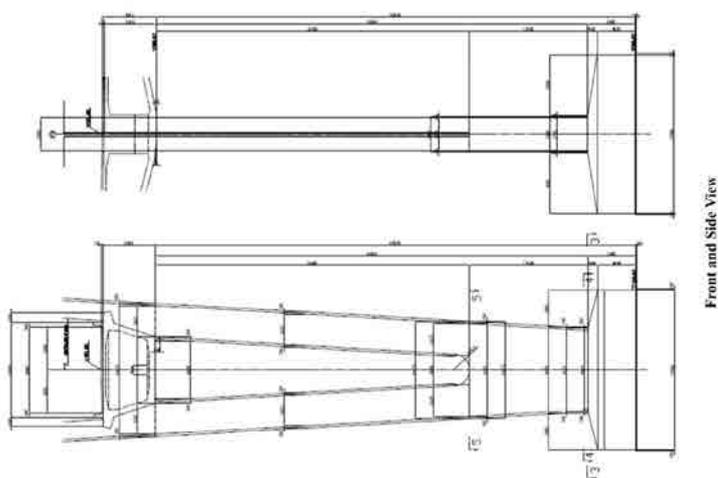
P2 is the beginning point of the extra-closed bridge. It is very high structure with 45.5m height columns. The foundation is spread. The columns continuously form towers for the outer cables, and they are connected rigidly with PC-box girder.

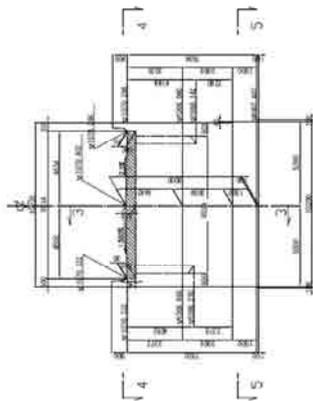
A2 is the ordinary reversed T-shaped with height of 8.0m (including footing). The foundation is spread foundation. It is the end point of the bridge and has 2 rubber bearings to support PC-box girder.

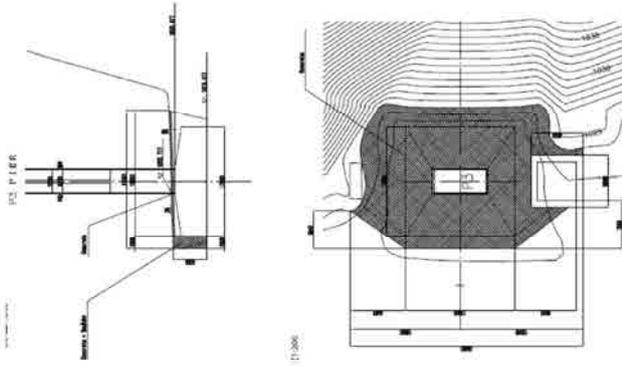
Fig. 44 Dimension of Revetment (P3)

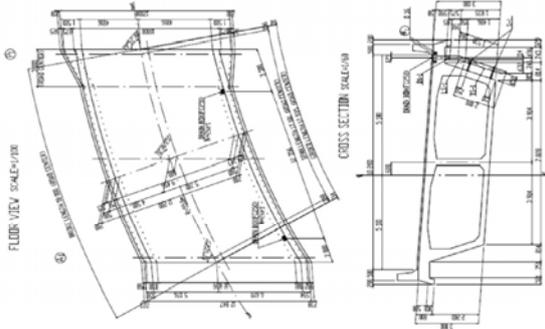
Fig. 51 Details of Drainage Pipes (RC-box Girder)

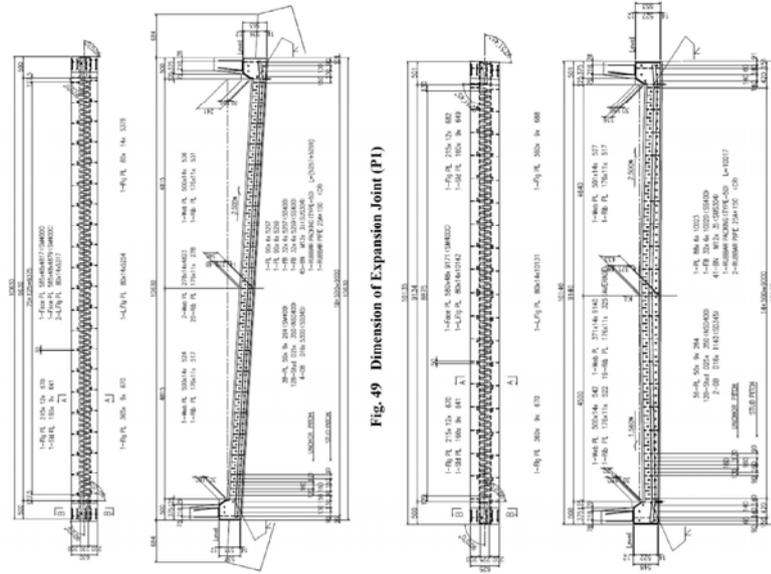
Fig. 49 Dimension of Expansion Joint (P1)

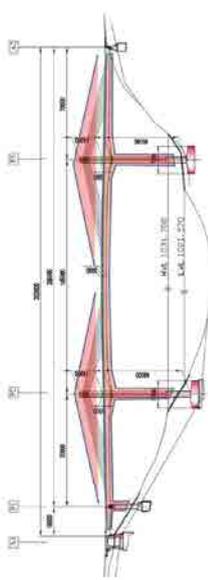
Fig. 54 Location of the Components for Inspection by UAV

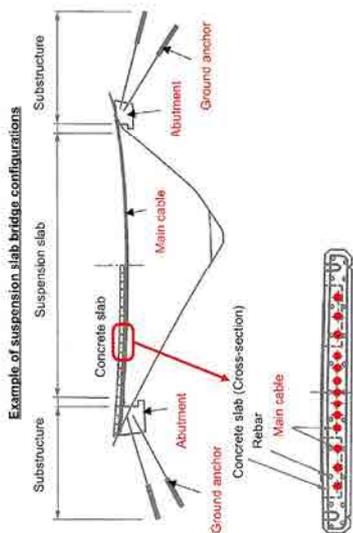
- 1) Tension member : Main cable  
Ground anchor
- 2) Tension member anchorage : Main cable anchorage  
Ground anchor anchorage
- 3) Member that affect the behavior of 1) and 2) : Abutment

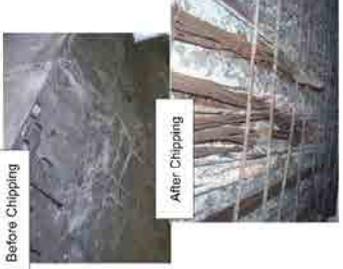
<p data-bbox="790 324 949 604">* The photo shows an example of cracks on the lower surface of the PC girder</p> <p data-bbox="949 324 1189 604">A case where cables placed in concrete corroded or broke due to insufficient grout filling or water intrusion. When the cables of cable-stayed bridges and extradosed bridges are covered with concrete, the deformation of internal steel may appear as floating concrete, pooling, rust juice, and precipitation of free lime. Therefore, it is better to check the condition of the concrete by hammering test.</p>	<p data-bbox="1189 324 1212 604">* The photo shows an example of cracks on the lower surface of the PC girder</p> <p data-bbox="1212 324 1236 604"><b>Note</b></p> <p data-bbox="1236 324 1276 604">■ If the steel inside the concrete is suspected of being corroded, it is conceivable to check the inside by chipping or non-destructive inspection.</p>

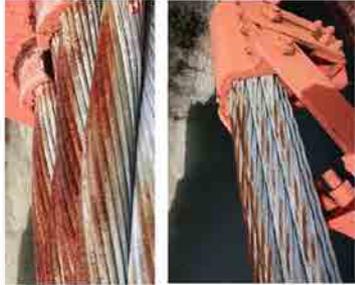
<p>A case where the galvanization of the main cable of a suspension bridge is worn out. It is difficult to accurately diagnose an abnormality such as corrosion inside a cable, in which a plurality of strands are bundled, just by looking at the appearance. Therefore, it is necessary to comprehensively judge the various information obtained from the appearance, such as the state of corrosion on the surface, leakage of rust liquid from the inside, deterioration and rust liquid from the inside, deterioration and consumption of rust preventive oil, and estimate the state of the interior that cannot be seen from the outside.</p>

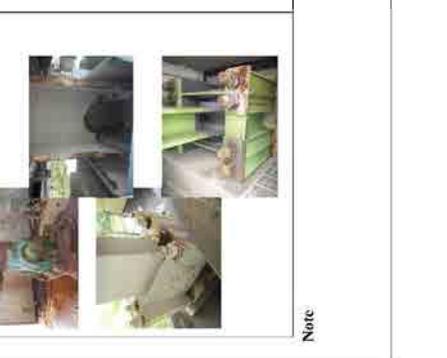
Saddle	15 / 35
<ul style="list-style-type: none"> <li>The saddle is a member that secures slip resistance by pressing with cable tension and holds the cable position.</li> <li>If a cable loosens or slides at the saddle, the length of the cable between the spans changes, which can upset the balance of the cable structure and affect the safety of the entire bridge.</li> </ul>	<ul style="list-style-type: none"> <li>Typical examples of saddles include: <ul style="list-style-type: none"> <li>Example of Vertex-Saddle

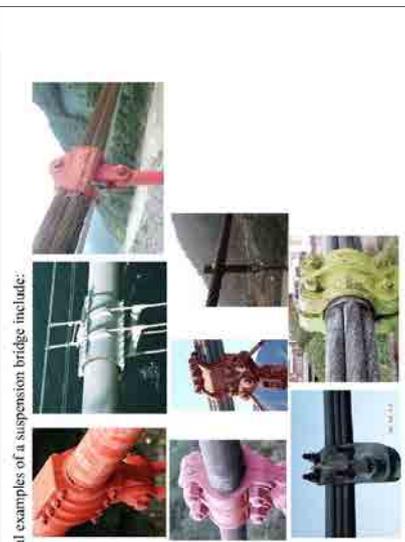
Cable Band	17 / 35
<p>1. The cable band of a suspension bridge is a connecting member for attaching hanging member to the main cable. In general, it is fixed by friction due to the tightening force of the band bolt, and if the frictional force decreases, such as when the axial force of the band bolt decreases, slippage may occur between the band and the main cable.</p> <p>2. As the cable band slides, the cable structure becomes unbalanced, potentially affecting the safety of the entire bridge.</p>	<div data-bbox="496 320 901 862"> <p>Typical examples of a suspension bridge include:</p>

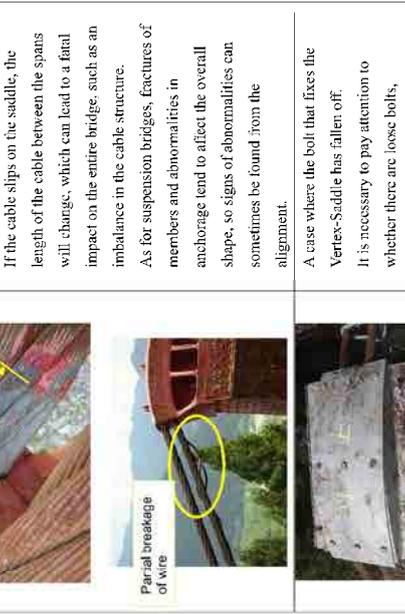
</div> <p>A case where the bolt that fixes the Vertex-Saddle has fallen off. It is necessary to pay attention to whether there are loose bolts, abnormal plates, and traces of removal.</p> <p>A case where corrosion is seen on the Vertex-Saddle.</p> <p><b>Note</b></p>

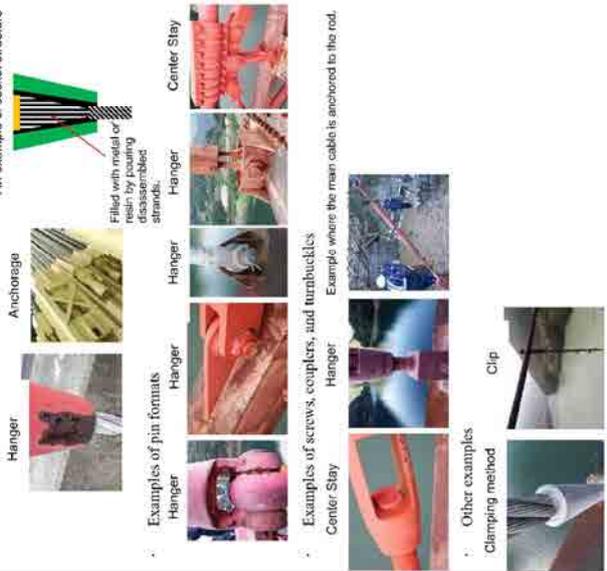
<p><b>Note</b></p> <p>■ Since the corrosive environment, anti-corrosion specifications, and stress distribution are different for each fixing method, it should be noted that the locations that are vulnerable to corrosion protection and fatigue also differ for each fixing method.</p>

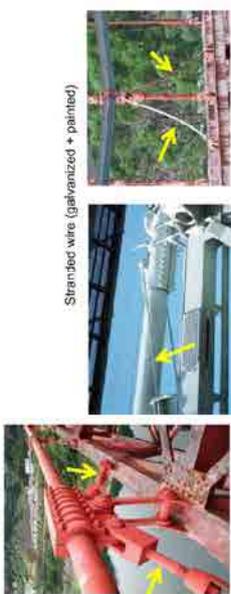
<ul style="list-style-type: none"> <li>Example of wind resistant cable (a member that suppresses the movement of the girder by pulling it diagonally downward in cooperation with the hanger that pulls it upward)</li> </ul>

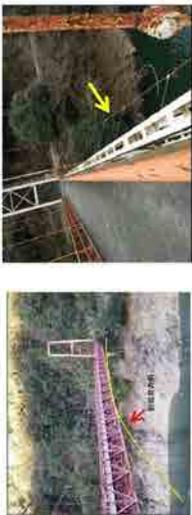
<ul style="list-style-type: none"> <li>In addition, there are various types.</li> </ul>	
<p><b>Note</b></p> <p>Damage (breakage, loosening) to suspension members and wind resistant cables may lead to a decrease in the fatigue durability of each part of the bridge. Therefore, it is necessary to check whether there is any deterioration in performance due to breakage, corrosion, etc., or deterioration due to loosening.</p>

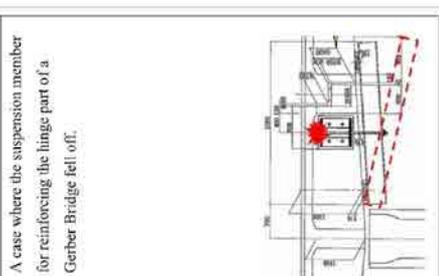
<p>A case where the suspension member for reinforcing the hinge part of a Gerber Bridge fell off.</p>
<p><b>Note</b></p>

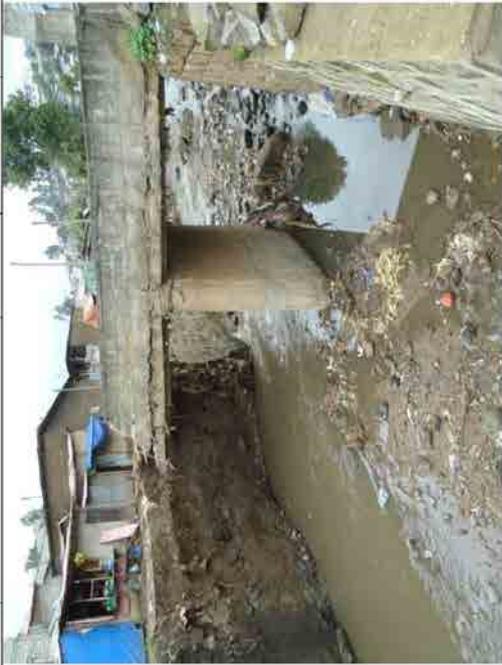
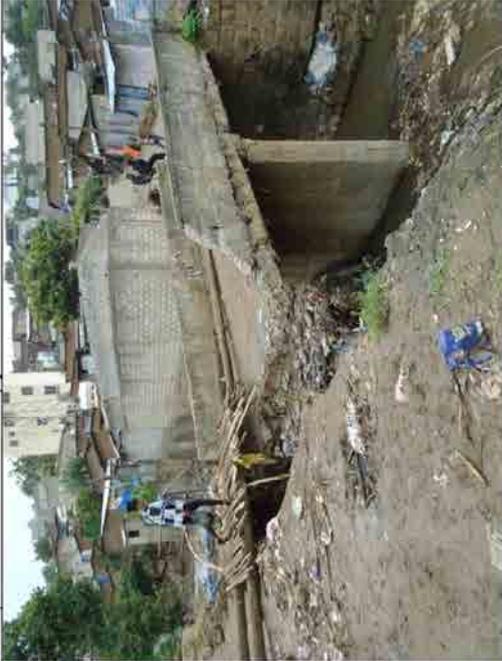
Item No.	Bridge Name	Span Length	Co-Ordinates		Year of Collapse/damage	Remark
			X-Coordinates	Y-Coordinates		
2	Goro-2	16 m	480974	994954	August, 2022	The flood is overtopped on the bridge & it has many other defects. It need replace. It was given the services for both vehicles & pedestrian.
