エチオピア連邦民主共和国  
エチオピア道路公社（ERA）  
アジスアベバ市道路公社（AACRA）

エチオピア国  
道路アセットマネジメント技術アドバイザー業務

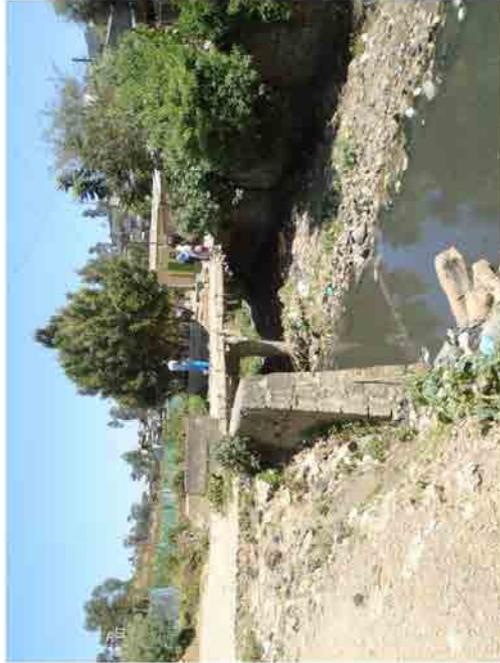
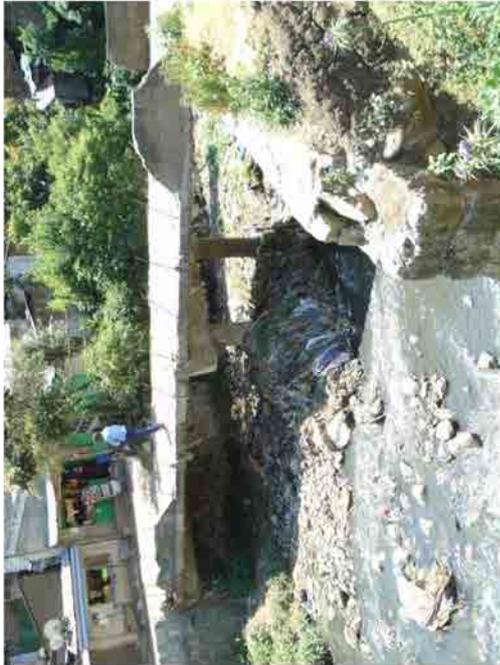
Item No.	Bridge Name	Span Length	Co-Ordinates		Year of Collapse/damage	Remark
			X-Coordinates	Y-Coordinates		
3	Goro-3	30 m	481057	995343	August, 2022	The bridge is totally washed away by flood. It need replace. It was given the services for both vehicles & pedestrian.

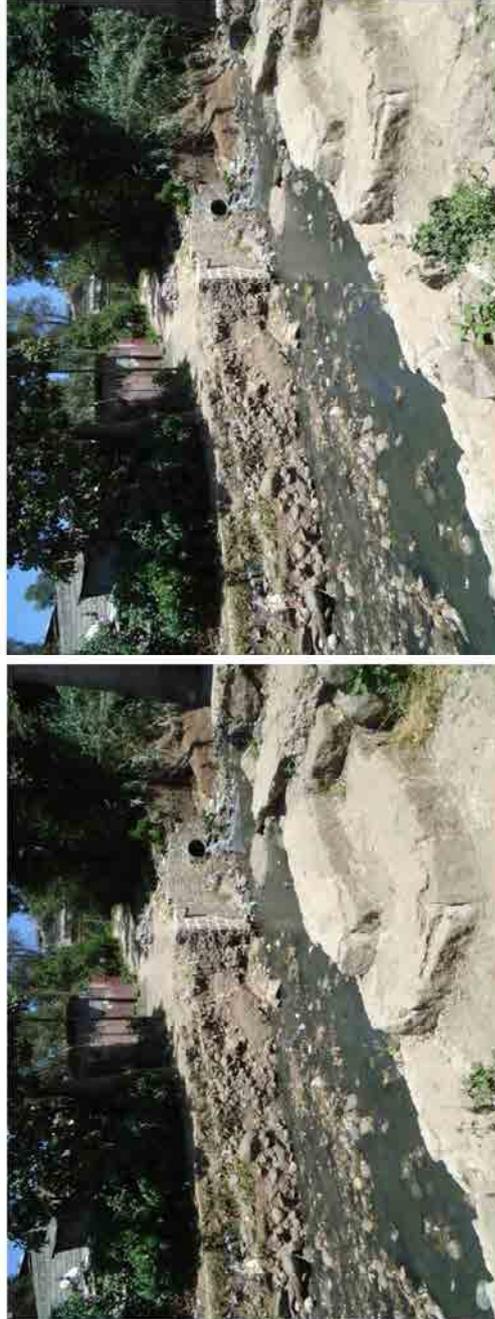
Item No.	Bridge Name	Span Length	Co-Ordinates		Year of Collapse/damage	Remark
			X-Coordinates	Y-Coordinates		
4	Tolossa Sefer	11 m	470360	995850	2016	Abutment scoured & then Deformed. It need replace. It was given the services for both vehicles & pedestrian.

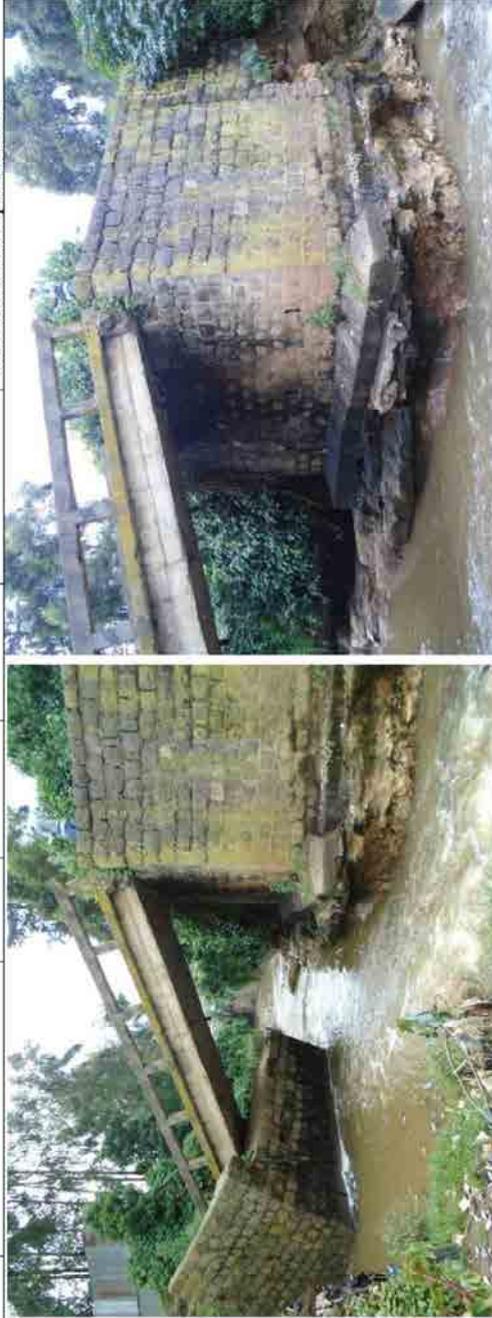
Item No.	Bridge Name	Span Length	Co-Ordinates		Year of Collapse/damage	Remark
			X-Coordinates	Y-Coordinates		
5	Bulgariya Tabot Maderiya	15 m	472178	993802	2018	Bending to collapses. In the previous time this bridge was used for passing bajaj & Motor Cycle, but now it uses only for Pedestrian. It need replace.

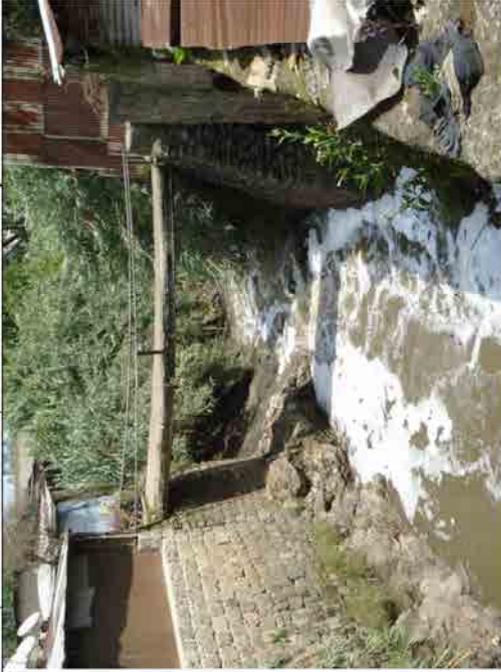
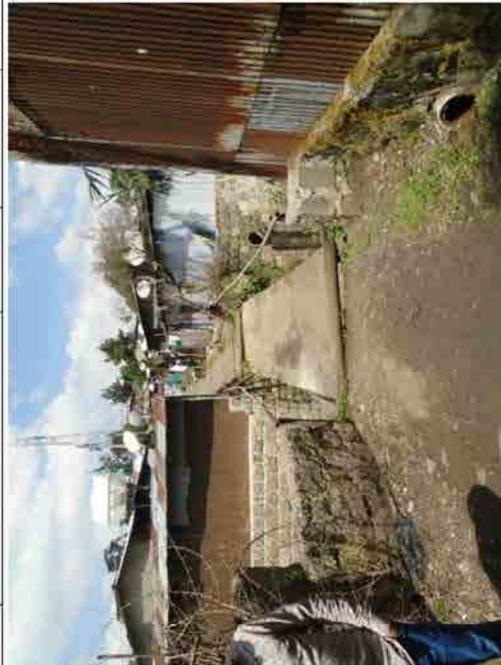
Item No.	Bridge Name	Span Length	Co-Ordinates		Year of Collapse/damage	Remark
			X-Coordinates	Y-Coordinates		
6	Ayer Tena Processing area	6 m	467237	992193	2018	It was a mistake during bridge construction, as a result of shortening the span. This causes for scour the abutment repeatedly. It was given the services for both vehicles & pedestrian.

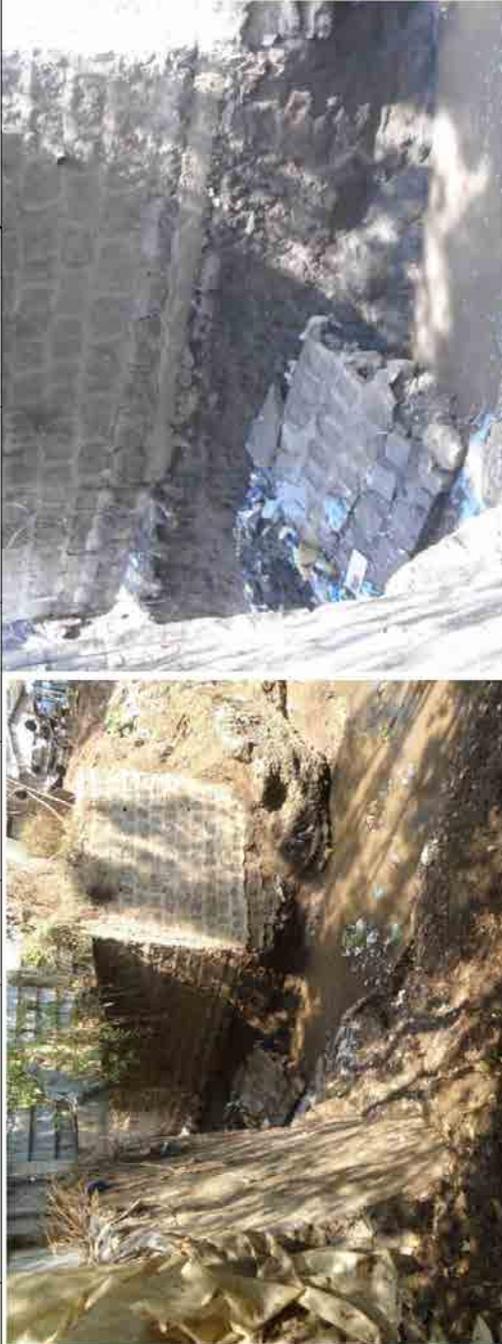
Item No.	Bridge Name	Span Length	Co-Ordinates		Year of Collapse/damage	Remark
			X-Coordinates	Y-Coordinates		
7	Mother Teressa	5 m	474165	999354	2015	It is a Culvert, But One side of abutment deformed and only pedestrian uses now. It was given the services for both vehicles & pedestrian.

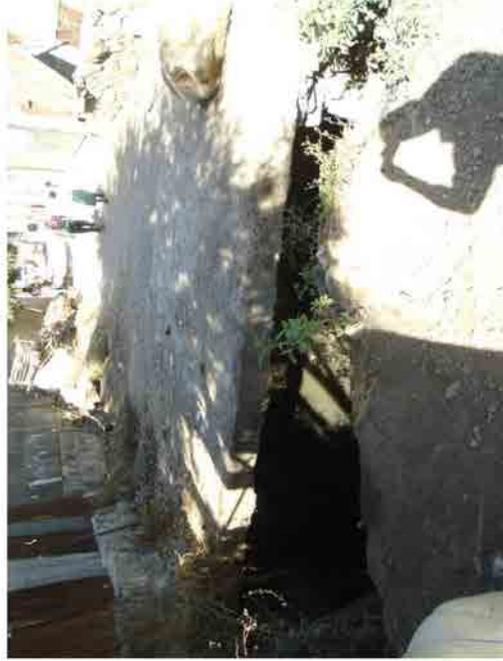
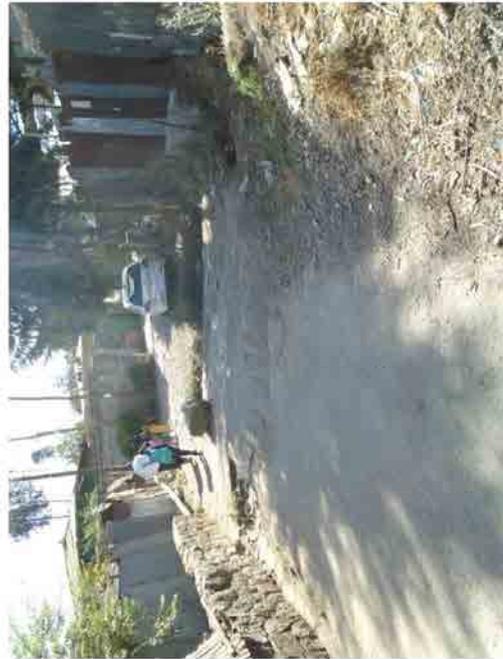
Item No.	Bridge Name	Span Length	Co-Ordinates		Year of Collapse/damage	Remark
			X-Coordinates	Y-Coordinates		
8	Addis Ketema	6 m	471080	998871	2012	The Slab Is much Deteriorated. At the moment it Uses for Pedestrians only. We want to replace the bridge based on the defect. In the future we want to the bridge gives the services for both vehicles & pedestrian.

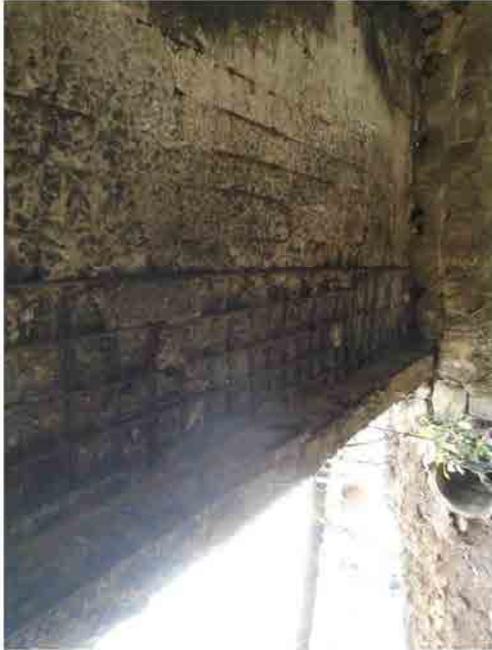
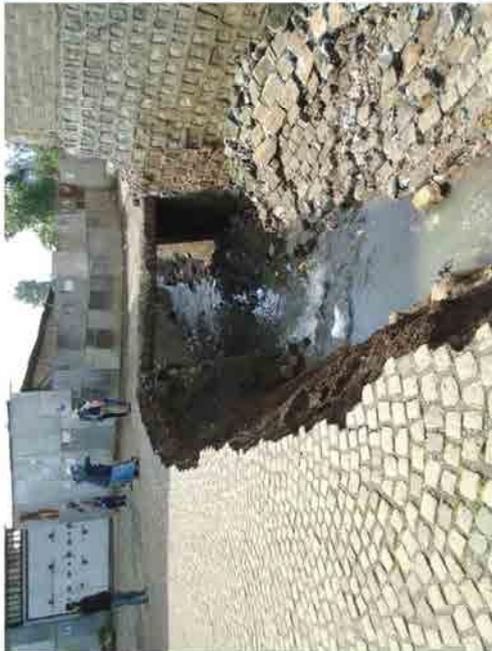
Item No.	Bridge Name	Span Length	Co-Ordinates		Year of Collapse/damage	Remark
			X-Coordinates	Y-Coordinates		
9	Abinet Clinic	4 m	469995	997156	2017	Both Abutments is highly scoured. It needed to replacement. It was given the services for both vehicles & pedestrian.

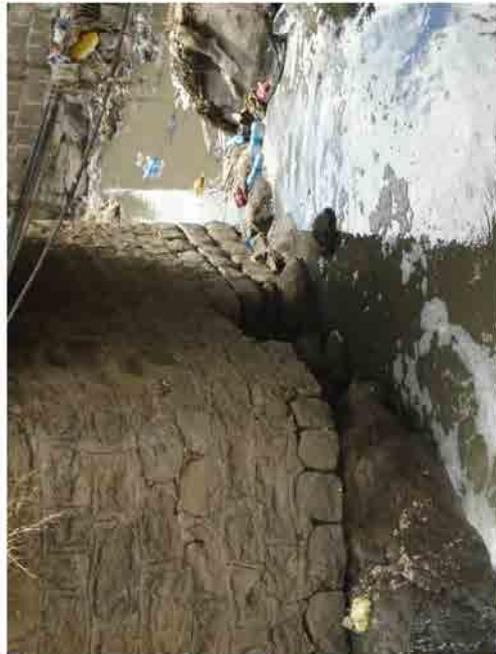
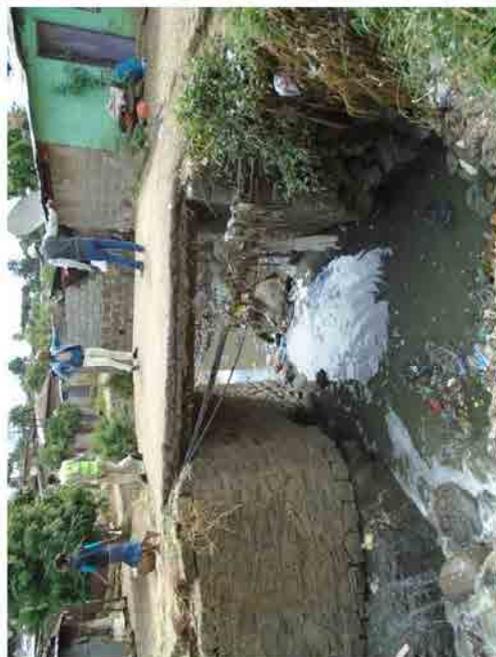
Item No.	Bridge Name	Span Length	Co-Ordinates		Year of Collapse/damage	Remark
			X-Coordinates	Y-Coordinates		
10	Gerji Giorgis	34 m	479638	994563	August, 2022	Steel Pedestrian Bridge. The bridge is totally washed away by flood during the rainy season. It need replace. It was given the services for pedestrian only.

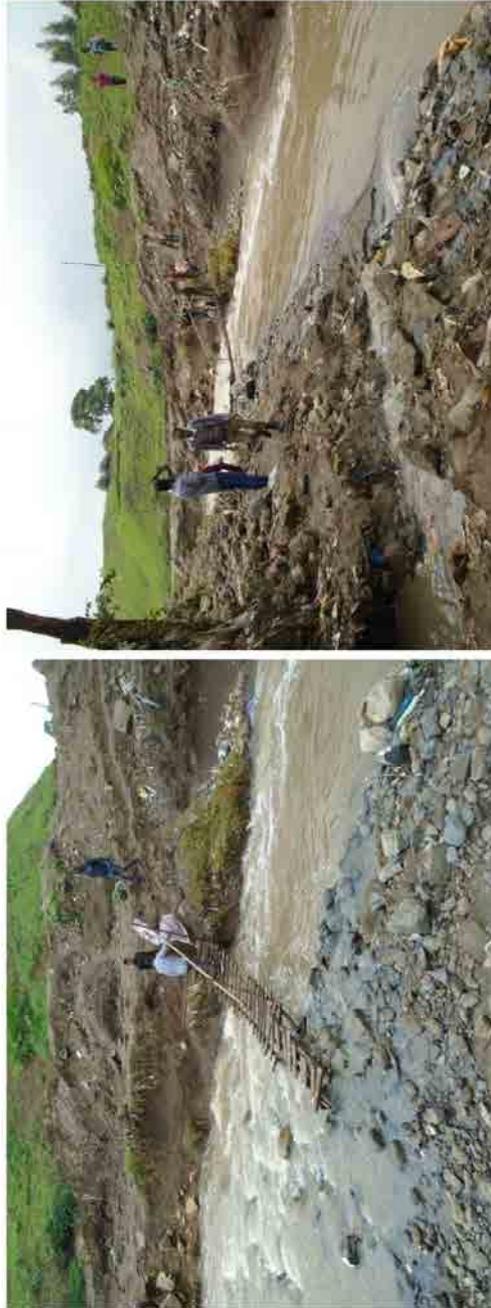
Item No.	Bridge Name	Span Length	Co-Ordinates		Year of Collapse/damage	Remark
			X-Coordinates	Y-Coordinates		
11	Gerji Wefcho Bet	27 m	479762	994792	It gives Service, But not Safe.	It is Wood Bridge. It should Replace by Either Bailey or any adequate structure. It was given the services for pedestrian only.

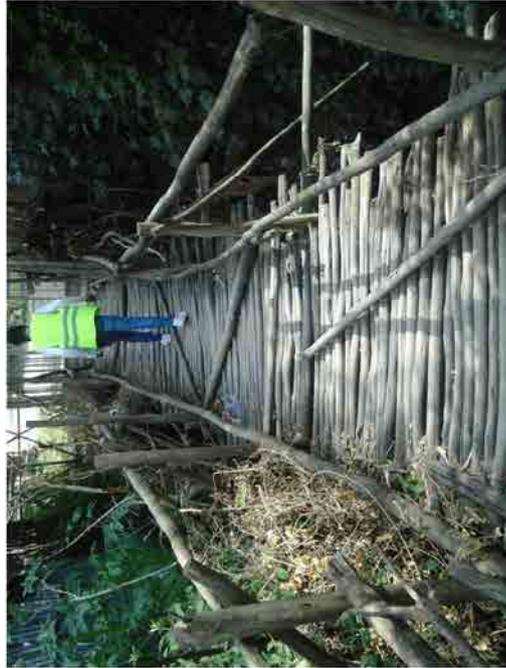
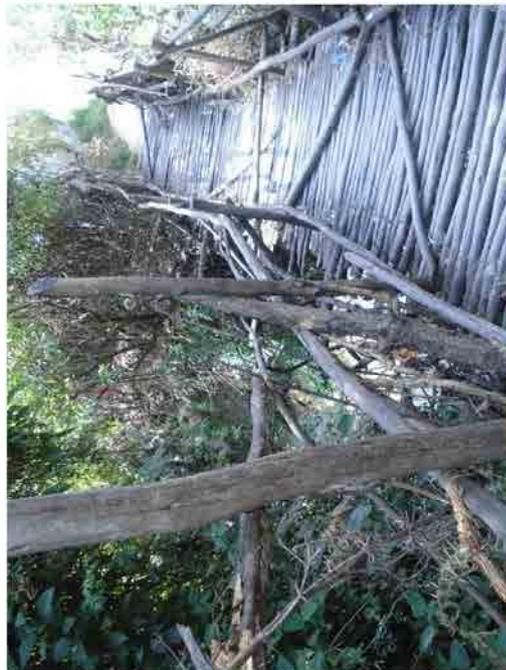
Item No.	Bridge Name	Span Length	Co-Ordinates		Year of Collapse/damage	Remark
			X-Coordinates	Y-Coordinates		
12	Ayer Tena Wood Process area	30 m	467239	992197	It gives Service, But not Safe.	It is Wood Bridge. It should Replace by Either Bailey or any adequate structure. It was given the services for pedestrian only.

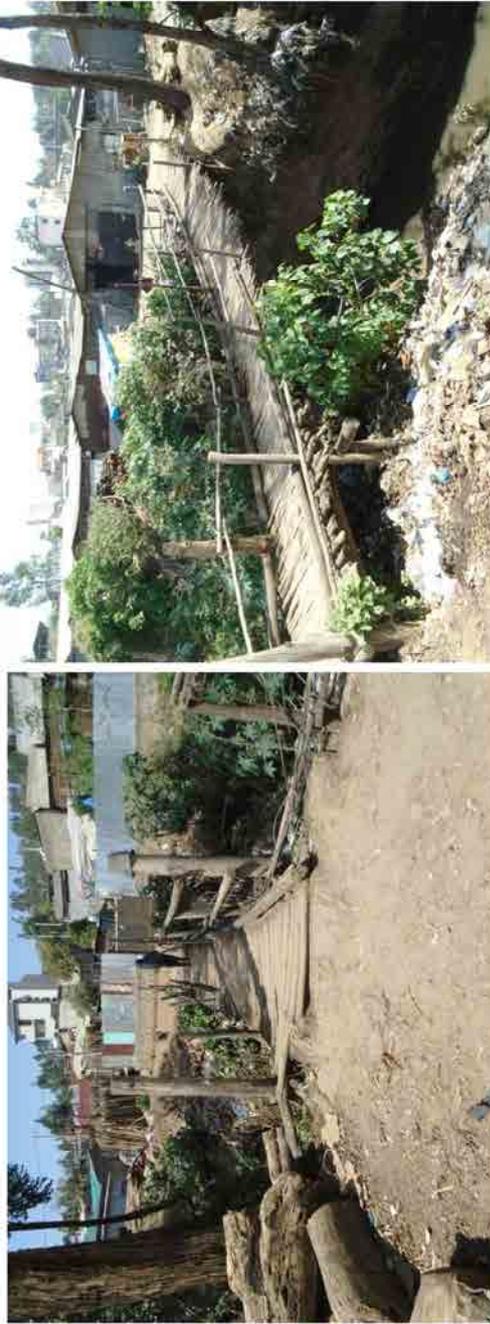
Item No.	Bridge Name	Span Length	Co-Ordinates		Year of Collapse/damage	Remark
			X-Coordinates	Y-Coordinates		
13	Around Zambiya Embassy-KidaneMihiret	8 m	471294	992727	Not Good Condition.	It gives the service for both vehicle & Pedestrians.

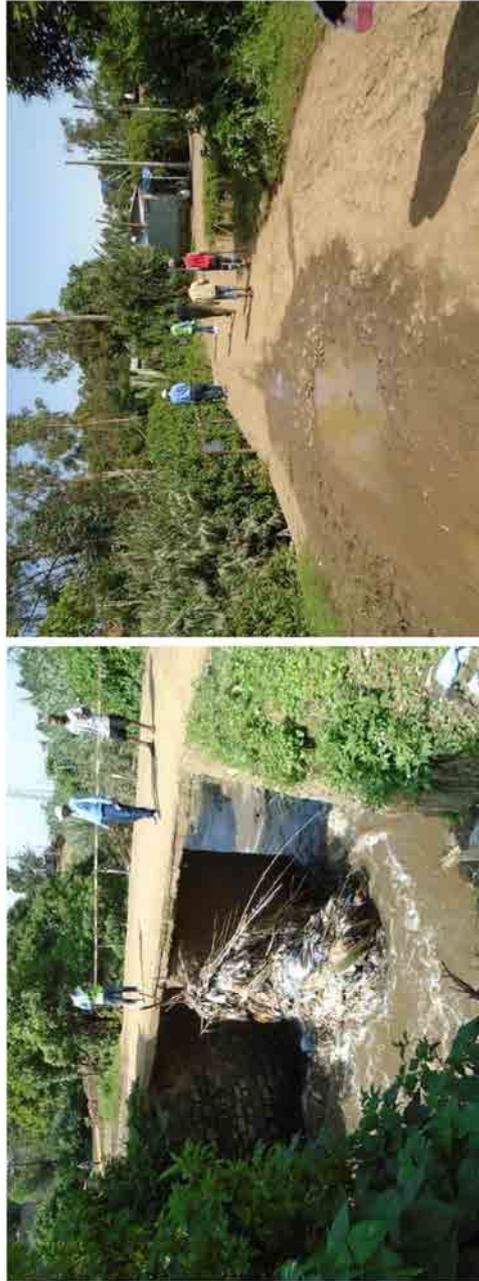
Item No.	Bridge Name	Span Length	Co-Ordinates		Year of Collapse/damage	Remark
			X-Coordinates	Y-Coordinates		
14	Ayer Tena Rufael Church	12 m	466046	992469	It gives Service, But not Safe.	It is Wood Bridge. It should Replace by Either Bailey or any adequate structure. It was given the services for pedestrian only.

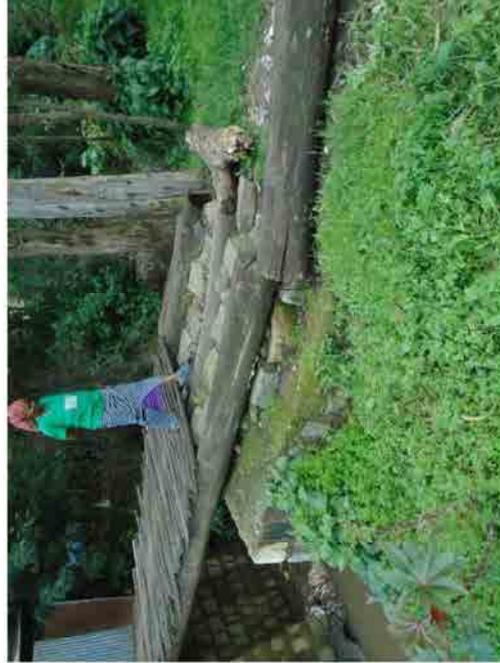
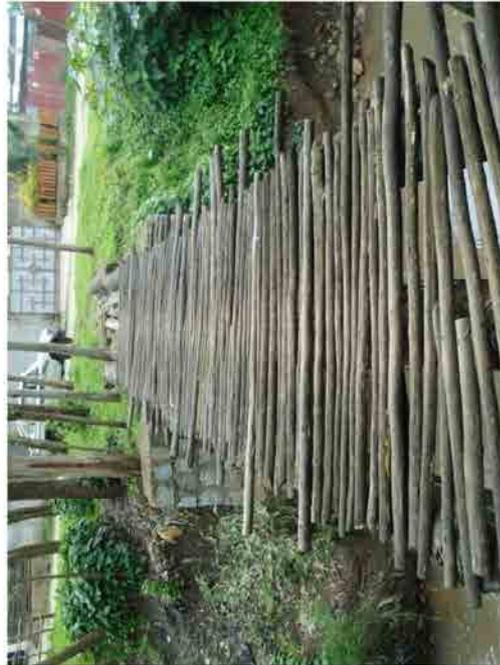
Item No.	Bridge Name		Span Length	Co-Ordinates		Year of Collapse/damage	Remark
				X-Coordinates	Y-Coordinates		
15	Ayer Tena Betekistean	Gebreal	8 m	466565	992477	It gives the service for both vehicles & Pedestrians	The superstructure is highly deteriorated. It needs replacement. Damaged railing. It was given the services for both vehicles & pedestrian.

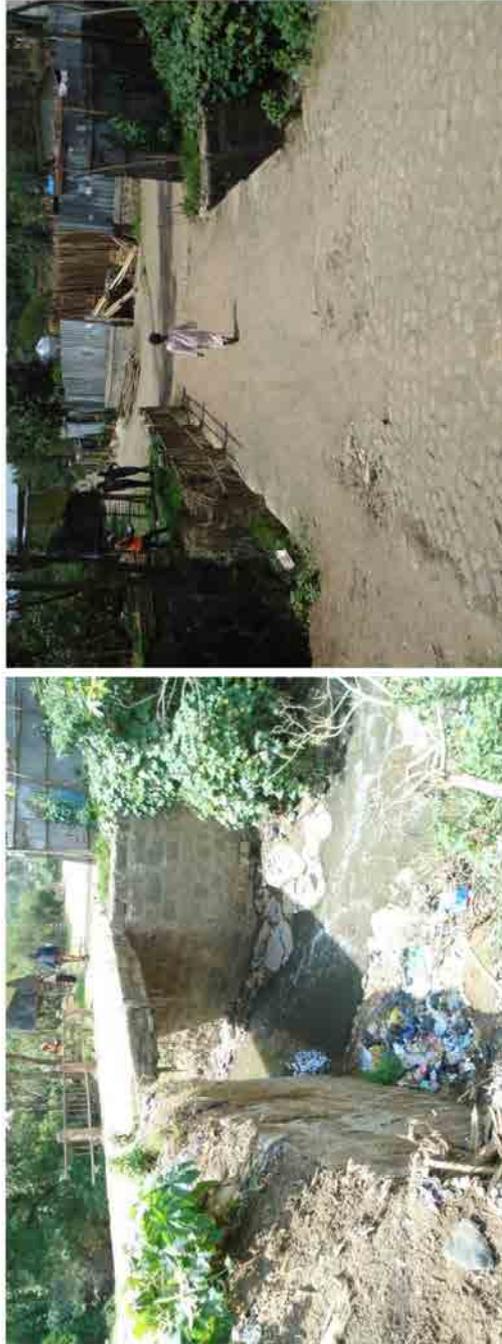
Item No.	Bridge Name	Span Length	Co-Ordinates		Year of Collapse/damage	Remark
			X-Coordinates	Y-Coordinates		
16	Ayer Tena woreda 02	6 m	466795	992401	It gives the service for both vehicles & Pedestrians	The superstructure is highly deteriorated. It has Rebar exposure, and Back fills & foundation scoured. It needs replacement. Damaged railing. It was given the services for both vehicles & pedestrian.

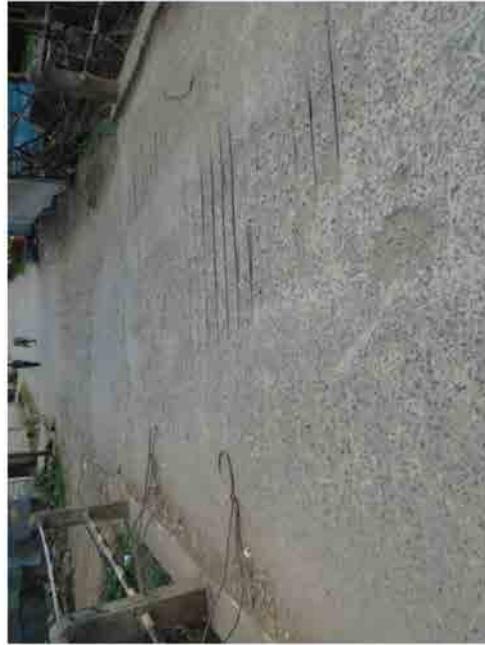
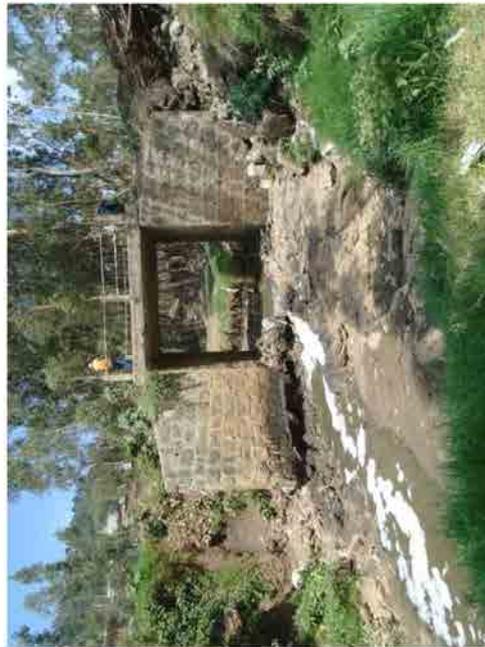
Item No.	Bridge Name	Span Length	Co-Ordinates		Year of Collapse/damage	Remark
			X-Coordinates	Y-Coordinates		
17	Alem Bank Silitte Mosque	6 m	463819	995207	Not Good Condition	It gives Service, but the Abutment foundation is scoured as a result of abutment stand on the river channel. The concrete slab also deteriorates and reinforcement exposed to air at the top. It needs replacement. It was given the services for both vehicles & pedestrian.

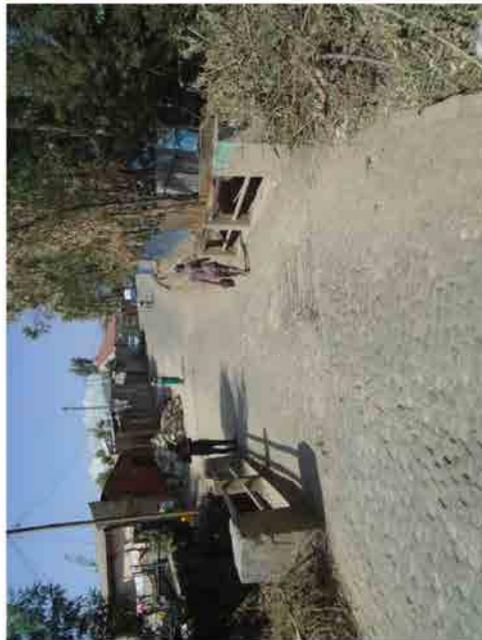
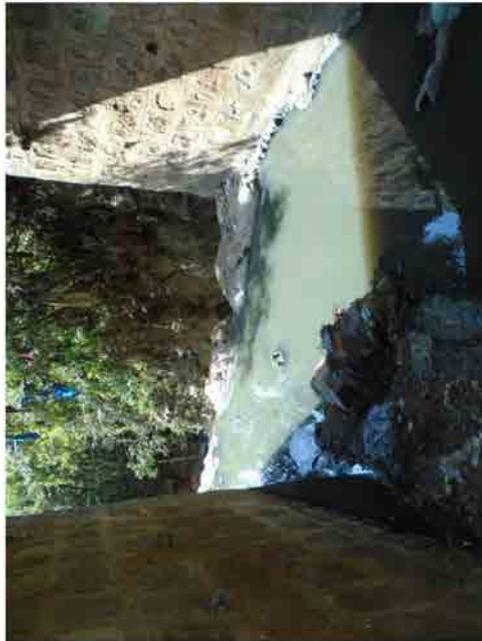
Item No.	Bridge Name	Span Length	Co-Ordinates		Year of Collapse/damage	Remark
			X-Coordinates	Y-Coordinates		
18	Rufael Ambessa Garage	7 m	470009	1001894	Highly Deteriorate	The road is Two lane, then It needs two lane Bailey Bridges/or two Bailey. It was given the services for both vehicles & pedestrian.

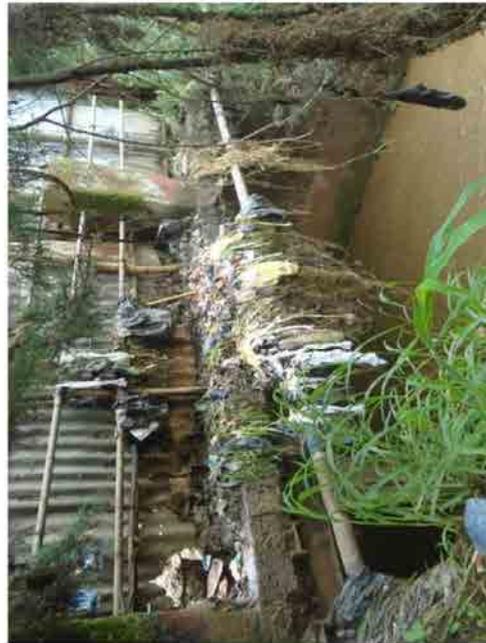
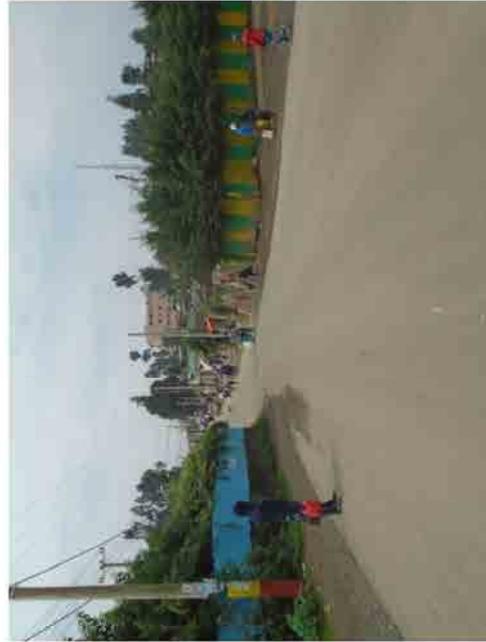
Item No.	Bridge Name	Span Length	Co-Ordinates		Year of Collapse/damage	Remark
			X-Coordinates	Y-Coordinates		
19	Akaki Yemengist School	7 m	476842	978788	2016	It gives Service. Abutment & Pier are highly scoured. The concrete slab is deteriorate and forms a hole. All parts of the bridge is either deformed or deteriorate. It needs Replacement. It was given the services for both vehicles & pedestrian.

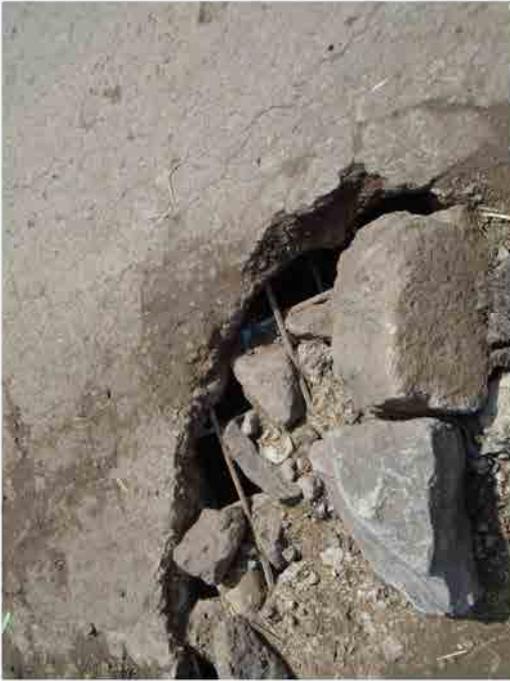
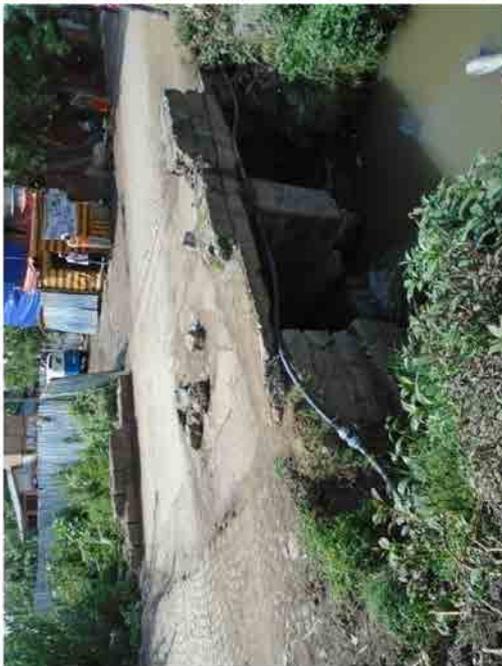
Item No.	Bridge Name	Span Length	Co-Ordinates		Year of Collapse/damage	Remark
			X-Coordinates	Y-Coordinates		
20	Ayer Tena Alfa School	6 m	463819	995207	Not Good Condition	It gives Service, but the Abutment foundation is scoured. It needs replacement. It was given the services for both vehicles & pedestrian.

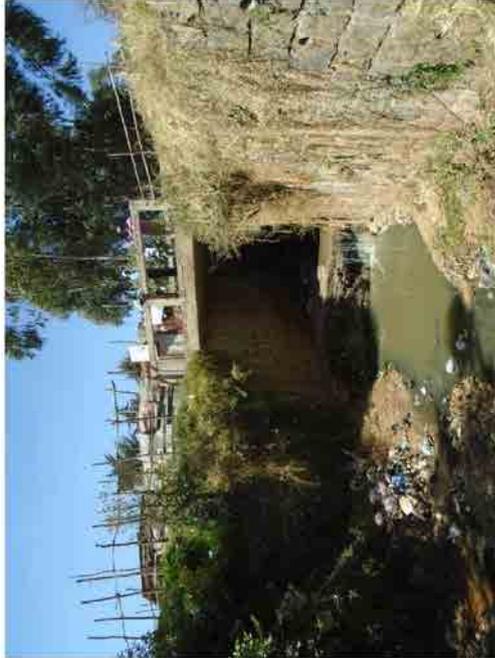
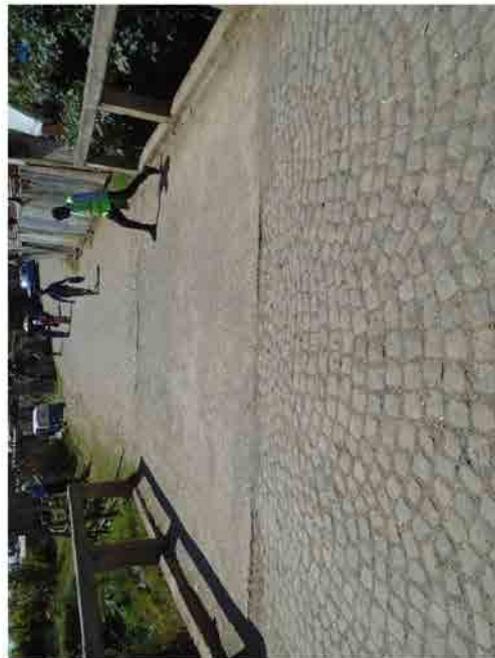
Item No.	Bridge Name	Span Length	Co-Ordinates		Year of Collapse/damage	Remark
			X-Coordinates	Y-Coordinates		
21	18 Mazoriya Tero Mesjid	6 m	467887	999913	Not Good Condition	It gives Service, but the Abutment foundation is scoured on both sides @ the inlet & Outlet sides. It needs replacement. It was given the services for both vehicles & pedestrian.

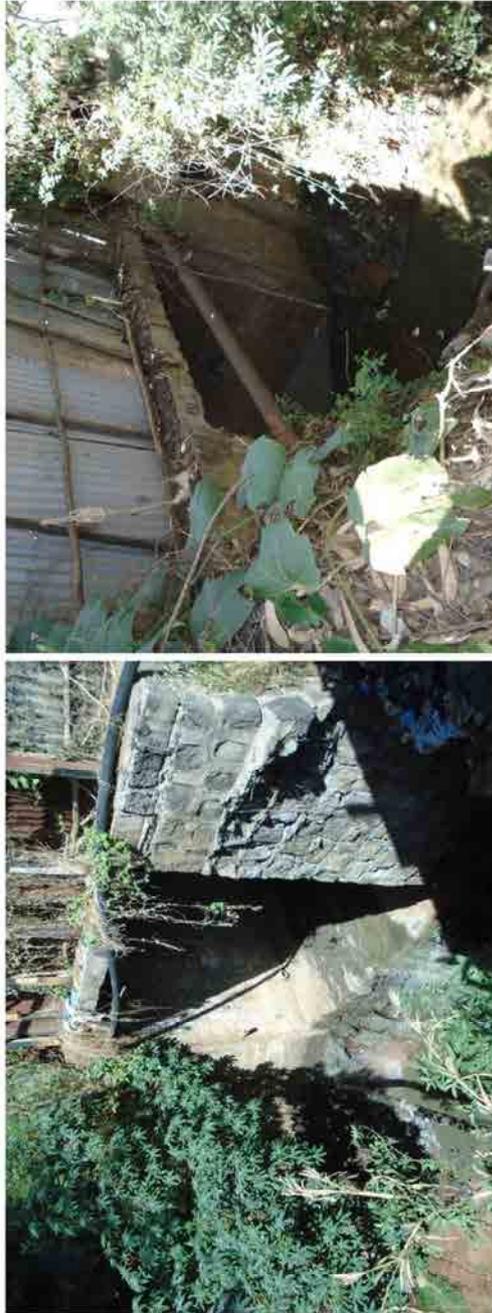
Item No.	Bridge Name	Span Length	Co-Ordinates		Year of Collapse/damage	Remark
			X-Coordinates	Y-Coordinates		
22	Lideta Mihiretu wefcho bet	10 m	469980	997237	Not Good Condition	It gives Service, but the superstructure is highly deteriorated. It needs replacement. It was given the services for both vehicles & pedestrian.

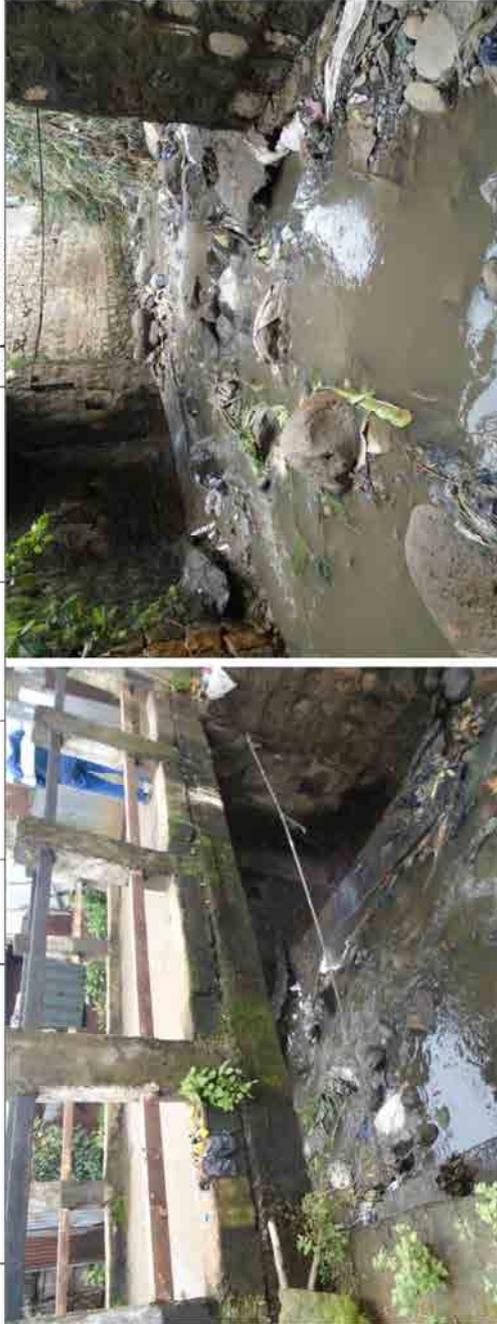
Item No.	Bridge Name	Span Length	Co-Ordinates		Year of Collapse/damage	Remark
			X-Coordinates	Y-Coordinates		
23	Bulgariya Salvatore Devita	10 m	471959	994099	It gives the service for both vehicles & Pedestrians	<p>The bridge has constriction, the It has overtopping during Flood. It was given the services for both vehicles &amp; pedestrian.</p>

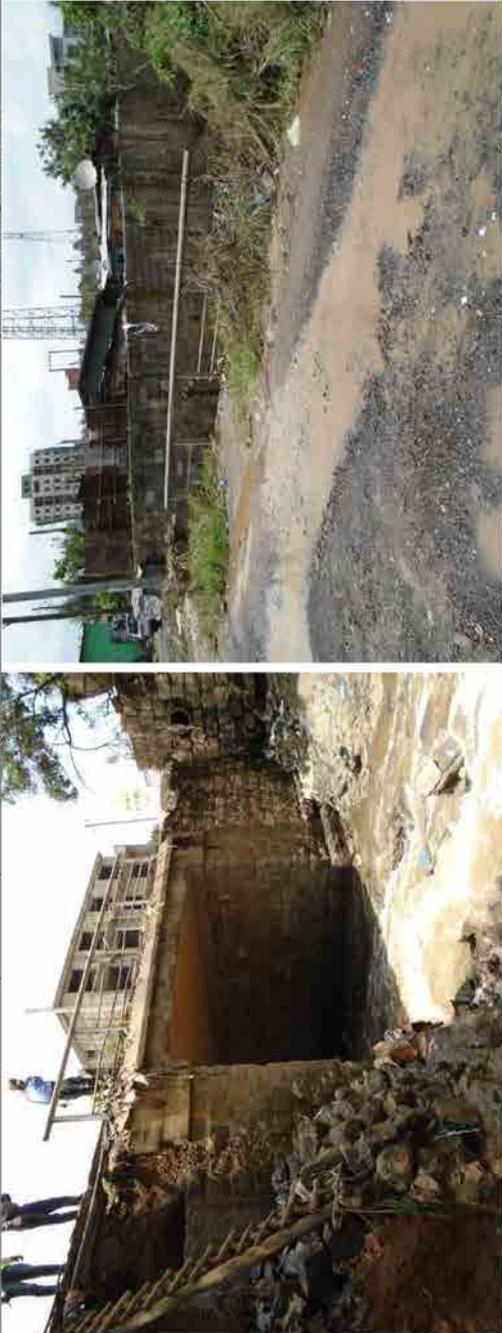
Item No.	Bridge Name	Span Length	Co-Ordinates		Year of Collapse/damage	Remark
			X-Coordinates	Y-Coordinates		
24	Addisu gebeya EgziAbher	9 m	471087	1001428	It gives the service for both vehicles & Pedestrians	The superstructure is highly deteriorated. It needs replacement. It was given the services for both vehicles & pedestrian.

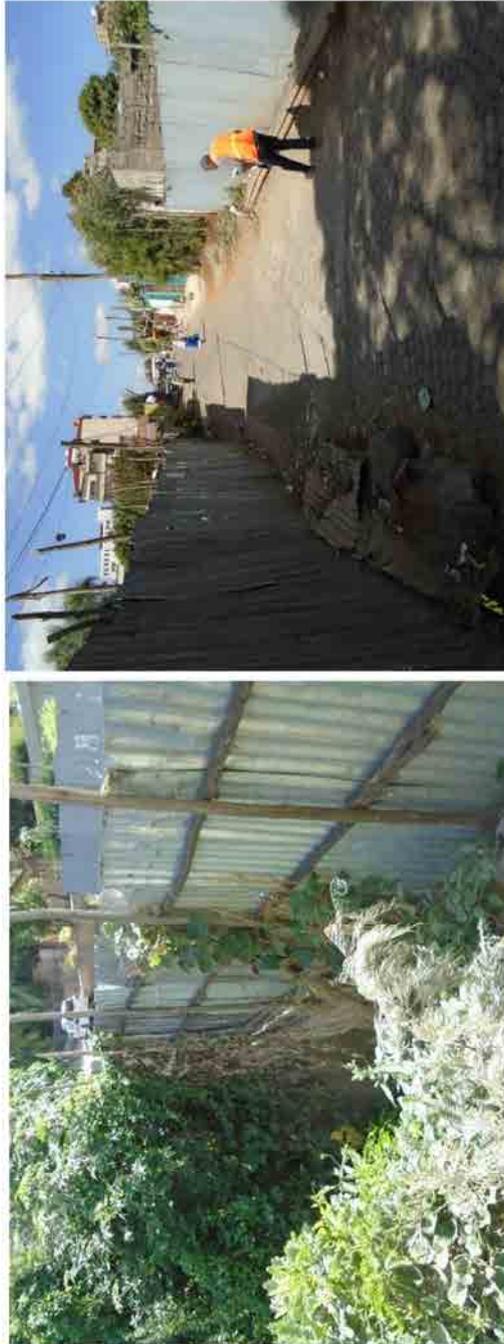
Item No.	Bridge Name	Span Length	Co-Ordinates		Year of Collapse/damage	Remark
			X-Coordinates	Y-Coordinates		
25	Philipos Mebrat Hail	6 m	467893	999065	It gives the service for both vehicles & Pedestrians	The superstructure is highly deteriorated. It needs replacement. Damaged railing. It was given the services for both vehicles & pedestrian.

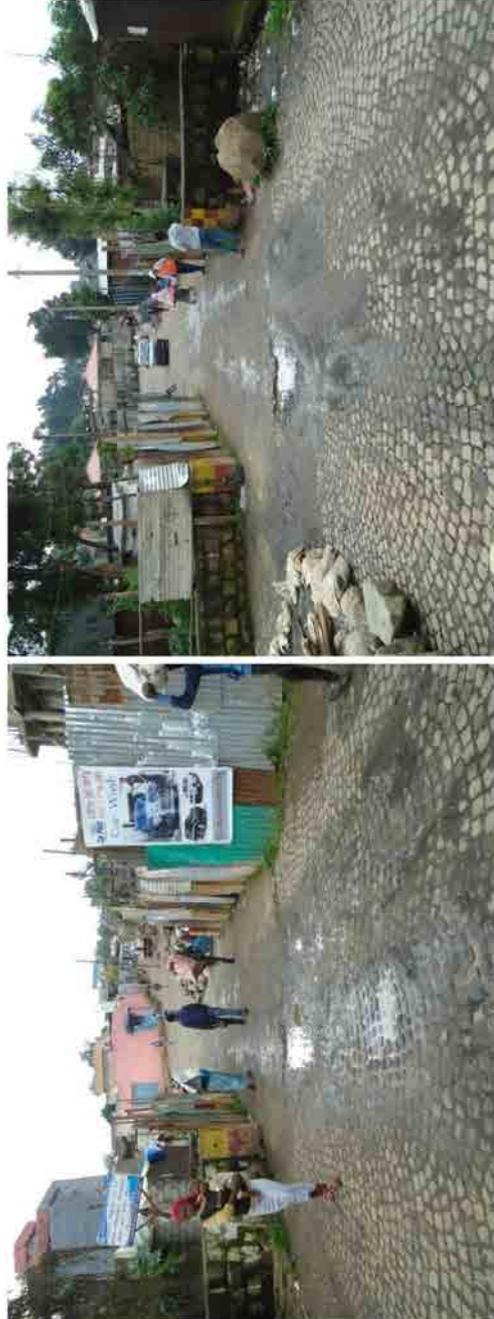
Item No.	Bridge Name	Span Length	Co-Ordinates		Year of Collapse/damage	Remark
			X-Coordinates	Y-Coordinates		
26	Ferensay Weybila Mariyam	10 m	474376	1001676	It gives Service, But not Safe.	It is Wood Bridge. It should Replace by Either Bailey or any adequate structure. It was given the services for pedestrian only.

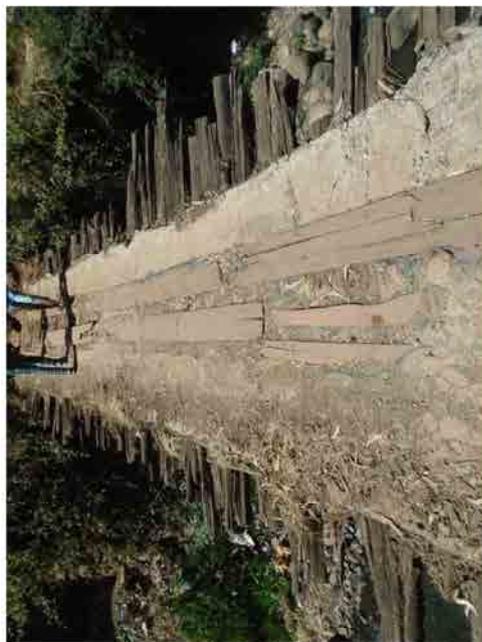
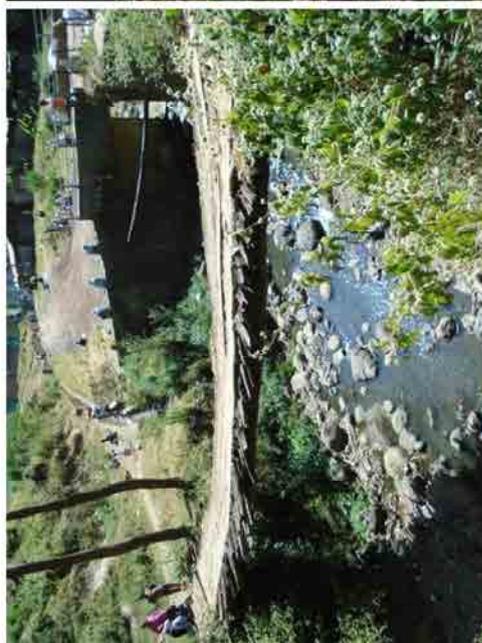
Item No.	Bridge Name	Span Length	Co-Ordinates		Year of Collapse/damage	Remark
			X-Coordinates	Y-Coordinates		
27	Tesfa Jember Sarefian	6 m	471674	996813	It gives the service for both vehicles & Pedestrians	The superstructure is highly deteriorated. It needs replacement. It was given the services for both vehicles & pedestrian.

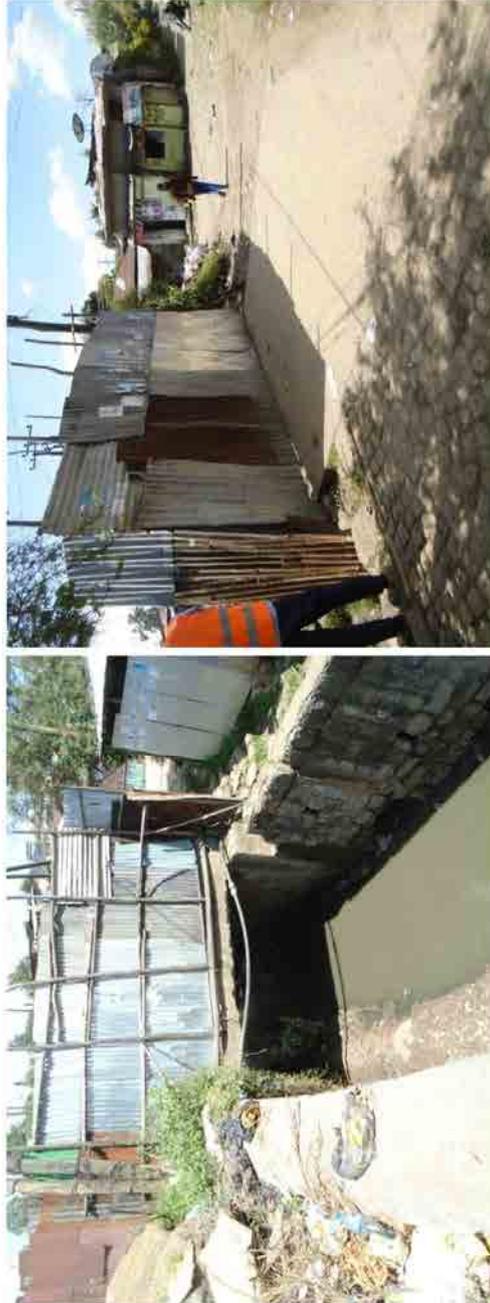
Item No.	Bridge Name	Span Length	Co-Ordinates		Year of Collapse/damage	Remark
			X-Coordinates	Y-Coordinates		
28	30 Kebele Geja sefer	6 m	471311	997306	It gives the service.	The superstructure is highly deteriorated. It needs replacement. It was given the services for pedestrian only.

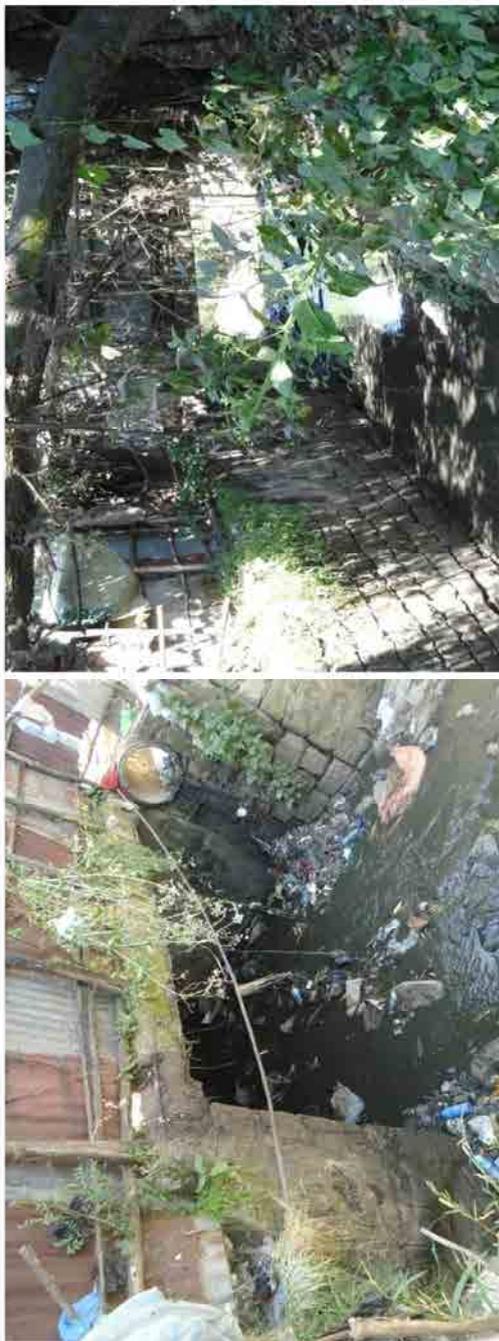
Item No.	Bridge Name	Span Length	Co-Ordinates		Year of Collapse/damage	Remark
			X-Coordinates	Y-Coordinates		
29	5th Police 47 Kebele	6 m	471847	997014	It gives the service.	The superstructure is highly deteriorated. It needs replacement. It was given the services for both vehicles & pedestrian.

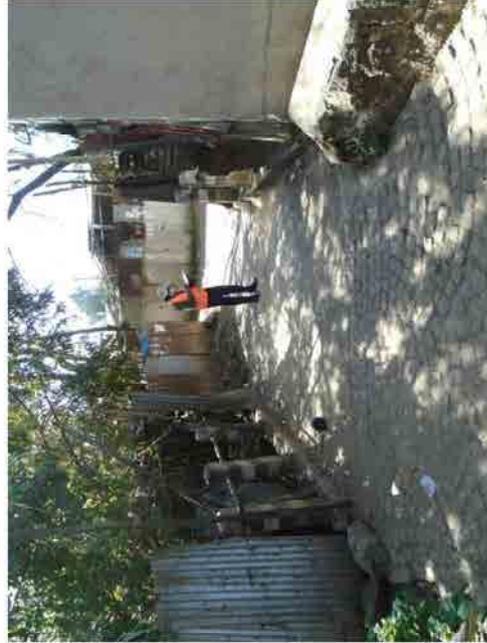
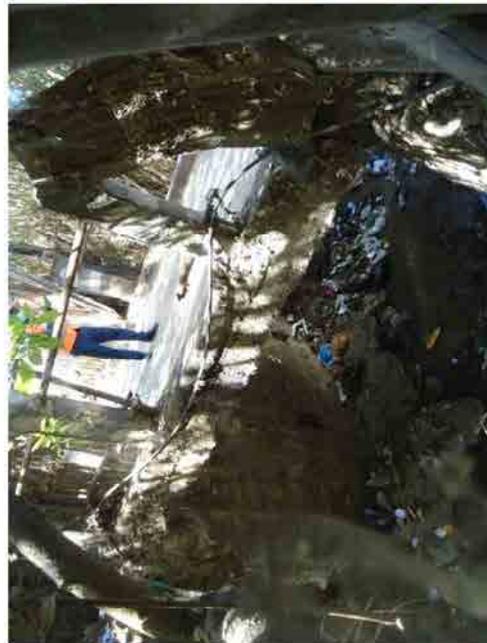
Item No.	Bridge Name	Span Length	Co-Ordinates		Year of Collapse/damage	Remark
			X-Coordinates	Y-Coordinates		
30	Gulele wereda 1	6 m	473622	1002872	It gives the service.	The superstructure is highly deteriorated. It needs replacement. It was given the services for both vehicles & pedestrian.

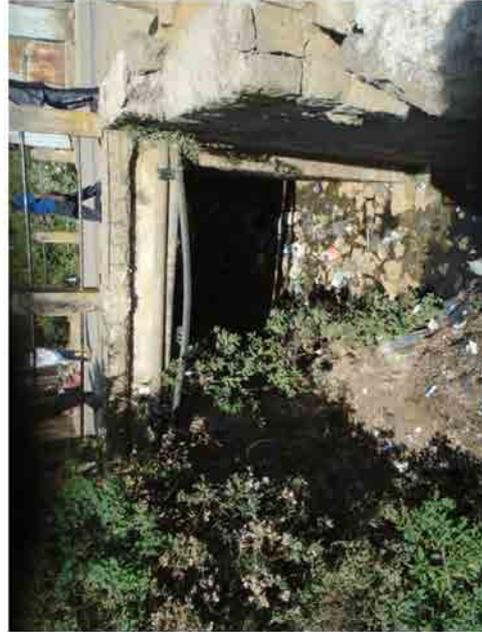
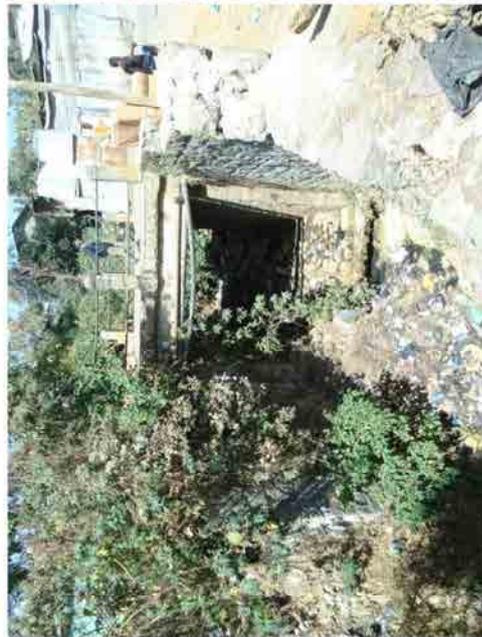
Item No.	Bridge Name	Span Length	Co-Ordinates		Year of Collapse/damage	Remark
			X-Coordinates	Y-Coordinates		
31	D' Afrique Mutu wengel	8 m	471700	996490	It gives the service.	The superstructure is highly deteriorated. It needs replacement. It was given the services for both vehicles & pedestrian.

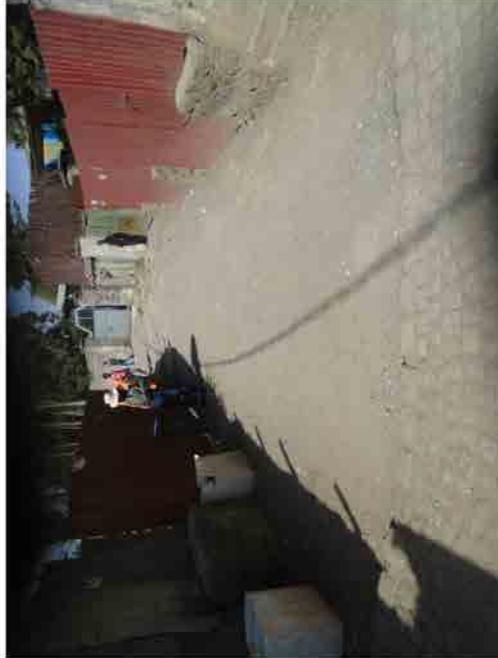
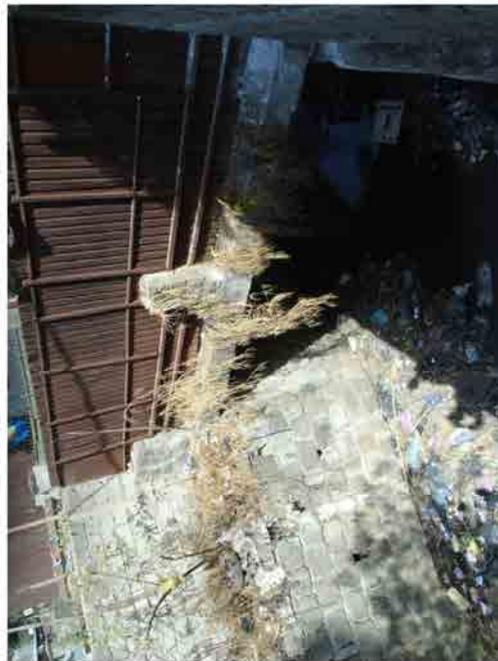
Item No.	Bridge Name	Span Length	Co-Ordinates		Year of Collapse/damage	Remark
			X-Coordinates	Y-Coordinates		
32	Jemmo-1 Burka School	40 m	469409	989844	It gives the service for pedestrian only	It is steel structure. The superstructure is highly Corrugated and the footing also scoured. It needs replacement.

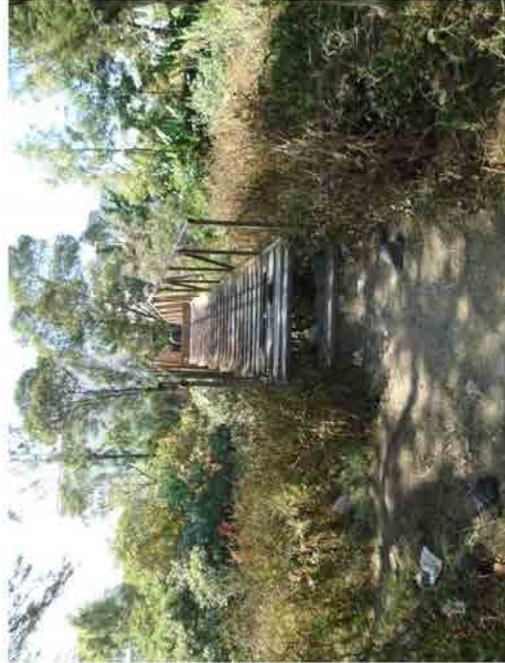
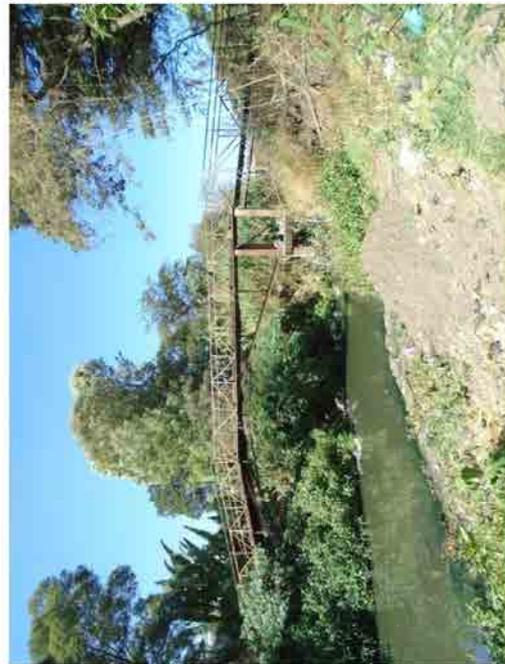
Item No.	Bridge Name	Span Length	Co-Ordinates		Year of Collapse/damage	Remark
			X-Coordinates	Y-Coordinates		
33	Lebu Medhani/Alem	6 m	472220	988452	2018	The Concrete Slab is deteriorate and forms a Hole. We want to change the bridge. It was given the services for both vehicles & pedestrian.
