エチオピア連邦民主共和国  
エチオピア道路公社（ERA）  
アジスアベバ市道路公社（AACRA）

エチオピア国  
道路アセットマネジメント技術アドバイザー業務

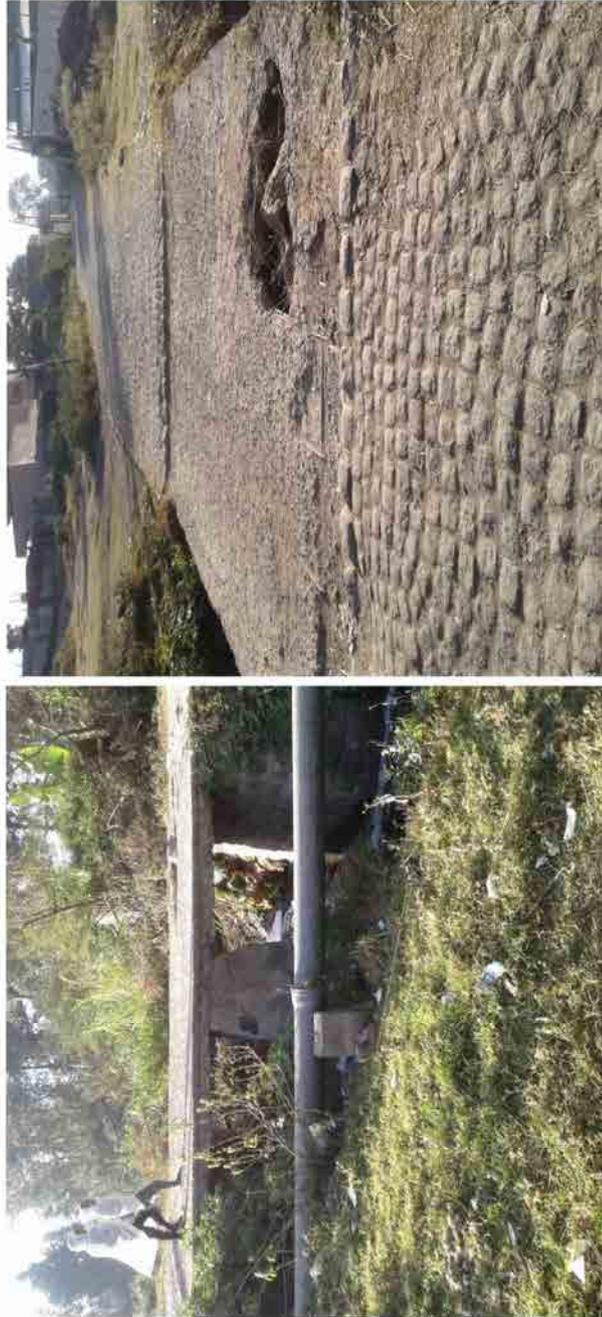
Item No.	Bridge Name	Span Length	Co-Ordinates		Year of Collapse/damage	Remark
			X-Coordinates	Y-Coordinates		
34	Gurd Shola-Misrak Ber School	30 m	481147	995936	It gives Service, But not Safe. It is in Danger condition.	It is Wood Bridge. It should Replace by Either Bailey or any adequate structure. It was given the services for pedestrian only.

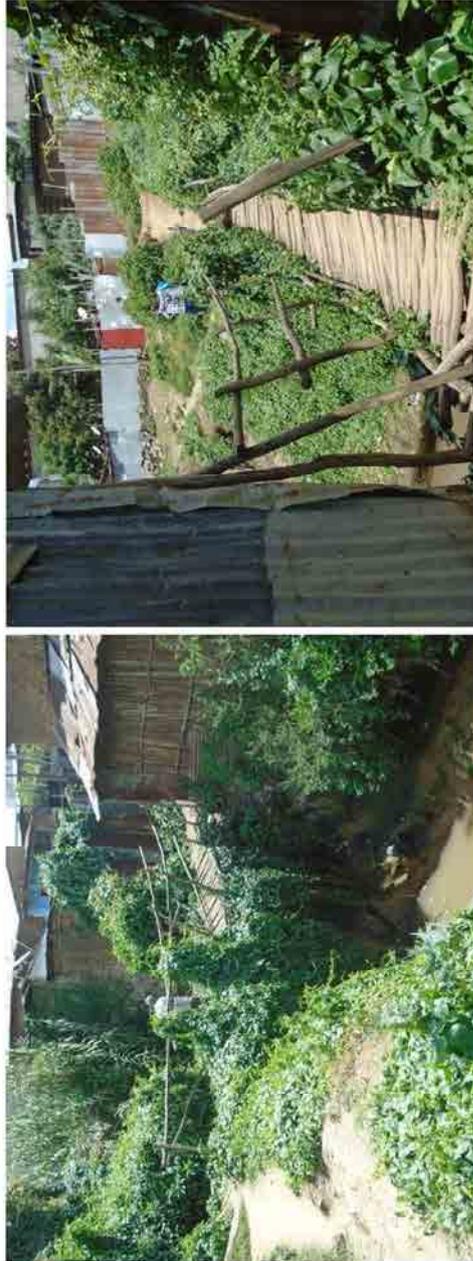
Item No.	Bridge Name	Span Length	Co-Ordinates		Year of Collapse/damage	Remark
			X-Coordinates	Y-Coordinates		
35	Gurd Shola Ketena 2-Kuas Meda	50 m	479762	994792	August, 2022	It was Slab bridge & support the slab at the middle by masonry pier. Pedestrian Bridge. The bridge is totally washed away by flood during the rainy season. It need replace. It was given the services for pedestrian only.

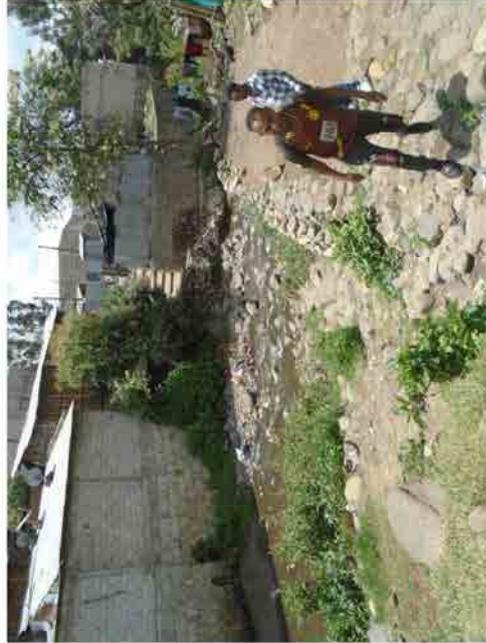
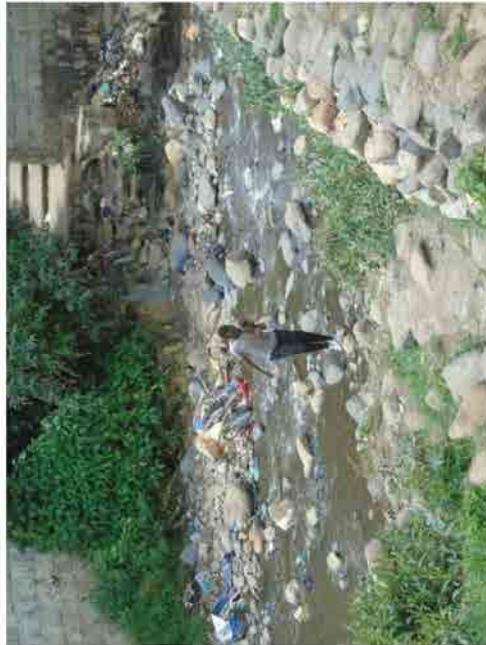
Item No.	Bridge Name	Span Length	Co-Ordinates		Year of Collapse/damage	Remark
			X-Coordinates	Y-Coordinates		
36	ባቲዋረዳ 1- ሄራዳጊ	40 m	466852	992126	It gives Service, But not Safe. It is in Danger condition.	It is Wood Bridge. It should Replace by Either Bailey or any adequate structure. It was given the services for pedestrian only.

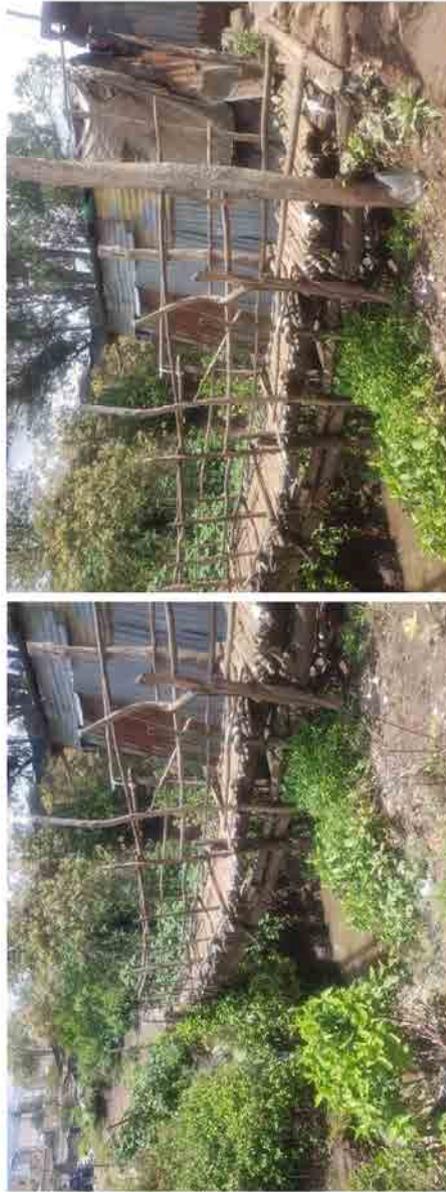
Item No.	Bridge Name	Span Length	Co-Ordinates		Year of Collapse/damage	Remark
			X-Coordinates	Y-Coordinates		
37	Sefere Genet	15	481262	995642	It gives Service, But not Safe. It is in Danger condition.	It is Wood Bridge. It should Replace by Either Bailey or any adequate structure. It was given the services for pedestrian only.

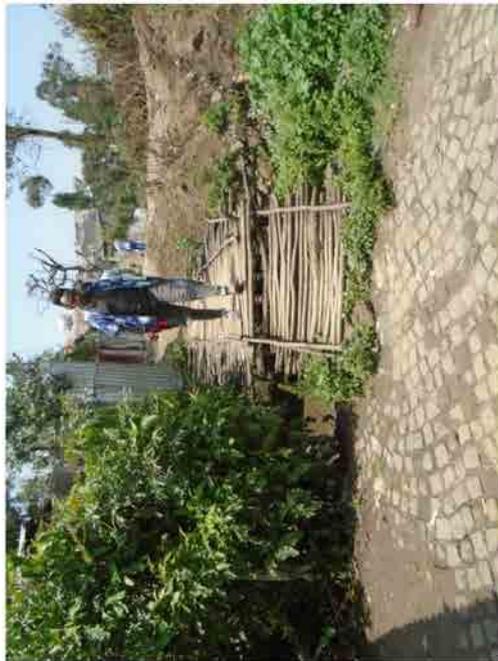
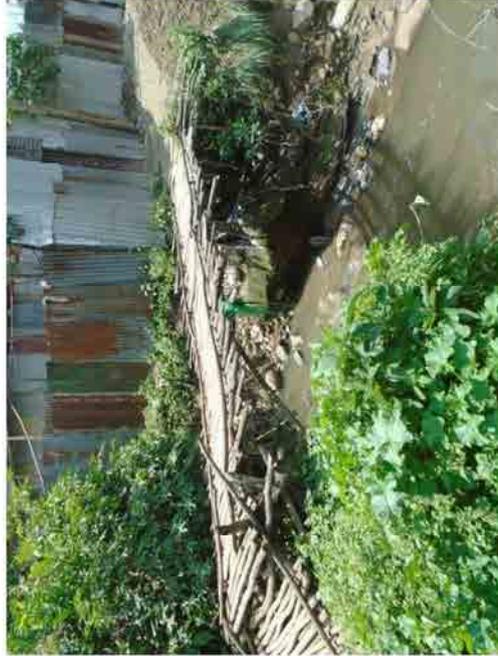
Item No.	Bridge Name	Span Length	Co-Ordinates		Year of Collapse/damage	Remark
			X-Coordinates	Y-Coordinates		
38	WeyBila Ashewa Meda	12	465424	997516	It gives Service, But not Safe. It is in Danger condition.	It is Wood Bridge. It should Replace by Either Bailey or any adequate structure. It was given the services for pedestrian only.

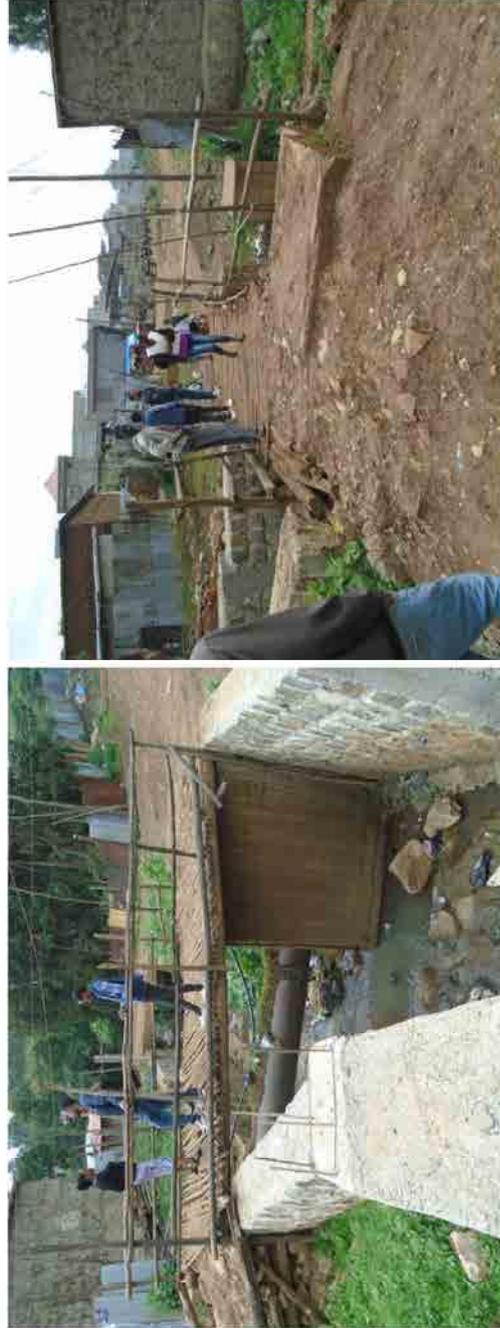
Item No.	Bridge Name	Span Length	Co-Ordinates		Year of Collapse/damage	Remark
			X-Coordinates	Y-Coordinates		
39	WeyBila Mariyam- Addis Sefer	10	465267	997457	It gives Service, But not Safe. It is in Danger condition.	It is Wood Bridge. It should Replace by Either Bailey or any adequate structure. It was given the services for pedestrian only.

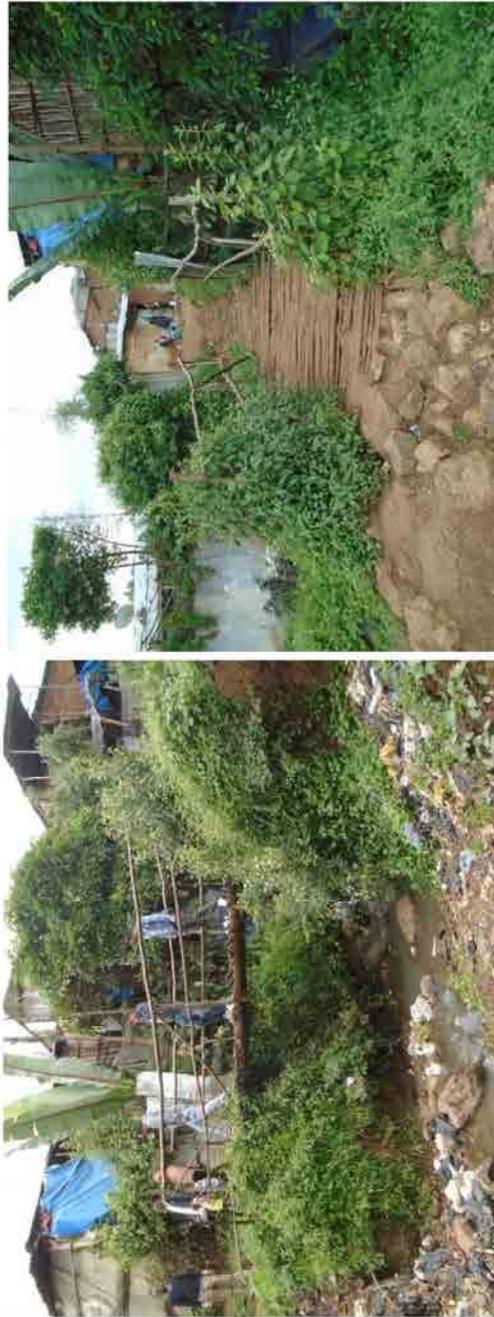
Item No.	Bridge Name	Span Length	Co-Ordinates		Year of Collapse/damage	Remark
			X-Coordinates	Y-Coordinates		
40	Addis Sefer-Tor Hiloch	15	465570	997934	It gives Service, But not Safe. It is in Danger condition.	It is Wood Bridge. It should Replace by Either Bailey or any adequate structure. It was given the services for pedestrian only.

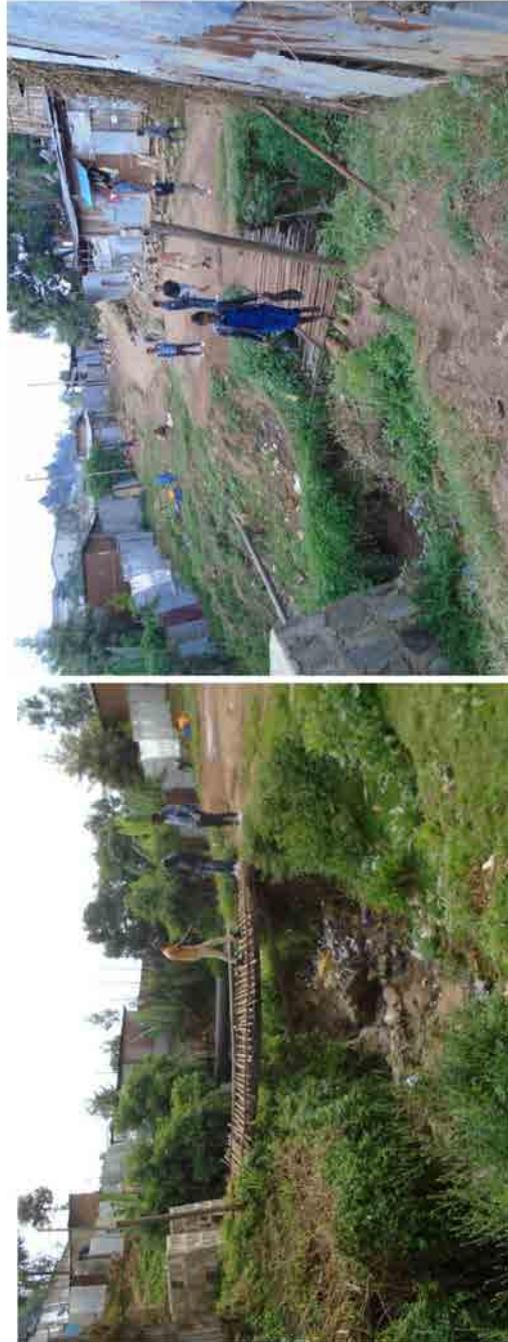
資料 6-1 収集した見積 (Bailey 橋)
