**PREPARATORY SURVEY
FOR THE PROJECT
FOR RECONSTRUCTION OF BRIDGES
ON PRIMARY NATIONAL HIGHWAY NO. 1
IN MONGAR DISTRICT**

FINAL REPORT

JAPAN INTERNATIONAL COOPERATION AGENCY

ORIENTAL CONSULTANTS GLOBAL CO., LTD.

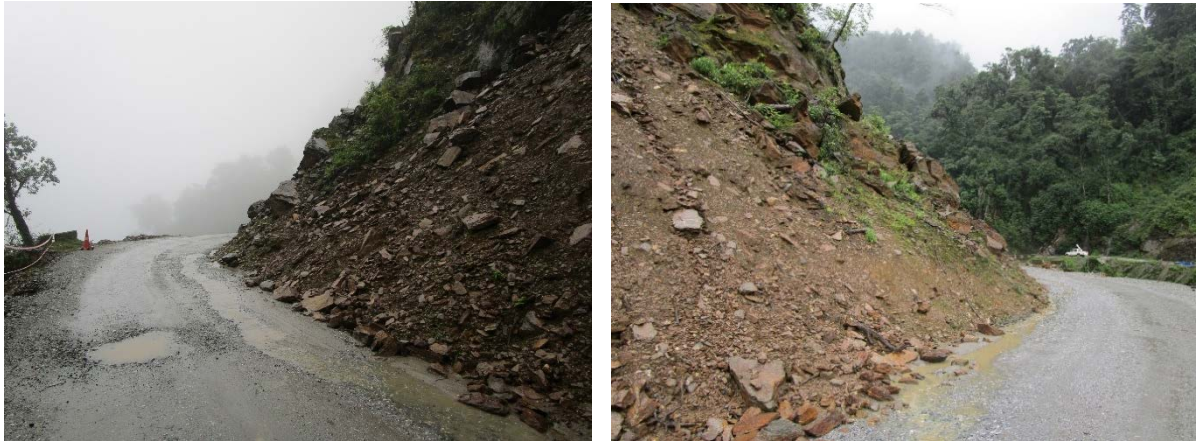
On the right bank side, as shown in Figure 1-3-45, partial areas of the road slope showed signs of collapse. The current road alignment is a gentle curve, and the exposed rock surfaces along this road exhibit a loose joint pattern, forming a weak bedding structure.

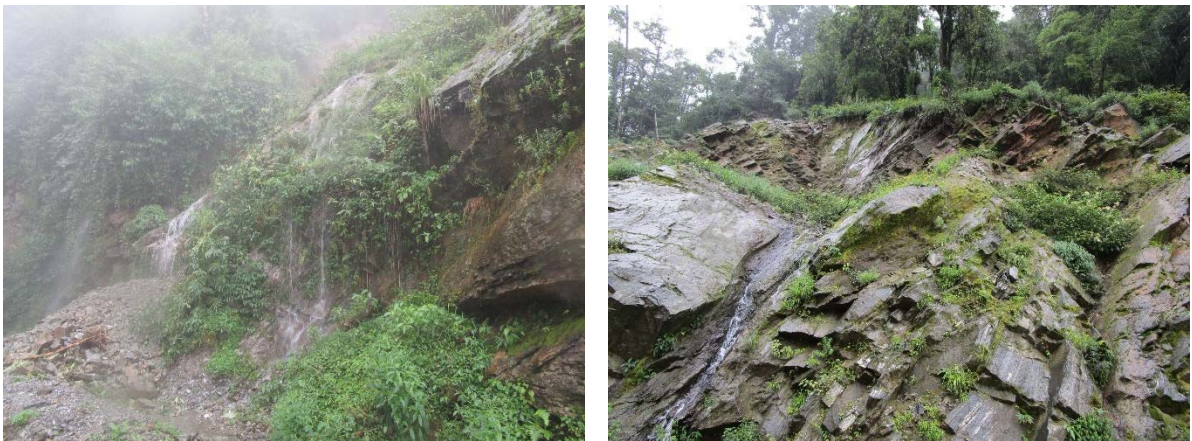
The left bank side of the road slope, as shown in Figure 1-3-46, partial areas of collapsed terrain, and surface water was observed flowing down the slope due to rainfall or other factors. It is important to note that at the planned bridging position on the left bank side, the exposed rock surfaces along the current road exhibit a weaker bedding structure than the cut slope (approximately 50°), forming a gentle flow bedding structure.

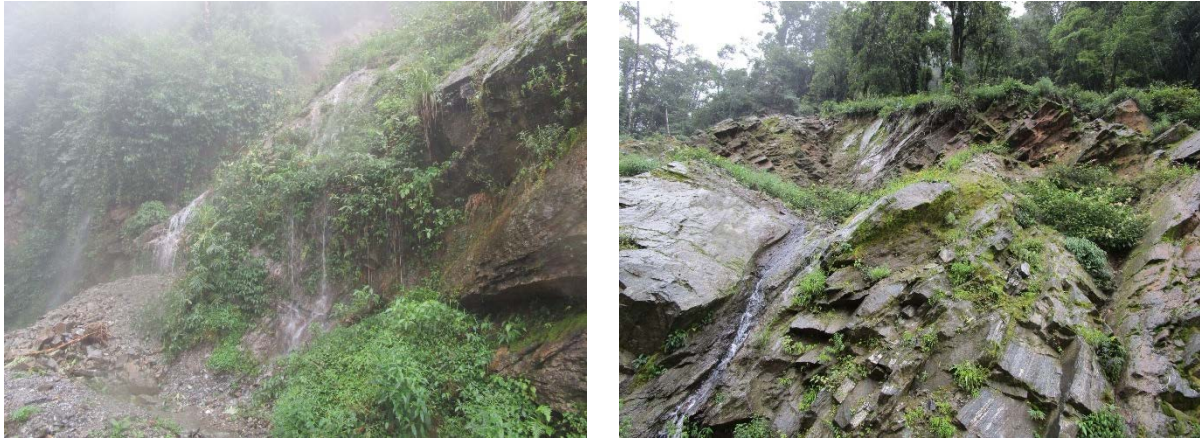
The left bank side of the road slope, as indicated in Figure 1-3-61, displayed partial areas of collapsed terrain, and surface water was observed flowing down the slope due to rainfall or other factors. It is important to note that at the planned bridging position on the left bank side, the exposed rock surfaces along the current road exhibit a weaker bedding structure than the cut slope (approximately 50°), forming a gentle flow bedding structure.

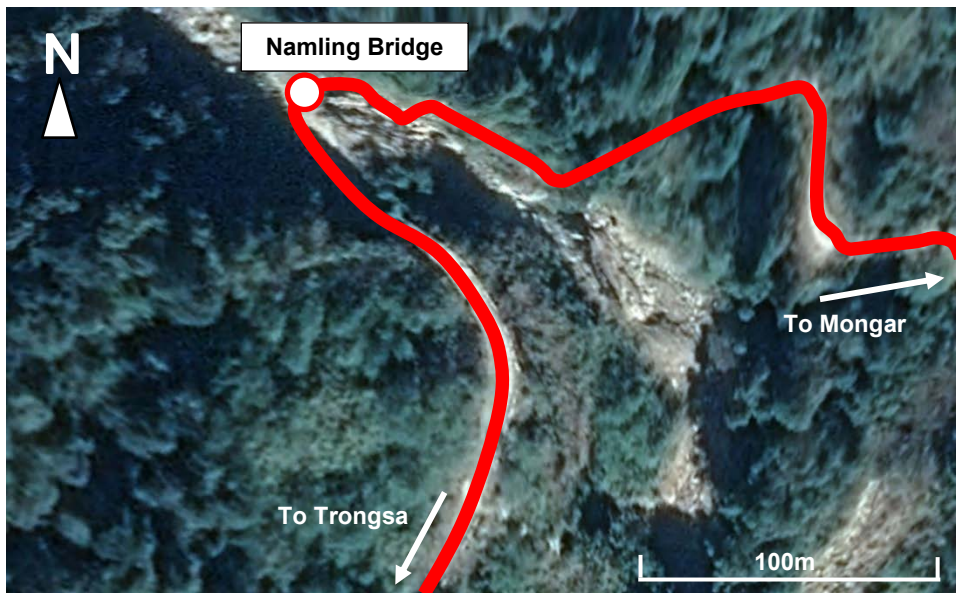
The surrounding road situation is shown in Figure 1-4-4. Bedrock appears on the right slope and minor rockfall was observed. On the other hand, the risk of rock fall is higher because the slope was composed of debris and bedrock on the left slope. Water leakage was observed from both side of the slope.

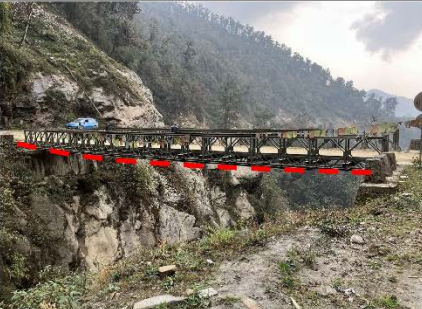
Photograph									
Category	e	Type of Damage	Extraordinary deflection	Pic.No.1	Category	e	Type of Damage	Scouring	Pic.No.2

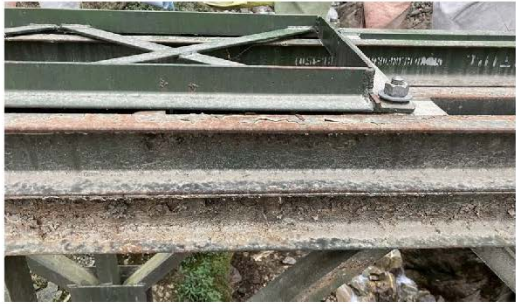
Category	e	Type of Damage	Deterioration of Painting	Pic.No.5	Category	e	Type of Damage	Abnormity	Pic.No.6

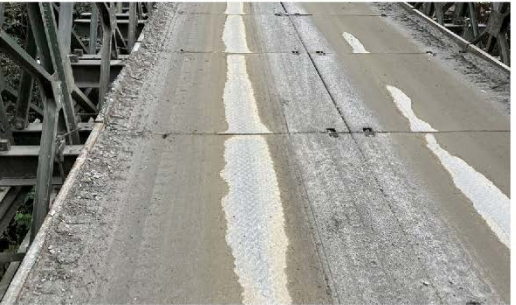
Category	e	Type of Damage	Sediment Deposition	Pic.No.7	Category		Type of Damage		Pic.No.8

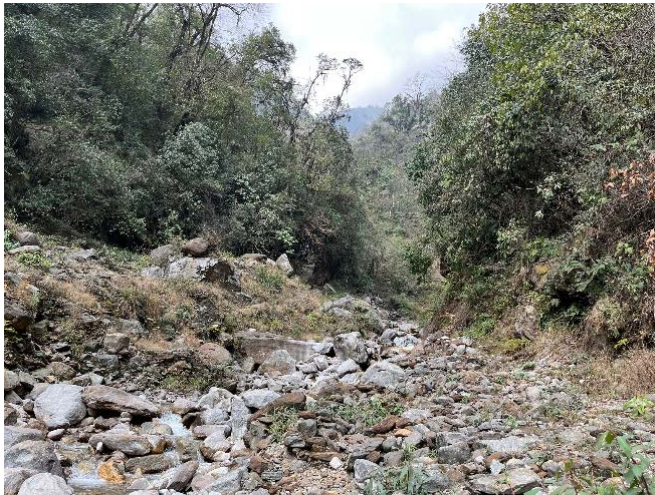
Upstream side of the existing bridg

The river is very steep from the existing bridge to downstream side and debris are found on the river. The upstream side are vegetated by grasses and trees and situation was visually unclear, but the angle was 15 to 20 degrees, which classified the occurrence or flow of debris flow area, according to the satellite photo data.

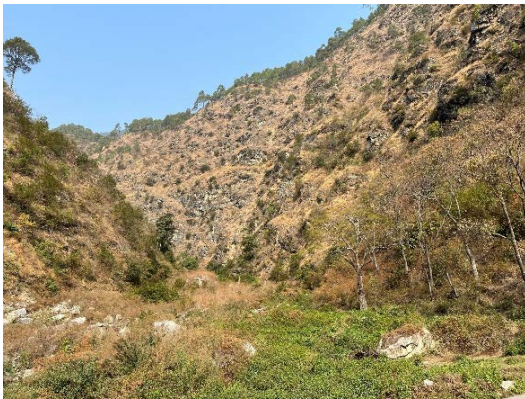
Upstream side of the existing bridge

Cobles were confirmed both upstream and downstream side of the bridge, and occurrence of debris flow was assumed. River water was not observed because our site survey was conducted in the dry season. River slope was visually gentle, but angle was 3 to 10 degrees, which classified debris deposit area, according to the satellite data.

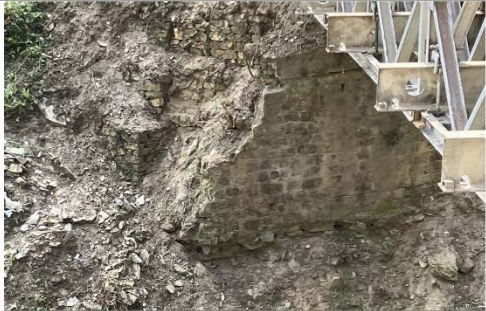
Photograph									
Category	e	Type of Damage	Scouring	Pic.No.1	Category	c	Type of Damage	Corrosion	Pic.No.2

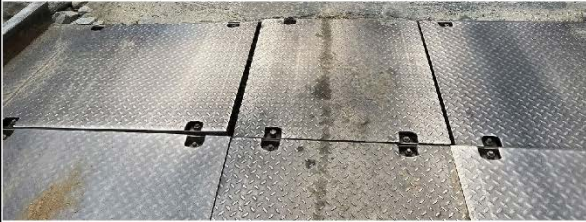
Category	e	Type of Damage	Deterioration of Painting	Pic.No.3	Category	b	Type of Damage	Corrosion	Pic.No.4

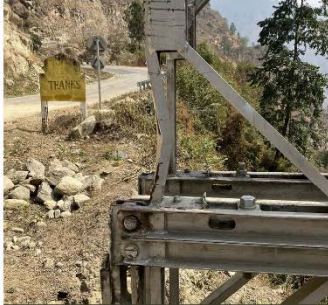
Category	e	Type of Damage	Fracture	Pic.No.5	Category	d	Type of Damage	Deterioration of Painting	Pic.No.6

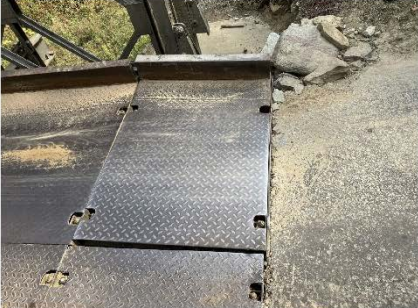
Category	e	Type of Damage	Abnormity	Pic.No.7	Category	e	Type of Damage	Unevenness	Pic.No.8

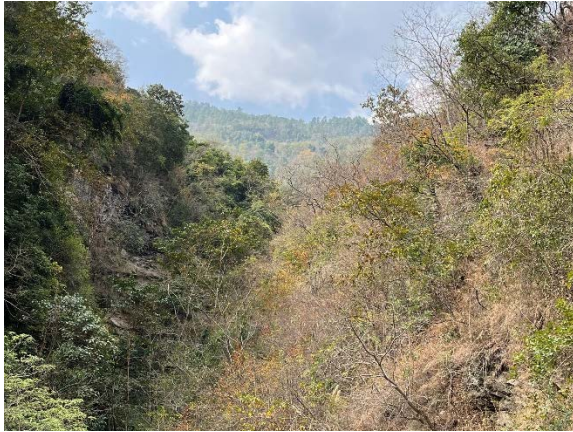
Upstream side of the existing bridge

River situation both upstream and downstream side were visually unclear because the river is covered with grasses and trees. River water was not observed because our site survey was conducted in the dry season. The angle was 10 to 20 degrees, which classified the mudslide deposit area to the occurrence or flow of debris flow area, according to the satellite photo data.

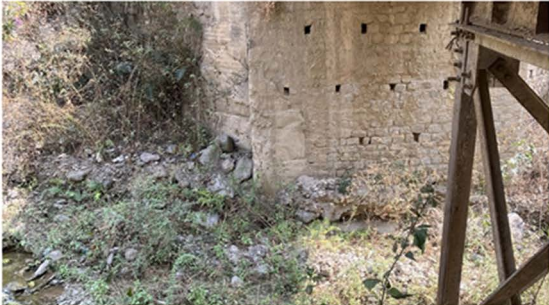
Photograph									
Category	e	Type of Damage	Scouring	Pic.No.1	Category	d	Type of Damage	Crack	Pic.No.2

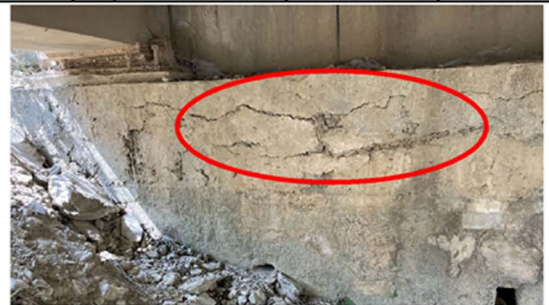
Category	e	Type of Damage	Crack	Pic.No.3	Category	e	Type of Damage	Rebar exposure	Pic.No.4

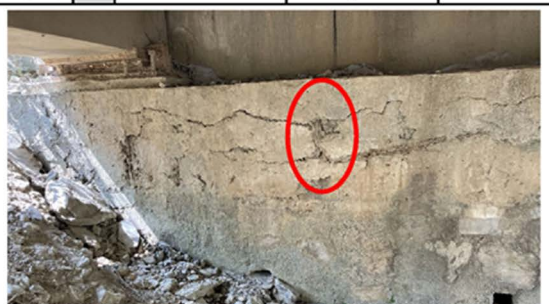
Category	e	Type of Damage	Honeycomb	Pic.No.5	Category	e	Type of Damage	Damage	Pic.No.6

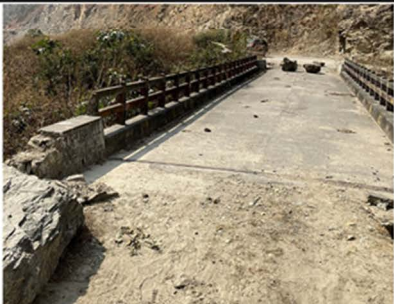
Category	e	Type of Damage	Sediment Deposition	Pic.No.7	Category	c	Type of Damage	Abnornity	Pic.No.8

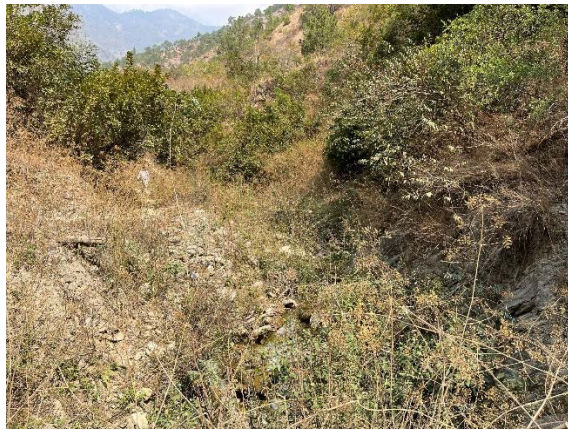
Upstream side of the existing bridge

Cobles were confirmed near to the bridge. River water was not observed because our site survey was conducted in the dry season. Upstream side was visually unclear because the river is covered with grasses and trees, on the other side, the river slope to downstream side were relatively gentle. According to the satellite photo, the angle was 3 to 10 degrees, which classified debris deposit area.

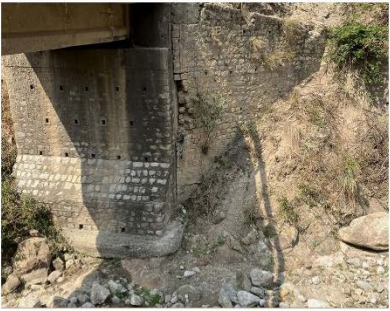
Photograph									
Category	e	Type of Damage	Scouring	Pic.No.1	Category	d	Type of Damage	Rebar exposure	Pic.No.2

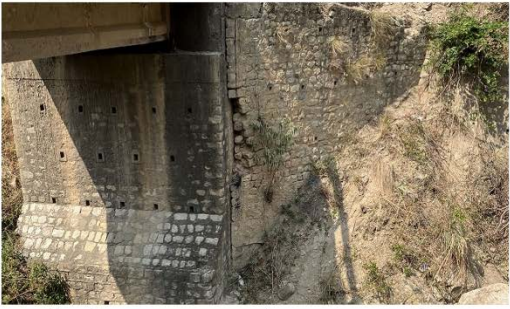
Category	c	Type of Damage	Damage	Pic.No.3	Category	c	Type of Damage	Abnormity	Pic.No.4

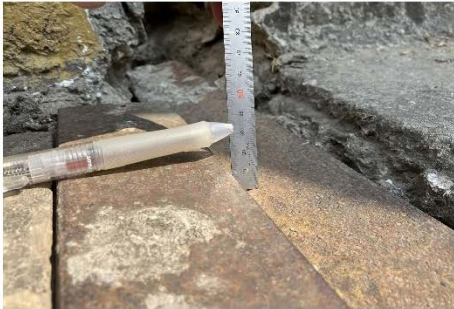
Category	e	Type of Damage	Unevenness	Pic.No.5	Category		Type of Damage		Pic.No.6
