Republic of Türkiye
Data Collection Survey on Development
of Disaster Prevention Capability for
Railways in Türkiye
Final Report

May 2025

Japan International Cooperation Agency (JICA)

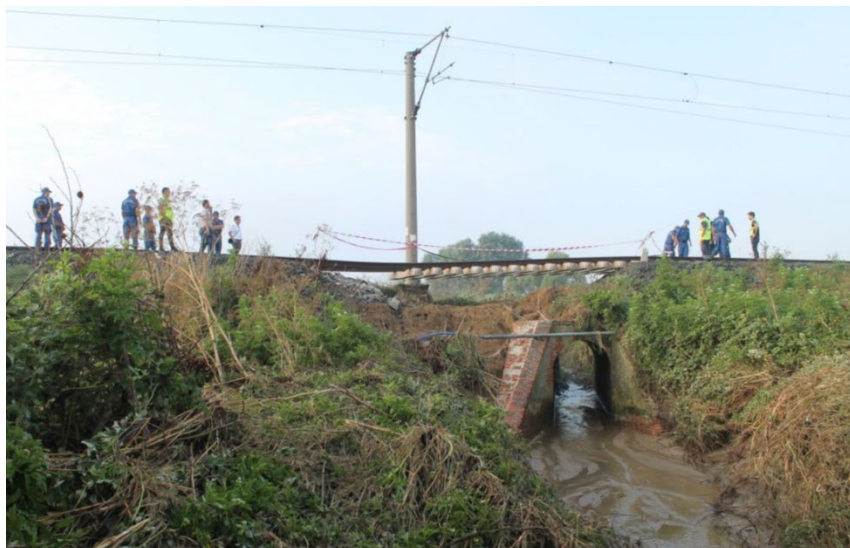
Figure 2-27 Post-Accident Situation

A culvert was installed at the accident site. Between 14:00 and 15:30 that day, the area recorded 32.4mm of rainfall, equivalent to 5% of the annual rainfall in the area. JST presumes that this localized heavy rainfall dammed the culvert and caused the ballast on the track bed to be washed away (Figure 2-28). This data was recorded at MGM's automatic observatory station located in Muratlı near the accident section.

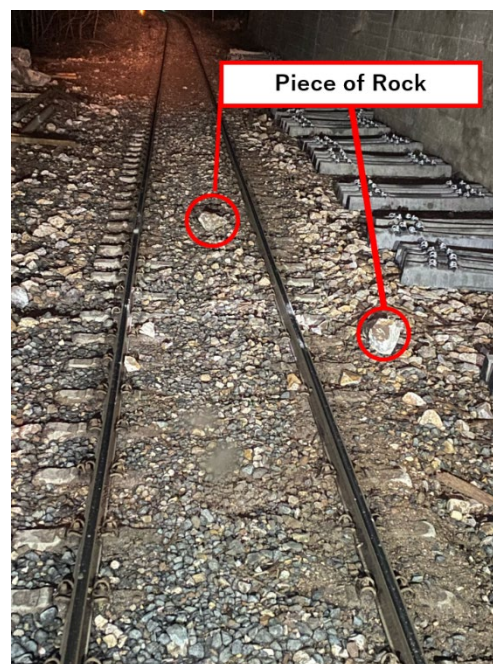
Figure 4-34 Track Condition After the Detection

- JST requested TCDD to inspect the site and to understand the condition of the track, and accelerometers.
- Although rockfall was confirmed in some areas of the track, it was confirmed on-site that there was no disruption to operation (Figure: Track Condition after the detection).
- When the investigation team compared the image data taken when the fence was installed under the latest circumstances, it was confirmed that a large stone remained in the retaining wall. For this reason, it was presumed that a relatively large stone had fallen from the slope, collided with the pole or fence, and its fragments had fallen into the track. (Figure: Before (left) and after (right) the accident)
- No damage was confirmed to the accelerometer itself, and it is presumed that accelerometer can continue to be used.

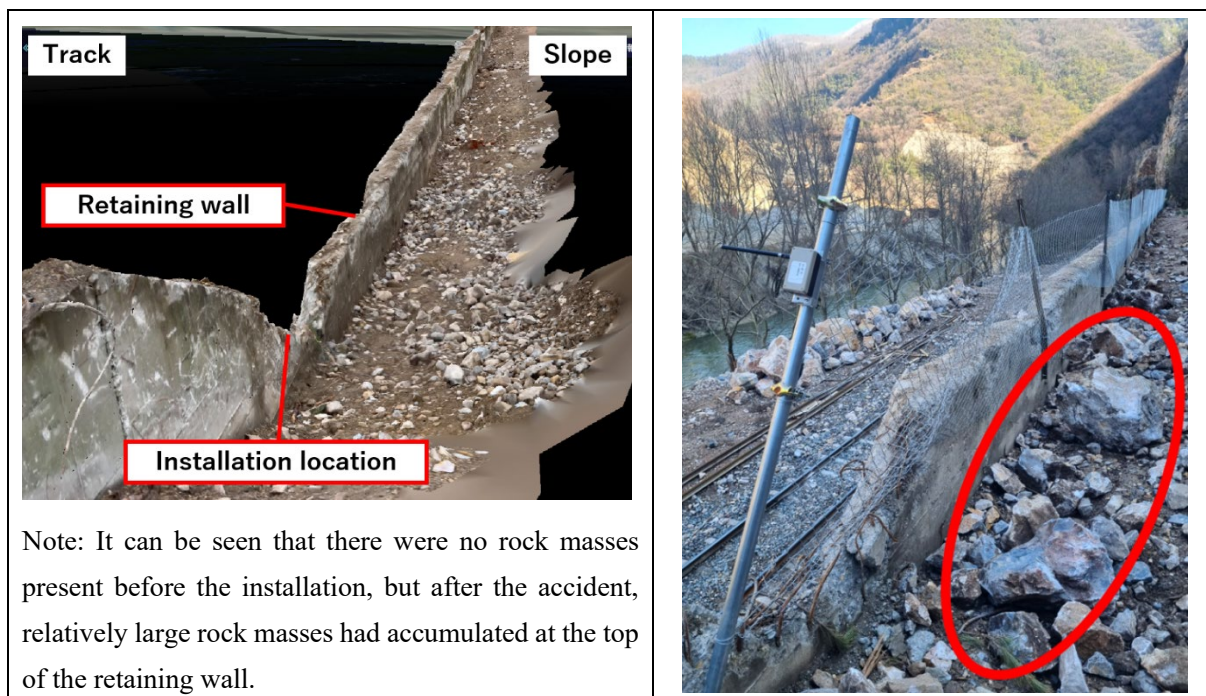
Note: It can be seen that there were no rock masses present before the installation, but after the accident, relatively large rock masses had accumulated at the top of the retaining wall.

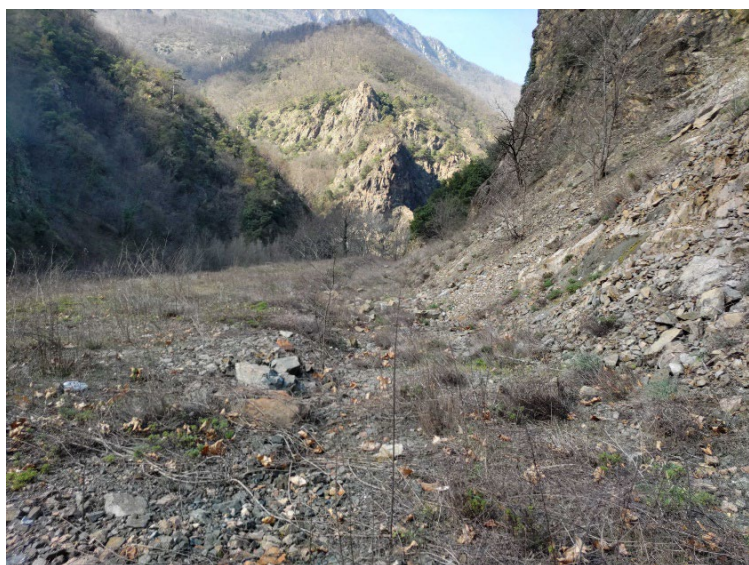
Figure 6-34 Gravel on Top of Corrugated Plate Tunnel Rock-Shelter Were Washed Away

The tunnel-type rockfall protection measures using corrugated steel plates adopted by TCDD may cause large displacement with relatively small energy in the event of a rockfall. The survey team expressed concern about the plan to support the power lines with corrugated steel plates in electrified sections.
