Result of the investigation on Nueva Santa Rosa

Investigation and analysis of La Guillen and Nueva Santa Rosa

Project for Control and Mitigation of Slope Disasters in the Central District
in Republic of Honduras

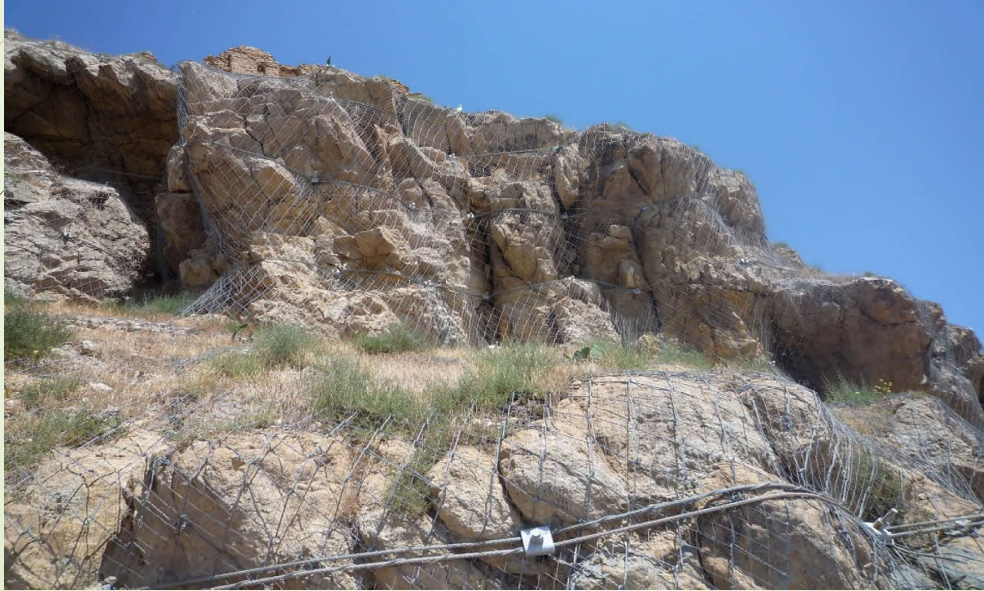
- ❑ **El fenómeno geológico que tuvo lugar en la zona fue una caída de rocas**
- ❑ **Los materiales afectados han sido conglomerados de la Formación Villa Nueva**
- ❑ **El fenómeno ha afectado tanto a edificios como a vías de comunicación**
- ❑ **Los estudios realizados identificaron dos zonas claramente diferenciadas: una basal formada por estratos de espesor decimétrico, aparentemente sin fracturación; y otra zona situada a techo de la anterior, masiva y fracturada, que es la que ha sido afectada por el evento.**

- ❑ **Como factores condicionantes se han considerado el estado de la roca, el agua (tanto de lluvia como la proveniente de conducciones), y la acción de las raíces de los árboles.**
- ❑ **Con los estudios de geofísica no se han detectado planos claros de debilidad, si bien se puede intuir a partir de la tomografía eléctrica una posible zona susceptible al movimiento.**
- ❑ **Durante los trabajos de campo se han podido cartografiar una serie de fracturas dentro del talud que pueden afectar a la estabilidad del mismo en el futuro**
- ❑ **Se han propuesto dos tipos de intervenciones, una destinada a la protección, por medio de barreras dinámicas, y otra de estabilización, por medio de membranas flexibles**
- ❑ **Como obras secundarias se recomienda la canalización de las aguas superficiales**

OBRAS PROPUESTAS

▸ ESTABILIZACIÓN: **MEMBRANAS FLEXIBLES**
