Minchin Flood Bund RD 90+000

Creation Date: 3/3/2024

Province	Zone	Division	Circle
Punjab	Bahawalpur Zone	Punjnad Headworks Division	Punjnad Canal Circle
Sr. No.	River Name	River System	Bank
P-001	Indus River	Indus River	Left
Bund Name		R.D.	GPS Coordinates
Minchin Flood Bund		RD 90+000 to 100+000	29°08'78.33"N, 70°76'66.67"E
Name of Vulnerable Point	Minchin Flood Bund RD 90+000 to 100+000		
Reason for the Vulnerability	<ul style="list-style-type: none"> In 2010 flood, seepage water crossed this bund at this reach and approx. 10 feet. deep pit was formed on the country side of the bund. During 2015 flood, the River Indus impacted the same reach once again 		
Flow Condition ¹	<ul style="list-style-type: none"> There is no flow at this location due to shift in the river's direction away from the bund. River is approx. 4 km away from the said reach. 		
Site Condition in the Country Side ²	<ul style="list-style-type: none"> Cultivated land is located on the countryside side of the bund, supporting agricultural activities in the area..

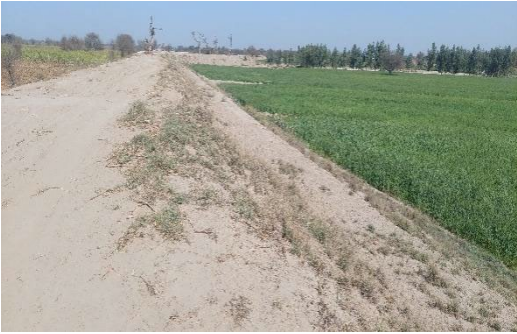
Observation Record ⁴ (Current status, effect of countermeasure, development of erosion, deformation, and deterioration)			
DD/MM/YYYY	Inspection Type	Description and Photo	Damage ⁵
03/3/2024	Visual Inspection	<ul style="list-style-type: none"> • Top level is bumpy and uneven. • Natural surface level is approximately 28 feet below the top level. • Cultivated areas are present on the countryside side of the bund. • Seepage was observed in the past flood.

<p>Cropped area towards country side</p>	L

Evaluation Process					
DD/MM/YYYY	Item		Result	Reason	
	Criteria For Evaluation Flow	Flood Damage		Yes	The inundation analysis indicates that the flood damage is severe
		Bund Damage		YES	Seepage was observed.
		Bund Dimension	Bund Height	Fail	Free board height is 5.1 feet.
			Bund Width	Pass	The soil cover thickness over HGL exceeds the guideline value (Soil Depth \geq 2 feet)
			Flood Plain Length	Pass	Floodplain length is about 15900 feet.
		Topographic Feature	Breach Record	No	There is no breach record.
			Flow Impact	NO	It hasn't been affected by strong water flow since before 2010 flood.
	Category			Emergent Type C	
	For Evaluation Score	Bund Damage		3	Seepage was observed.
		Bund Dimension	Bund Height	1	Free board height is 5.1 feet.
			Bund Width	0	The soil cover thickness over HGL exceeds the guideline value (Soil Depth \geq 2 feet)
			Flood Plain Length	0	Floodplain length is about 15900 feet.

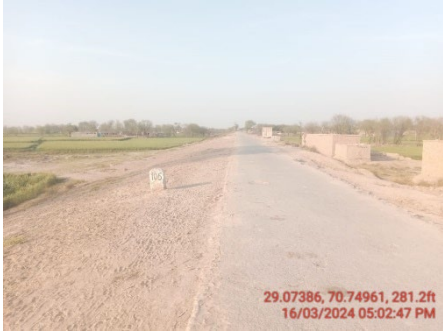
<p>29.07386, 70.74961, 281.2ft 16/03/2024 05:02:47 PM</p> <p>Metaled road on top of the bund</p>

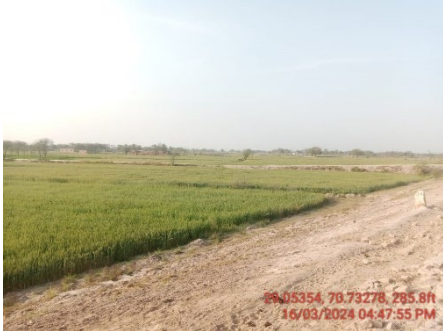
<p>29.05354, 70.73278, 295.8ft 16/03/2024 04:47:55 PM</p> <p>Cropped area on either side of the bund</p>	A

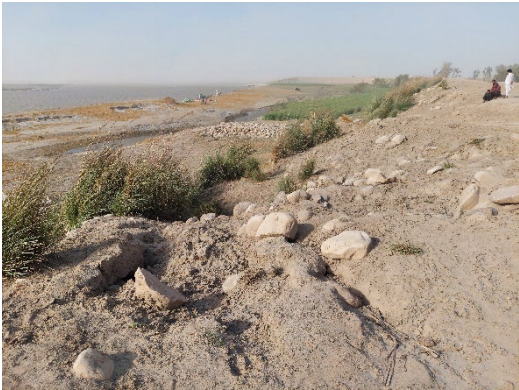
Observation Record ⁴ (Current status, effect of countermeasure, development of erosion, deformation, and deterioration)			
DD/MM/YYYY	Inspection Type	Description and Photo	Damage ⁵
02/3/2024	Visual Inspection	<ul style="list-style-type: none"> • Extreme erosion has been observed along the flood bund at this RD. • Top level is bumpy and uneven. • 5/R Chahchran Disty. is observed towards the country side of the said RD. • Cultivated area has been observed beyond the Disty. Which 22 feet. beneath the top level of the said reach.

<p>Extreme erosive action</p>

Evaluation Process					
DD/MM/YYYY	Item		Result	Reason	
	Criteria For Evaluation Flow	Flood Damage		Yes	The inundation analysis indicates that the flood damage is severe
		Bund Damage		YES	The bund body is currently damaged.
		Bund Dimension	Bund Height	Pass	Free board height is 9.8 feet.
			Bund Width	Pass	The soil cover thickness over HGL exceeds the guideline value (Soil Depth \geq 2 feet)
			Flood Plain Length	Fail	The river touch the bund
		Topographic Feature	Breach Record	No	There is no breach record.
			Flow Impact	NO	It hasn't been affected by strong water flow since before 2010 flood.
	Category			Emergent Type C	
	For Evaluation Score	Bund Damage		3	The bund body is currently damaged.
		Bund Dimension	Bund Height	0	Free board height is 9.8 feet.
			Bund Width	0	The soil cover thickness over HGL exceeds the guideline value (Soil Depth \geq 2 feet)
			Flood Plain Length	2	The river touches the bund

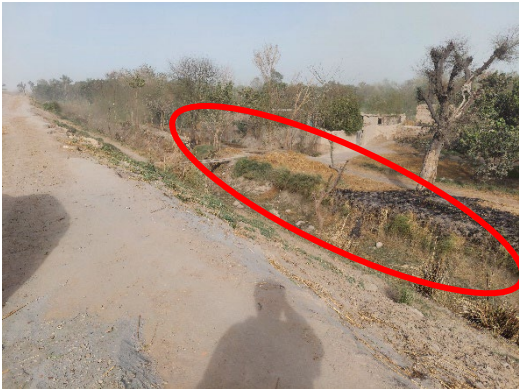
<p>5/R Chahchran Disty. is observed towards the country side</p>

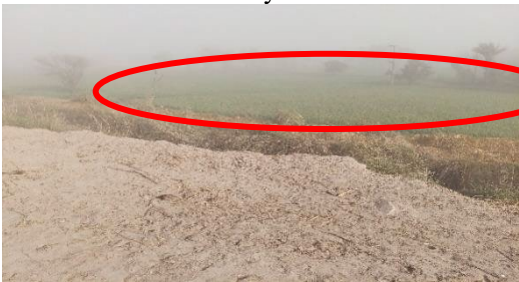
<p>Cropped area observed beyond the Disty.</p>	c

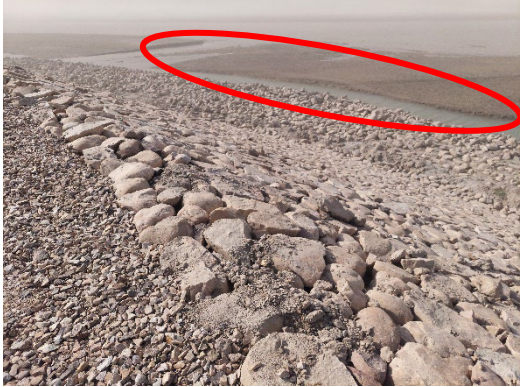
<p>Small creek / standing water observed along the said reach</p>

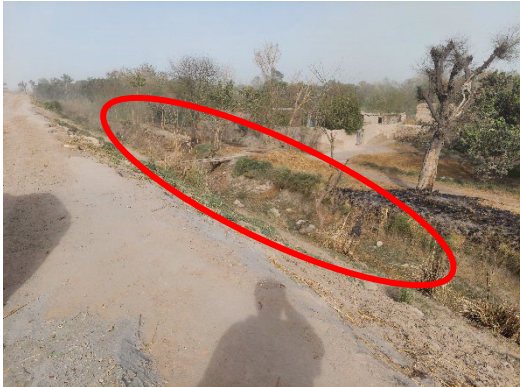
<p>5/R distributary (Small canal) is flowing along the country side</p>	a

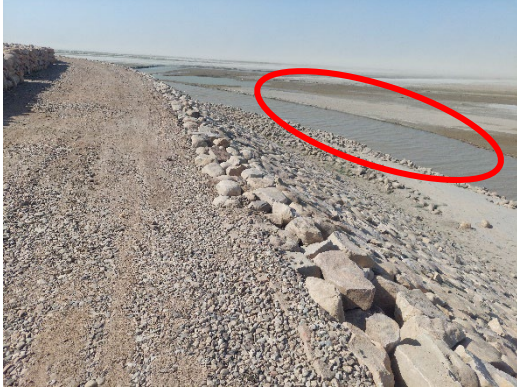
<p>Small creek flowing along the said reach</p>

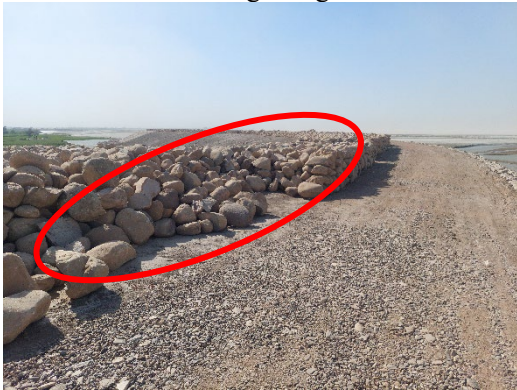
<p>Reserve stock of stones was present at the top of spur</p>	a

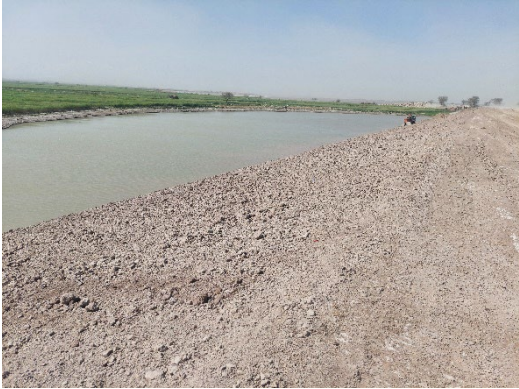
Observation Record ⁴ (Current status, effect of countermeasure, development of erosion, deformation, and deterioration)			
DD/MM/YYYY	Inspection Type	Description and Photo	Damage ⁵
02/3/2024	Visual Inspection	<ul style="list-style-type: none"> • Deep pit was formed during 2022 flood, with a depth of 45 feet, caused by the river's erosive action. • After restoration, J-head portion again damaged at nose which disturbed the pitching too.

<p>Deep pit formed in 2022 flood with 45 feet sounding</p>

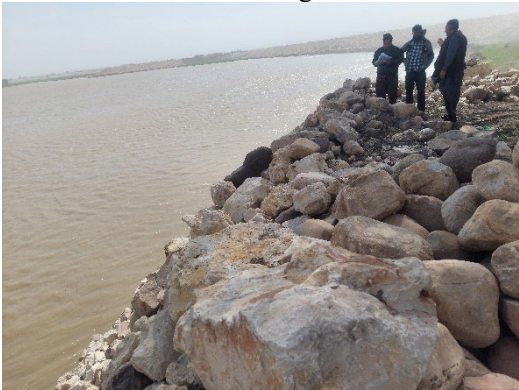
<p>Damaged nose portion</p>	c

Evaluation Process					
DD/MM/YYYY	Item		Result	Reason	
	Criteria For Evaluation Flow	Flood Damage		Yes	The inundation analysis indicates that the flood damage is severe
		Bund Damage		YES	The bund body is currently damaged.
		Bund Dimension	Bund Height	Pass	Free board height is 13 feet.
			Bund Width	Pass	The soil cover thickness over HGL exceeds the guideline value (Soil Depth \geq 2 feet)
			Flood Plain Length	Fail	Floodplain length is about 200 feet.
		Topographic Feature	Breach Record	No	There is no breach record.
			Flow Impact	NO	It hasn't been affected by strong water flow since before 2010 flood.
	Category			Emergent Type C	
	For Evaluation Score	Bund Damage		3	The bund body is currently damaged.
		Bund Dimension	Bund Height	0	Free board height is 13 feet.
			Bund Width	0	The soil cover thickness over HGL exceeds the guideline value (Soil Depth \geq 2 feet)
			Flood Plain Length	1	Floodplain length is about 200 feet.

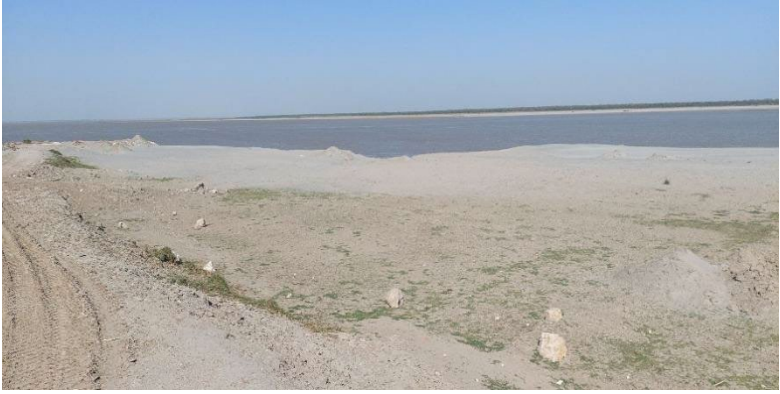
<p>Erosive action 200 feet away from bund inside the river bed</p>	
	<p>Photo with 360° angles</p>

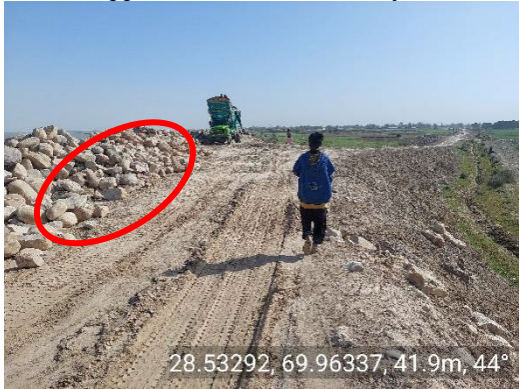
<p>Stone dumped at this reach for the restoration works</p>	a

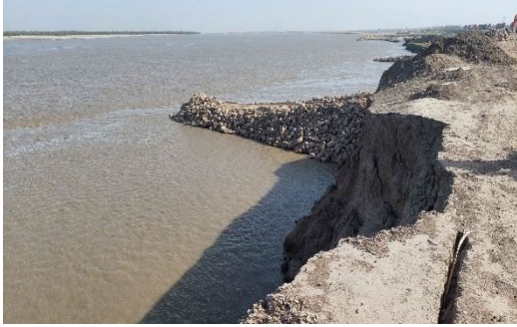
Observation Record ⁴ (Current status, effect of countermeasure, development of erosion, deformation, and deterioration)			
DD/MM/YYYY	Inspection Type	Description and Photo	Damage ⁵
03/1/2024	Visual Inspection	<ul style="list-style-type: none"> • Continuous erosion was observed along river side. • Top level is bumpy and uneven. • Natural surface level is 12 feet. below the top level.

<p>Continuous erosion observed along river side</p>	c

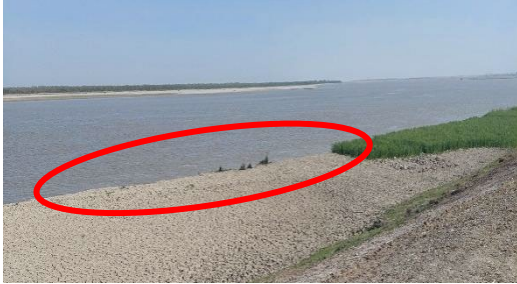
<p>Continuous erosion observed along river side</p>

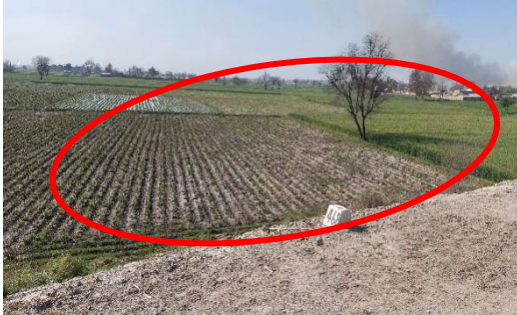
<p>Cropped area towards country side</p>	a

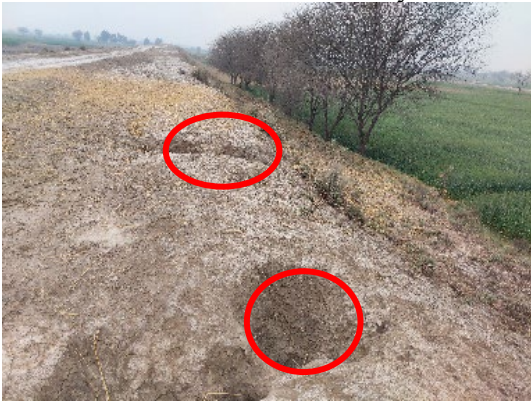
<p>Design parameters of the bund was not well maintained</p>	a

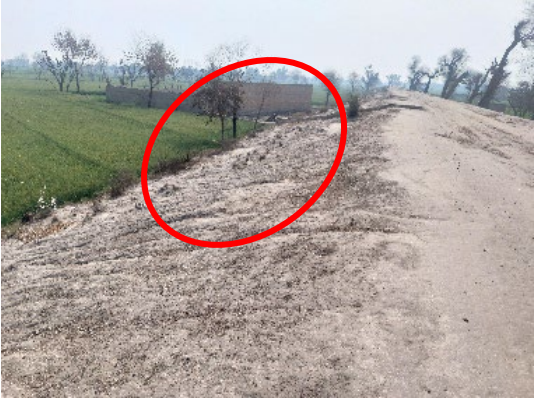
<p>Rain cuts observed on side slopes</p>	A

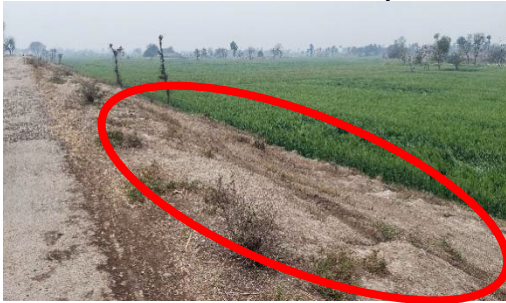
<p>Design parameters of the bund was not well maintained</p>	a

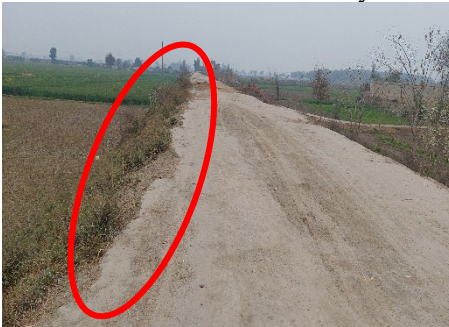
<p>Design parameters of the bund was not well maintained</p>	a
