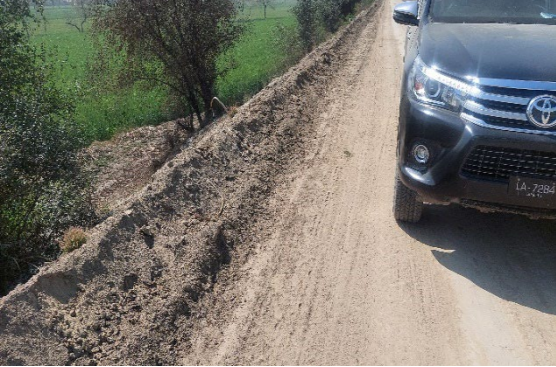
| Observation Record ⁴ (Current status, effect of countermeasure, development of erosion, deformation, deterioration) | | | |
|---|---|---|---|
| 22/2/2024 | Visual Inspection | <ul style="list-style-type: none"> The River Indus is currently striking the bund between RD 60+000 and RD 70+000. Cultivated area is observed on the country side. Bottom level is Approximately 15 feet below the top level. <p>Cultivated area is present on country side</p> | a |

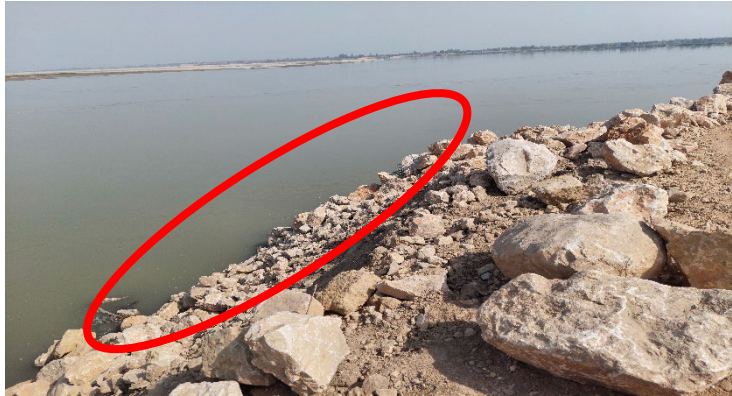
| | <p>Close View of Damages</p> <p>Apron, nose and stone pitching of the J head spur at RD 70+000 damaged</p> | |

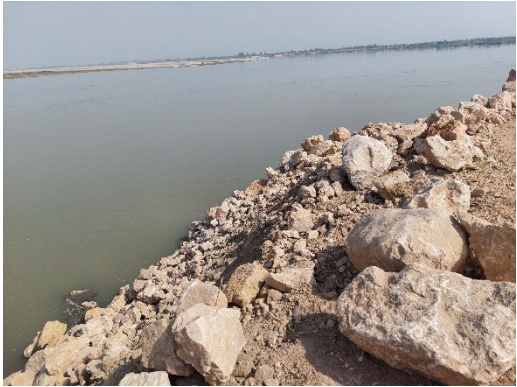
| Observation Record ⁴ (Current status, effect of countermeasure, development of erosion, deformation, deterioration) | | | |
|---|--|--|--|
| | | <p>Apron and nose of Inverted hockey stud at RD 63+700 observed</p> <p>Apron, nose and stone pitching of the J-Head Spur at RD 70+000 damaged</p> | |

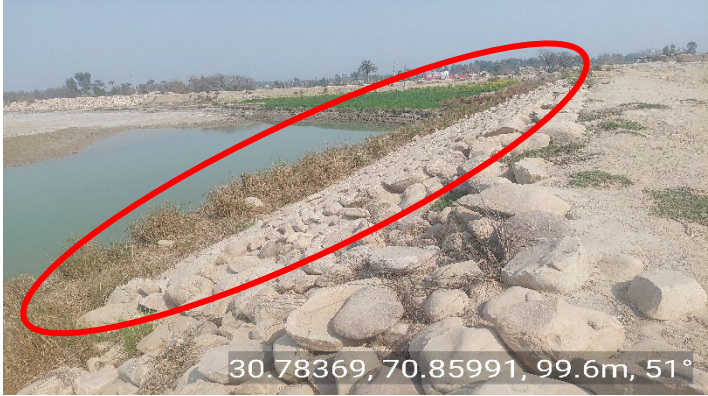
<p>30.78369, 70.85991, 99.6m, 51°</p> <p>Damaged apron</p> | | | | | | | | | | | | | | | |
| | <p>Photo with 360° angles</p>

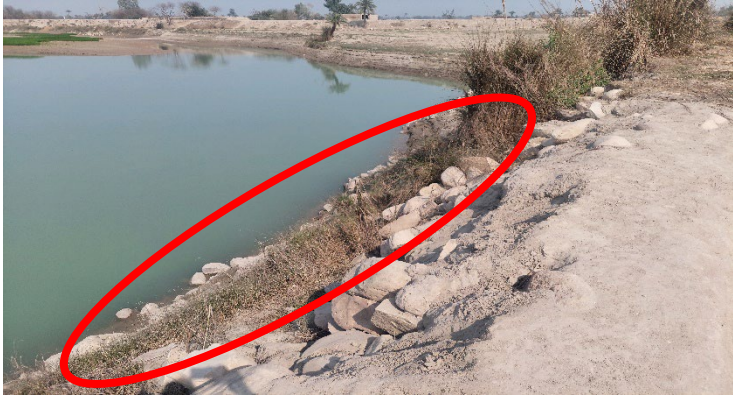
| | <p>Close View of Damages</p> <p>Damaged apron of the spur</p> | |

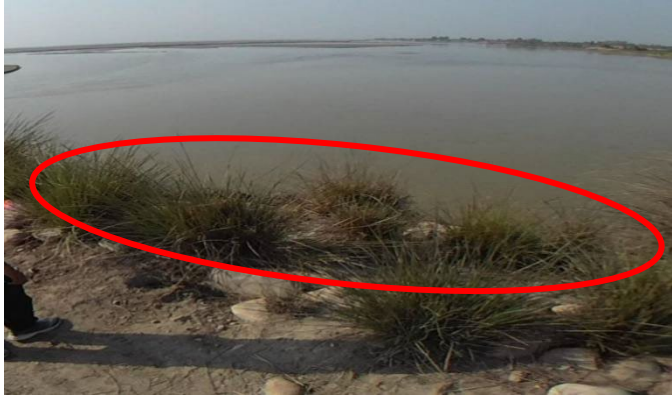
| | <p>Close View of Damages</p> <p>Apron damaged</p> | | | |

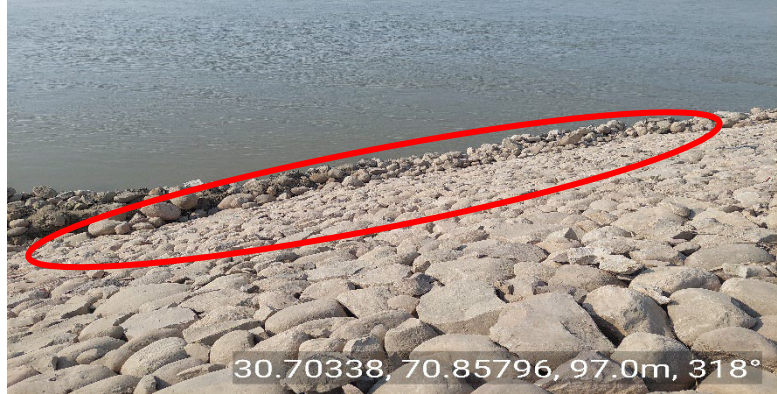
| | <p>Close View of Damages</p> <p>30.70338, 70.85796, 97.0m, 318°</p> <p>Damaged apron of the spur</p> | |

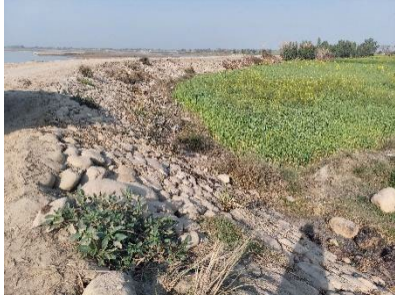
| Observation Record ⁴ (Current status, effect of countermeasure, development of erosion, deformation, deterioration) | | | |
|---|---|--|---|
| 24/2/2024 | Visual Inspection | <ul style="list-style-type: none"> • Village is approximately one km away from the spur. • Cultivated area is observed on the country side. • Main river is directly impacting the spur. • Extreme turbulent flow is observed. <p>Cultivated area is observed on the country side</p> <p>Main river directly impacting the spur</p> | c |

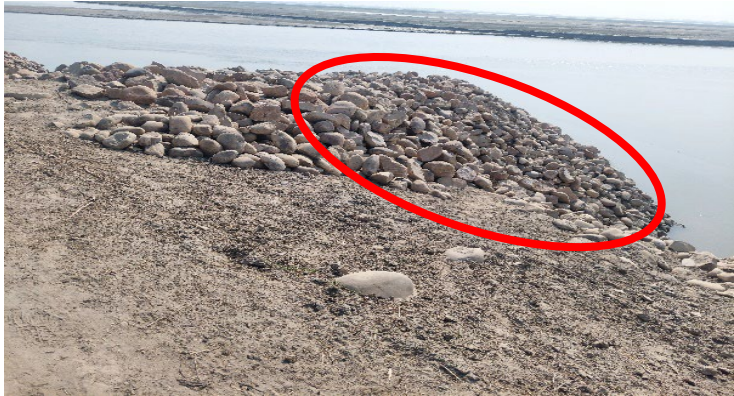
| Site Photo | | | | | |
|--|--|--|---|--|--|
| Close View of Deformation | <p>Damaged stone stud</p> | | | | |

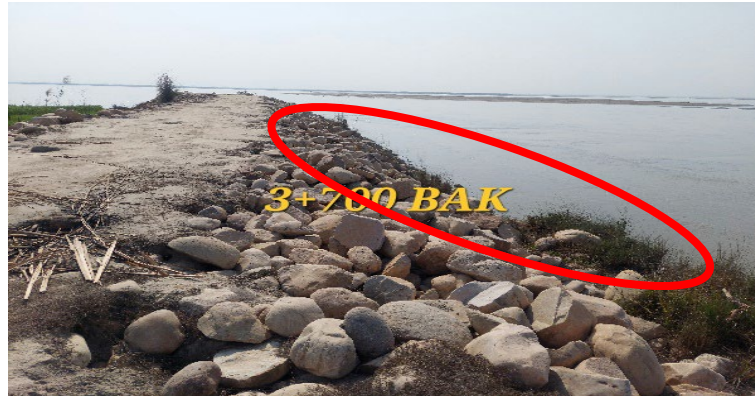
Damaged apron of the spur

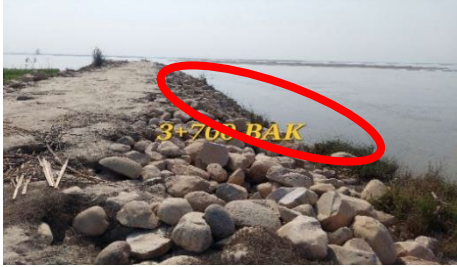
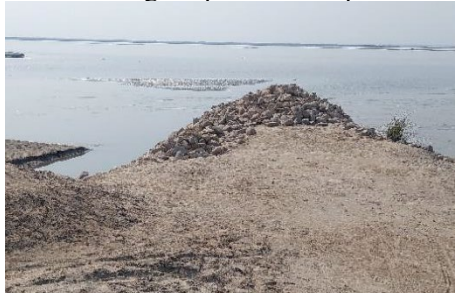
| Observation Record ⁴ (Current status, effect of countermeasure, development of erosion, deformation, deterioration) | | | |
|---|---|--|---|
| 24/2/2024 | Visual Inspection | <ul style="list-style-type: none"> • Cultivated area is observed on the country side of this reach. • Bottom level is approximately 10 feet below the top level. • Inverted hockey spur is under direct impact of the river and continuous erosion occurring around the spur. • 480 feet apron of solid stone portion plus nose portion damaged. • 4 solid stone studs in between RD 4+400 to RD 5+700 of protection bund is directly impacted from the main river. • Extreme turbulent flow was observed. <p>Cultivated area is observed on the country side</p> <p>Damaged apron of the spur</p> <p>Solid stone studs are directly hit from the main river</p> | c |

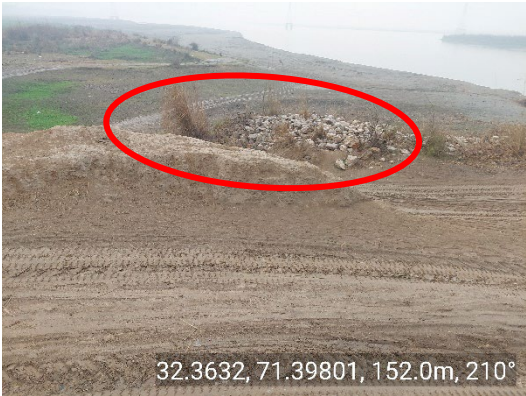
| Site Photo | | | | | |
|--|--|--|---|--|--|
| Close View of Deformation | <p>32.3632, 71.39801, 152.0m, 210°</p> <p>Side slopes on downstream side of the spur found damaged</p> | | | | |

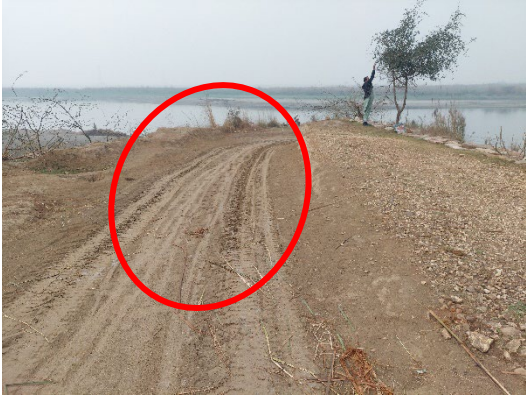
| | <p>Close View of Damages</p> <p>Nose portion depressed than the shank portion</p> | |

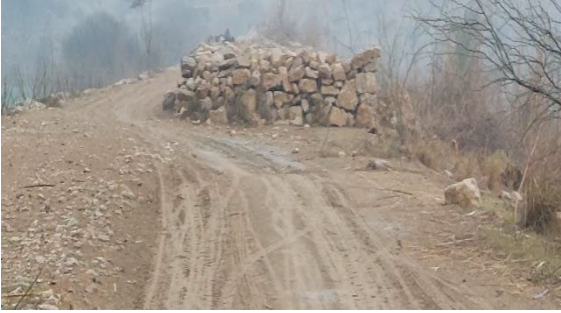
| Observation Record ⁴ (Current status, effect of countermeasure, development of erosion, deformation, deterioration) | | | |
|---|---|---|---|
| 19/2/2024 | Visual Inspection | <ul style="list-style-type: none"> • Reserve stock of stones is available throughout the under-construction J-Head Spur. • Alluwali village is approximately 15 feet above the top level of Spur. • Spur is under construction, with 1400 feet completed. The remaining portion is in the model study phase. <p>Reserve stock of stone lying throughout the shank portion of spur</p> | c |

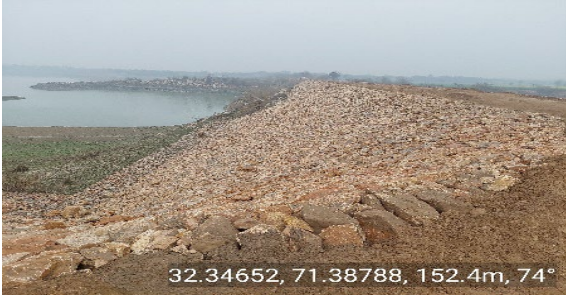
| Observation Record ⁴ (Current status, effect of countermeasure, development of erosion, deformation, deterioration) | | | |
|---|---|---|---|
| 19/2/2024 | Visual Inspection | <ul style="list-style-type: none"> • The construction of Dhingana Guide Head Spur started in 2018. • The 1400 feet shank portion (97 %) has been completed. • The PC-1 of head portion of spur (900 feet) is under approval. • Stone pitching with wire crates was observed at apron of the newly constructed shank portion of spur. <p>32.34652, 71.38788, 152.4m, 74°</p> <p>Stone pitching on side slopes and wire crates for apron</p> | c |

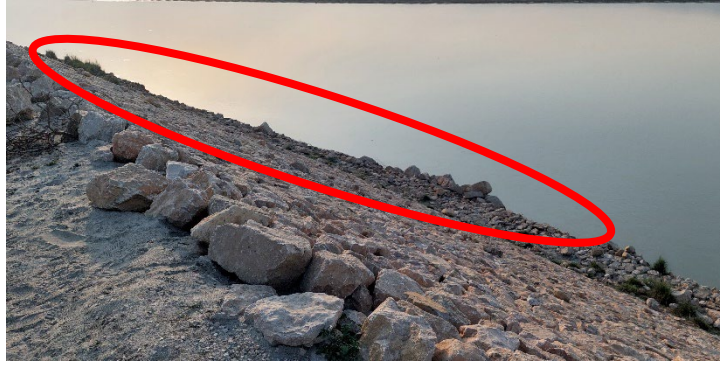
Apron found damaged at the nose of the spur

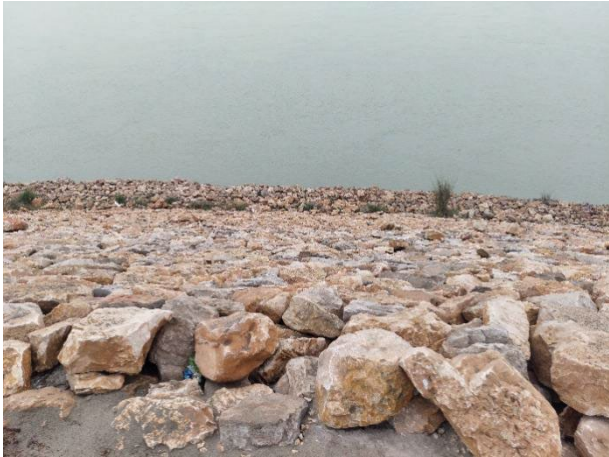
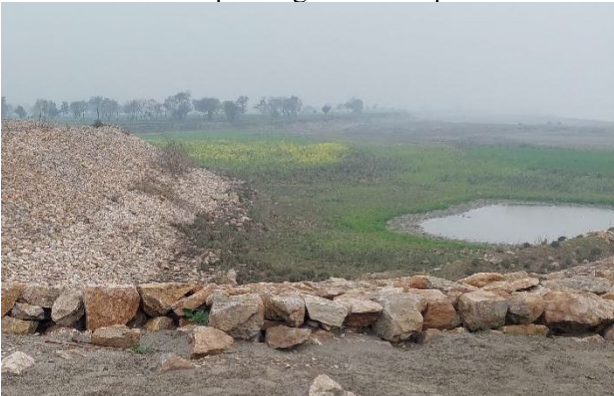
| Observation Record ⁴ (Current status, effect of countermeasure, development of erosion, deformation, deterioration) | | | |
|---|---|--|---|
| 19/2/2024 | Visual Inspection | <ul style="list-style-type: none"> • The construction of Doaba J-Head spur started in 2018. • Stone pitching with wire crates at apron was observed in newly constructed spur portion. • Cultivated area was observed along country side. <p>Stone pitching on side slopes</p> <p>Cultivated area is present on country side</p> | c |
