Appendix-2

Emergency Repairing Work Plan

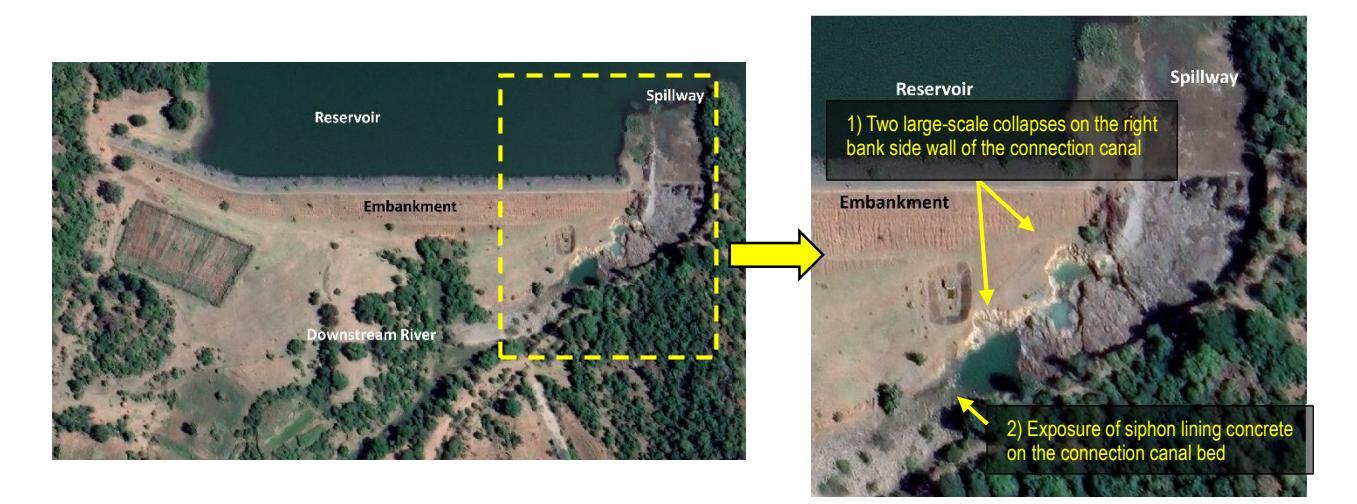
Figure 2.1 Deteriorations/Damages Evaluated as "A"-1

There are two deteriorations/damages which are evaluated as "A", 1) Two large-scale collapses on the right bank side wall of the connection canal, and 2) Exposure of siphon lining concrete on the connection canal bed (see Figure 2.1 and Figure 2.2). In respect to 1), a collapse reaches to the point 6m from the edge of embankment. It would reach to the edge after seven years and affect the stability of embankment. Also, another one reaches to the point 1.5 m from slope protection works for valve house. It would reach to the slope protection works within two years and affect the operation of valve.

While in respect to 2), since rocks are scattered around and upstream of the siphon lining concrete, erosion is likely to occur when rocks are delivered by floods and impact the lining concrete. As the erosion progresses and siphon pipes are damaged, sufficient irrigation water would not be supplied to farmland and the irrigation scheme may be dysfunctional.

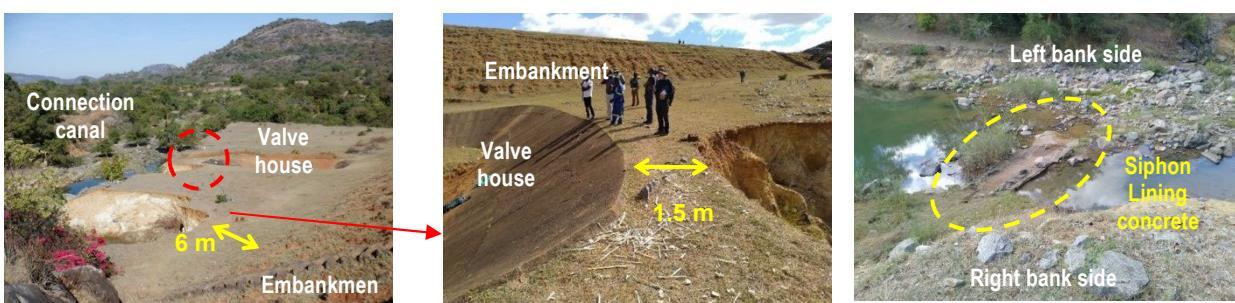
Figure 2.2 Deteriorations/Damages Evaluated as "A"-2

1) Two large-scale collapses on the right bank side wall of the connection canal

2) Exposure of siphon lining concrete on the connection canal bed

Covering the lining concrete by wet masonry (t=0.5) aiming to preventing erosion caused by flood is planned.

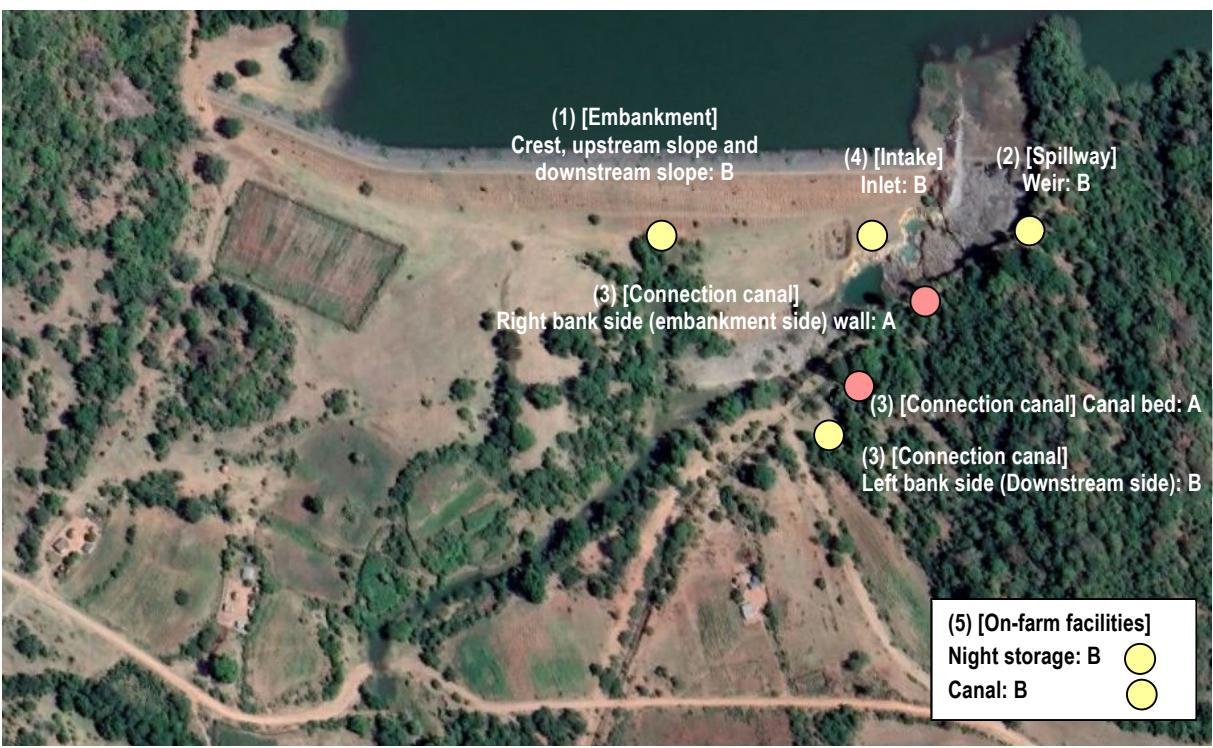
Figure 3.1.1 Locations of Deteriorations/Damages on Magudu Dam

The locations of deteriorations/damages found of Magudu Dam are shown in Figure 3.1.1, and the summary of the evaluation results of each deterioration/damage are shown in Table 3.1.1.

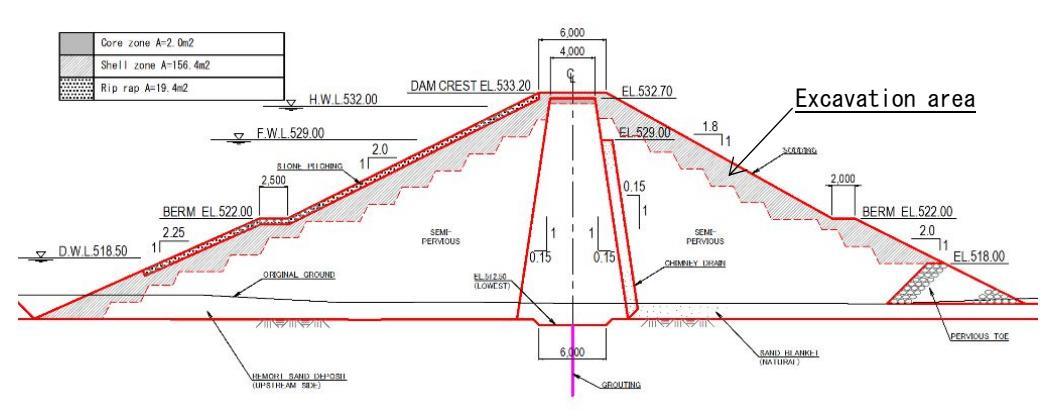
Figure 3.2.4 The Typical Cross-Section of Excavation for Rehabilitation (Magudu dam)

Disturbance of riprap, dam body exposure, erosion, and trees around the embankment is caused by thinning of the surface riprap due to weathering and livestock invasion on the embankment slope. To repair the embankment and to prevent similar problems in the future, the surface layer (including trees) is removed, the embankment replaced with new material, and riprap is placed on both upstream and downstream sides. Since riprap has not been installed downstream of the Magudu dam, new riprap is installed. In addition, Geotextile is placed between the dam body and the riprap to prevent the runoff of

A typical cross-section and plan drawings of the embankment rehabilitation are shown in Figure 3.2.4 and Figure 3.2.6. The surface excavation depth is at least 1m for root removal. To increase the boundary area between the excavated surface and the new material, and to ensure accurate compaction at the boundary, the excavated surface of the existing embankment is shaped like steps (1.5 m high, slope 1:0.5), and the compaction width is to be at least 4 m for workability. In addition, the thickness of the newly installed riprap is 1 m. It should be noted that this rehabilitation causes the boundary of the embankment slope to expand in the upstream and downstream directions.

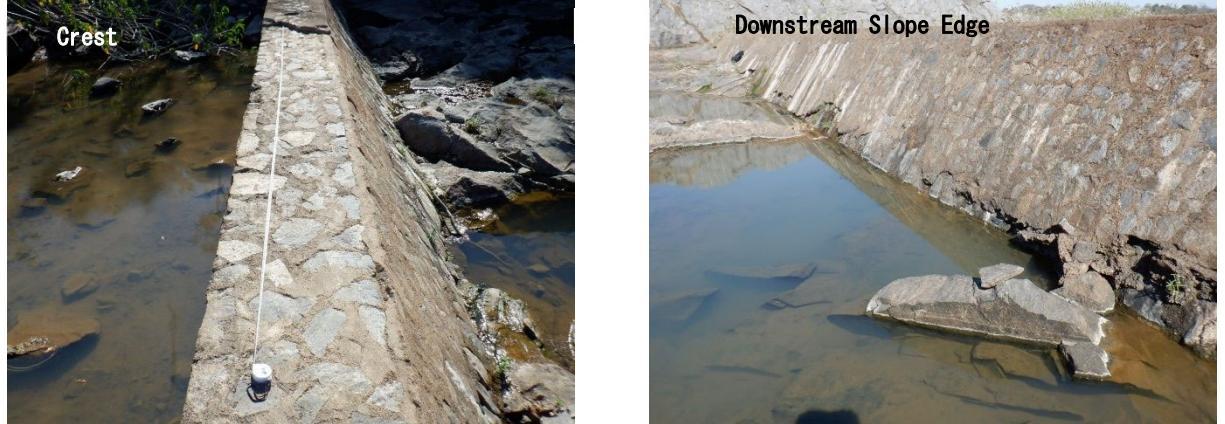
Figure 3.2.7 Surface Concrete Peeling

[Weir] Surface concrete peeling at the crest and the edge of the downstream slope

Since the scale of the damage is small, the Zimbabwean side will deal with the damage through regular maintenance.

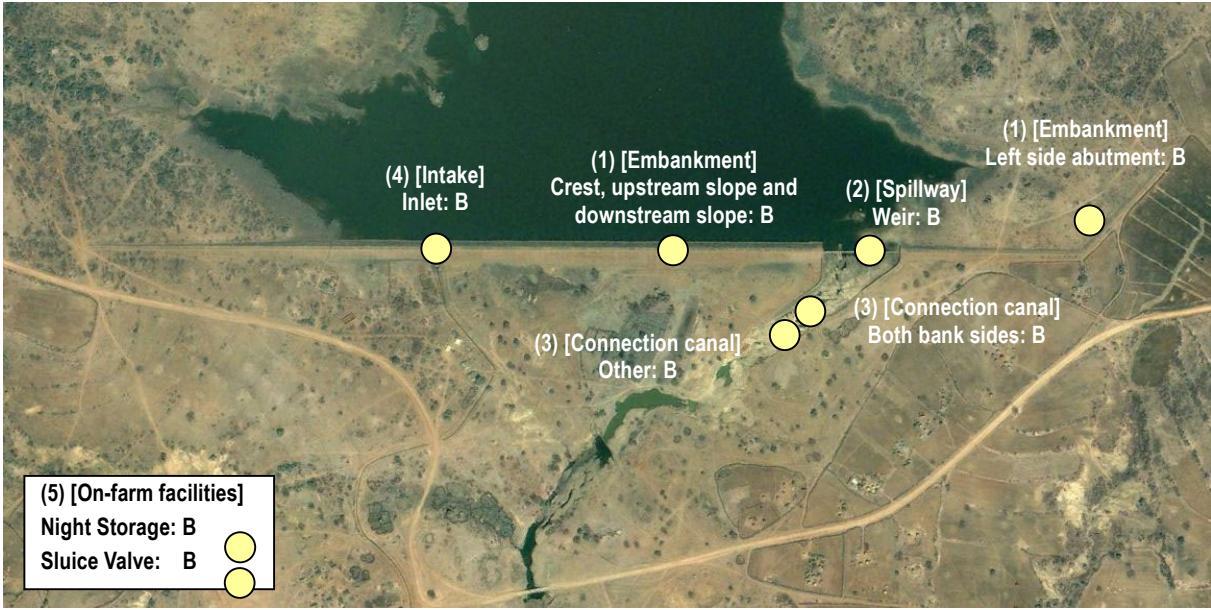
Figure 3.13.1.1 Locations of Deteriorations/Damages on Musaverema Dam

The locations of deteriorations/damages found of Musaverema Dam are shown in Figure 3.1.1, and the summary of the evaluation results of each deterioration/damage are shown in Table 3.1.1.

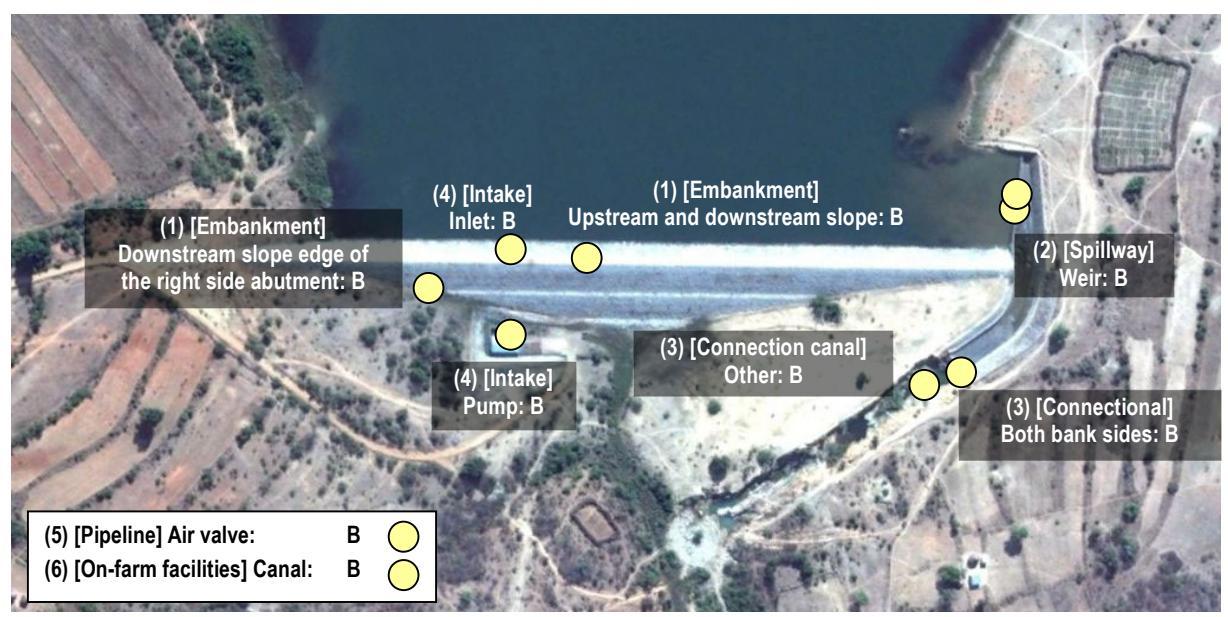
Figure 3.1.1 Locations of Deteriorations/Damages on Chinyamatumwa Dam

The locations of deteriorations/damages found of Chinyamatumwa Dam are shown in Figure 3.1.1, and the summary of the evaluation results of each deterioration/damage are shown in Table 3.1.1.

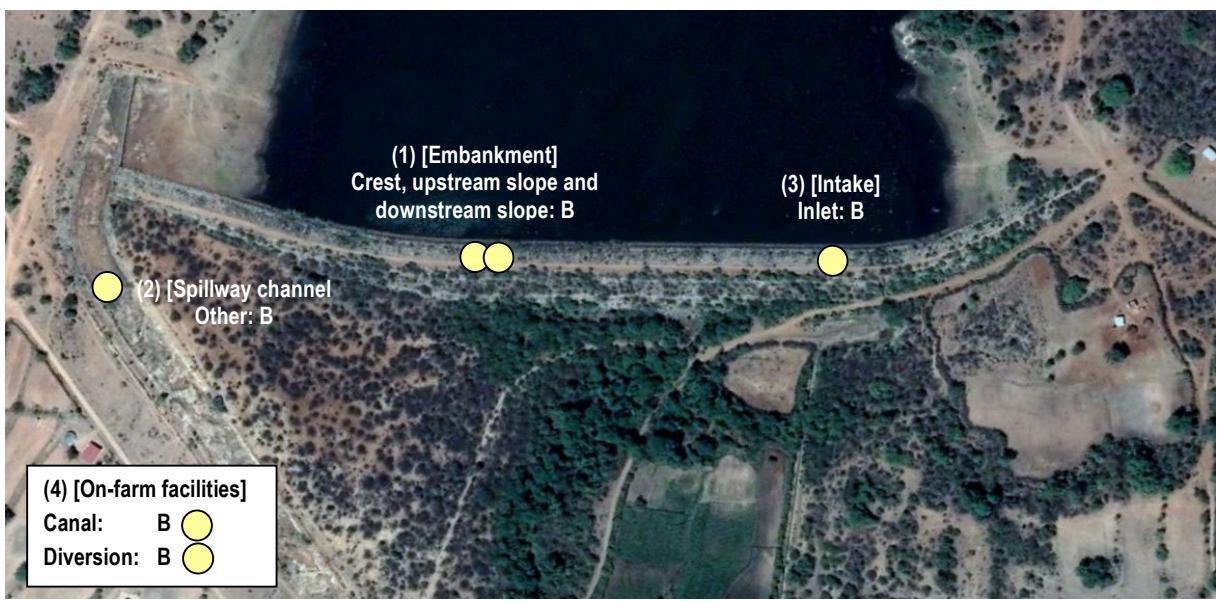
Figure 3.1.1 Locations of Deteriorations/Damages on Mashoko Dam

The locations of deteriorations/damages found of Mashoko Dam are shown in Figure 3.1.1, and the summary of the evaluation results of each deterioration/damage are shown in Table 3.1.1.

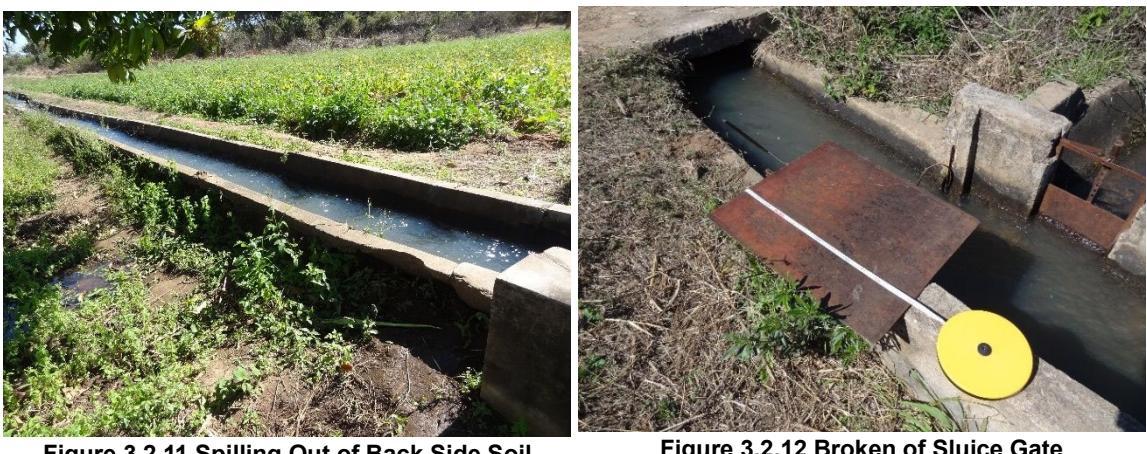
Figure 3.2.11 Spilling Out of Back Side Soil

[Diversion] Broken of sluice gate
