**P A R T : D    Damage due to Rising Groundwater**

#### D. DAMAGE DUE TO RISING GROUNDWATER

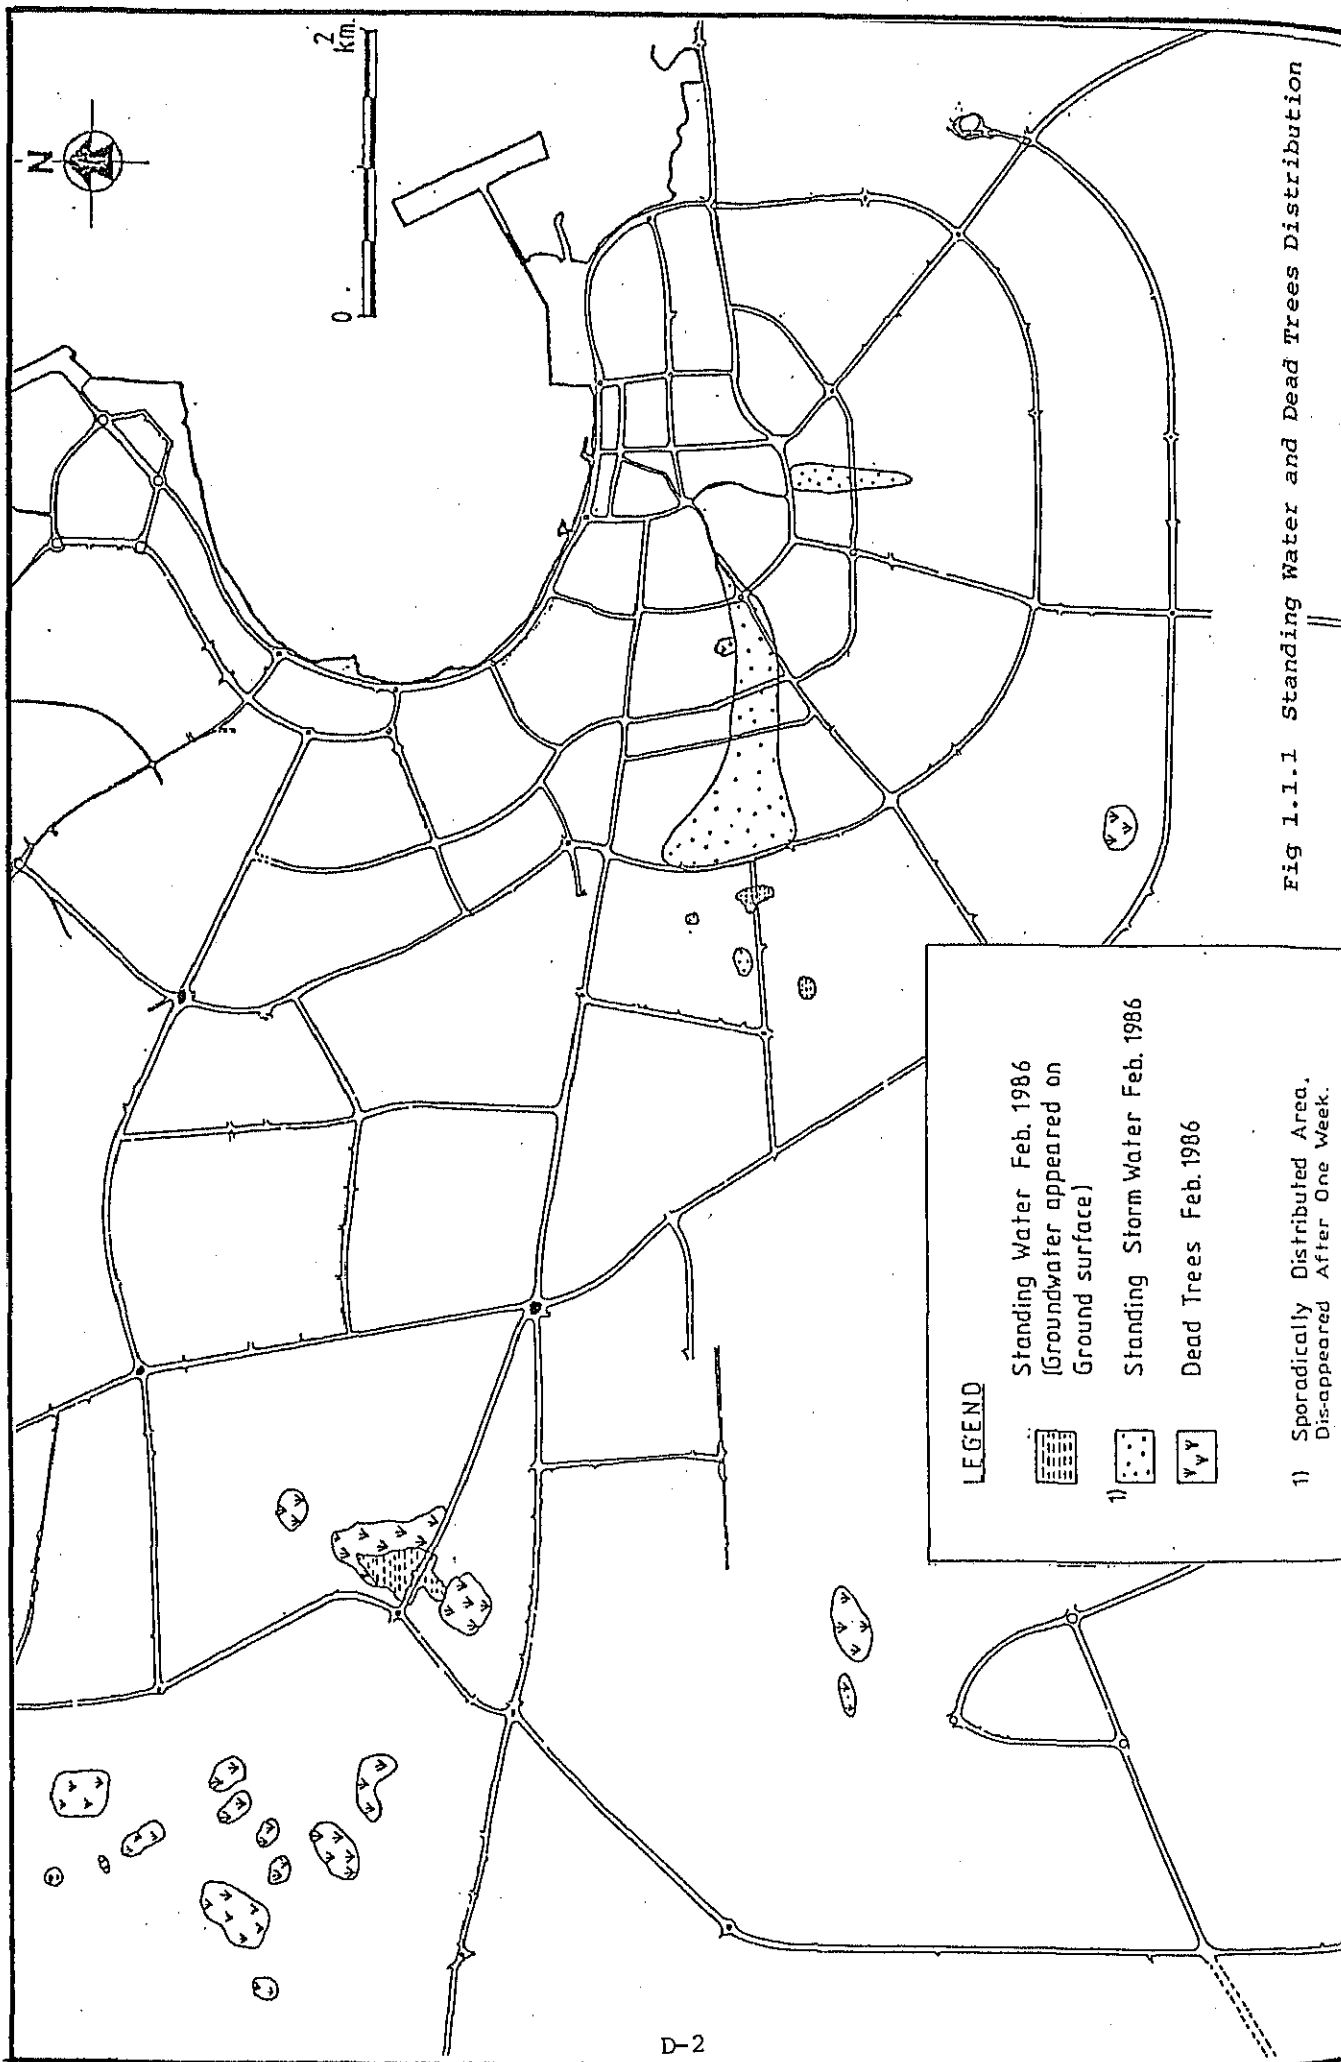
Fig 1.1.1 Standing Water and Dead Trees Distribution

Standing water due to groundwater is found at the following areas:

- Rayyan
- Abu Sadirah just downstream of the Wadi Musherib Dam
- Right bank located 700 to 800 m upstream of the Wadi Musherib Dam
- Abandoned farm near Al Ahli Sports Club
- Abu Hamour

Rayyan is the most affected area. Standing water first appeared in the early months of 1985 but soon decreased due to the strong evaporation during the dry season. The standing water observed in this study is new, reappearing under the weak evaporation conditions of the wet season.

The standing water found in the right bank of Wadi Musherib Dam has high salinity in the order of 130,000 micro mhos/cm. This standing water seems to have recently appeared.

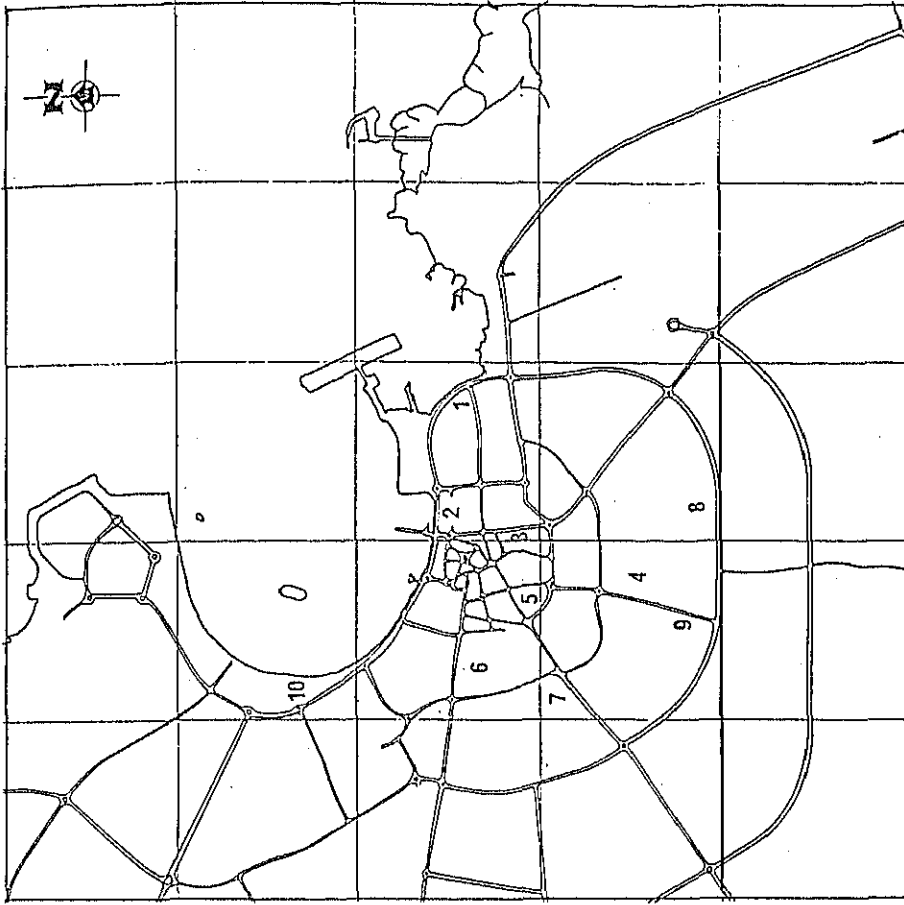
Fig. 1.3.1 Location of Some Structures Effected by Rising Groundwater

SITE	STATUS	DAMAGE
1) Qatar National Museum	Completed	Leaks in aquarium which is underground. Rencol prepared a report for remedy.
2) Ministry of Finance & Petroleum	Completed	Leakage in basement. White, Young & Partners consultants investigated and concluded leakage due to tidal water. Remedial work executed.

3) Al Khaledj Insurance Bldg.	Under Construction	Costly dewatering operations during foundations construction raised foundations costs by about 1.5 times.

4) Abdallah el Attiyah Bldg.	Under Construction	Leakage in basement due to insufficient insulation. At time of construction start groundwater was not at shallow depths. Owner having problems sealing basement and cannot receive completion certificate. 4 consultants have been requested to help in addition to Doha Municipality.

5) Exchange Chamber, QNTS	Completed	Groundwater leakage at points of entry of cables into chamber. Despite many efforts to seal. 3 years ago chamber was filled with water causing service disruptions. Sump pit and pump installed recently.

6) Abdallah Sherif Bldg.	Completed 9 - 10 years	Leakage is occurring in basement from two opposite walls. Behind one wall is a sewerage cess pit, and there is a garden behind the other. Residents complain water sometimes reaches 15 cm above basement floor.

7) Ahmed Bin Mobd. Al Thani Bldg.	Constructed 6 - 7 years ago	Leakage of basement. In mid 1985 extra thickness of concrete was poured on basement floor to a ht. of 8 50 cms, and since then no leakage has been reported. Groundfloor occupied by shops and car showrooms. Completion certificate withheld by Doha Munic. because of exceeding ht. limits and leakage problems.

8) Commercial Offices Bldg.	Under Construction, finishing stage. Construction started 3 years ago	Leakage appeared during winter 1985 at lift pits, and was repaired by sand & cement spray under pressure over wire mesh. In Feb. 1986, after some heavy rain leakage appeared in basement floor construction joints. Water samples were taken from pit dug beside the basement wall where water level was at a depth of 1.4 m.

9) Montazah Park Swimming Pool Pump Room	Constructed about 19 years ago. Room all underground. Dims. 10x10 m	Leakage at wall which is opposite common wall between swimming pool and pump room. No insulation applied at time of construction. Room floor damp and salt contamination appearing on walls. Consultants have been called in but no remedial decision has been reached.

10) National Theater	Completed	Leaks in basement. White, Young & Partners consultants investigated and remedial work executed. Leakage due to tidal water, consultants believe. It is also believed that irrigation water is also to blame.

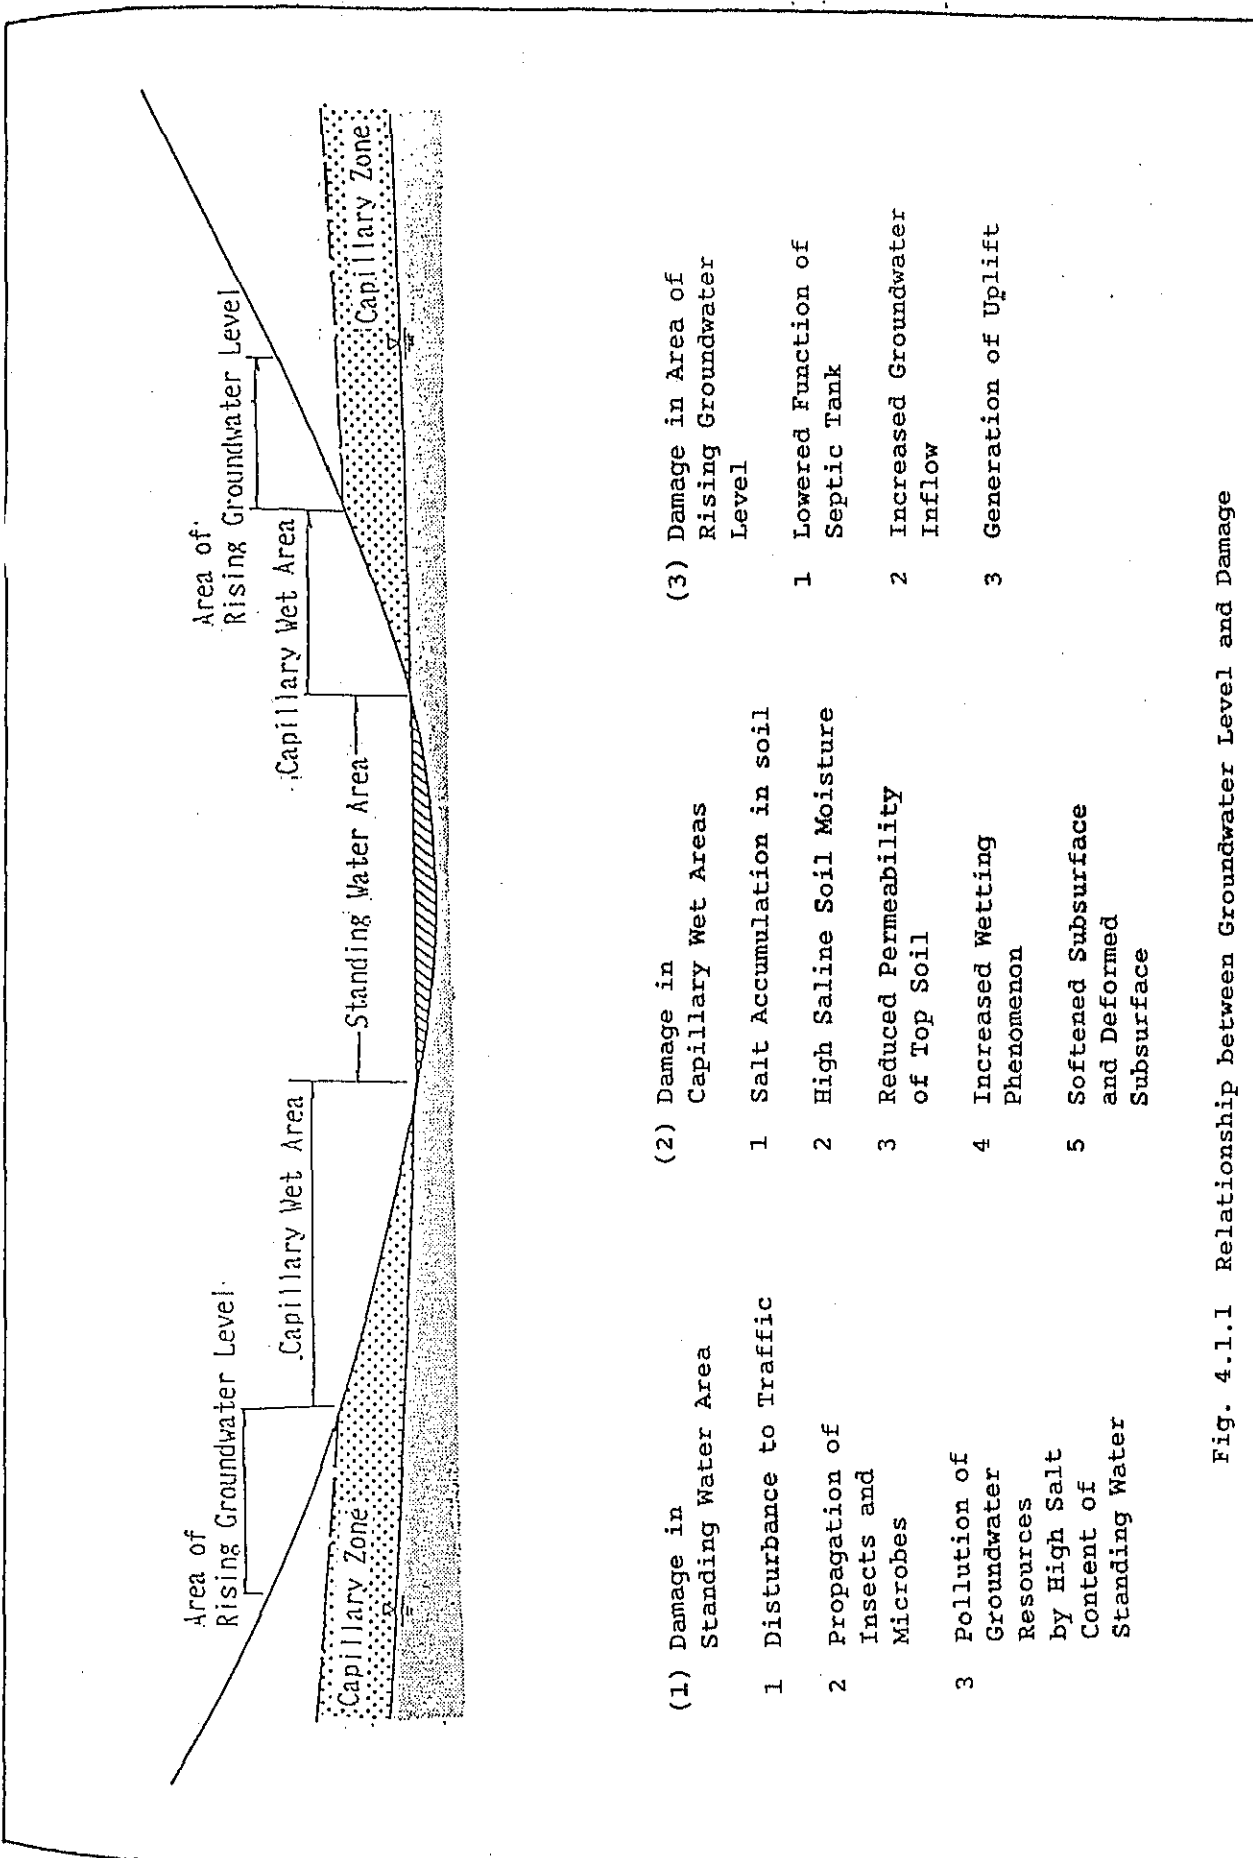
Fig. 4.1.1 Relationship between Groundwater Level and Damage

- (1) Damage in Standing Water Area
- 1 Disturbance to Traffic
  - 2 Propagation of Insects and Microbes
  - 3 Pollution of Groundwater Resources by High Salt Content of Standing Water
- (2) Damage in Capillary Wet Areas
- 1 Salt Accumulation in soil
  - 2 High Saline Soil Moisture
  - 3 Reduced Permeability of Top Soil
  - 4 Increased Wetting Phenomenon
  - 5 Softened Subsurface and Deformed Subsurface
- (3) Damage in Area of Rising Groundwater Level
- 1 Lowered Function of Septic Tank
  - 2 Increased Groundwater Inflow
  - 3 Generation of Uplift
