### **3. INUNDATION AND FLOOD DAMAGE**

SUPPORTING REPORT  
ON  
INUNDATION AND FLOOD DAMAGE

STORM DRAINAGE SYSTEM IMPROVEMENT PROJECT  
 IN ASUNCION CITY, PARAGUAY  
 JAPAN INTERNATIONAL COOPERATION AGENCY

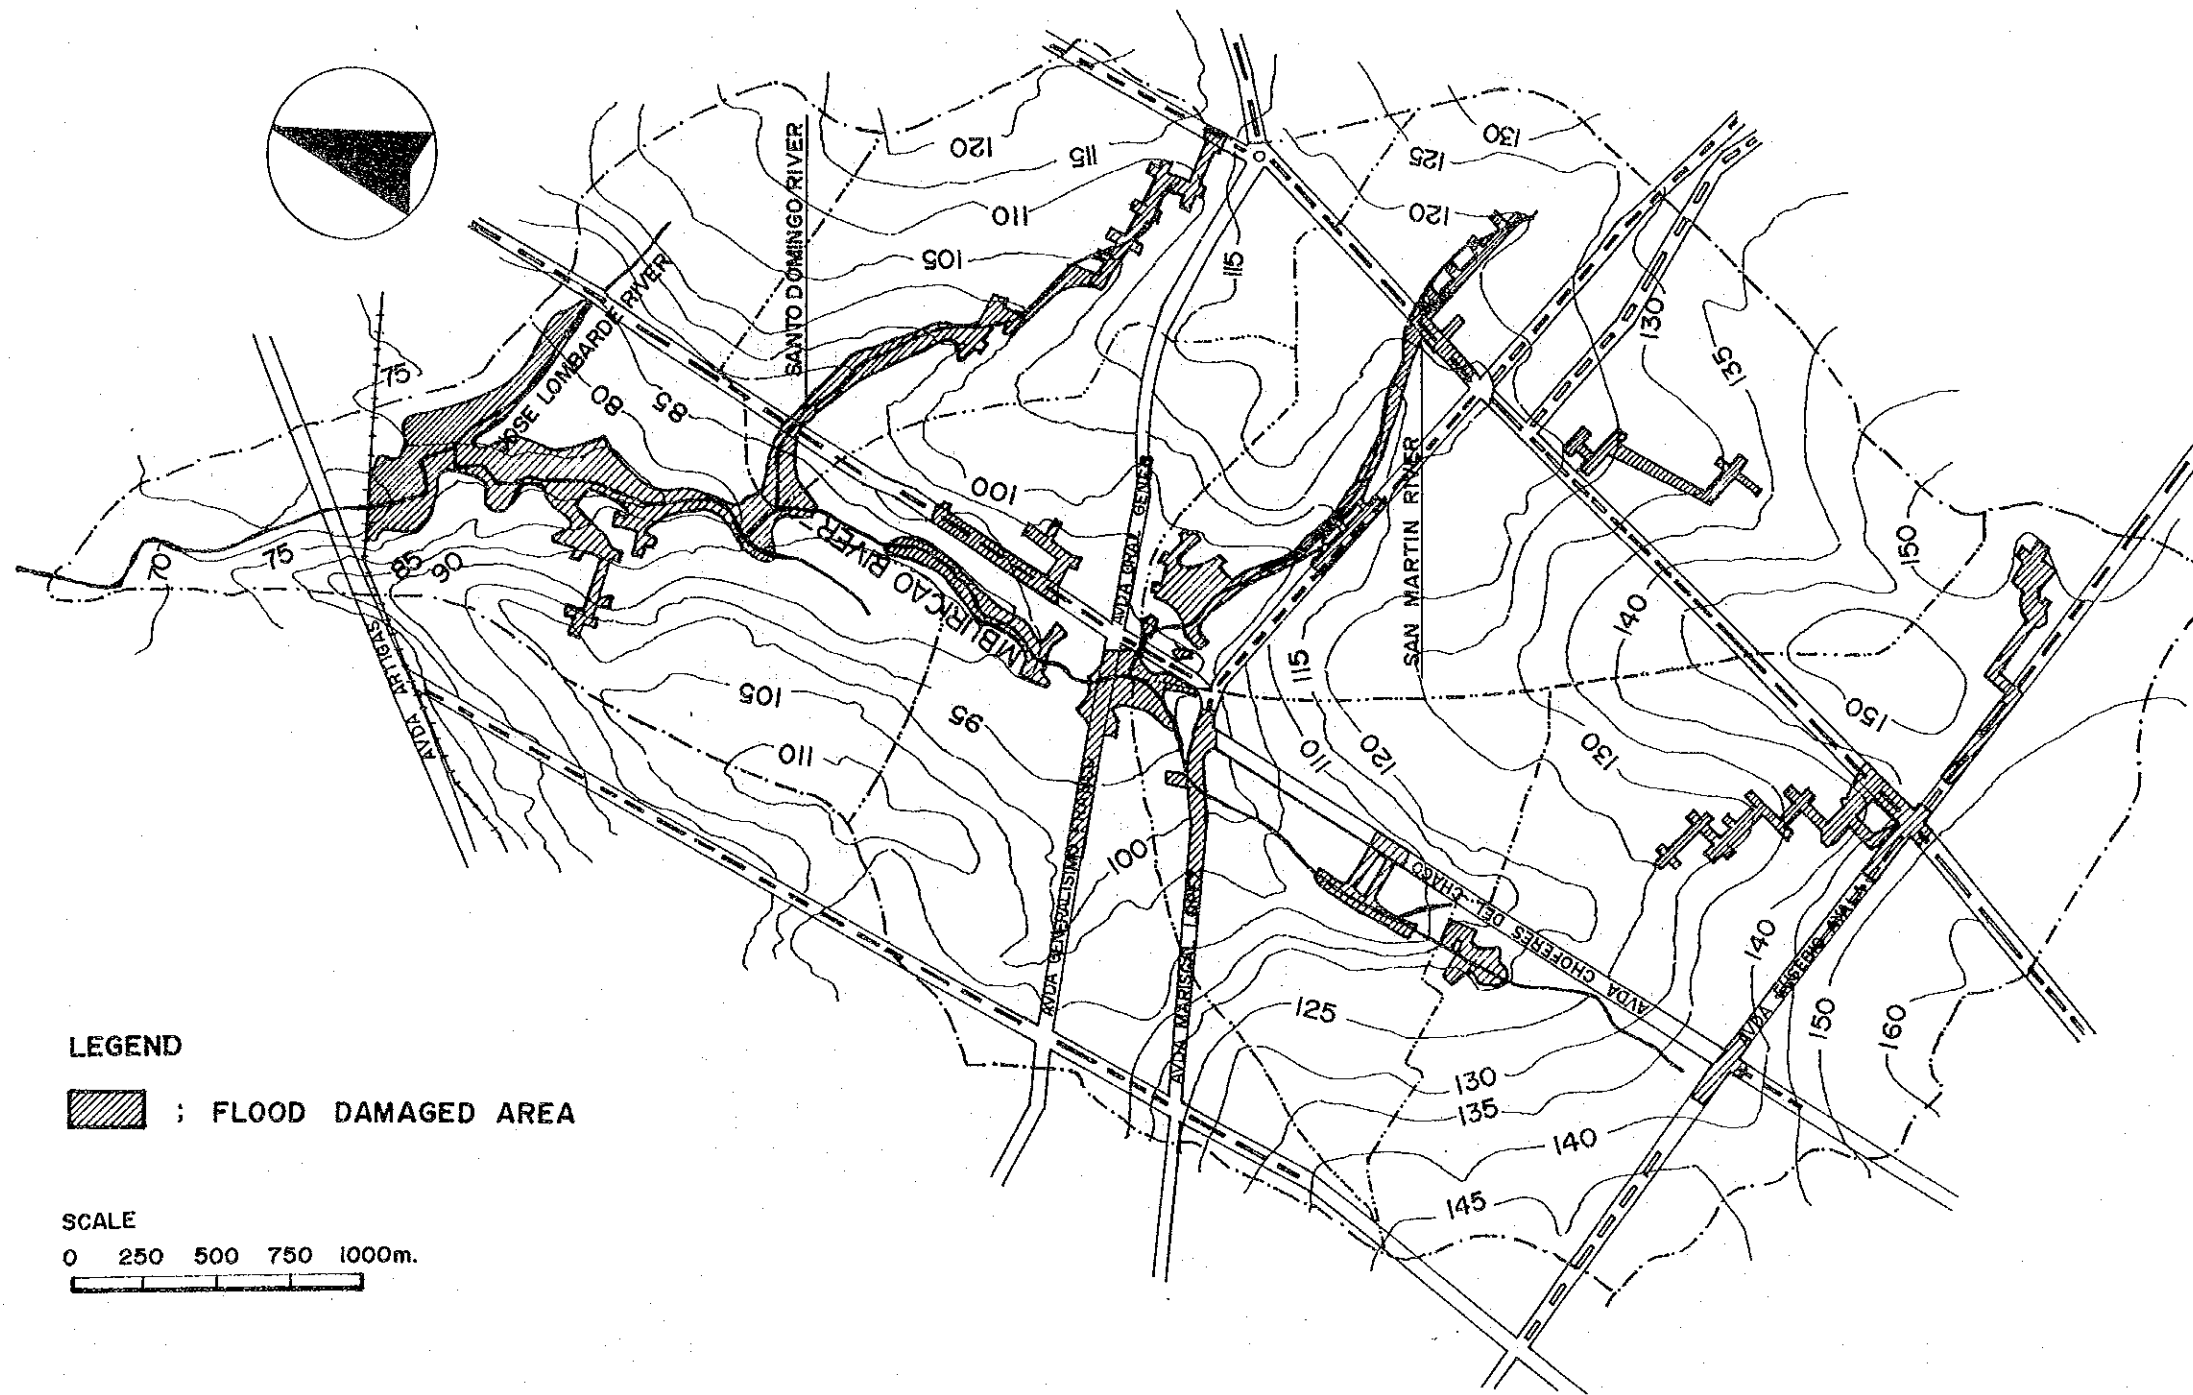
Fig. 3-2 (1/2) TOPOGRAPHIC FEATURES AND FLOODED AREA (MBURICAO RIVER BASIN)

Fig. 3-2 shows the topographic features in detail and the flood damaged areas of Mburicao and Itay river basins as examples.

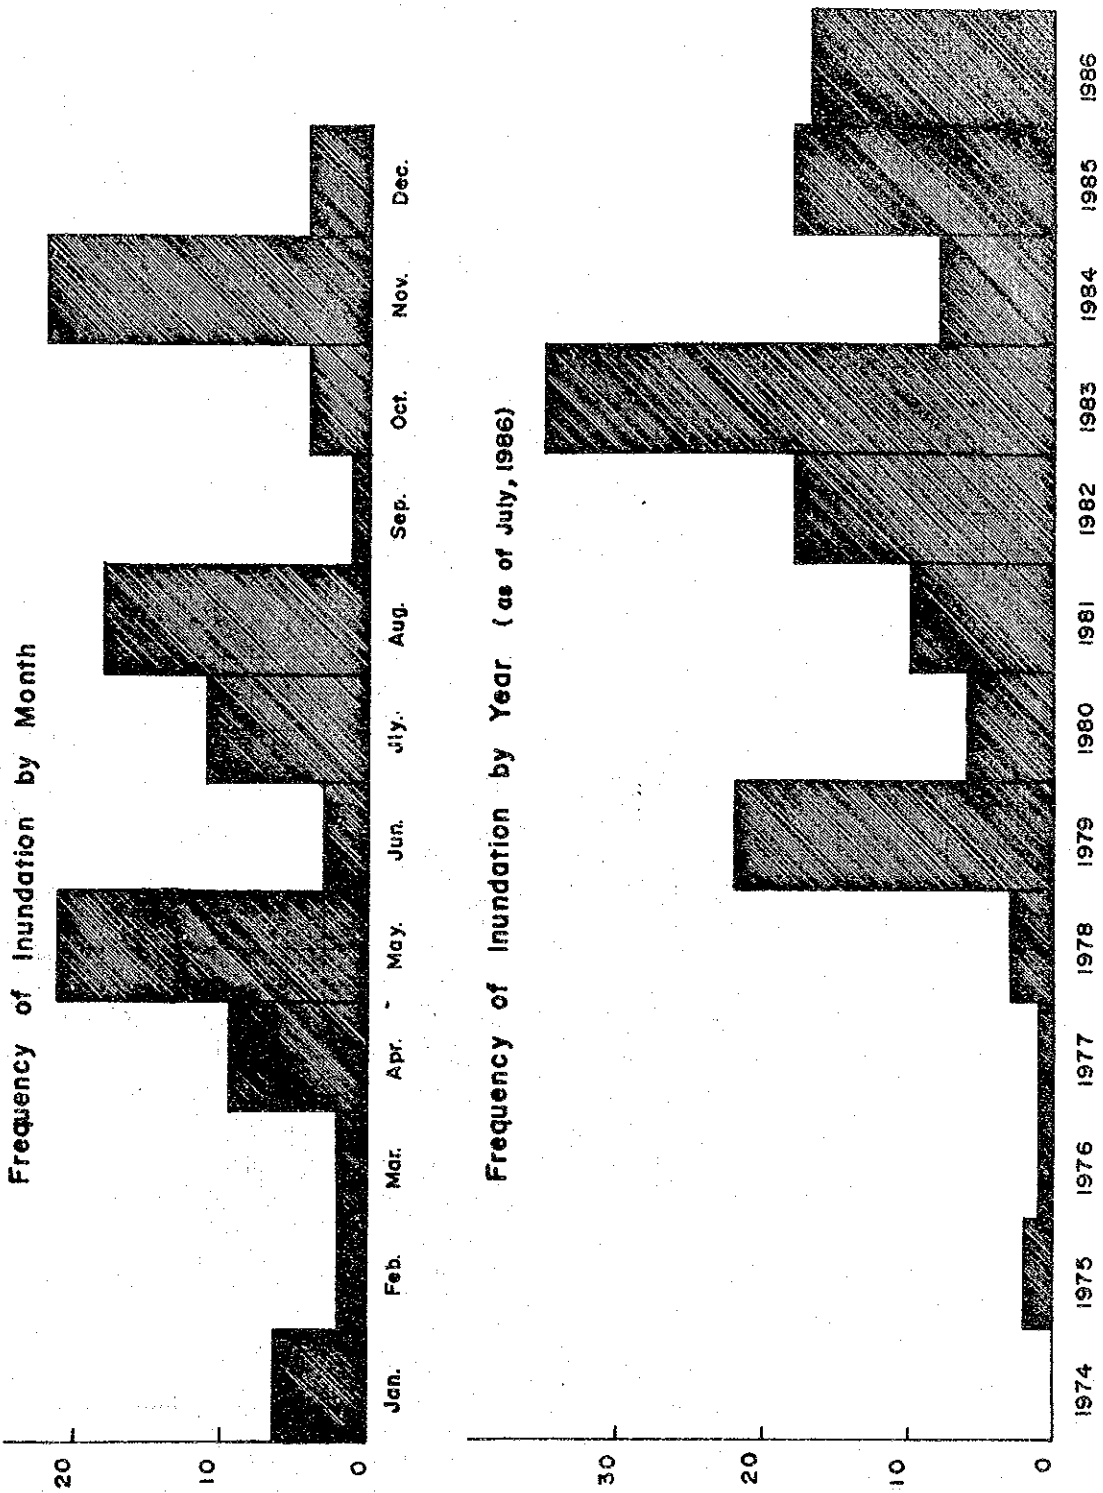
Fig. 3-3 FLOOD INFORMATION ON RECORD

Inundation and flood damage have taken place several times a year at portions such as along the river courses, at the crossing point of rivers and roads, at confluences of rivers, and at the intersections of roads. Based on Fig. 3-3 which shows the frequency of floods by month and year obtained from the data on record, it was generally understood that the frequency of flood is gradually increasing with the urban development. The highest frequency of flood a year was observed in 1983.

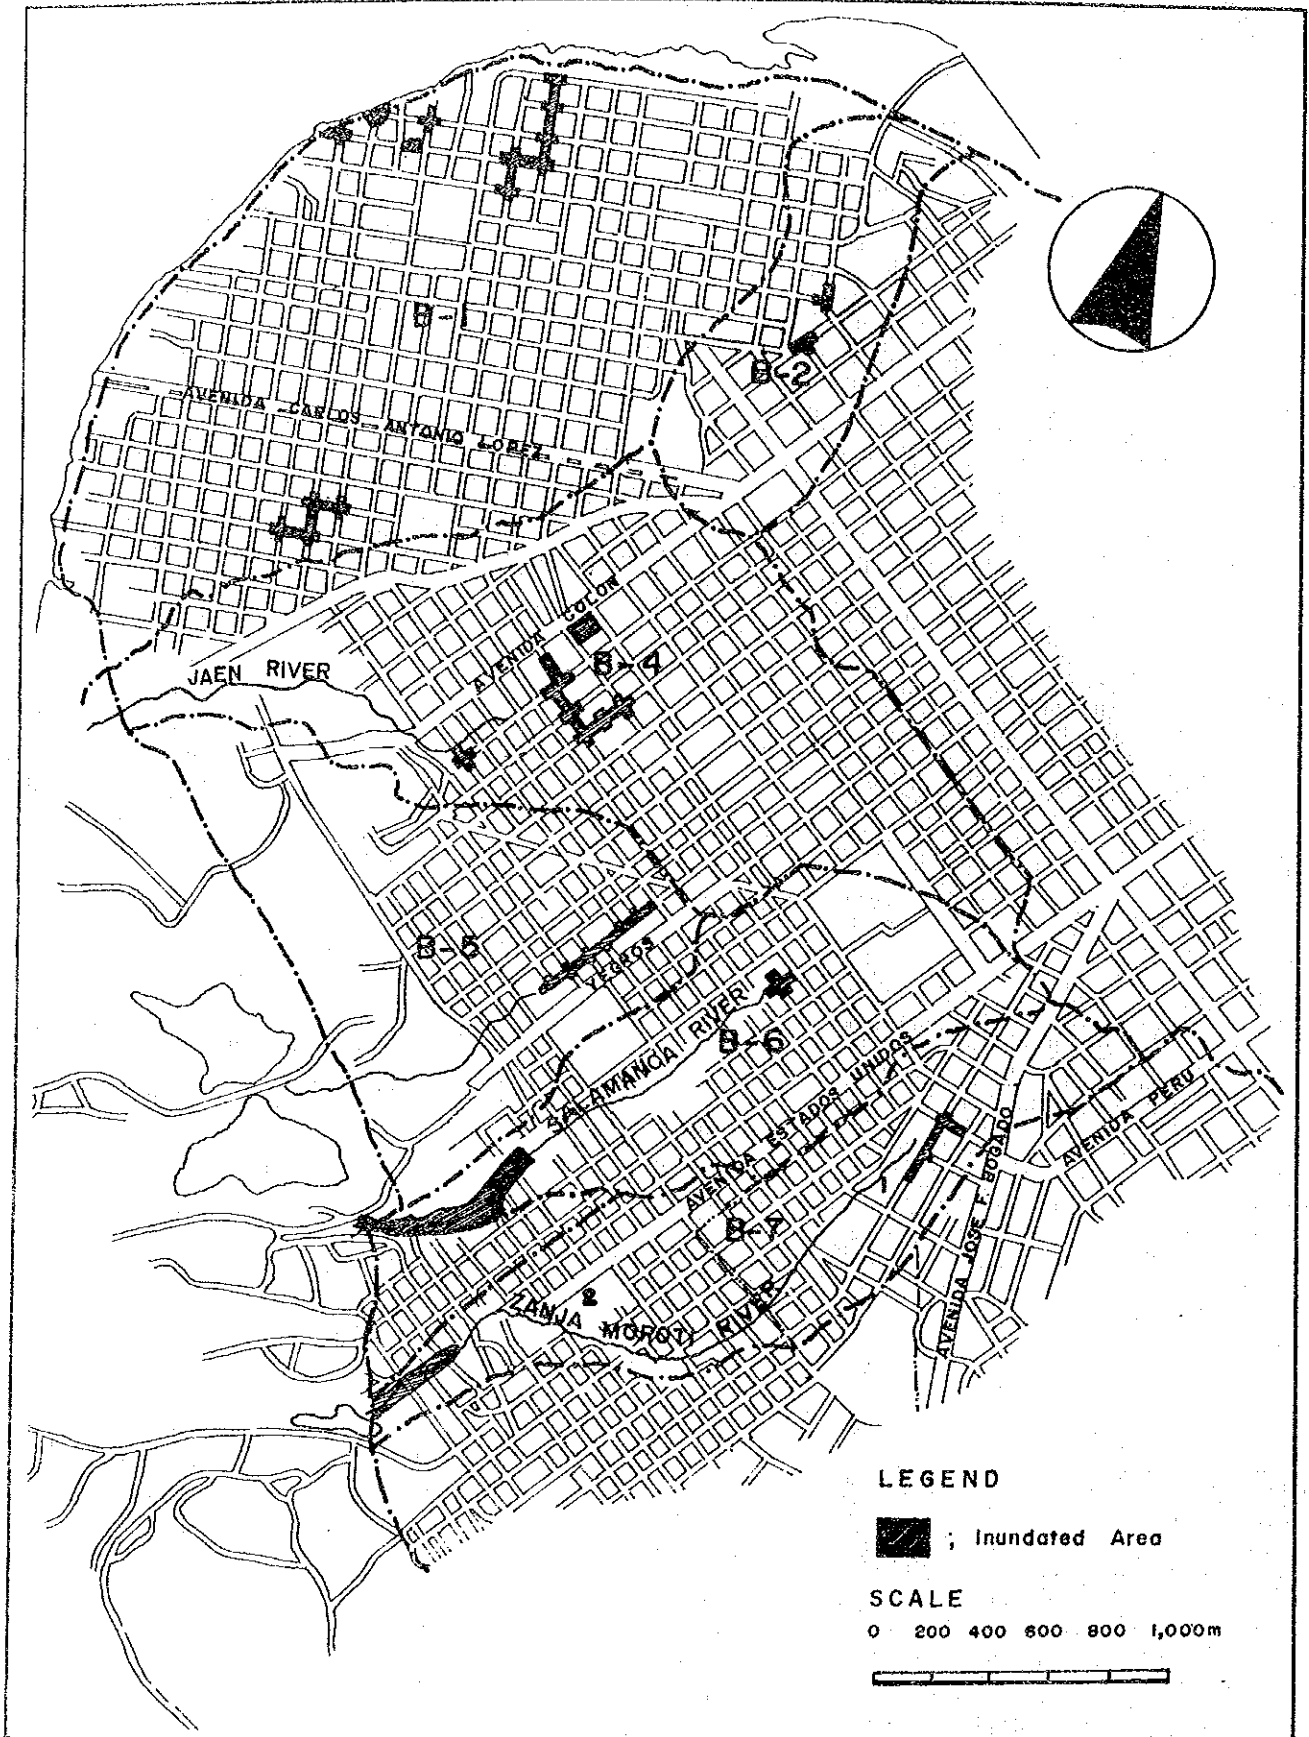
Fig. 3-4 (1/6) FLOODED AREA IN DIVIDED BASIN

Fig. 3-4(1/6) and Table 3-1 show the flooded area and flood damage at the time of the recorded maximum flood. There were thirteen (13) inundated street intersections and eight (8) inundated houses.

Fig. 3-4(1/6) and Table 3-1 show the flooded areas and flood damage at the time of the recorded maximum flood. There were three (3) inundated houses.

Fig. 3-4(1/6) and Table 3-1 show the flooded area and flood damage at the time of the recorded maximum flood. There were eight (8) inundated street intersections and eight (8) inundated houses.

Fig. 3-4(1/6) and Table 3-1 show the flooded area and flood damage at the time of the recorded maximum flood. There were seven (7) inundated street intersections.

Fig. 3-4(1/6) and Table 3-1 show the flooded area and flood damage at the time of the recorded maximum flood. There were one (1) inundated street intersection and thirty-one (31) inundated houses.

Fig. 3-4(1/6) and Table 3-1 show the flooded area and flood damage at the time of the recorded maximum flood. There were five (5) inundated street intersections and eleven (11) inundated houses.

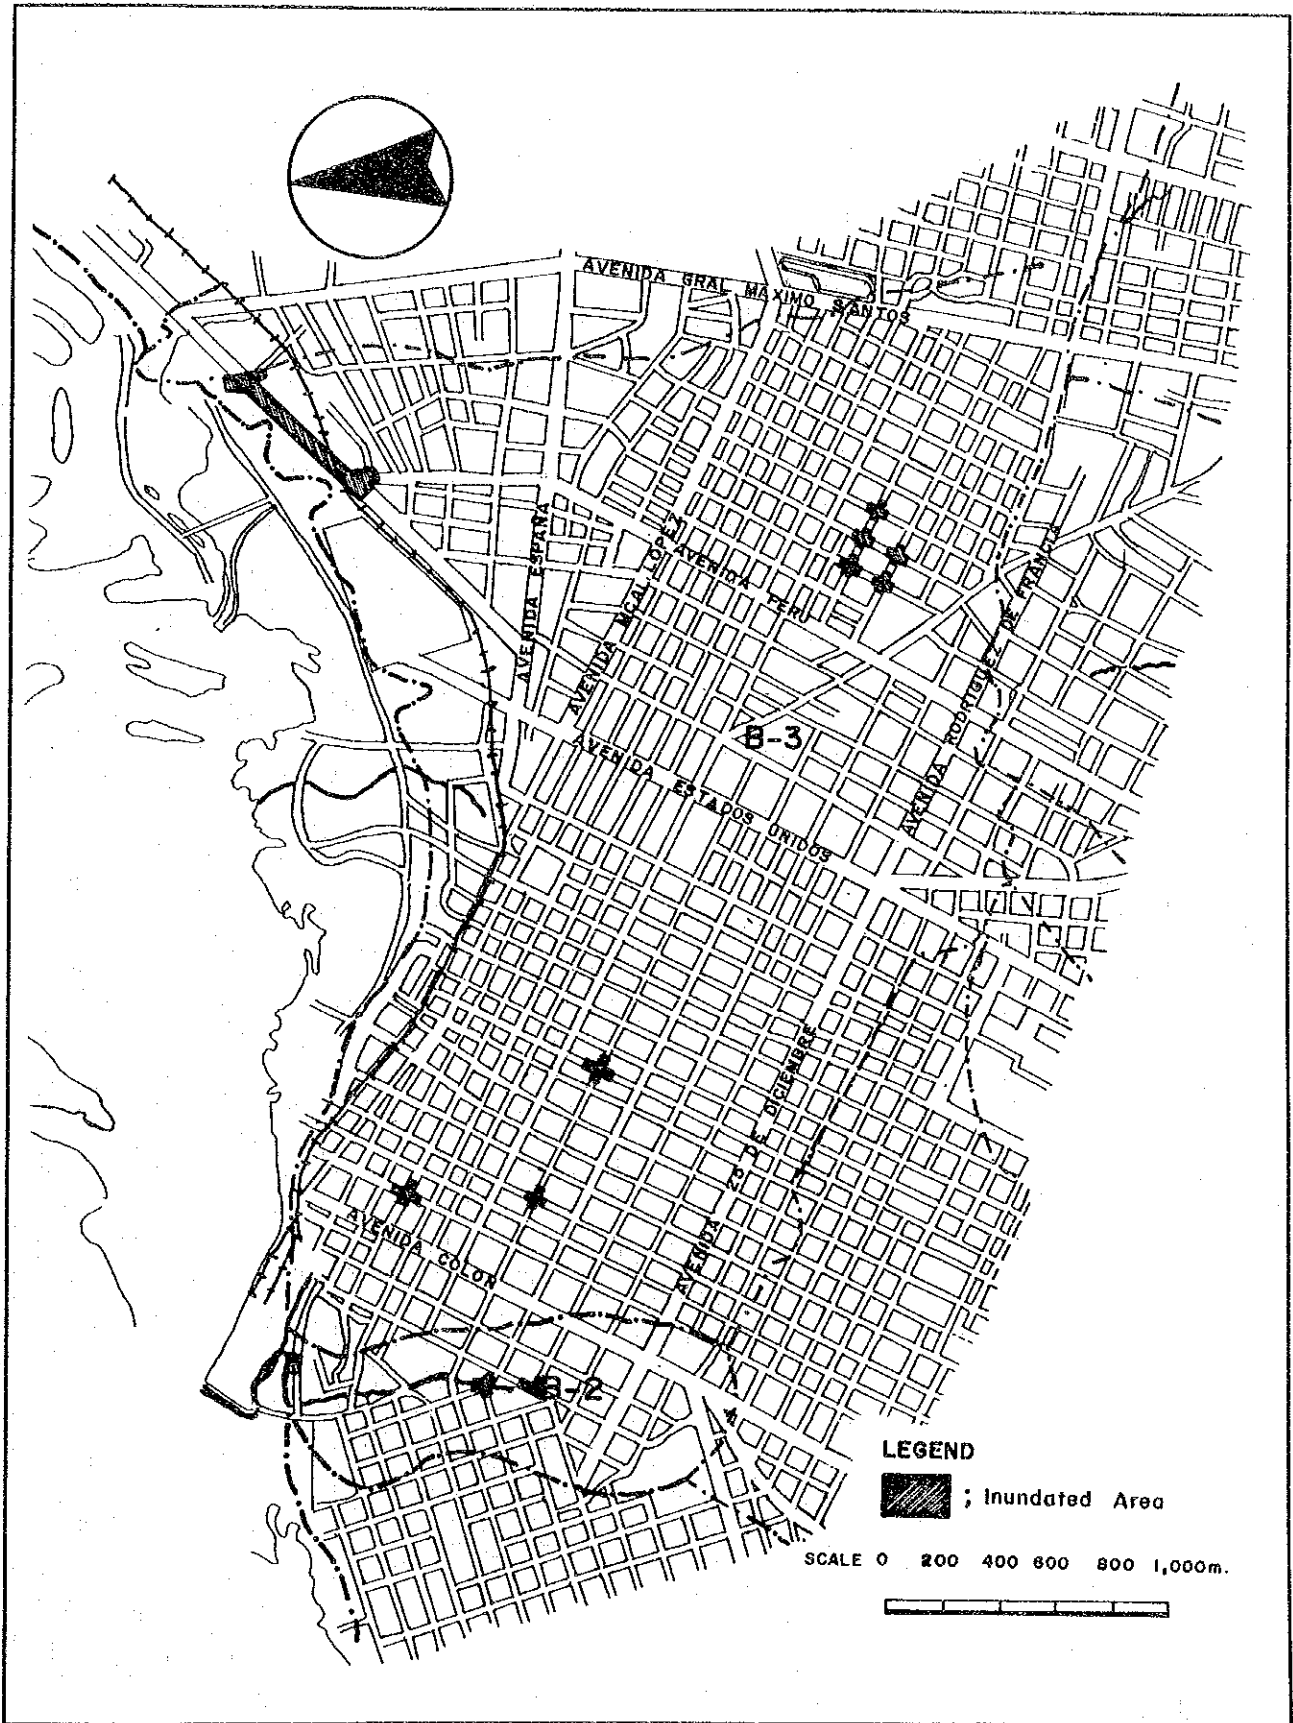
Fig. 3-4 (2/6) FLOODED AREA IN DIVIDED BASIN

There is no conspicuous flood damage in the area where the water drainage system financed under the Inter-American Development Bank (IDB) loan has been completed in 1983. On the streets not covered by the system and at the portions where maintenance of the system is not adequate, floods still occur frequently.

Fig. 3-4(2/6) and Table 3-1 show the flooded area and flood damage at the time of the biggest flood after the completion

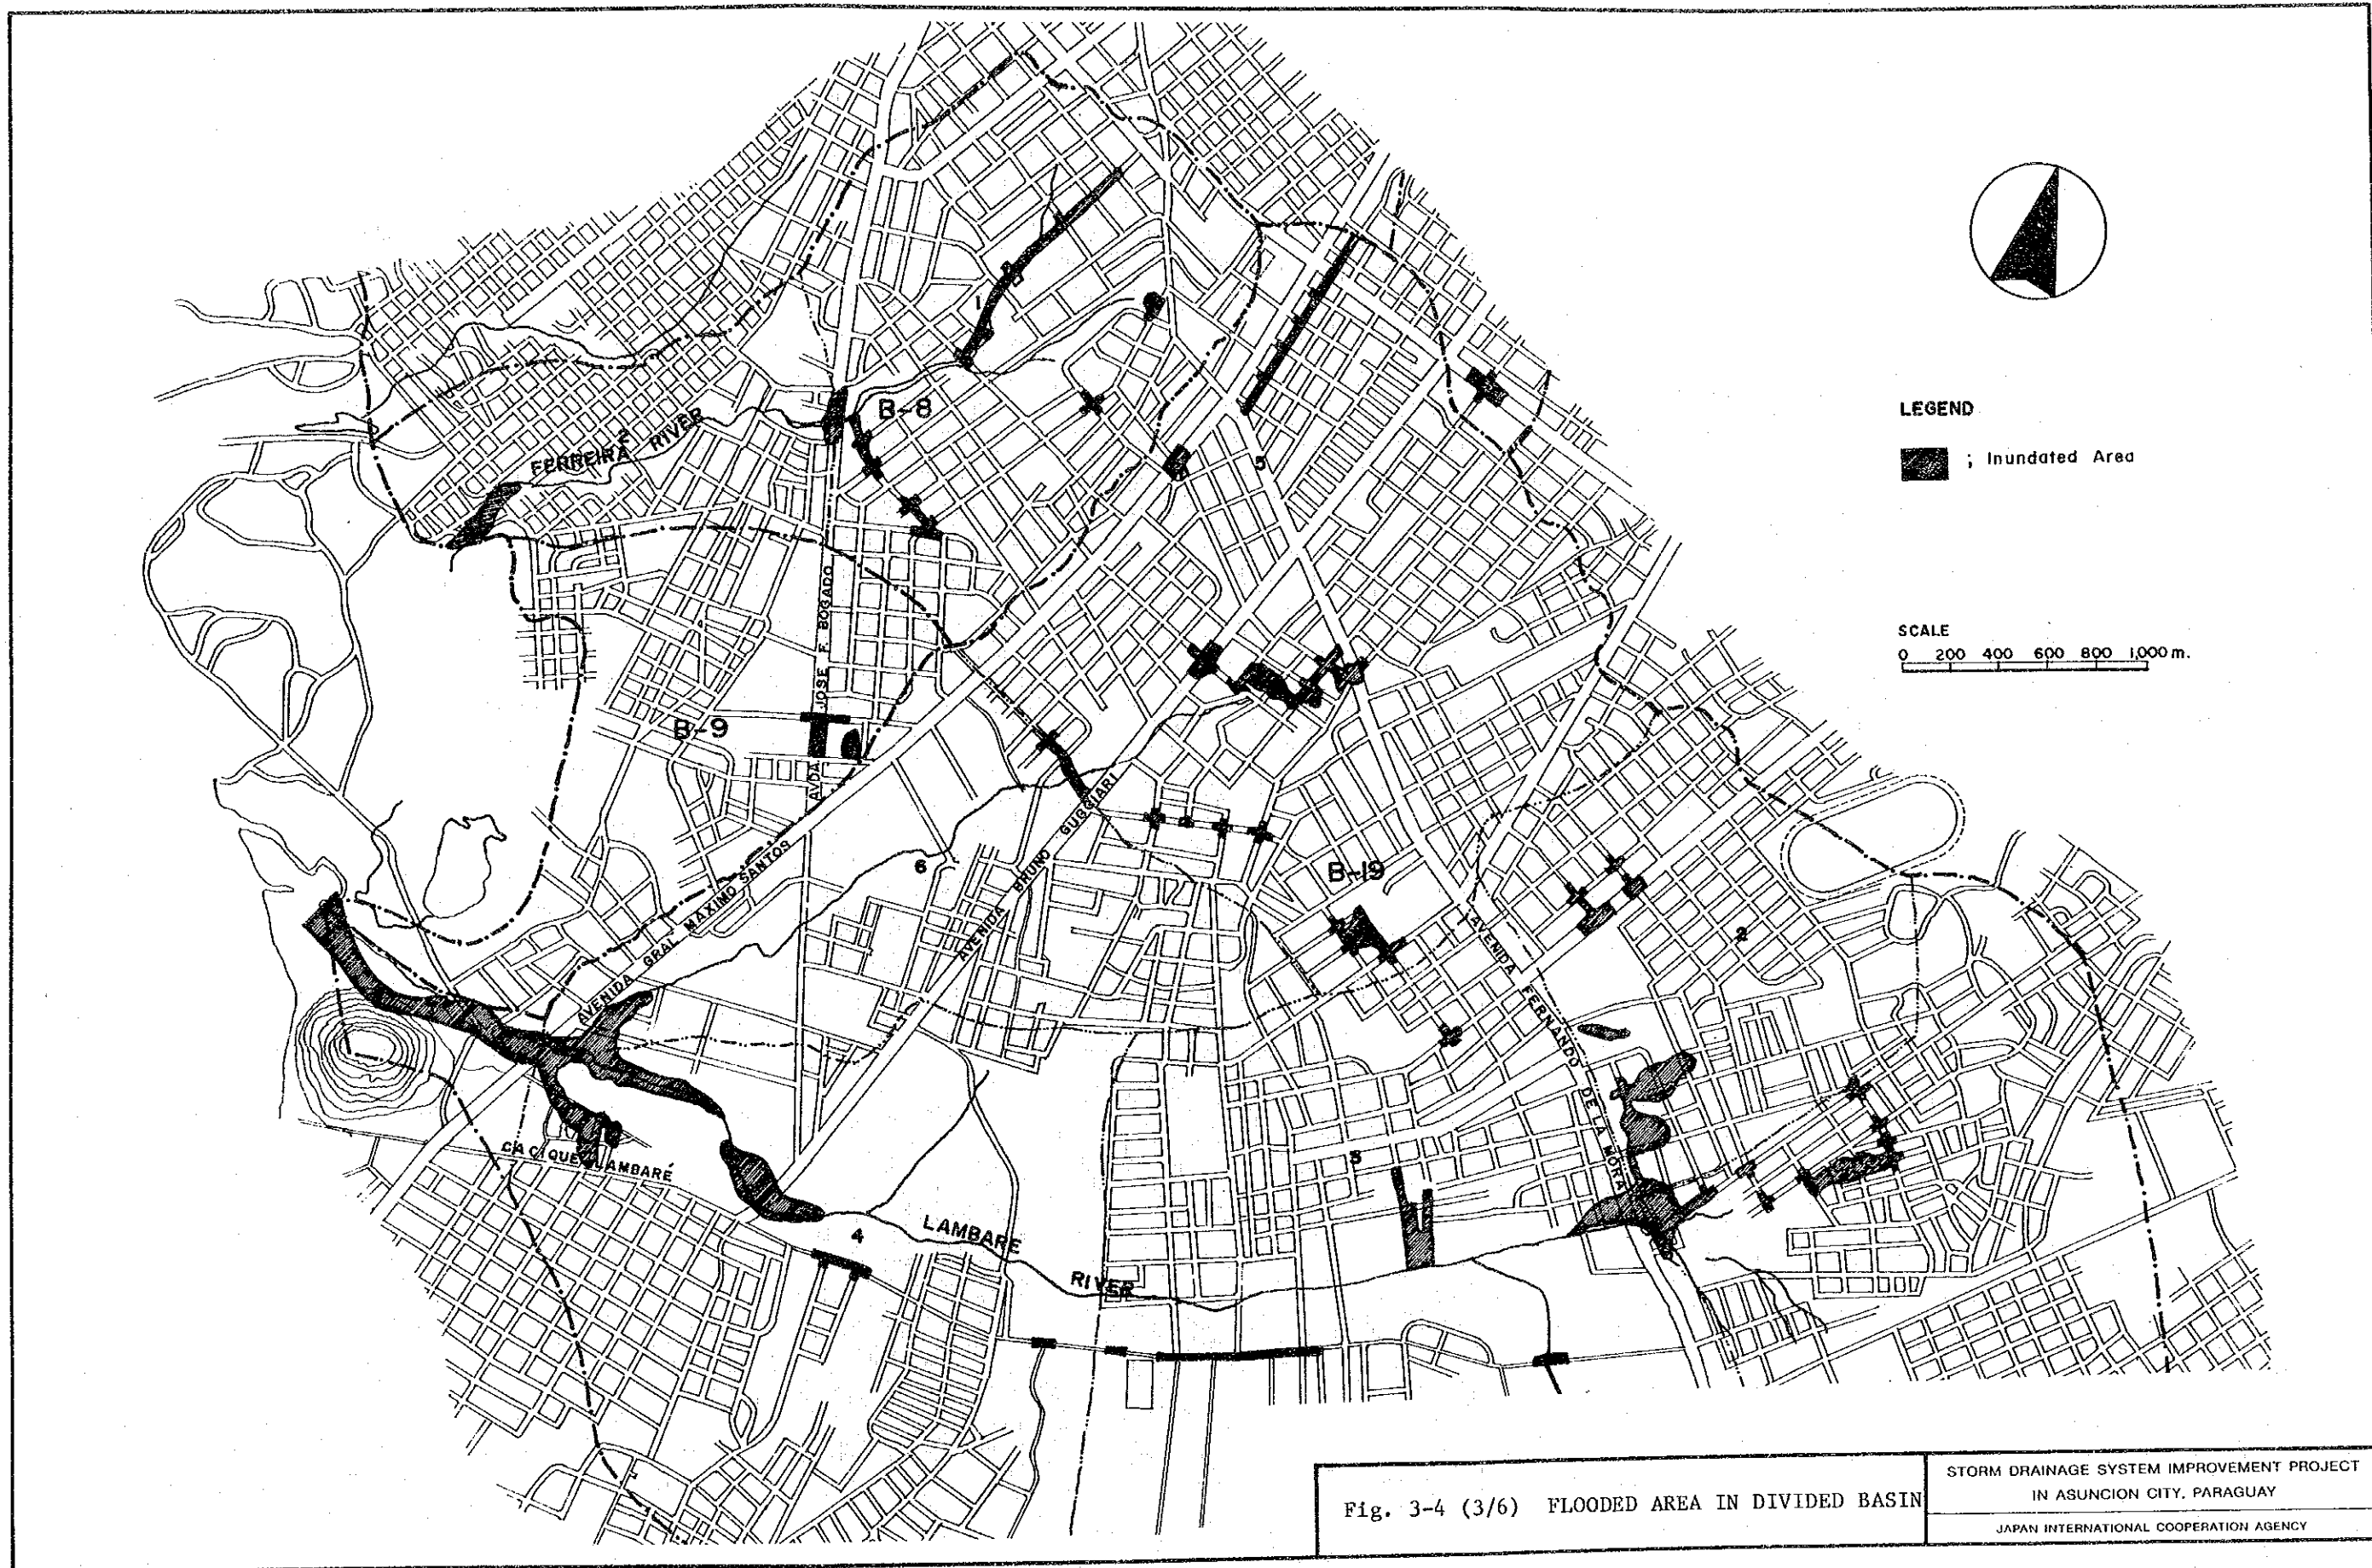
Fig. 3-4 (3/6) FLOODED AREA IN DIVIDED BASIN

Together with the inundation damage from the river in the downstream, floods along the Pozo Favorito Street and the crossing point of Jose Felix Bogado Avenue and Ferreira River are giving serious damage to traffic. Especially, the traffic interruption occurring two or three times a year along Jose Felix Bogado Avenue causes much adverse influence on the economic activities since this avenue is one of the trunk roads connecting the center of Asuncion City with Lambare City.

Fig. 3-4(3/6) and Table 3-1 show the flooded area and flood damage at the time of the recorded maximum flood. There were one (1) inundated trunk road, seventeen (17) inundated street intersections, and eight (8) inundated houses.

Floods of short duration occur on and near the Jose Felix Bogado Avenue but the frequency of occurrence is low, and flood in other areas of this basin cannot be found. Flood damage in this area can be described as relatively minor among the basins.

Fig. 3-4(3/6) and Table 3-1 show the flood area and flood damage at the time of the recorded maximum flood.

As shown in Fig. 3-4(3/6), the pattern of flood in this basin is similar to that in the Mburicao River Basin, i.e., the inundation damage on houses occurs at the confluence of the rivers, and the floodwaters on the roads at several points in all its subbasins flow towards the uppermost reach of the river.

One of the most seriously damaged areas are at the crossing point of the Lambare River and the Fernando de la Mora Avenue, and at the uppermost reaches of Sosa River, a tributary of Lambare River. At the uppermost reach of the Lambare River, flood frequency exceeds five (5) times a year. As shown in Table 3-1 which indicates the flood damage at the time of the recorded maximum flood, the number of inundated trunk roads, street intersections and houses were six (6), sixty-nine (69) and two hundred eleven (211), respectively.

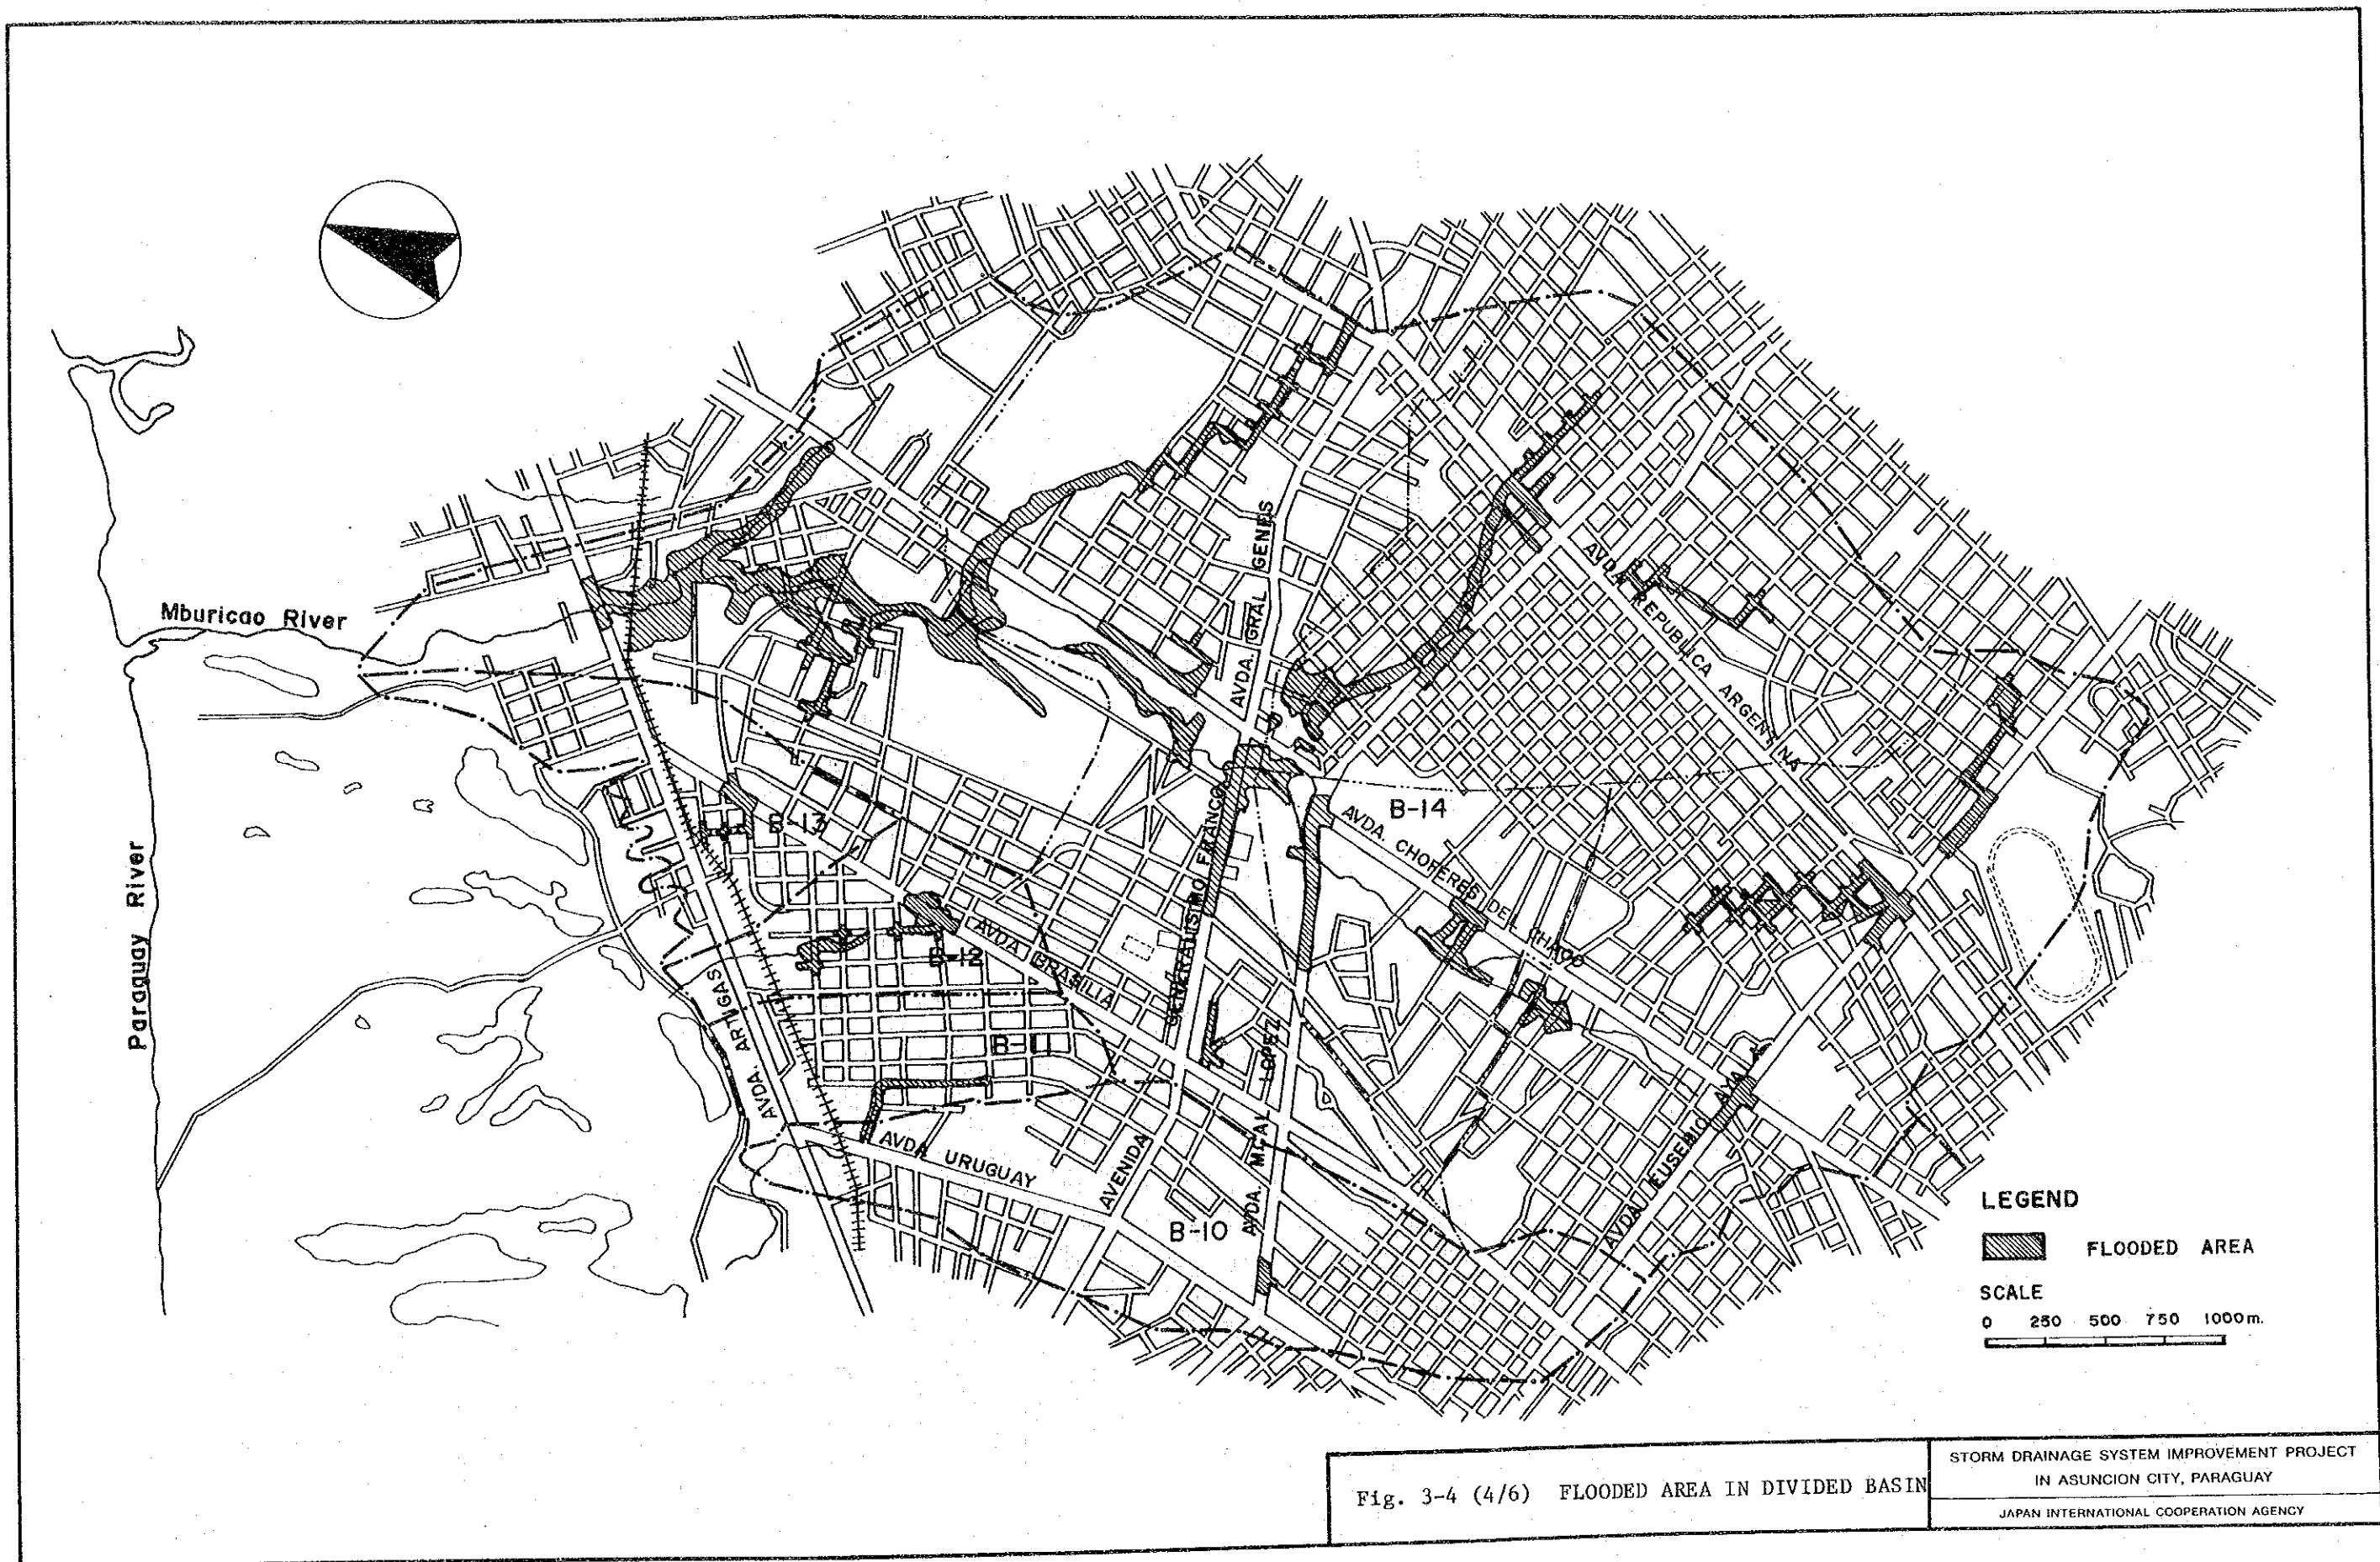
Fig. 3-4 (4/6) FLOODED AREA IN DIVIDED BASIN

Fig. 3-4(4/6) and Table 3-1 show the flooded area and flood damage at the time of flood after the completion of the drainage system. There were one (1) inundated trunk roads and two (2) inundated street intersections.

Fig. 3-4(4/6) and Table 3-1 show the inundated area and flood damage at the time of the recorded maximum flood. There were five (5) inundated street intersections.

Storm water concentrating on the Brasilia Avenue flows down to the starting point of the Bella Vista River through the unpaved street. Flood damage in the basin is serious although the catchment area is small.

Fig. 3-4(4/6) and Table 3-1 show the inundated area and flood damage at the time of the recorded maximum flood. There were one (1) inundated trunk road, six (6) inundated street intersections, and fourteen (14) inundated houses.

Fig. 3-4(4/6) and Table 3-1 show the inundated area and flood damage at the time of the recorded maximum flood. There were one (1) inundated trunk road, five (5) inundated street intersections, and six (6) inundated houses.

Inundation from the river and flooding on the roads causing the inundation of houses and traffic interruption along the trunk roads occur at many points with high frequency. Traffic interruption is serious especially at the crossing points of Mburicao River and Generalisimo Franco Avenue, as well as Mariscal Lopez Avenue, and along Eusebio Ayala Avenue with very high frequency. At the said crossing points, floods on the road are also caused by inundation from the river. The inundation and flood damage in this basin is one of the most serious among the basins.

Fig. 3-4(4/6) and Table 3-1 show the flooded area and flood damage at the time of the recorded maximum flood. There were eight (8) inundated trunk roads, sixty-seven (67) inundated street intersections, and one-hundred (100) inundated houses.

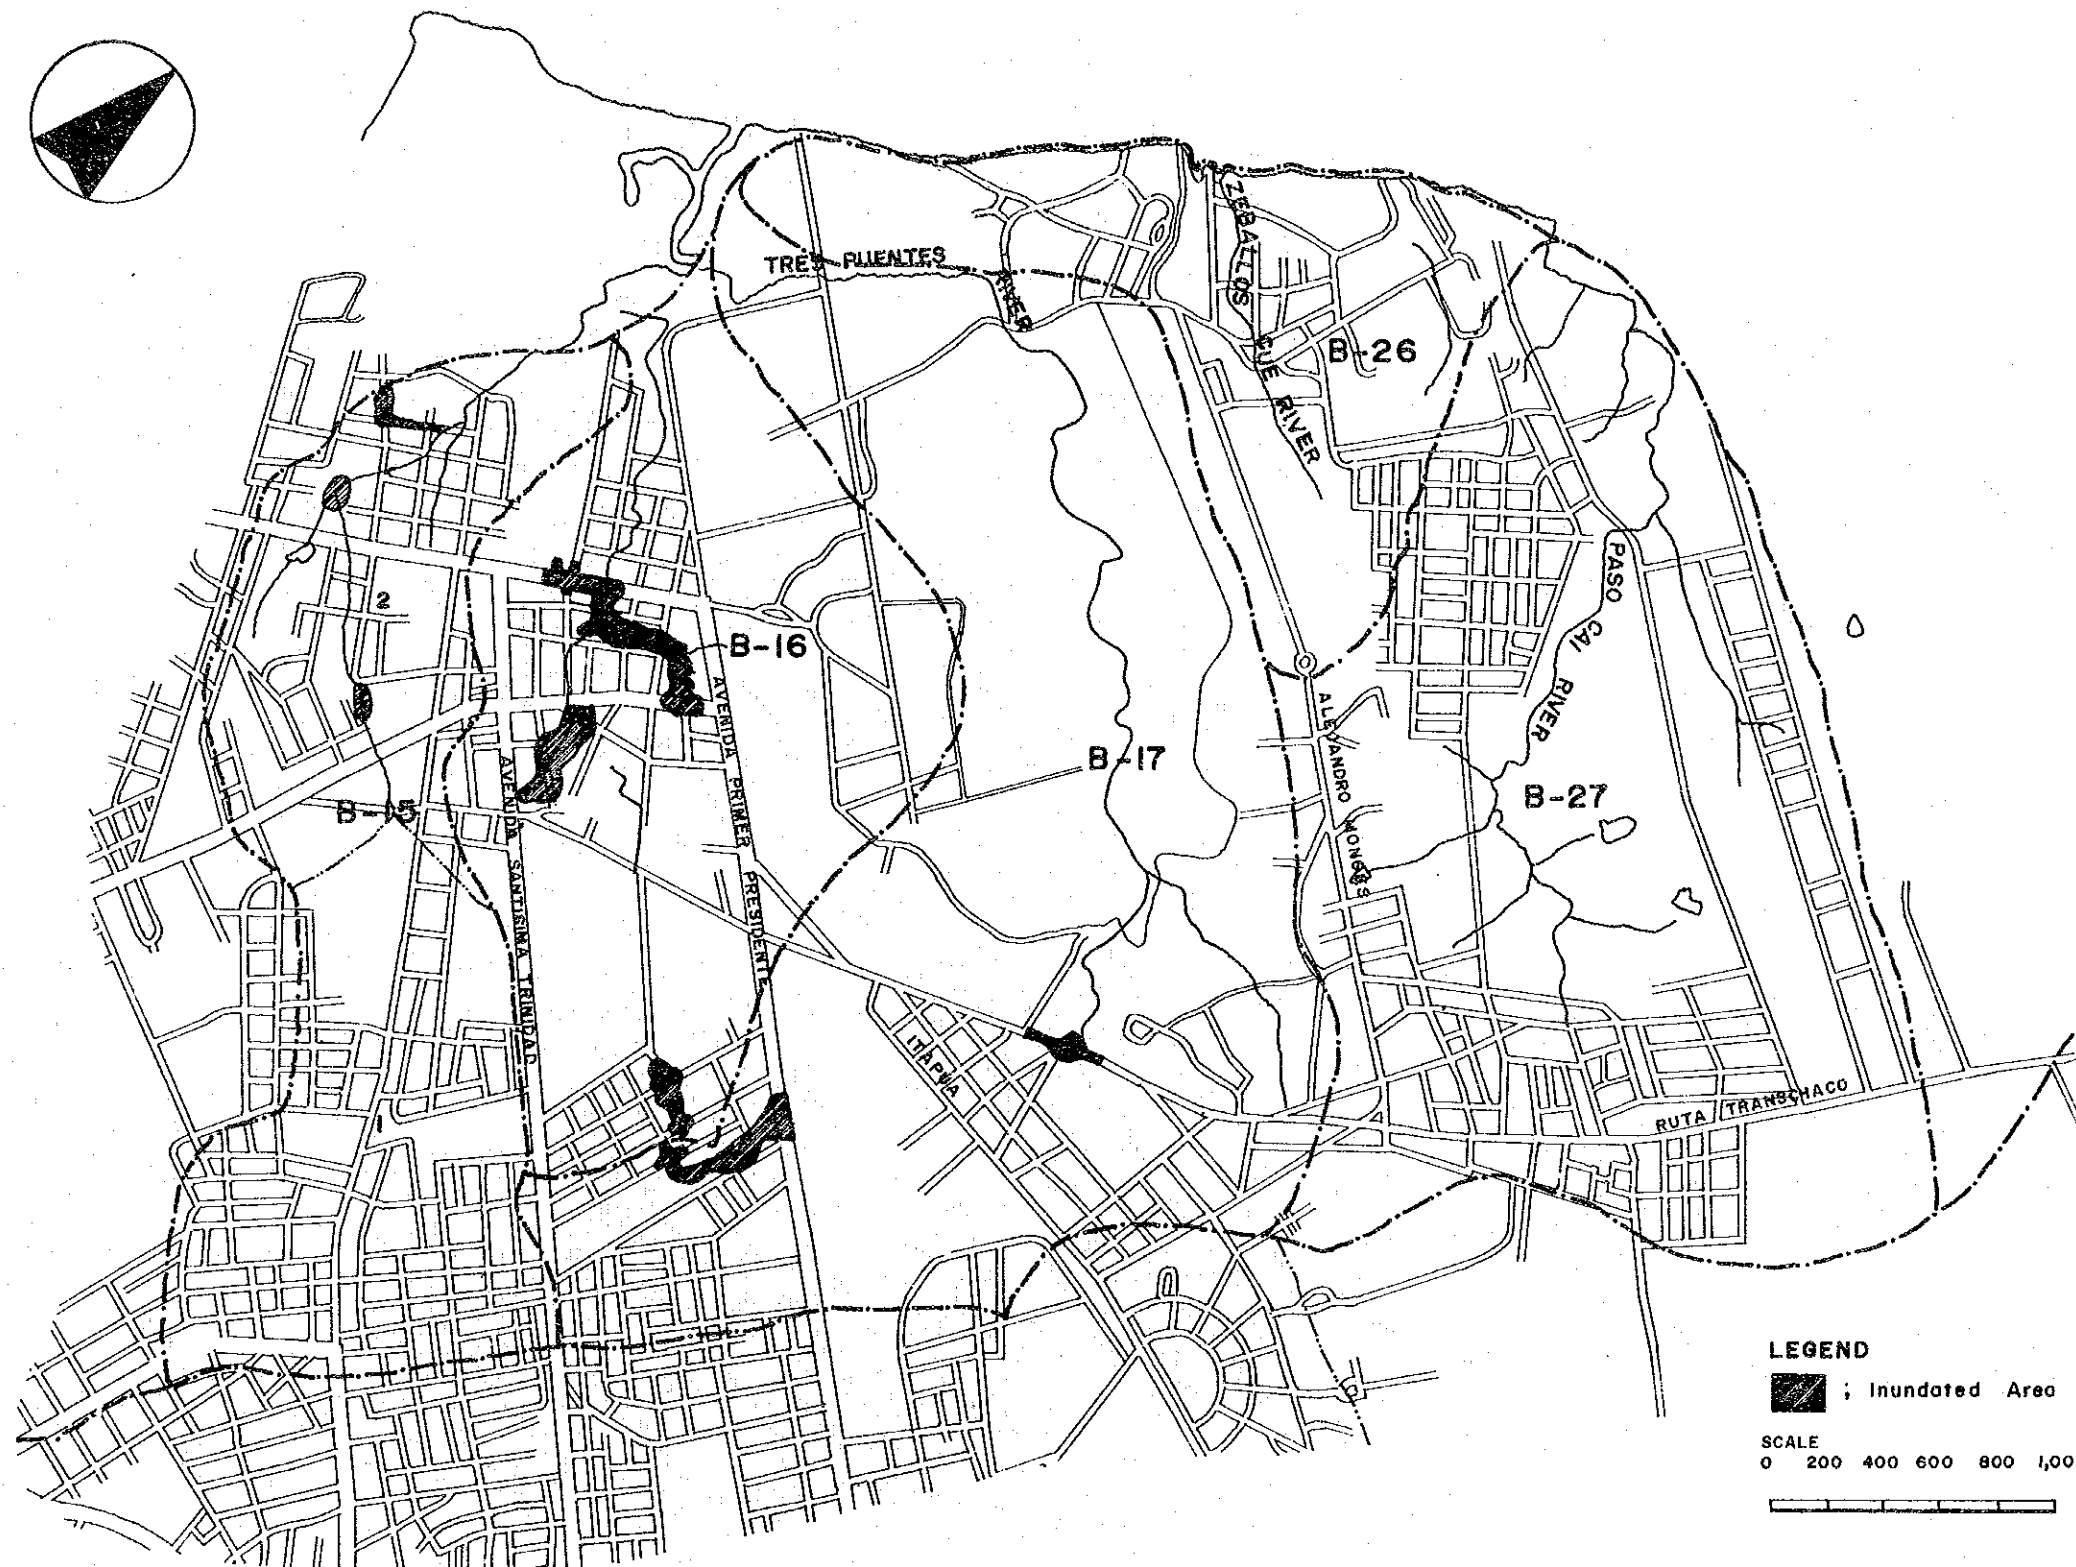
Fig. 3-4 (5/6) FLOODED AREA IN DIVIDED BASIN

Fig. 3-4(5/6) and Table 3-1 show the inundated area and flood damage at the time of the recorded maximum flood. There were two (2) inundated street intersections and twenty-two (22) inundated houses.

Inundation from the river at the crossing point of the river and Artigas Avenue as well as Santisimo Sacramento Avenue occur two or three times a year because the river width is narrow in the upper reaches above Artigas Avenue, and yet several small ditches join together at many points. However, the ponding of water in this area lessens the inundation damage in the downstream from the Artigas Avenue.

Fig. 3-4(5/6) and Table 3-1 show the flooded area and flood damage at the time of the recorded maximum flood. There were one (1) inundated trunk road, eight (8) inundated street intersections, and forty-four (44) inundated houses.

Damage caused by floods is not serious since flood frequency and population density is low and the traffic volume is small at present.

Fig. 3-4(5/6) and Table 3-1 show the inundated area and flood damage at the time of the recorded maximum flood. There were one (1) inundated trunk road, one (1) inundated street junction, and twenty-two (22) inundated houses.
