At the Mae Kuang damsite, a primary geological investigations which consists of a geological reconnaissance survey and drillings were carried out for study of a feasibility of dam construction by Soil & Geology Div. R.I.D. in 1974. At the time, the scale of proposed dams were rather small (Crest height of the Main dam was only 33 meters), therefore the scale of the investigation works were also small and poor. The conclusion of the investigation was that there were some unsuitable geological conditions but a construction of dam was feasible by conducting of some foundation treatments. (Referene C-1)

At the project site, the primary geological investigation for the dam foundation was carried out in 1974, and the second investigation was conducted in 1979. Farther the investigation for the overburden was also executed in 1978.

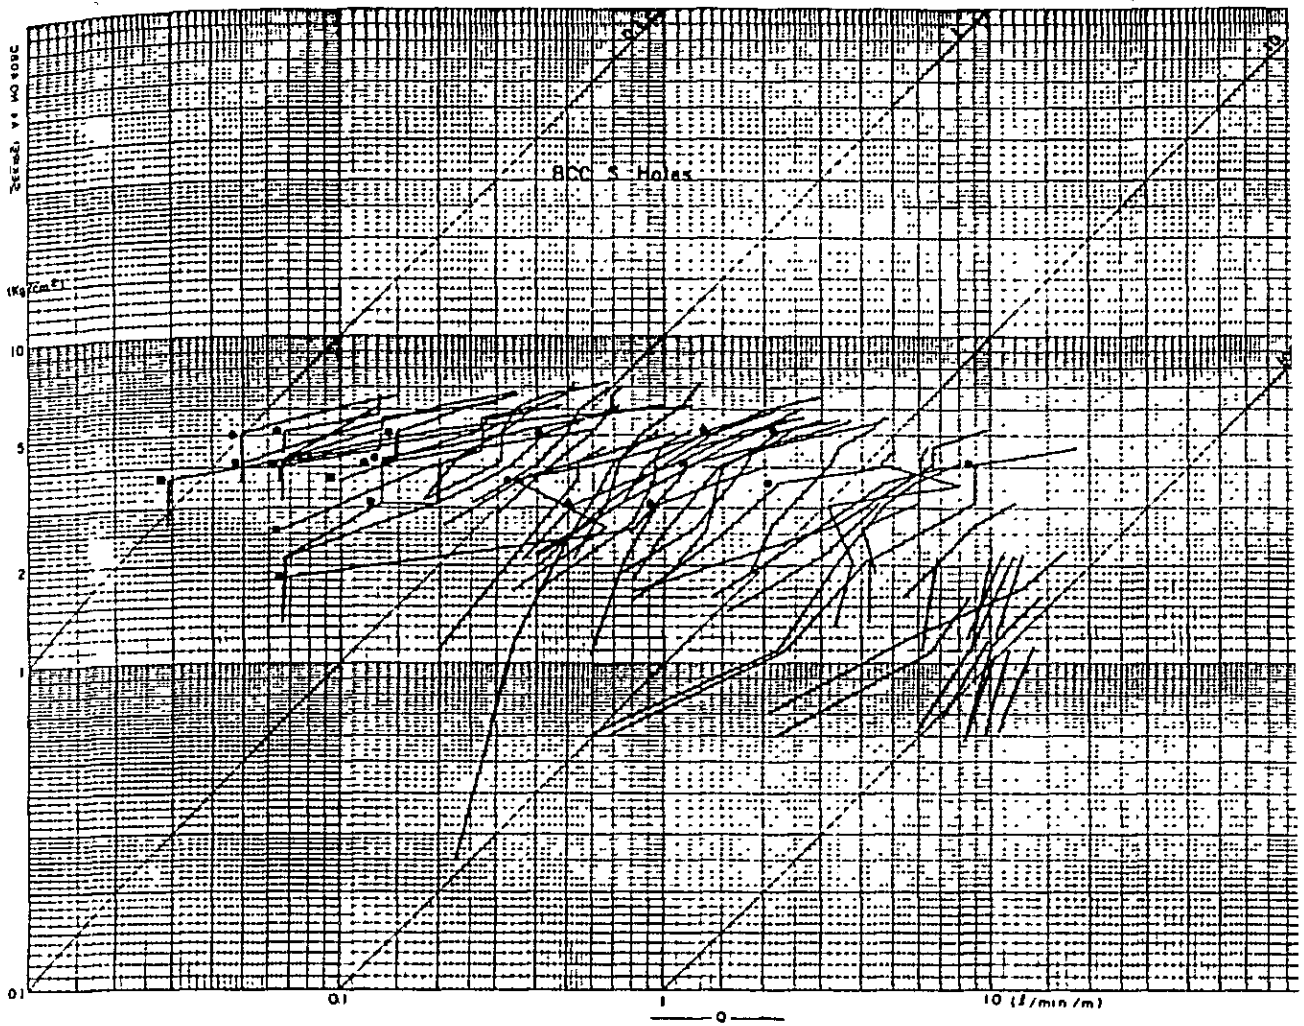
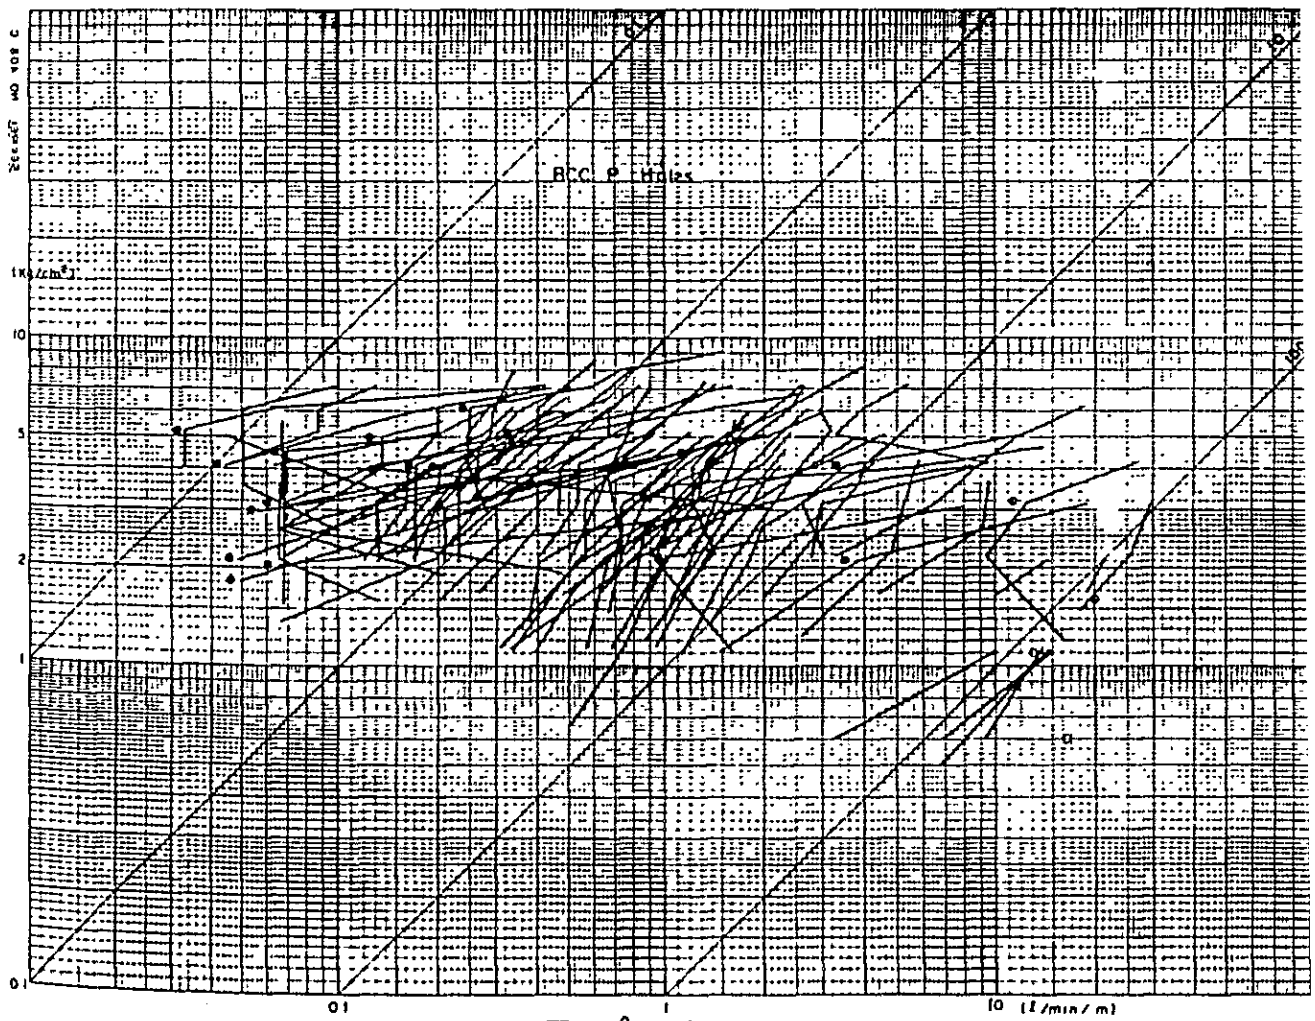
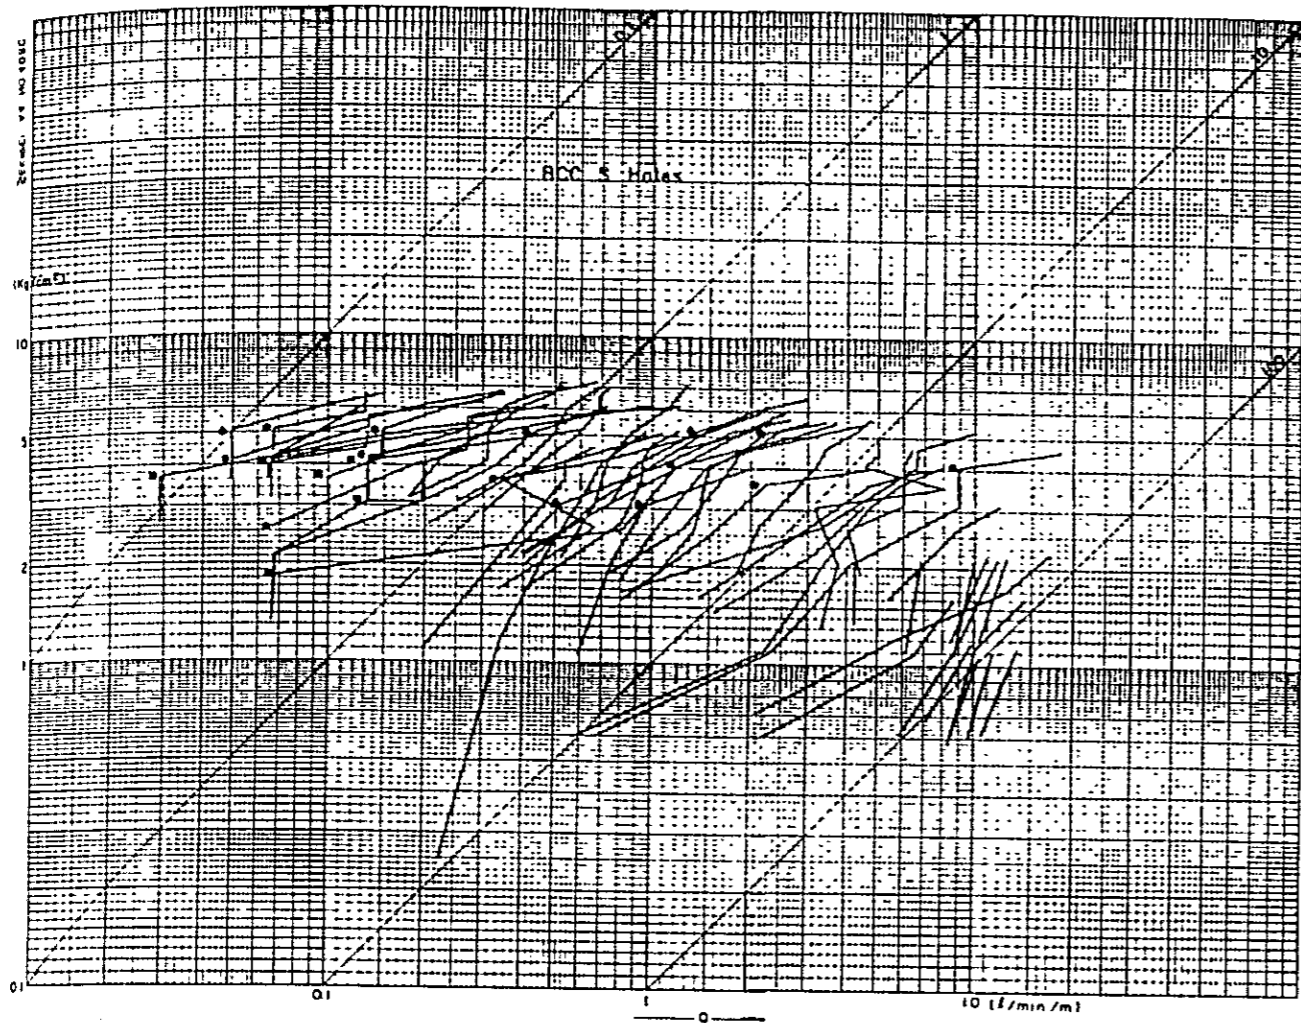
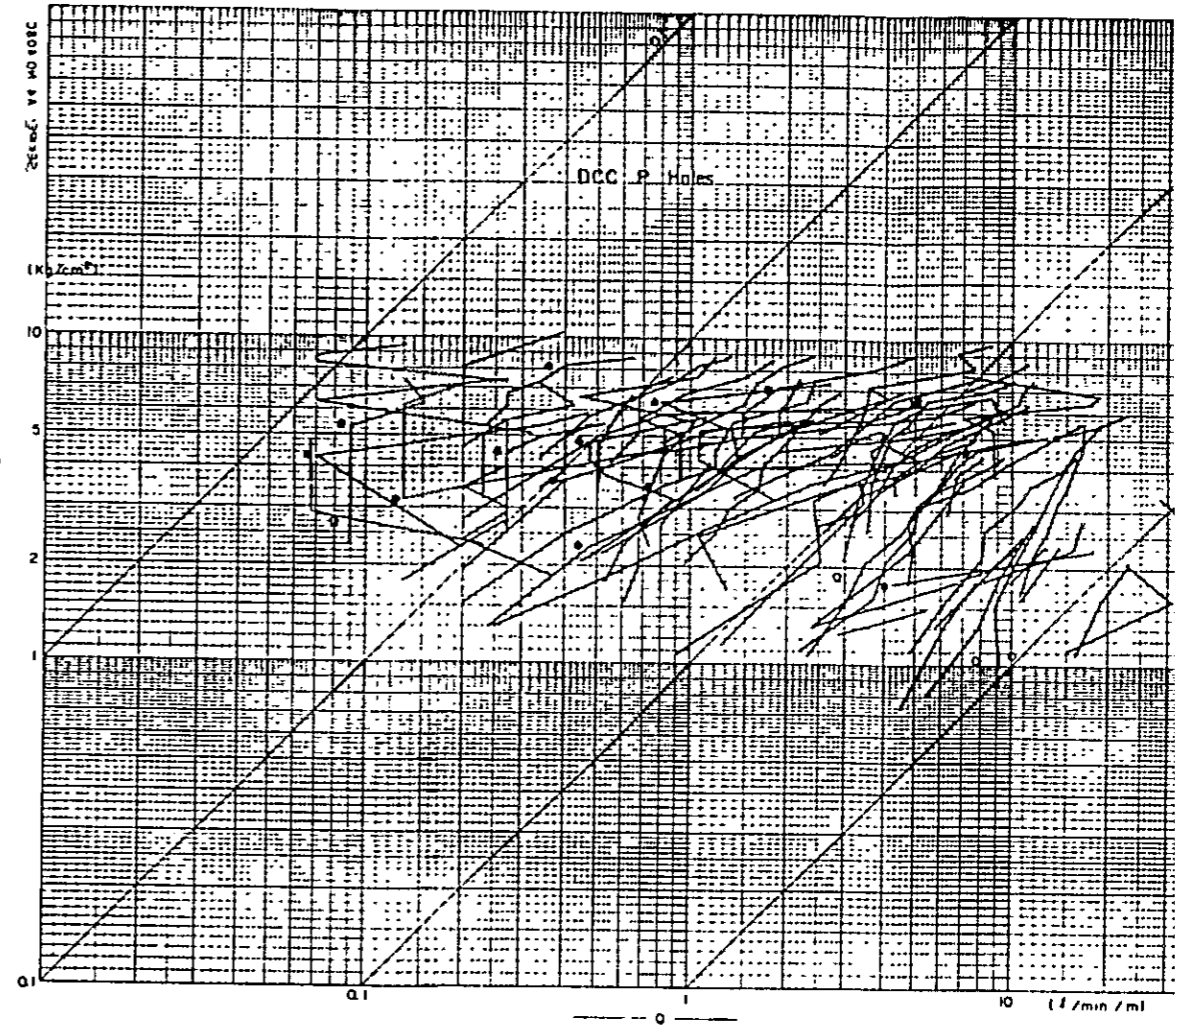
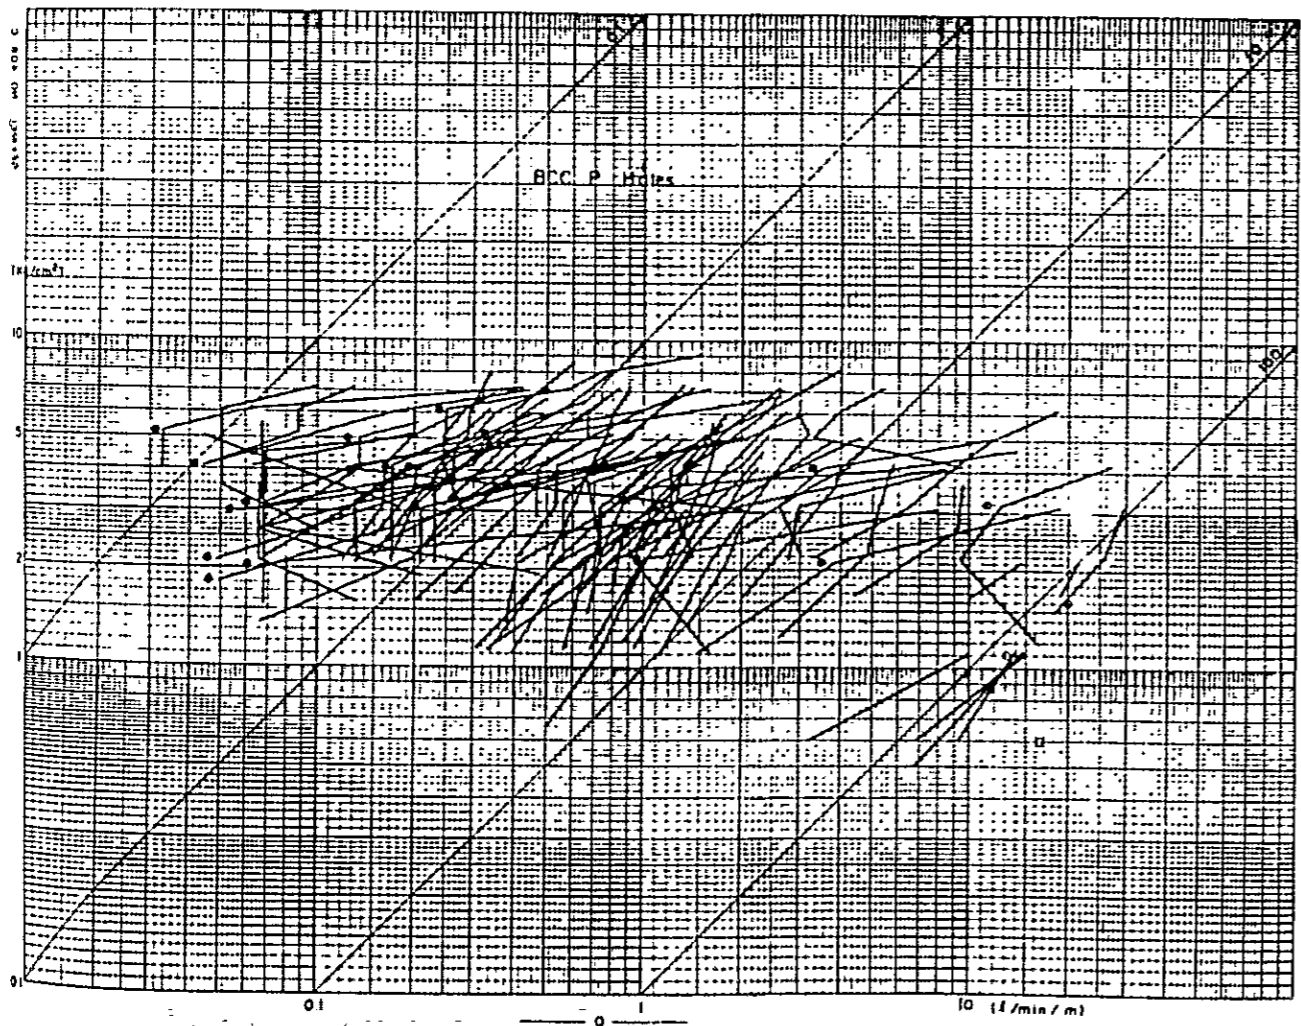
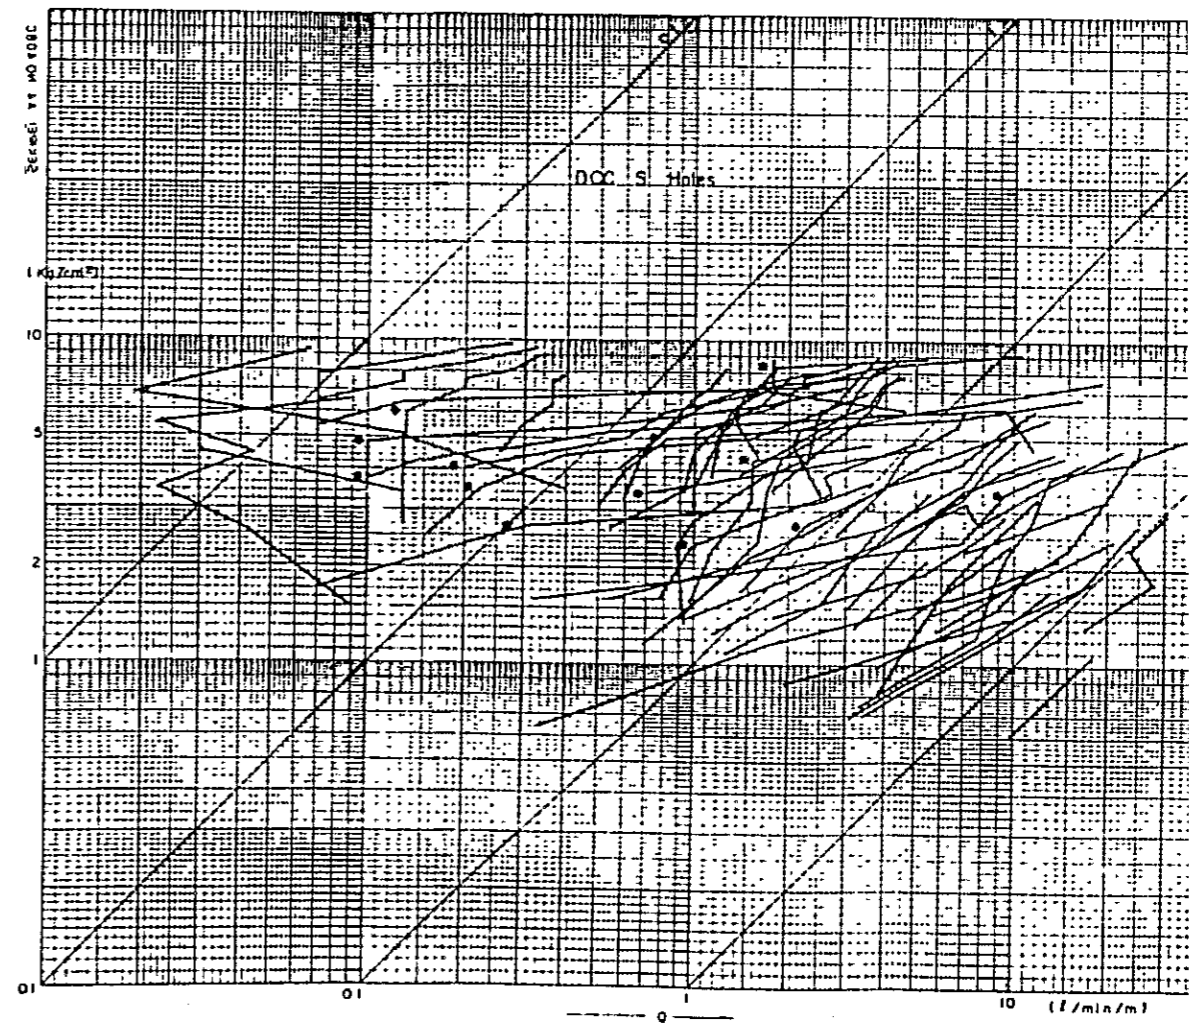
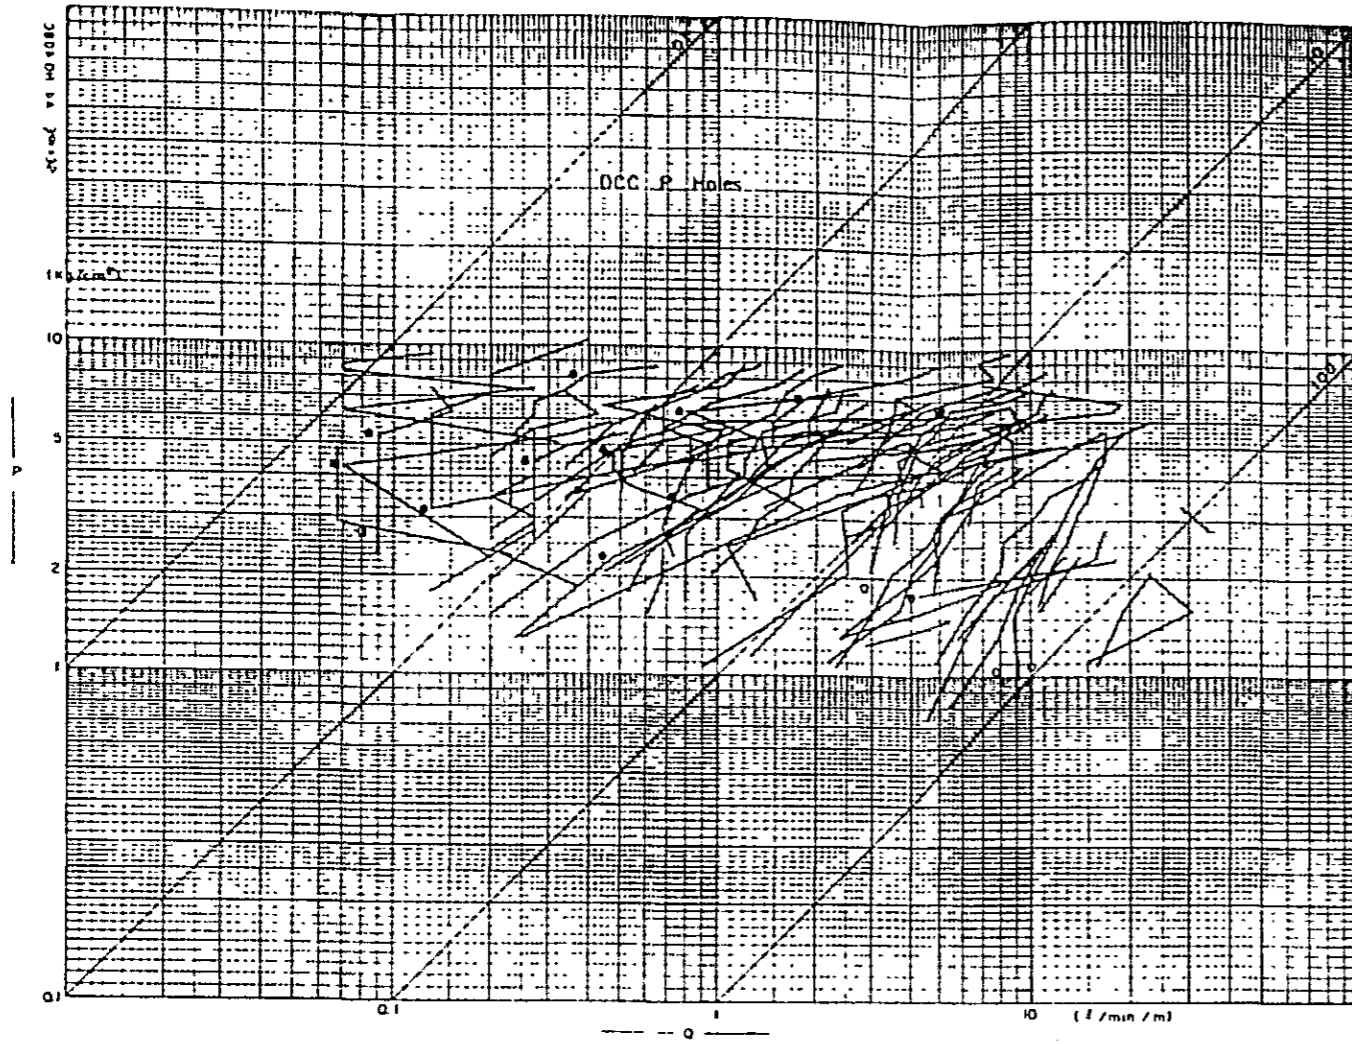
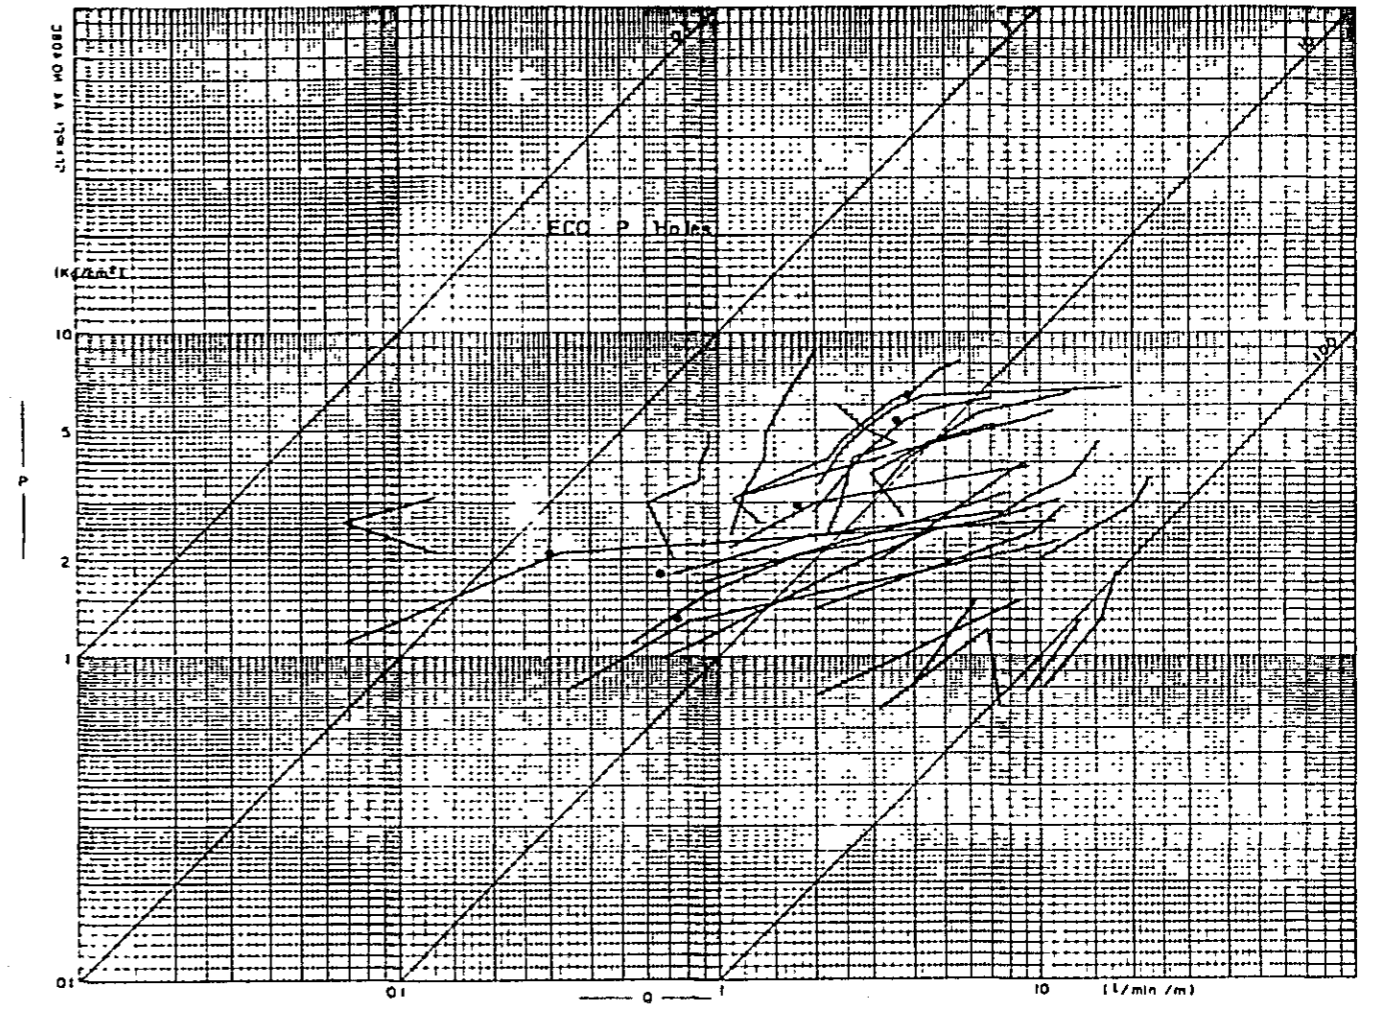
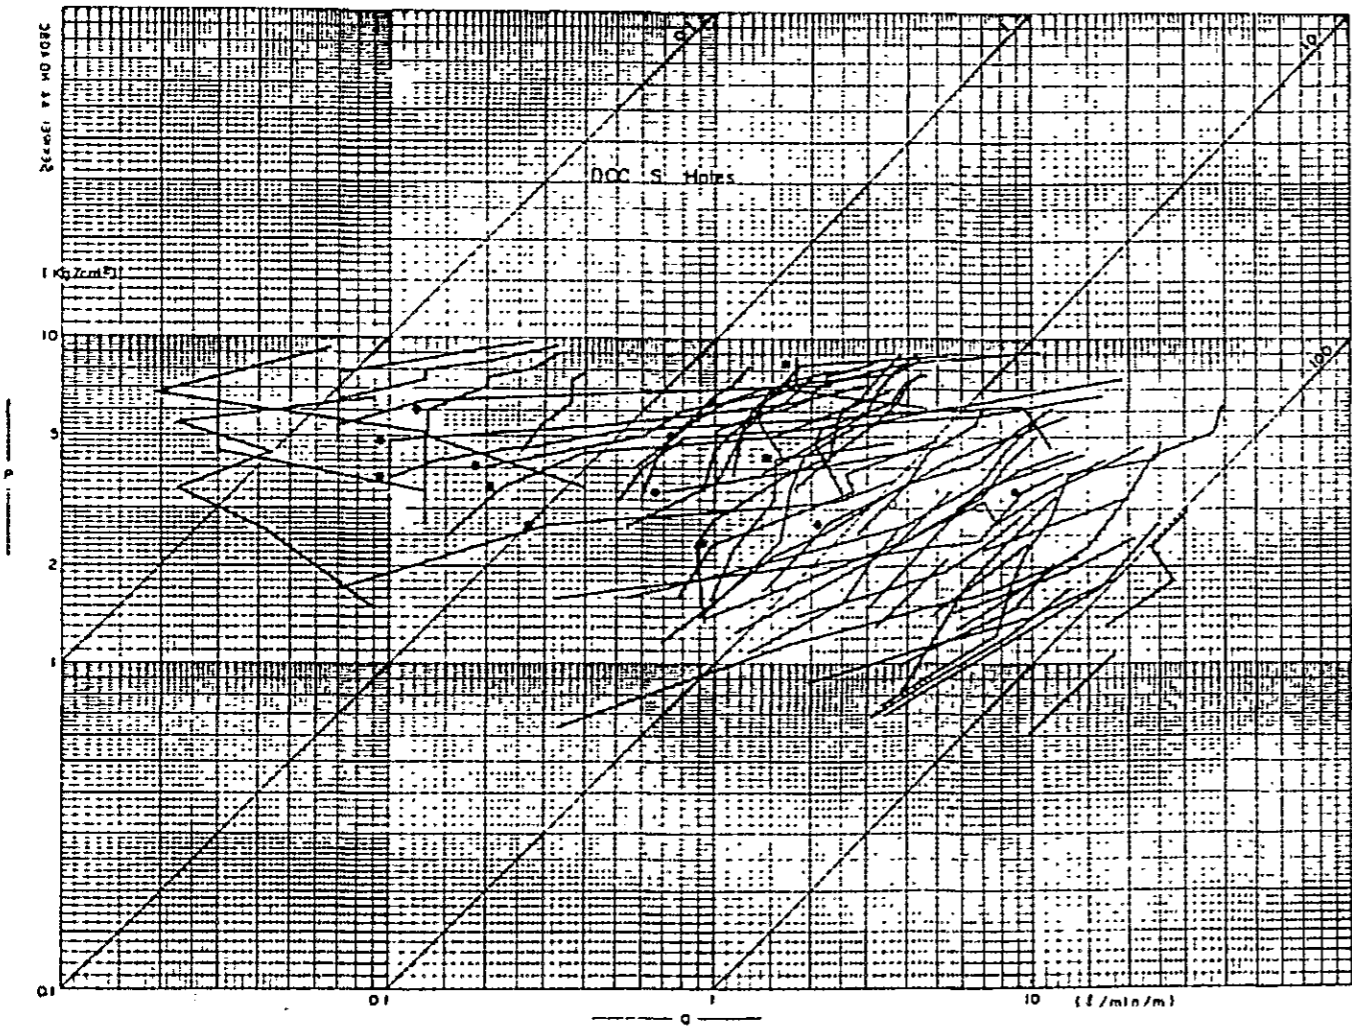
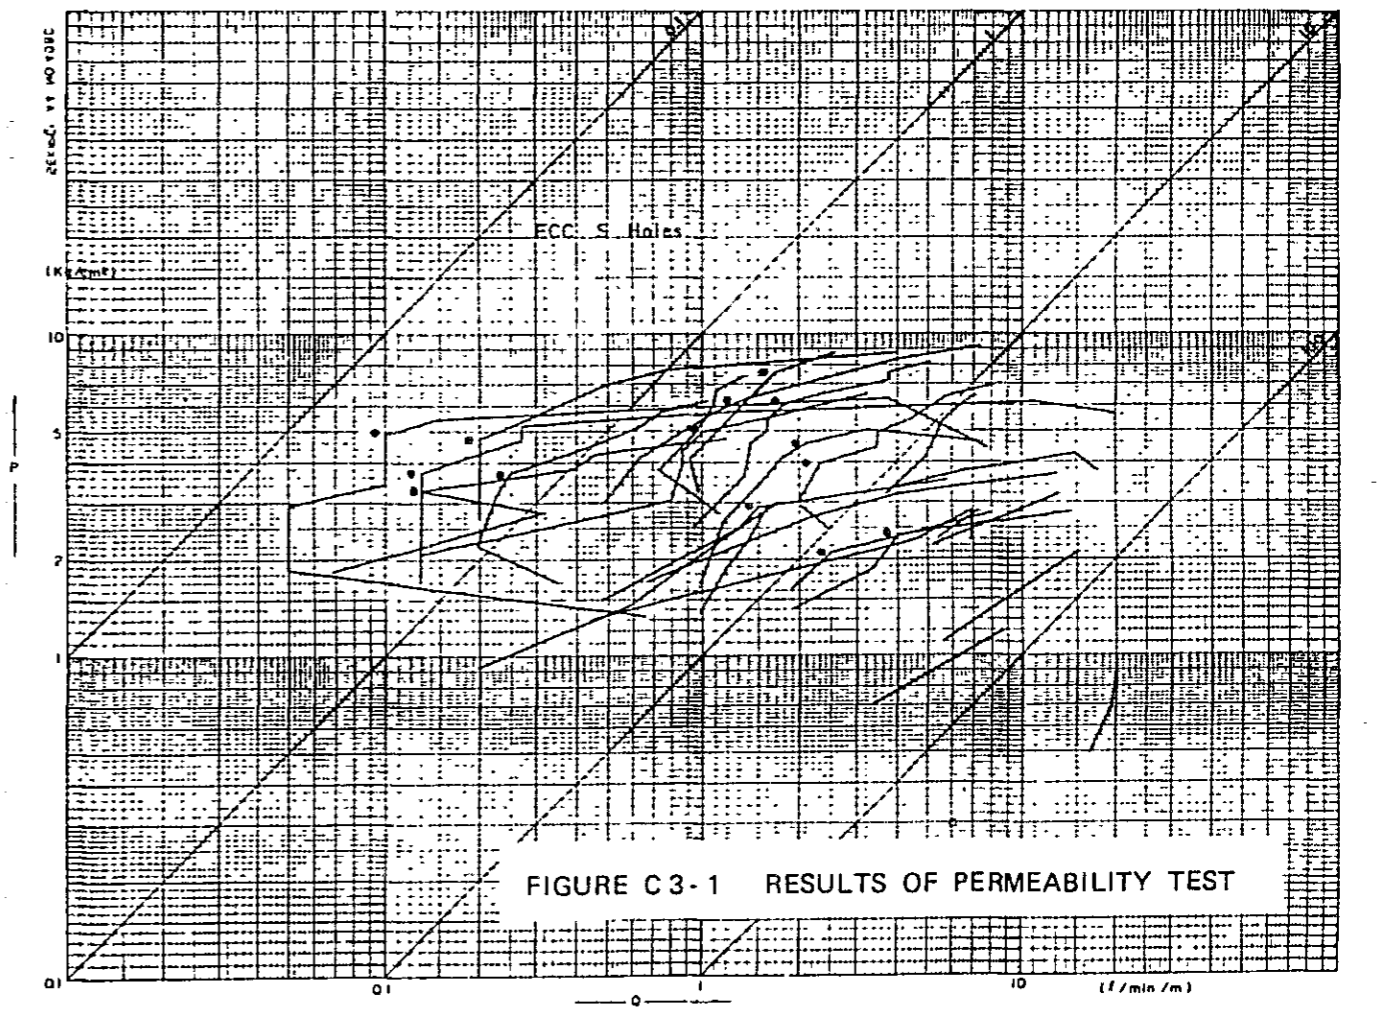
FIGURE C 3-1 RESULTS OF PERMEABILITY TEST

Then, "pressure-intake curves" grouped into enforcing blocks are shown in Figure C 3-1. The inclined scale of the graph means a lugeon value. The graph shows the foundation has wide ranged permeability coefficients, the lowest one is less than 0.1 lugeon and the highest one is more than 200 lugeons.

And the pressure-intake curves which indicate low permeability also indicate low critical pressure as pointed by black dot simultaneously. Among them there are some extreme cases that even the beginning pressure of the test has already exceeded its critical pressure. Further the most of critical pressures shown in the graph are less than  $5 \text{ kg/cm}^2$ . This situation means very dangerous condition as a dam foundation, that is to say, the critical pressure at considerable part of the foundation should be less than the water head of proposed reservoir when the reservoir has filled up.

These pressure-intake curves are drawn separating the data of P-holes (Primary Holes) and the data of S-holes (Secondary Holes), but a difference between these two graphs has not recognized. It means the distance of P-holes (6 meters) is too far to improve the foundation effectively.

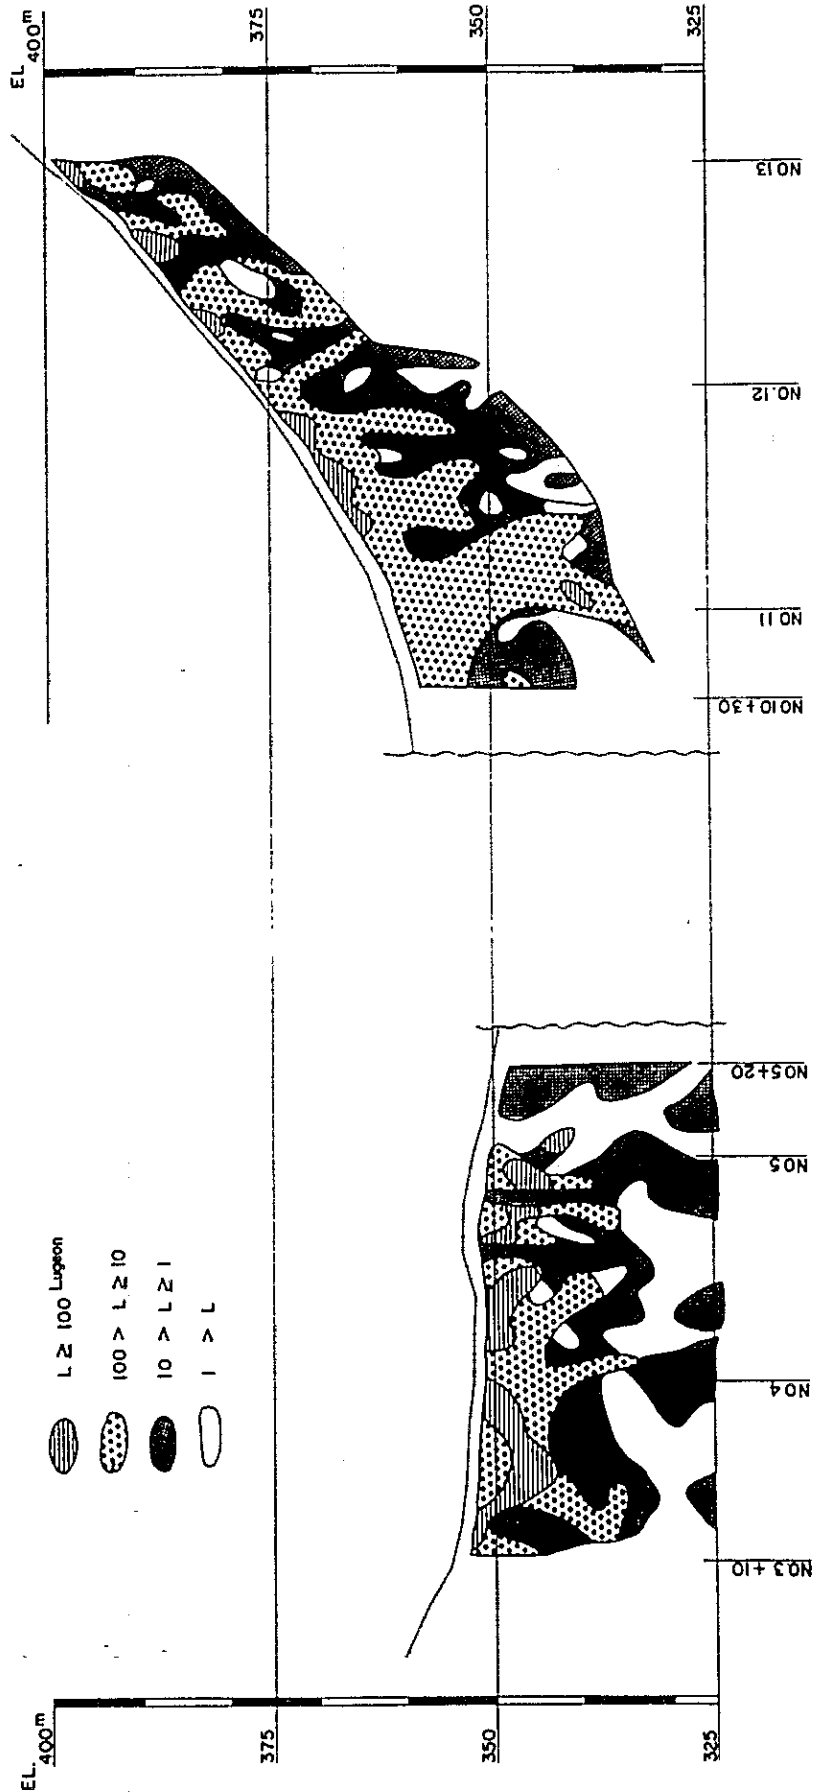
FIGURE C3-2 LUGEON-MAP OF LEFT SADDLE DAMSITE  
SCALE (H = 1 1,000  
V = 1 500)

The permeability of the bedrock in the Left Saddle damsite varies extensively ranging from less than one lugeon to more than 100 lugeons. The lugeon map of the foundation was drawn up based on those data (Figure C 5-2). The map indicates the following situation.

From a glance of the map it is noticed that the parts having a very high permeability more than 100 lugeons extend mainly at uppermost of the foundation. This situation suggests that most of those extremely high permeability zones were derived from a weathering of the

bedrock. However, some highly pervious zones distribute also in the depths and rather high permeability zones (more than several tens lugeons) usually extend to a deep portions of the foundation. And the distribution of these rather high permeability zones tends to extend vertically, certainly along some weak zones like as fault.

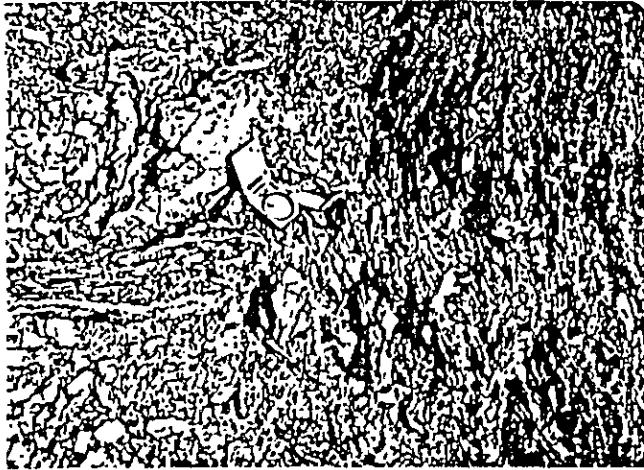
Picture P-1      Slate      (core trench)

The bedrock consists of sandstone and shale alternation and slate but slate is dominant, especially at the outlet trench almost all of the bedrock is slate. The slate has heavy schistosity and heavily altered by folding (see Picture P-1). The alternation of sandstone and slate or sandstone bed intercalated are generally hard but cracked.

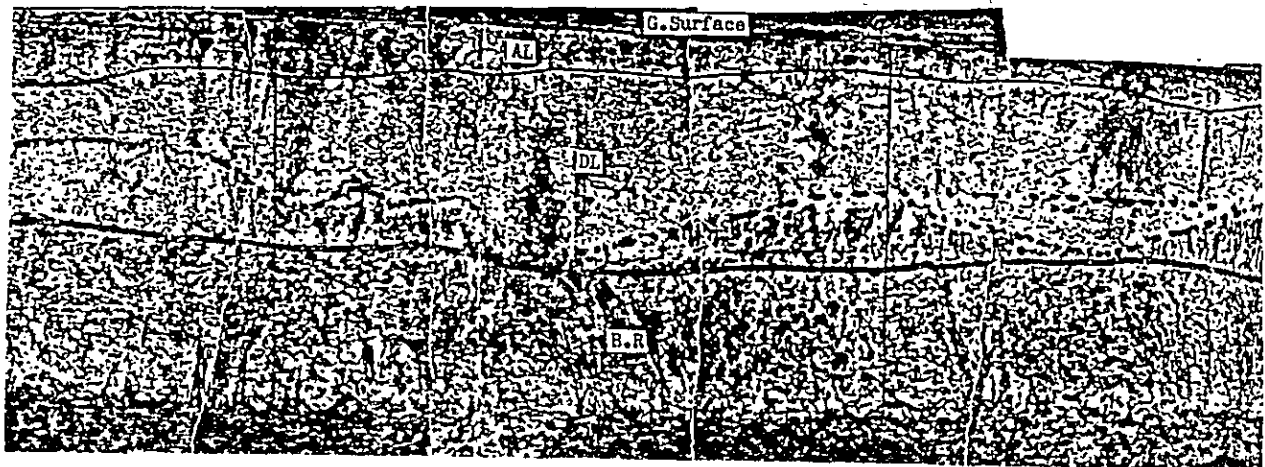
Picture P-2 Overburden (trench)

An overburden in the trenches are usually 5 to 6 meters in depth and at somewhere 8 meters in depth, and mainly consists of well compacted diluvial deposits. An alluvial deposit destributes thinly at the top of the overburden as a top-soil, but at a gully it is rather thick (see Picture P-2).

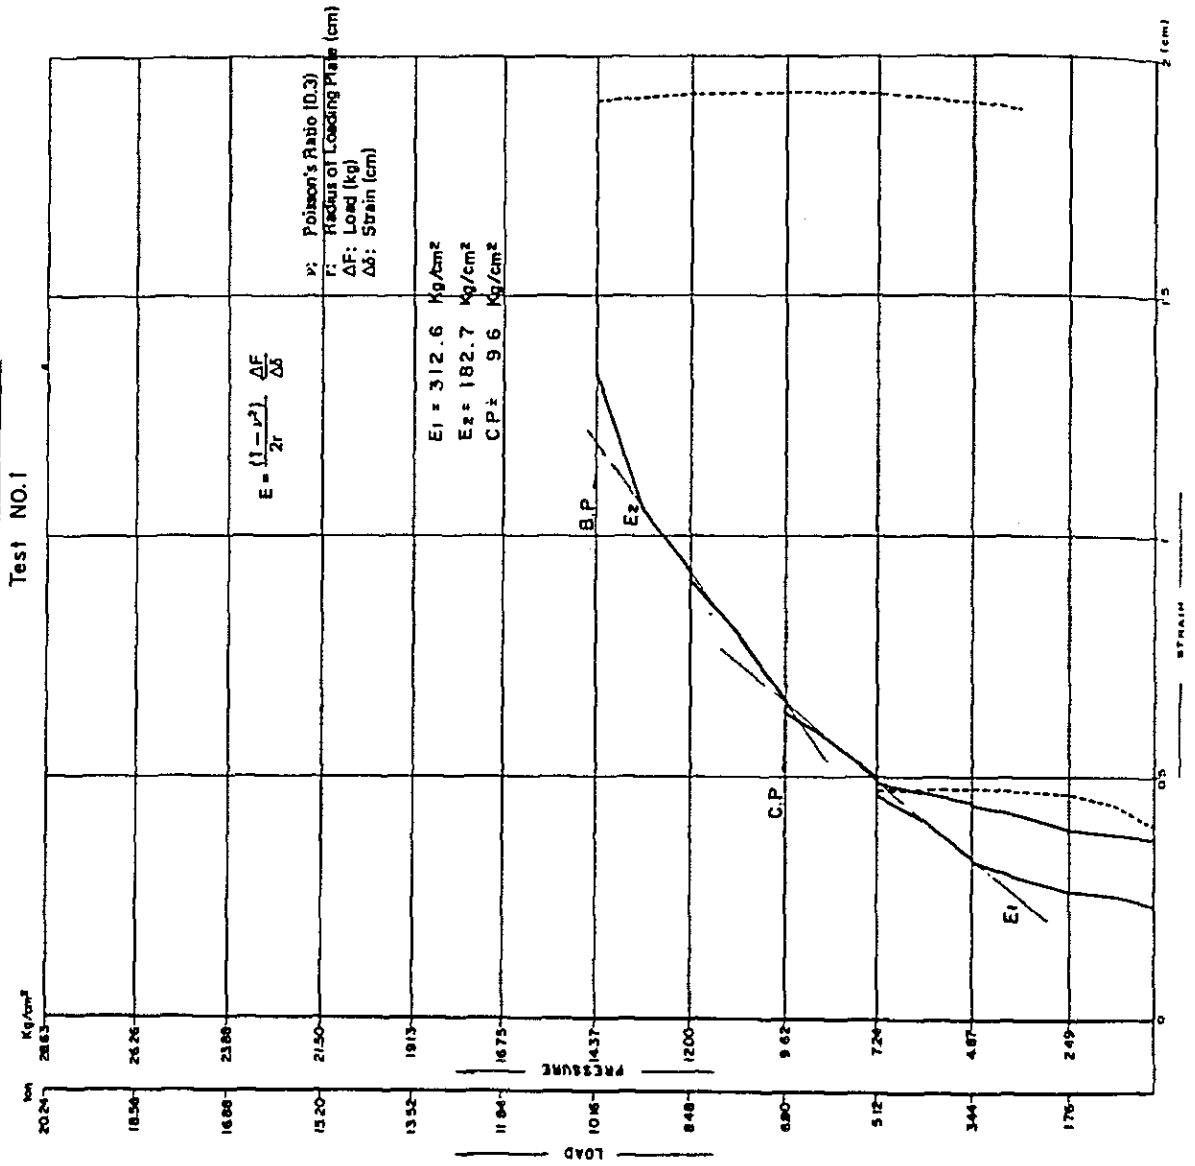
FIGURE C 4 - 4 (1) BEARING CAPACITY TEST

The analyzid charts are shown in Figure C 4-4 (1) to Figure C 4-4 (2). The result of No.1 test shows that both of the critical pressure and the failure-strength are extremely low, about  $9.6 \text{ kg/cm}^2$  and about  $14 \text{ kg/cm}^2$  respectively. The result is derived from that the target point of the test was heavily altered and sheared zone, and it indicates even the critical pressure of the point is less than the design load.

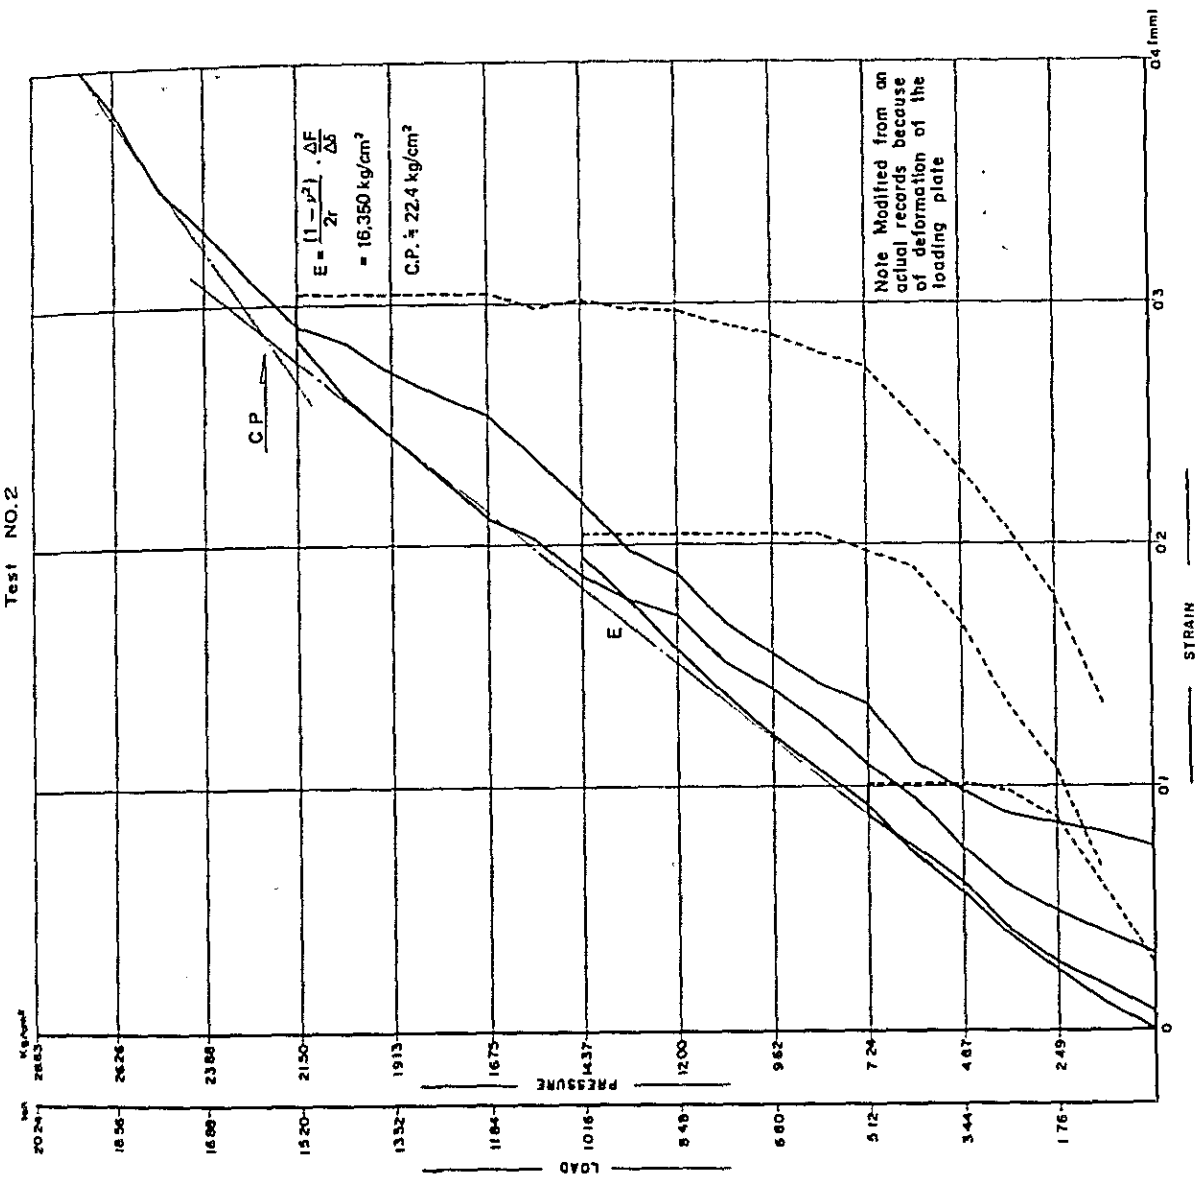
FIGURE C-4(12) BEARING CAPACITY TEST

The No.2 test targetting a weathered sandstone indicates a rather high critical pressure of about  $22 \text{ kg/cm}^2$  which means about twice times of the design load. The result suggests the weathered sandstone has a bearing capacity for the dam at least, but the value is not enough for dam foundation (usually a critical pressure of dam foundation is required a value more than three times of the design load).

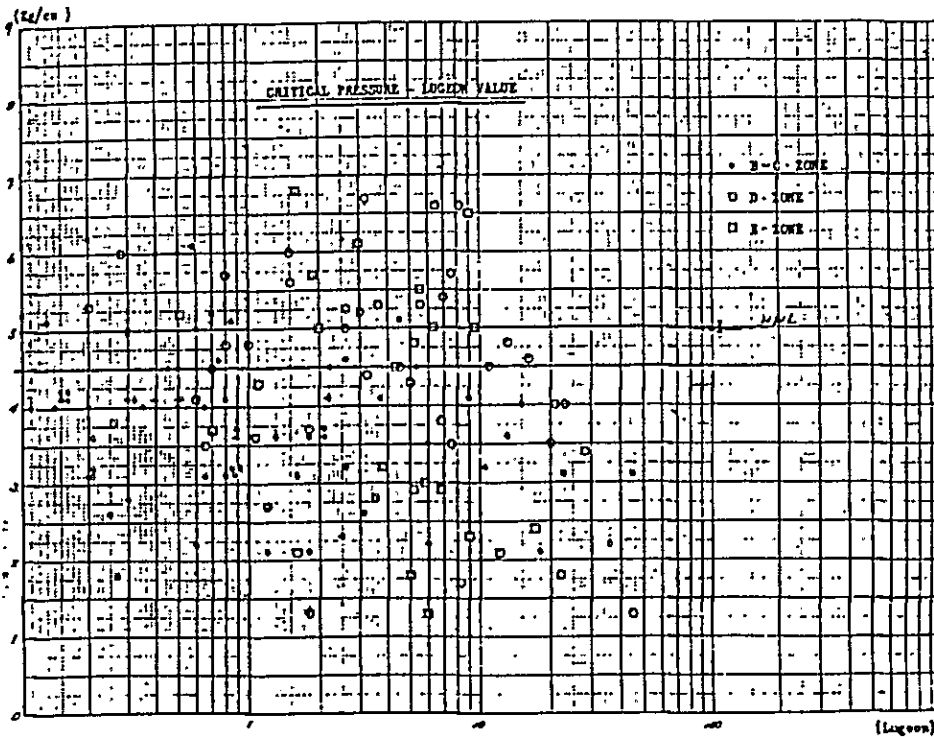
Figure C 5-2 Relationship between Critical Pressure and Permeability

The pressure-intake curves got by the permeability tests show that critical pressures of permeability groups indicating the lowest lugeon value and the highest lugeon value are remarkably low. The relationship between critical pressure and permeability is shown in Figure C 5-2. The figure is derived from the Figure C 3-1 and dotted by the data indicating obvious critical pressure. The figure indicates the most of critical pressures should be less than the water head of proposed reservoir if it has filled up.
