APPENDICES FOR CHAPTER 9

10 - 1	Summary of Geological Survey- - - - -	195
10 - 2	Realignment of Critical Sections - - - - -	213
10 - 3	Stability Calculations - - - - -	219
10 - 4	Condition of Disaster and Selected Countermeasures - - - - -	227

Appendix 10-2 Realignment of Critical Sections

APPENDIX 10-4 Condition of Disaster and Selected Countermeasures DALTON PASS SECTION (1)

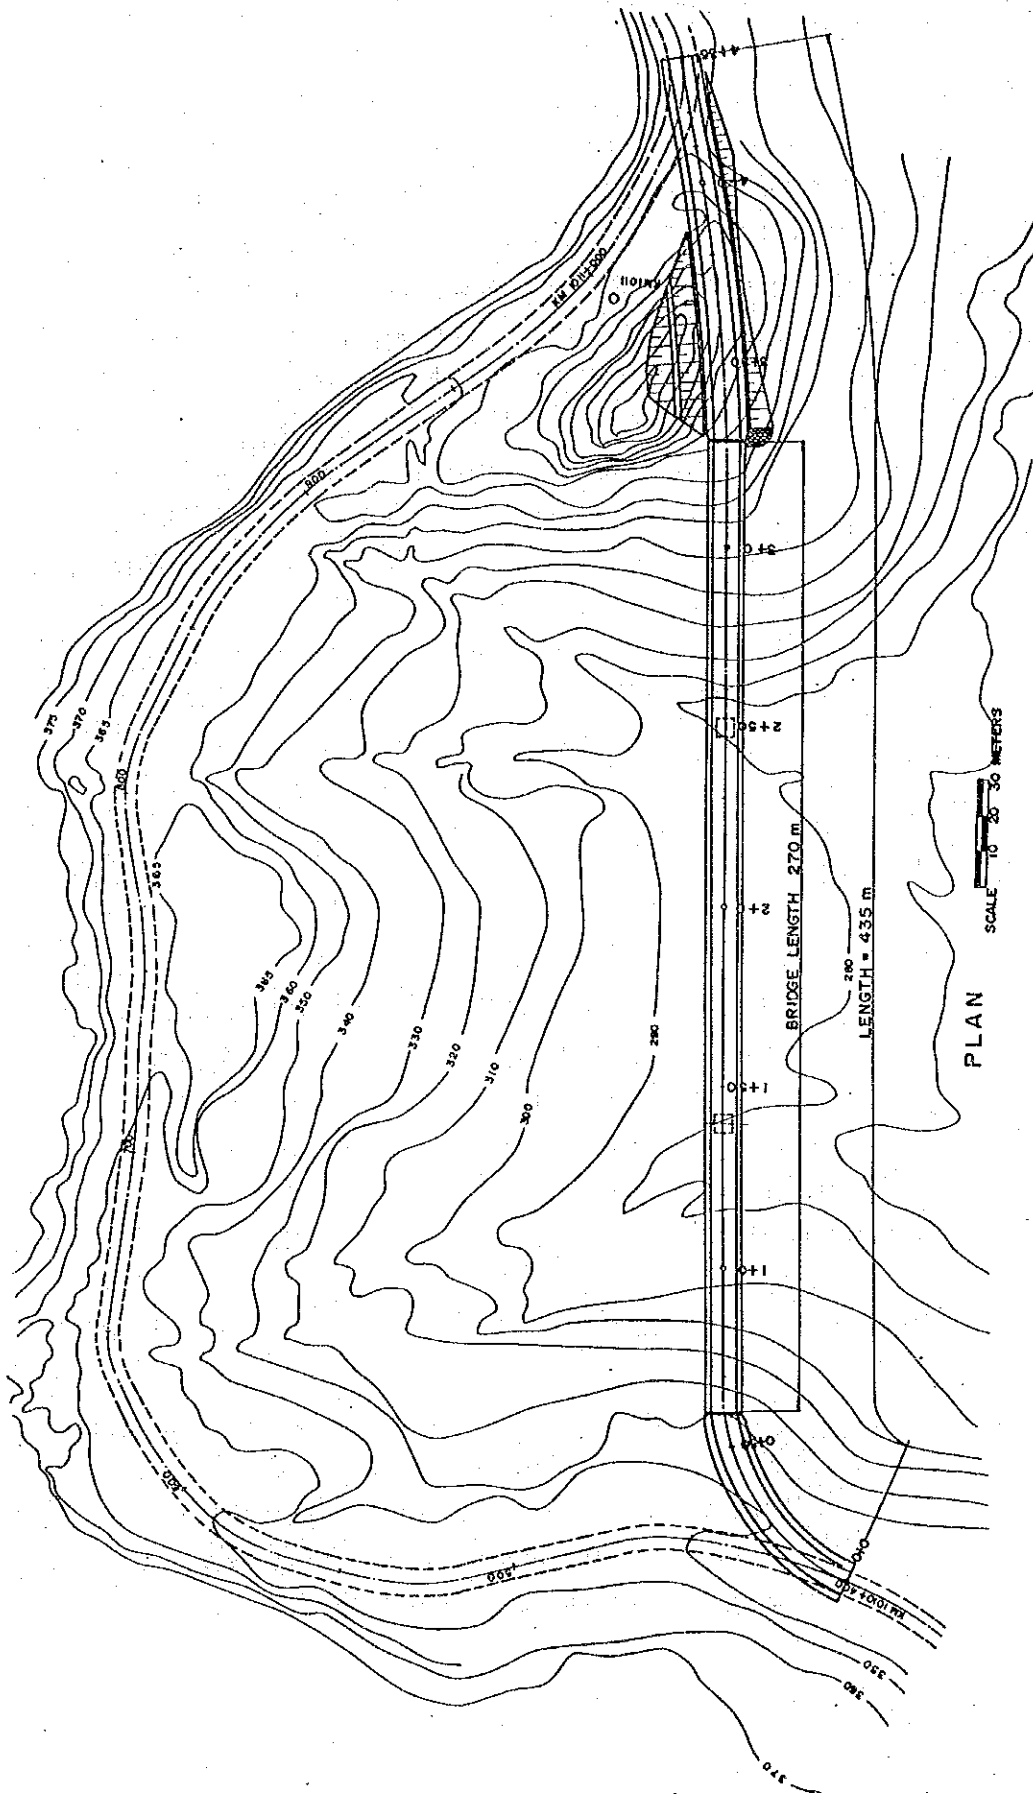
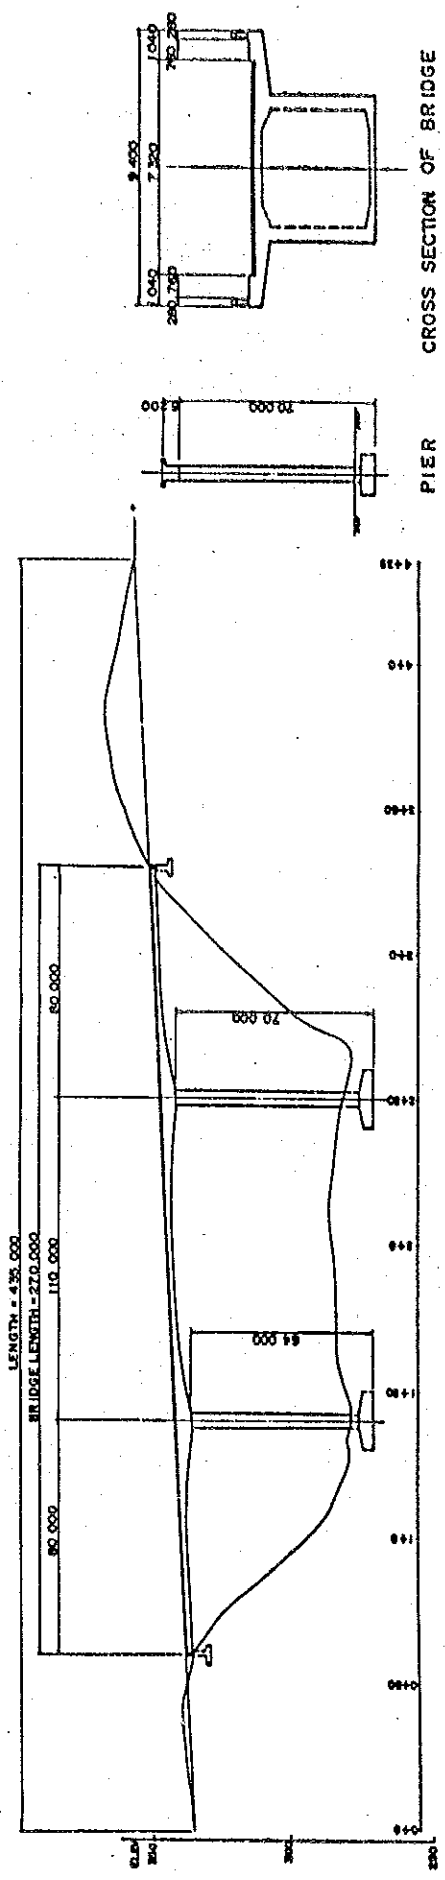
A short section at Km. 1,010 + 700 (spots VIII-80 and 81) in Mahaplag-Sogod Section is subjected to the largest scale of cut slope failure and embankment slope failure.

As Plan-2 requires a bridge of 270 meters in length with piers of 70 meters in height, construction cost of Plan-2 is more expensive by about double than Plan-1. Plan-1 which is slope protection of existing slopes was recommended for adoption to the preliminary design.

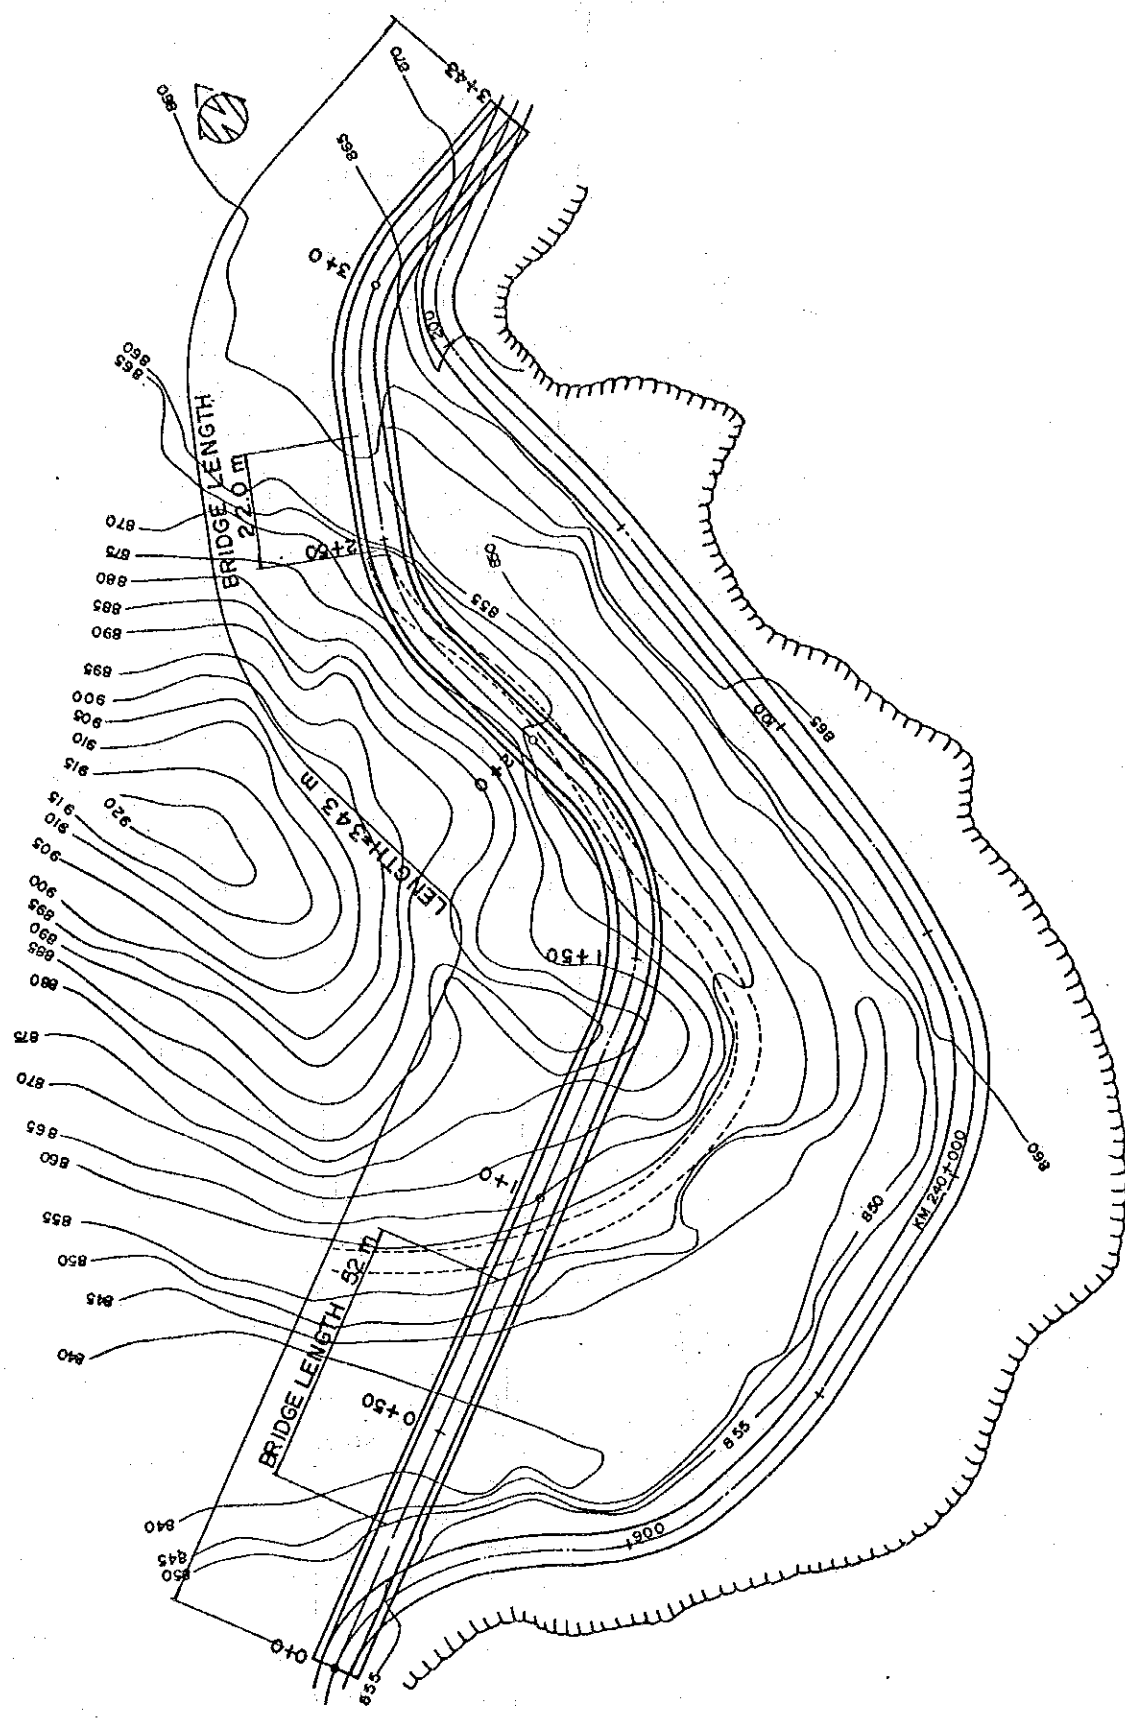
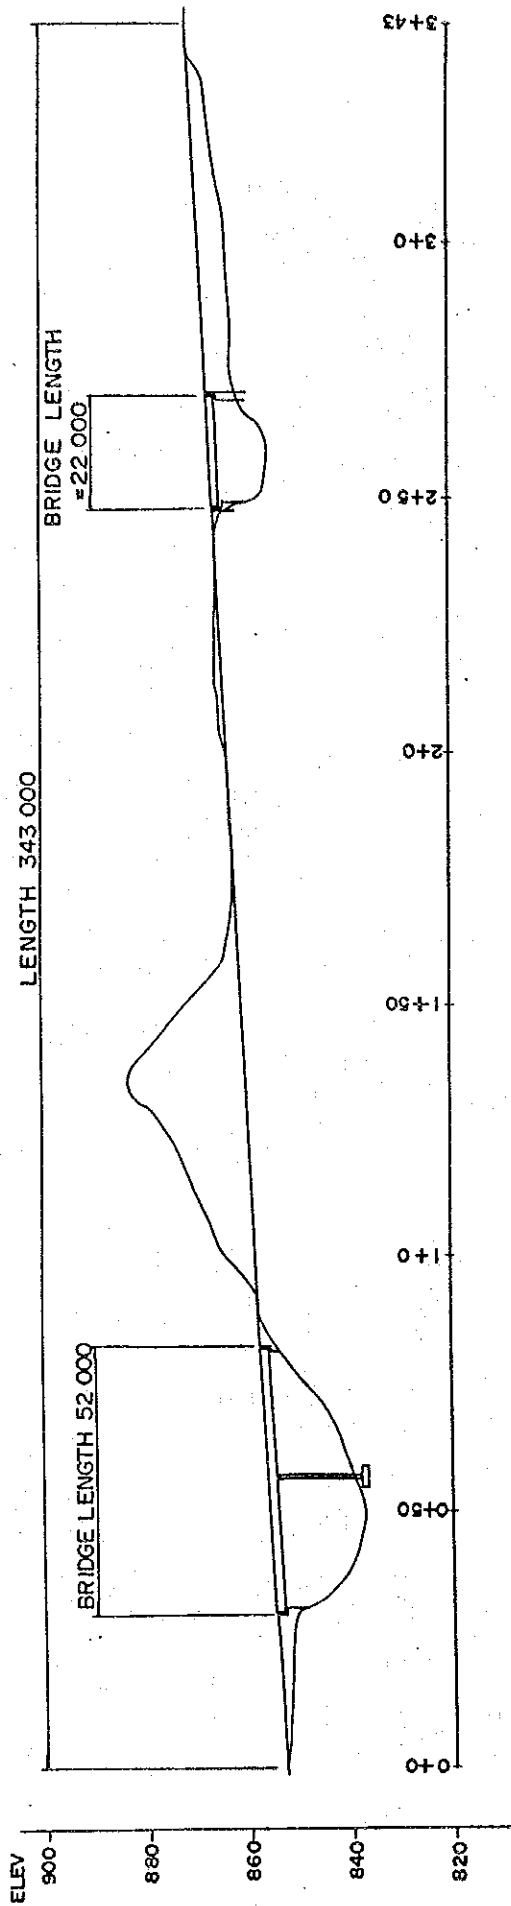
Quite steep and high cut slopes continue along this section which contains four (4) disaster spots of IK-39, 40, 41 and 42. In addition to a plan to provide slope protection works on the existing slopes, a route realignment plan was considered. New alignment was selected on the opposite side of the Bued River. New alignment has length of 343 meters which is shorter by about 70 meters than the existing route, however, new alignment has to cross the Bued River twice requiring two bridges. It also requires high cut slopes of about 25 meters in height (see Figure on next page).

Plan-2, realignment plan is more expensive by about 3 times than Plan-1. Plan-1, slope protection of existing slopes was recommended.

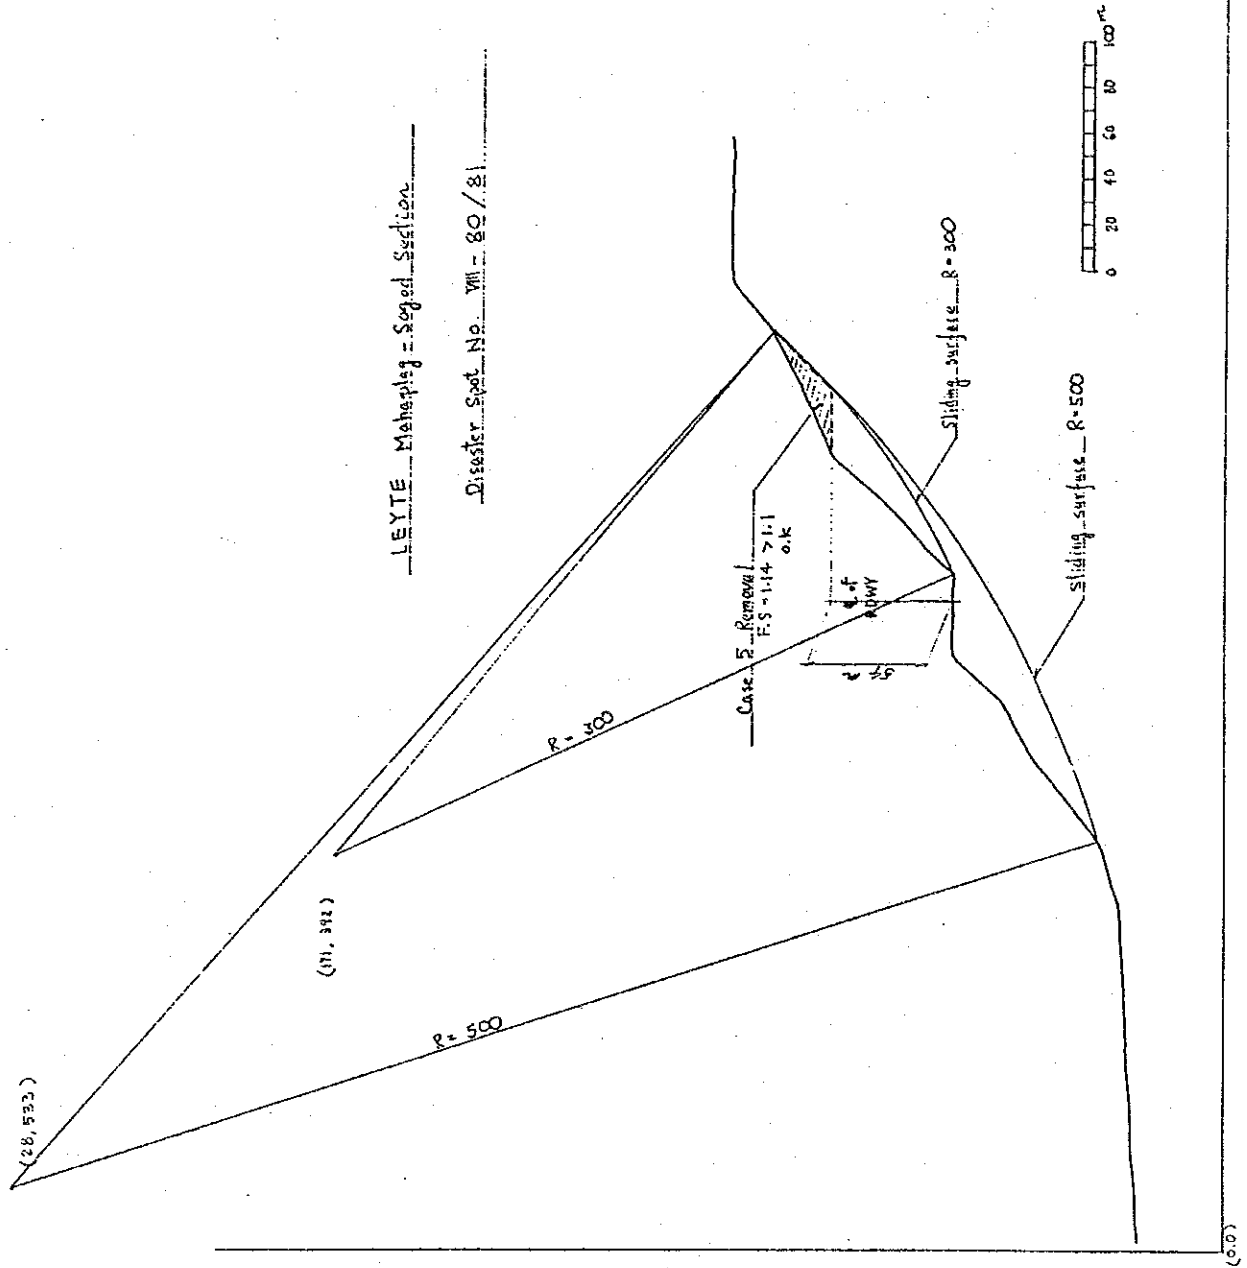
A) STABILITY CALCULATION (Disaster Spot No. VII - 80/81)

$F.S = 1 \longrightarrow \tan \phi = 1.64 \text{ and } c = 0.00 \text{ t/m}^2$   
 $\tan \phi = 0.00 \text{ and } c = 11.75 \text{ t/m}^2$

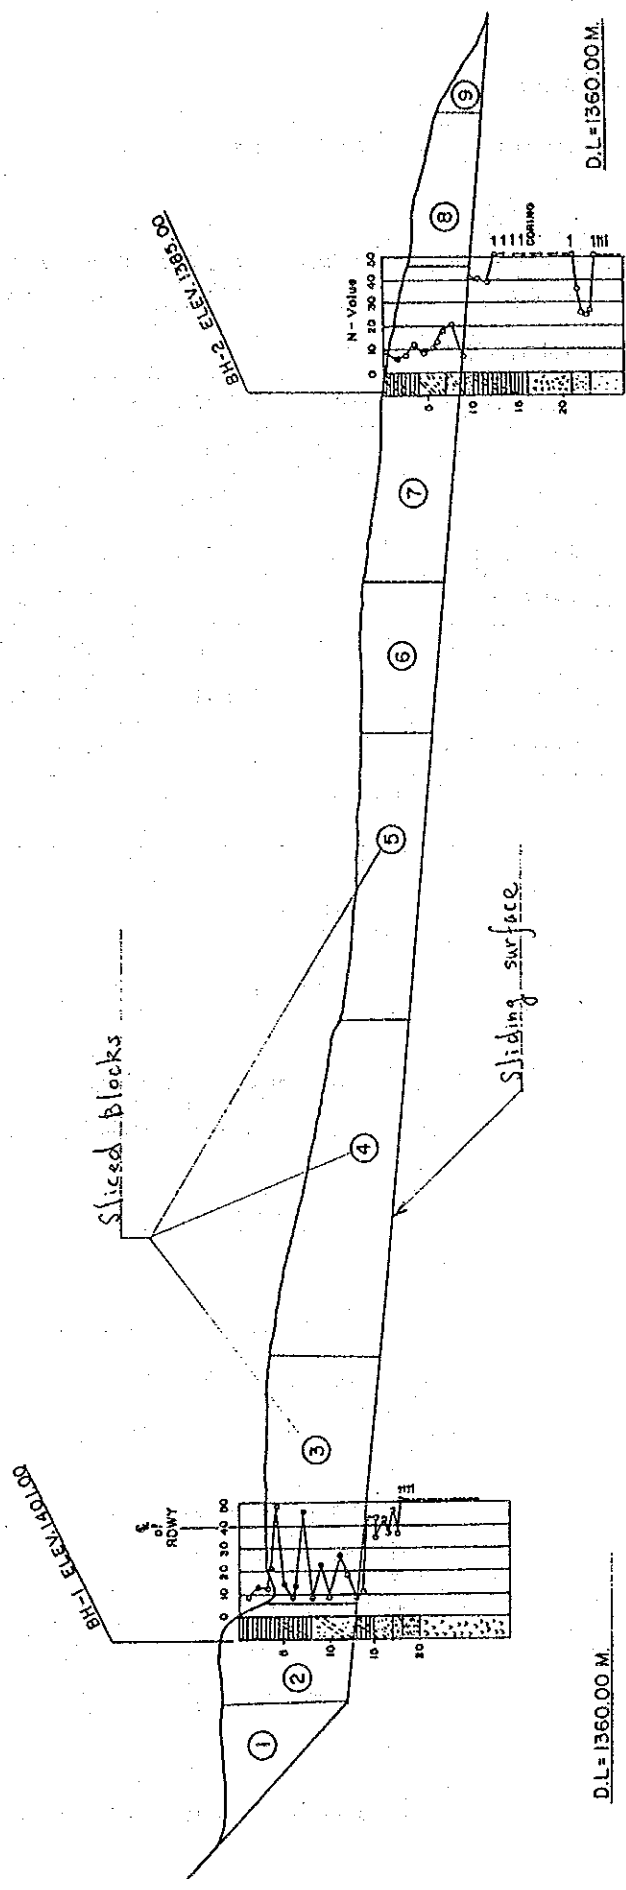
B) STABILITY CALCULATION (Disaster Spot No. IK-48)

$$C = 0 \rightarrow \tan \phi = 0.129 \quad (\phi = 7.4^\circ)$$

$$\tan \phi = 0 \rightarrow C = 1.834 \text{ t/m}^2$$
