SURVEY REPORT
ON
THE LONG-TERM MULTIPURPOSE DAM SCHEMES

APPENDIX II GEOLOGICAL SURVEY

JUNE 1978

JAPAN INTERNATIONAL COOPERATION AGENCY

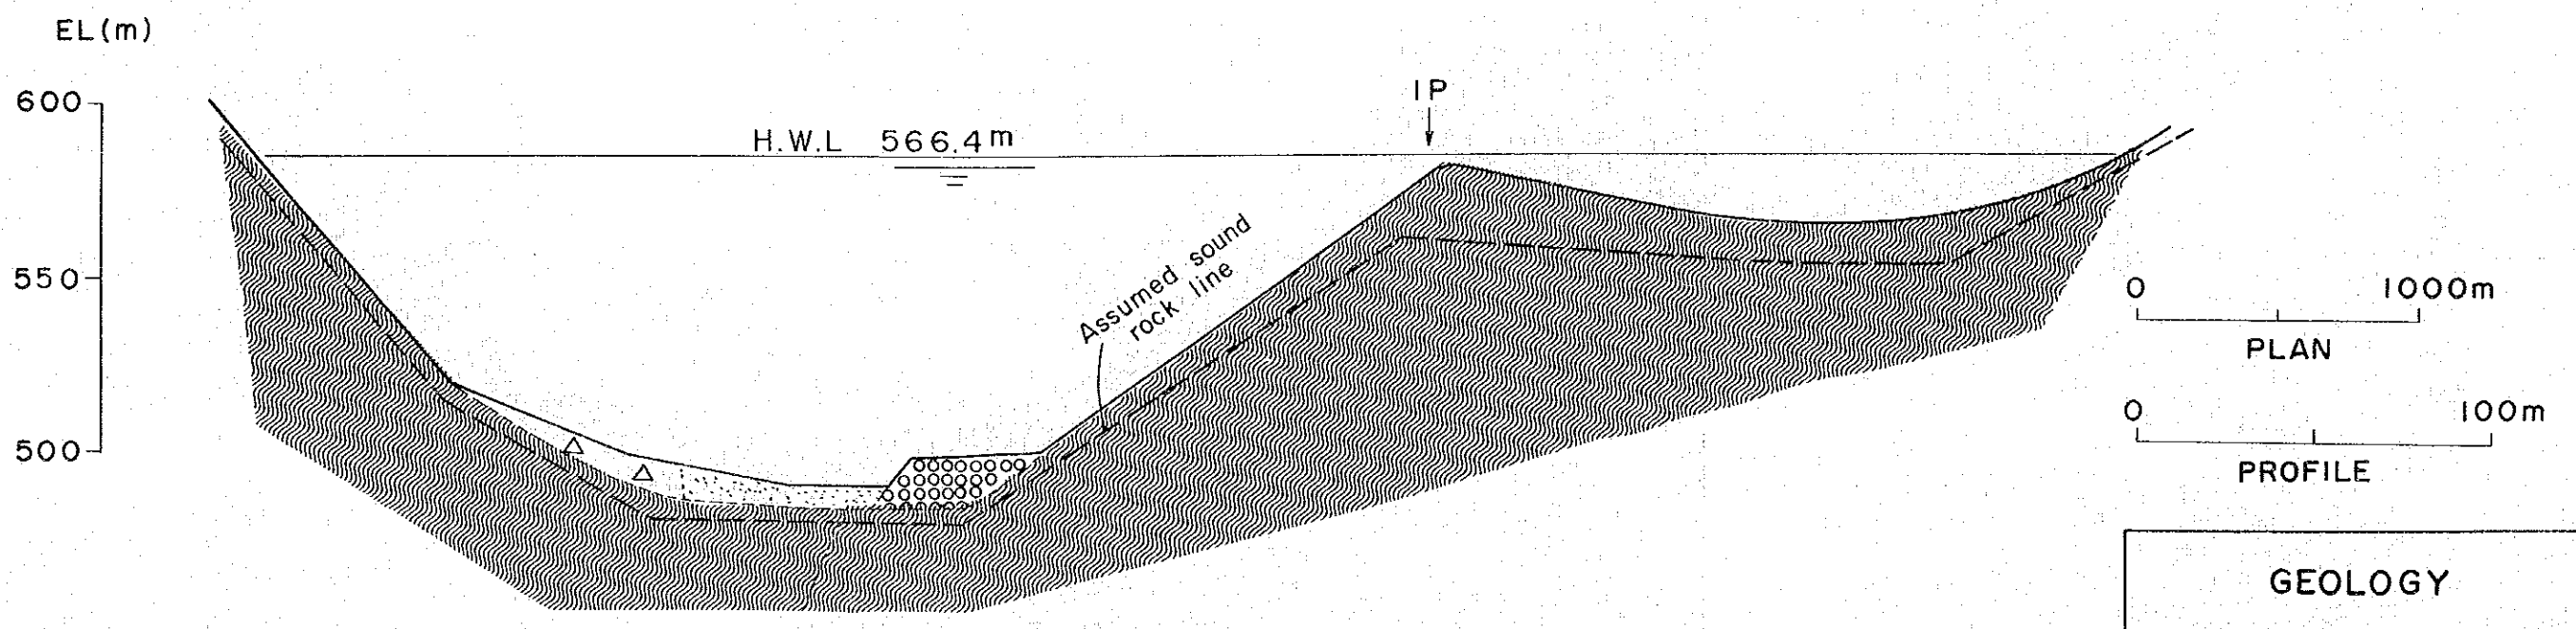
GEOLOGY
 2-23 HUPYEONG(後坪)
 Feb 28, 1978 | Fig - 6

foundation for the dam. In the riverbed, rather thin deposits of gravel are covering hard and sound base rock of granite gneiss underneath.

Spillway: Spillway can be laid either on left bank or on right bank side from the geological point of view. However it is better to lay on the right bank side under the topographical conditions --- using the thin ridge as an overflow crest.

Tunnel: Tunnel of 11.5 km length is passing through granite gneiss mass on the right bank side. The gneiss is firm and sound. There may be no big fractured zone that may cause spouting of ground water.

- A) Base rock in the project area is a sound granite gneiss, providing firm foundation for all structures.
- B) Special investigation will be necessary on the thin ridge on the right bank side. Bearing strength and permeability on the ridge ground should be carefully confirmed.
- C) It is required that confirmation and selection of borrow pit for exploitation of impervious materials.

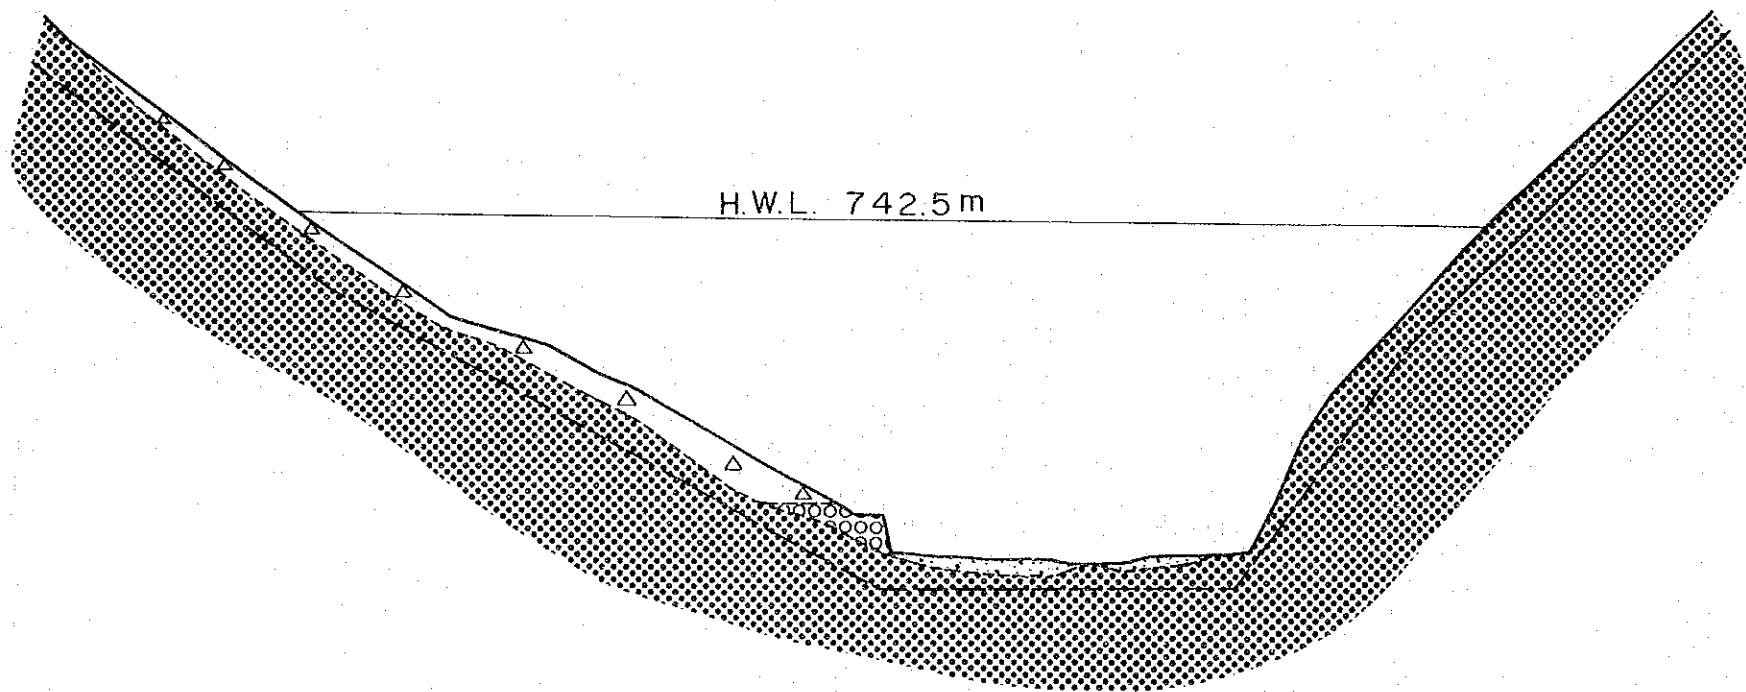
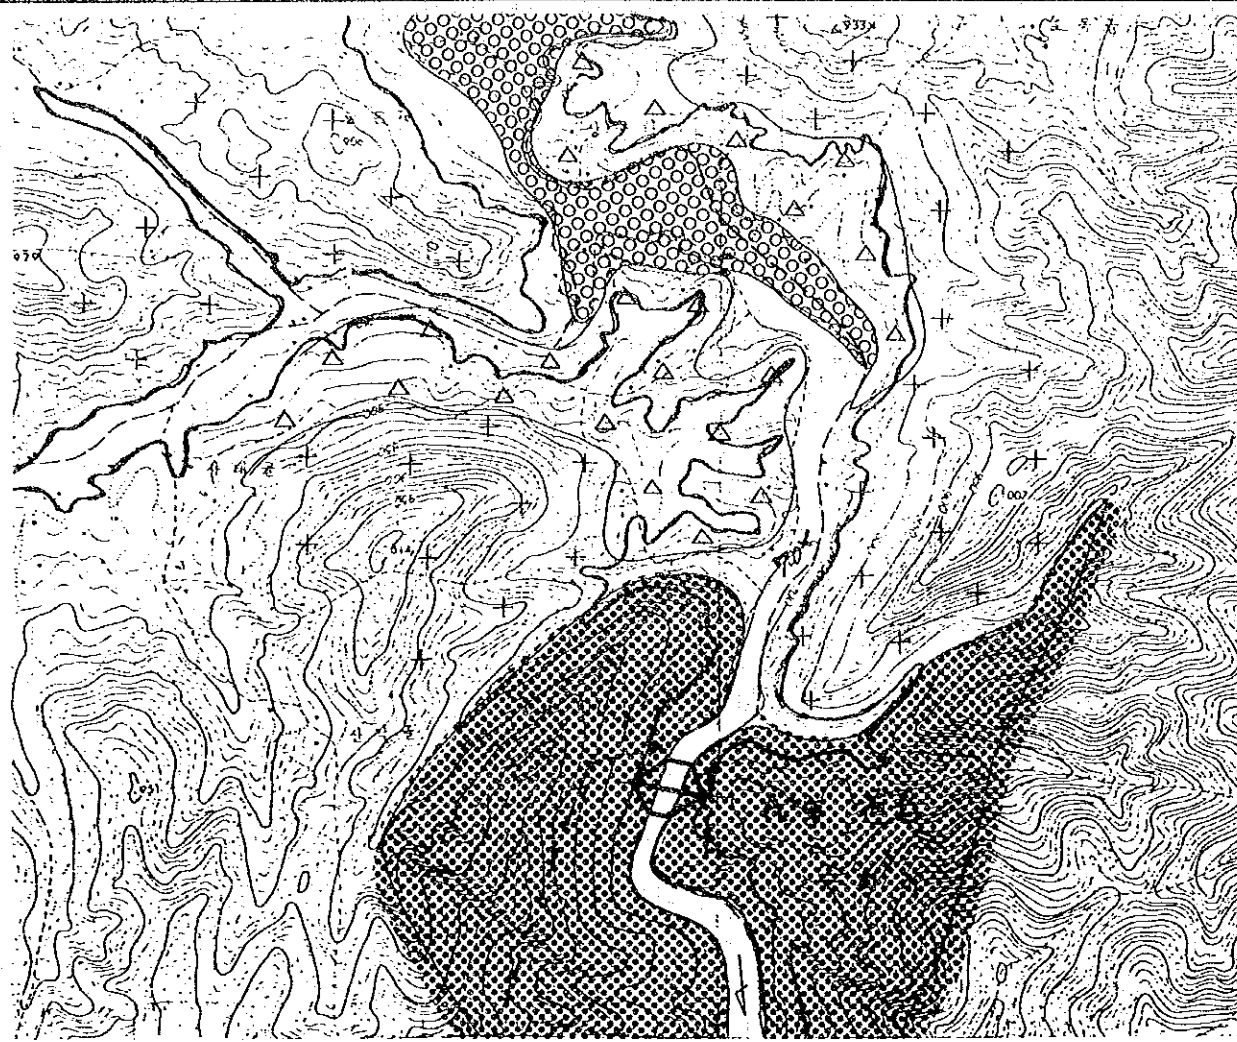
GEOLOGY
6-3. GUJEOL (九切)
 (Alternative site)
 Feb. 20. 1978 | Fig. - 10

Right Abutment: The right bank consists of massive sandstone. There is practically no deposition of slope wash. Although cracks are conspicuous at the surface of the bed rock, it is a sound, good-quality foundation rock as a whole. Gullies can be seen to be developed at high locations (100 m or more from the riverbed) downstream from the temporary axis.

Tunnel: It was not possible to investigate the entire tunnel route. However, the geology of the sector consists of so-called coal-bearing sandstone and shale. Going by the lithological character the rock involves no problem as tunnel foundation. However, since the topography is complex, investigations must be made hereafter regarding weak zones such as faults. Since this is a coal mining area, it is believed detailed geological investigations will have already been made. It will be necessary to fully utilize existing data prior to embarking on investigations.

Penstock and Power station: The two sites are located near Hajapyeon, the junction point of the Songcheon River and a tributary. (The final locations are undecided.) In lithological character, the bed rock consists of alternations of very hard sandstone and shale, and there are no problems involved as foundation rock for the two structures. Attention must be paid to the fact that rock falls are frequent in this area. Consequently, the sites should be selected at locations which are topographically stable.

- A) Selection of the dam axis should be made within the stretch from the present temporary axis upstream to the vicinity of an inflowing stream found at the left bank.

- D) The geological investigation should consist of first carrying out a surface geological survey based on a topographical map of scale of around 1/1,000 to select the dam axis, and the principles for subsequent investigations should be established according to the geological conditions of that site.

- E) With respect to the investigations of the tunnel area, efforts should be made to obtain geological map of the coal mining area as it would be extremely useful if investigations are made using such material as references.

- F) When investigating river terrace deposits in the reservoir as possible concrete aggregate source, it will be necessary to pay attention not only to gradation, but also quality (degree of weathering, strength, etc.) of sand and gravel.

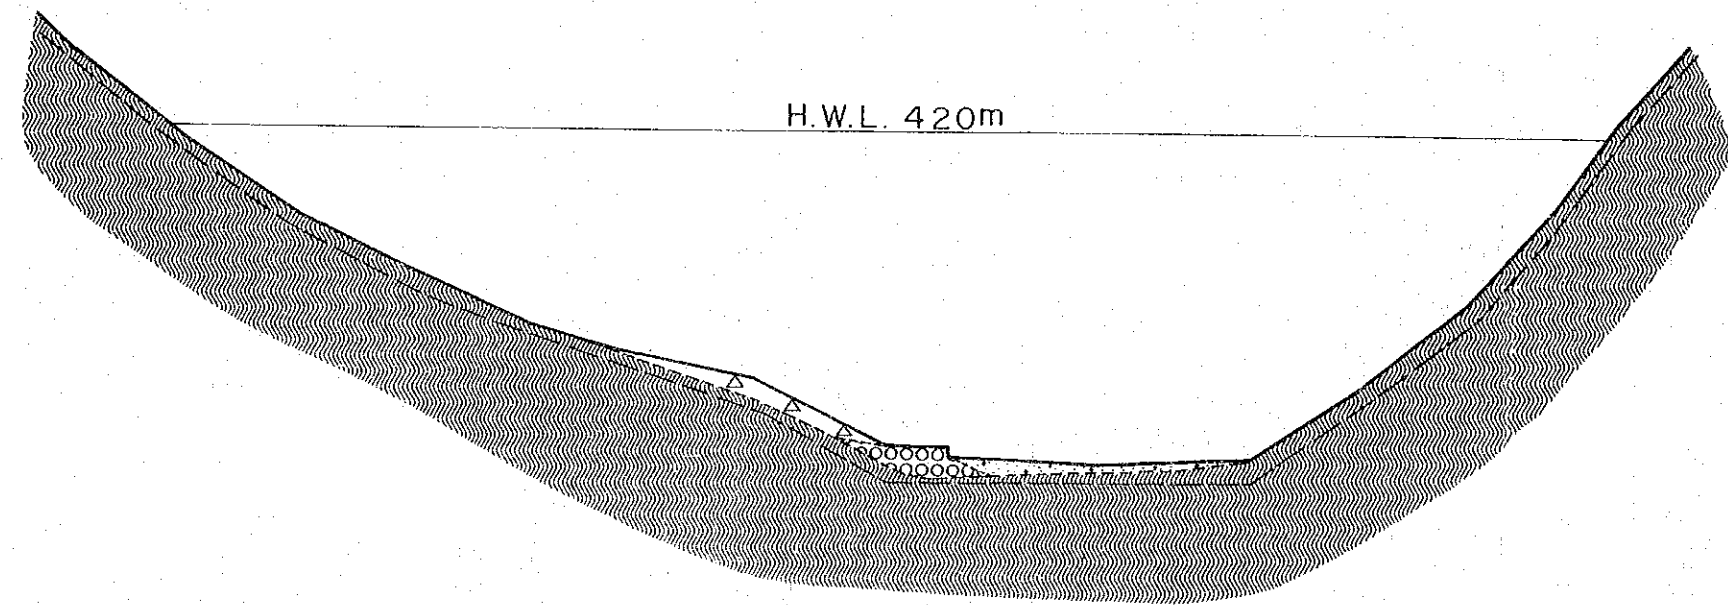
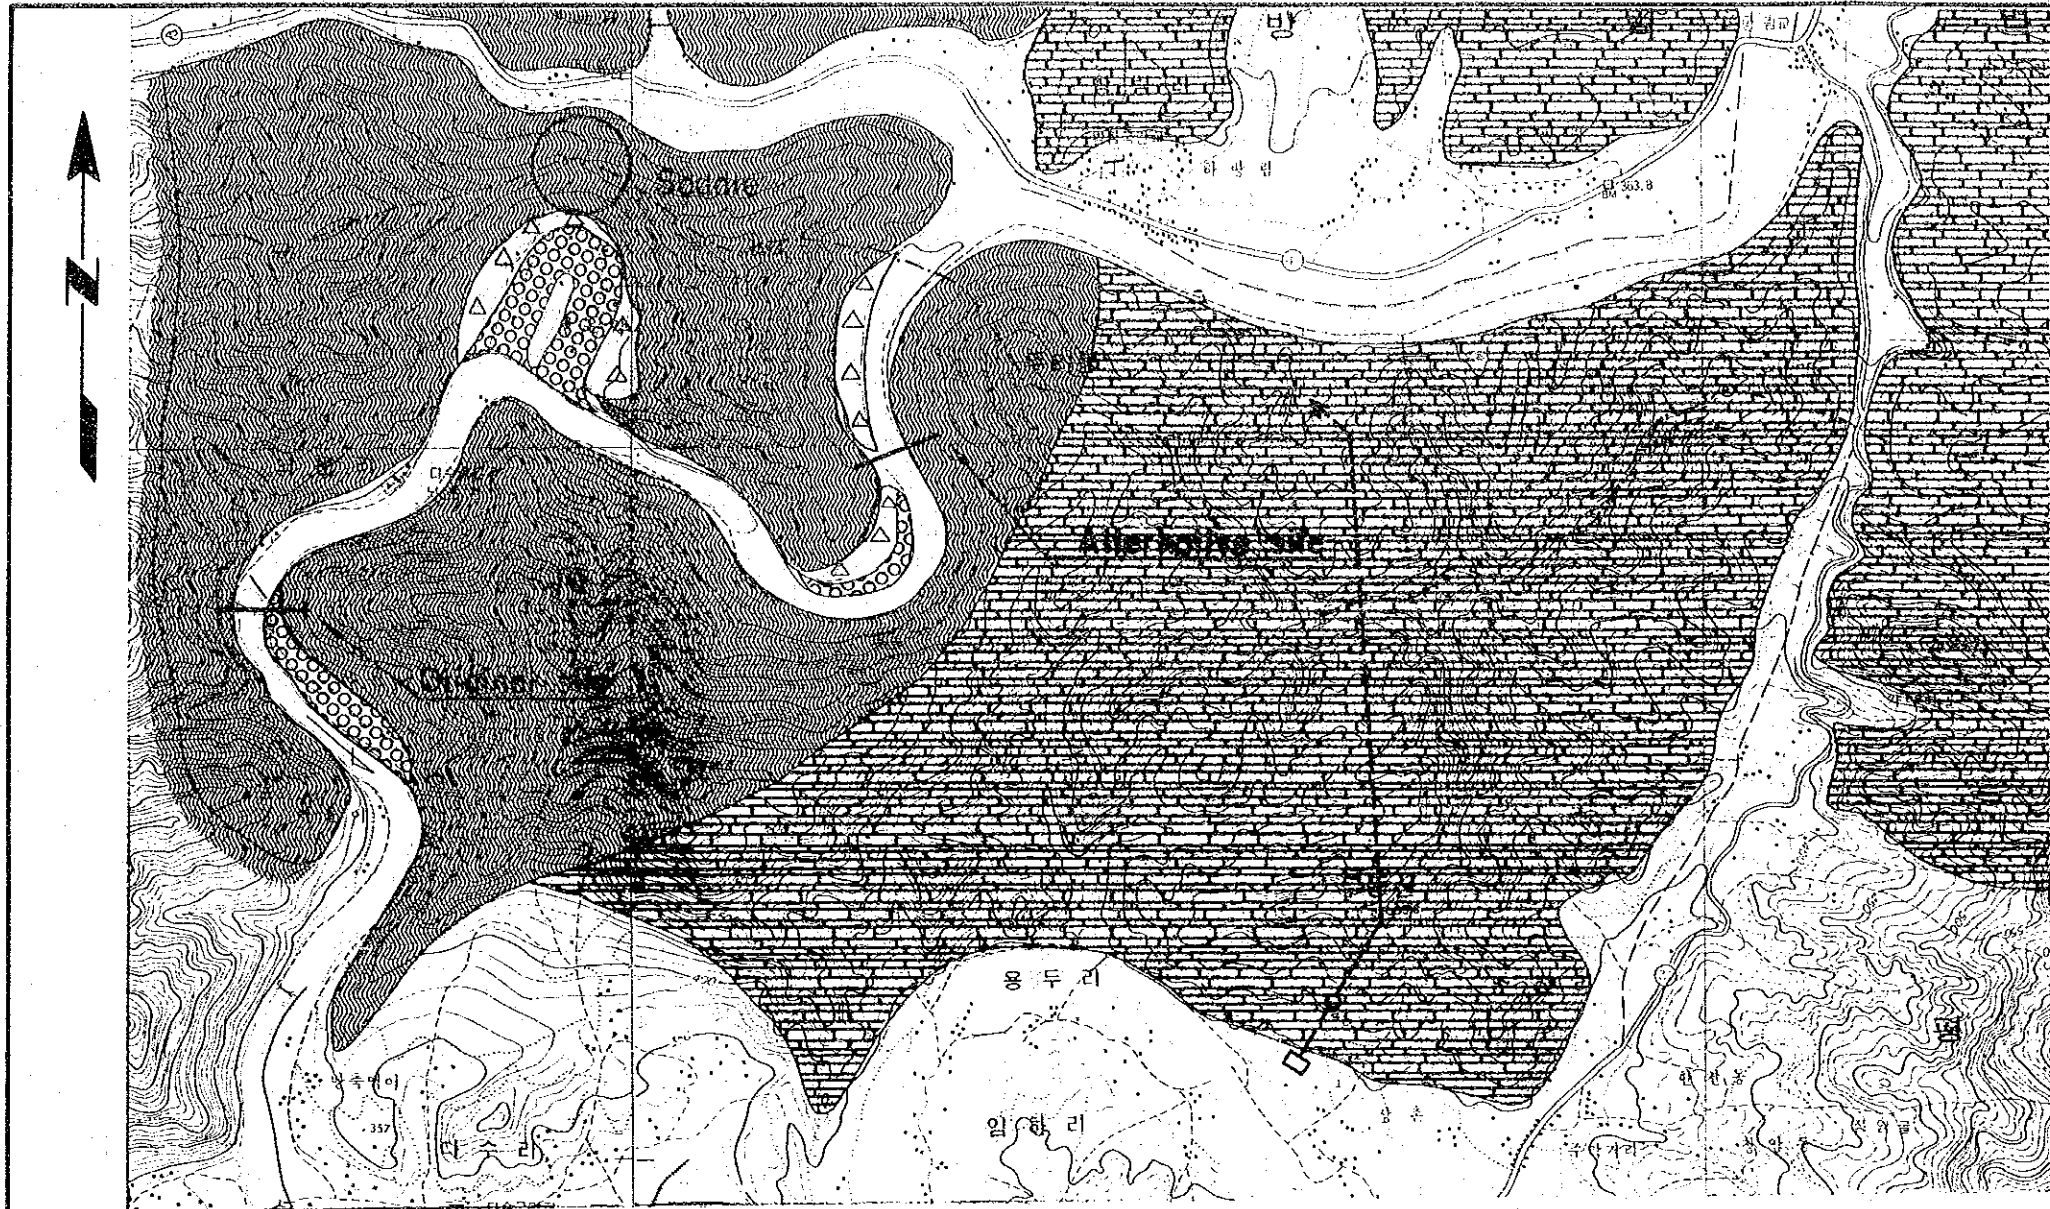
GEOLOGY
7-9. PYEONGCHANG (平昌)
Feb. 20. 1978 | Fig.- 11

Left Abutment: The foundation rock is a hard and dense gneiss. Slope wash is deposited to a relative height about 20 m from the top of the river terrace in a thickness of several meters. There is little cracking of the foundation rock on the whole.

Riverbed: The thickness of the deposits at the present riverbed is estimated to be not more than several meters. However, there is a river terrace deposit approximately 40 m in width of relative height of 10 to 15 m from the riverbed existing on the left-bank side. The foundation rock of the riverbed is thought to be comprised of gneiss.

Right Abutment: The foundation rock is comprised of hard, dense gneiss. Slope wash cannot be seen. There are many open cracks and unstable rock blocks at the surface of exposed rock.

Left Abutment: The foundation rock is mainly gneiss, and schistose gneiss is partially seen. The surface portion of the foundation rock is covered thinly by slope wash. Exposed foundation rock is slightly remarkable in cracking and has been subjected to weathering.

Riverbed: The entire width of the river is covered by sand-gravel estimated to have a thickness of around 5 m. Estimating by the geology of both banks, the foundation rock is thought to be gneiss. From a topographical judgment, it is inconceivable that a large-scale weak zone exists at the riverbed.

Right Abutment: The abutment consists of hard gneiss, but has numerous open cracks and is unstable as a whole.

In case the alternative damsite is selected, there is a risk of leakage at the saddle. This saddle has a width of about 300 m at El. 420 m on a 1/25,000 topographical map. The foundation rock at the surface consists of hard but cracky gneiss. The reservoir side slope is approximately 30°, and the downstream side slope is a steep 35° to 45°. The reservoir side slope is covered by a thin slope wash, but the downstream side has numerous outcrops of bedrock, and moreover, there are rock falls (gullies) at places.

- A) According to judgments based on topographical and geological conditions of the both damsites, the original site is more stable than the alternative site.
- B) In case of the original site, it will be necessary for the thickness of the terrace deposit at the left bank to be investigated, together with which it will be necessary for investigations of terrace materials to be made whether it will be permissible for the terrace deposit to be left in the rockfill zone.
- C) Since the foundation rock of both abutments of the original site is cracky at the surface portion, drill holes combining permeability tests will be required.

- D) In case of the alternative site, it is necessary for the dam axis to be selected based on topographical and geological data upon detailed surface geological surveys using detailed topographical maps. When feasible as the damsite, it will be necessary for investigations to be made of the permeability of the site foundation rock by drill holes along with preparation of a topographical map of the surroundings of the saddle site.

- E) A fill-type dam is proposed, and it will be necessary for thorough investigations to be made beforehand of impervious core materials. The site where there is possibility of obtaining material will be limited to the gently sloped area at the skirt of the mountain. (The flat area is comprised of sand-gravel, while the steeply sloped area consists of a deposit of rock fragments.)

- F) Investigations for rock materials should be carried out considering use of river and terrace deposits along with investigations of rock quarries.
- G) This reservoir is in an area where limestone is distributed. Geological investigations in the reservoir area should be conducted based on 1/10,000 to 1/25,000 topographical maps. Further, when these investigations are made, investigations of rock fall areas should be carried out at the same time.
