3-9 Suju

(1) Outline of Project

Dam type : Rockfill
Dam height : 107 m
H.W.L. : 432 m
Power station : Dam and Tunnel

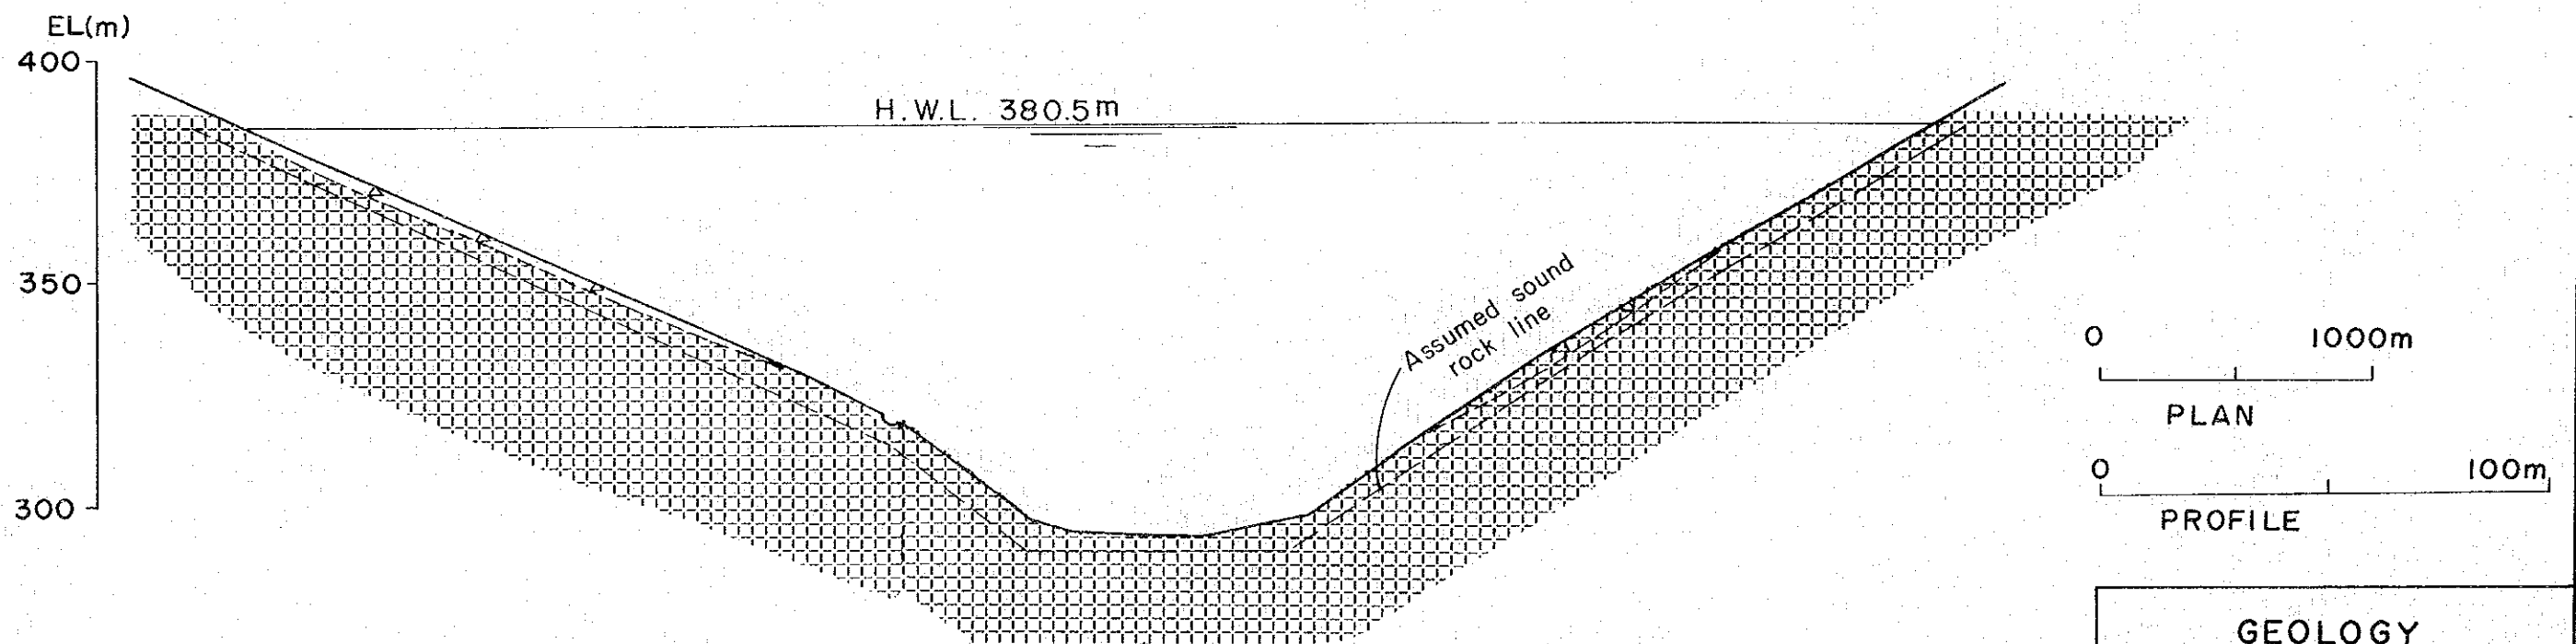
GEOLOGY
 16-51 HAMYANG (咸陽)
 (SININWOL) (新引月)
 Feb. 27. 1978 | Fig.- 20

A damsite is selected at narrow gorge, just downstream of wide open valley. Left bank slope is very steep of 40° to 25 m height and suddenly changes to 25° slope. Riverbed is 50 m in width with rocky floor. Right bank is single slope of 32°. Many big rock blocks scattered on the slope. Tumbling down of these blocks during construction excavation should be carefully protected. Base rock itself, however, is firm and stable, never cause sliding.

Fresh diorite is exposed on the riverbed, accompanying no major fault or fracture. On the right bank, base rock of diorite is also expected underneath scattered blocky rocks and weathered and cracky zone of 2-3 m thickness.

Sound diorite occupies whole damsite, providing firm foundation for dam building.

- A) The proposed damsite is a most favourable site from a view-point of topographical and geological conditions.
- B) Location of fractured zones along the tunnel route should be thoroughly investigated before final layout of the tunnel course.

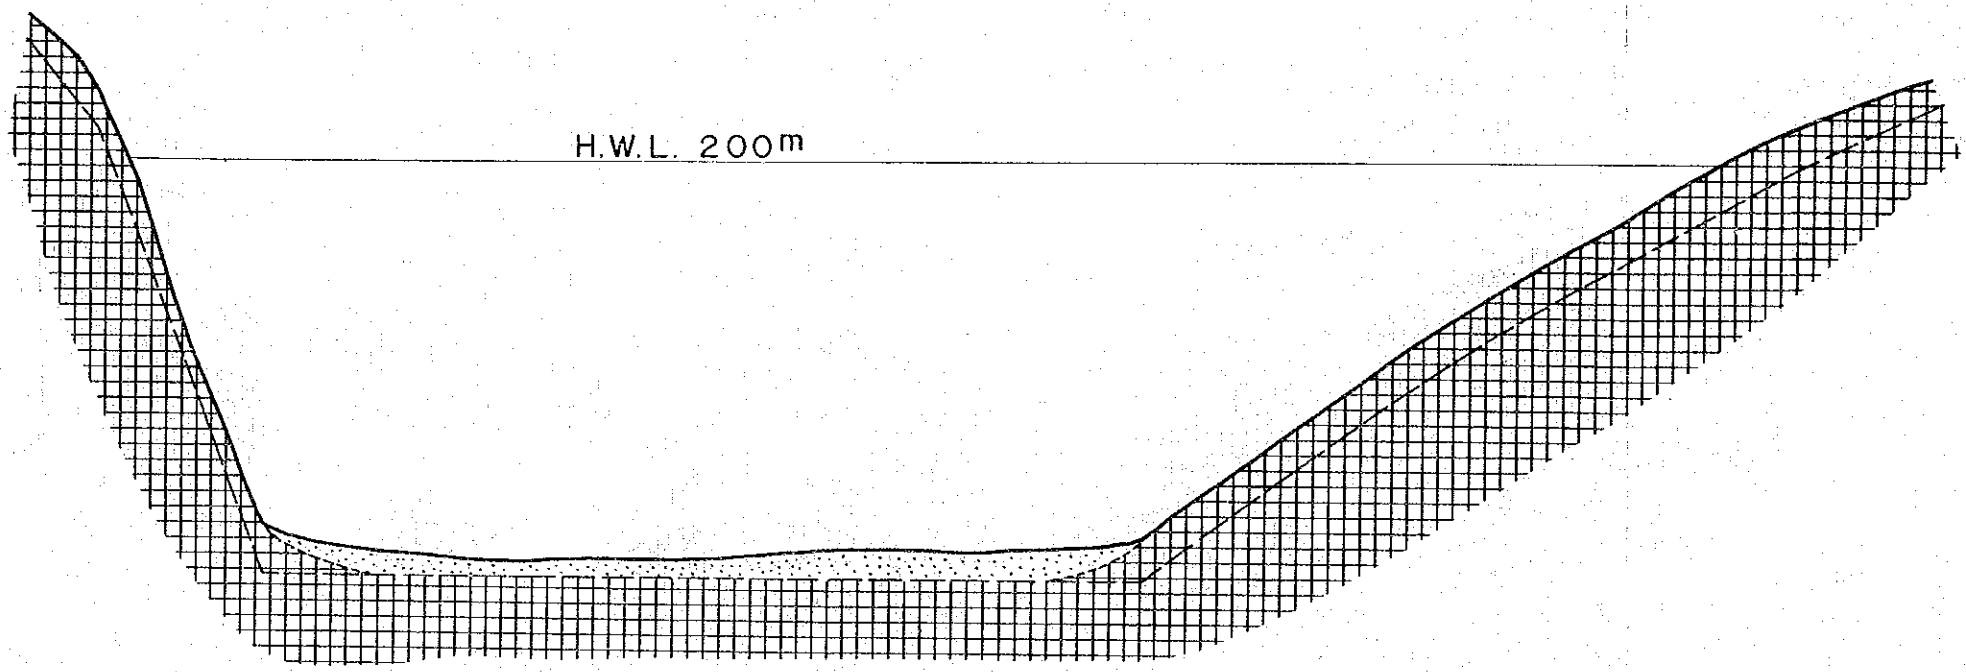
GEOLOGY
19-63. SUTONG (水通)

River Abutment: Similarly to the left abutment, the geology of the abutment is comprised of good-quality rhyolite-porphyry. Base rock is exposed as a whole with only small-scale slope washes seen to be deposited at small gullies upstream and downstream of the dam axis. There are some irregular cracks and openings of joints seen at outcrops. The orientation of joints are the same as at the left abutment. Weak zones such as faults could not be distinctly recognized during the reconnaissance.

- A) The foundation rock at the damsite is sufficiently good as the foundation for the proposed dam.

- B) It is considered that the depth of excavation for the dam foundation will be 1 to 2 m after removal of unstable rocks.
- C) It will be necessary to further carry out permeability tests by drill holes and study the need for rim grouting at the ridge at the top of the left abutment. At the time of this reconnaissance, it will be necessary for investigations to be made also on the downstream-side gully.
- D) Since permeability tests were not performed at the time of investigations for the 1962 Report, it will be necessary for several drill holes with permeability tests to be provided at the left and right abutments and the riverbed for data needed to prepare a foundation treatment plan. In such case the drill holes at the riverbed should be made inclined holes to confirm the contact between dyke and base rocks, and whether there are faults at the riverbed.
