The objective of the Project is to rehabilitate the Demonstration Unit of N-N Irrigation Project which was seriously damaged by the flood in 1987.

RECORD OF DISCUSSION FOR DESIGN DETAILS (2ND)

ON
REHABILITATION OF IRRIGATION UNIT
IN
N-3 IRRIGATION PROJECT

NARAYANGANJ-NARSINGDI IRRIGATION PROJECT
REHABILITATION OF DEMONSTRATION UNIT
THE PEOPLE'S REPUBLIC OF BANGLADESH

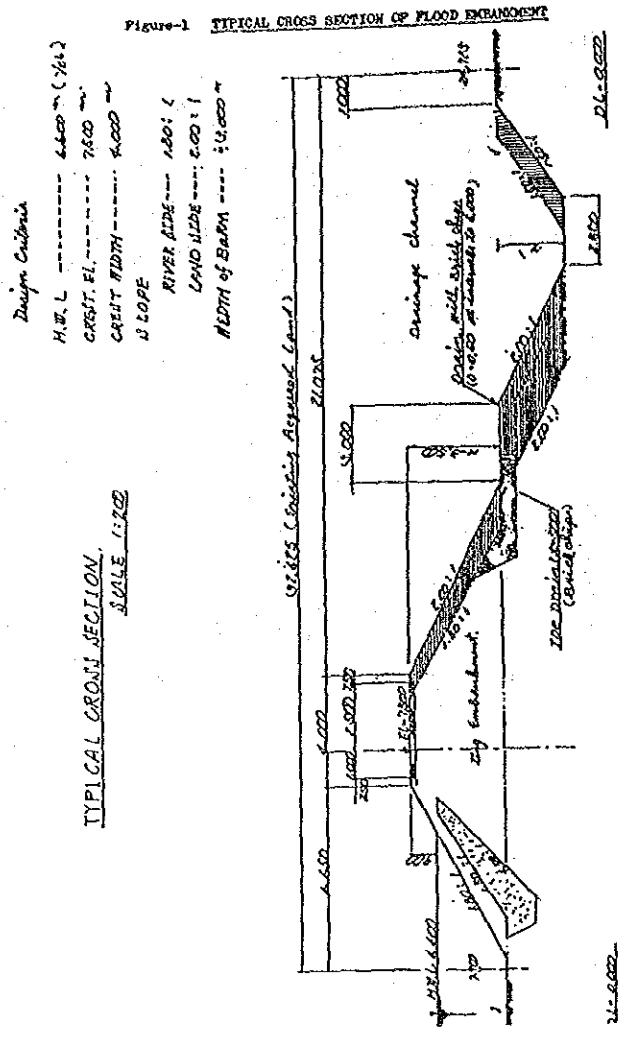
Figure-1 TYPICAL CROSS SECTION OF FLOOD EMBANKMENT

- 1) Widening of crest: 4.0 m (3.0 m after Emergency Repair Work)
- 2) Making slope gentle: 1 : 2.0 (1 : 1.8 - ditto -)
- 3) Width of berm step: 3.0 m (as same as original width)

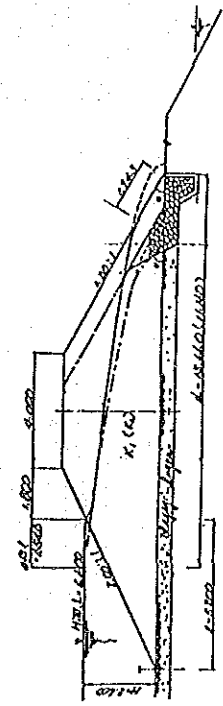
Figure - 2a SEEPAGE LINE IN THE EMBANKMENT (Without Core Wall)

According to the results of geological investigation (boring on the flood embankment), the flood embankment consists of loose fine sand or soft clayey silt, which are not homogeneous. Especially in the section beyond some 3.40 km point from the Pumping Station, it is commonly found out that the existing (original) embankment was built with unsuitable materials, such as loose fine sand and silt with N-value of 2 - 4 and has many animal holes and some voids seem to be due to insufficiency of compaction in its body. These conditions are much similar to the brached portion. The above mention means that the embankment body in this section is much permeable more than the other section.

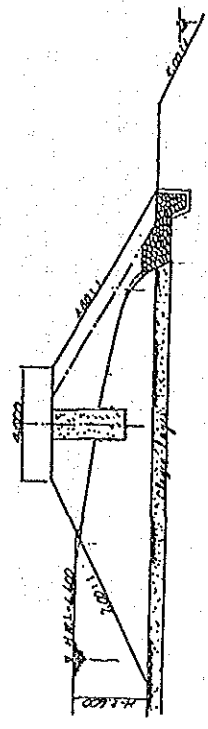
Figure - 3a CENTER CORE (suggested by E/DB)

(d) Core-wall:
Core-wall facing outside slope may require regular maintenance due to slope failure. Accordingly the Counterpart requested a study for the feasibility of a center core in place of the side core proposed by the Team.

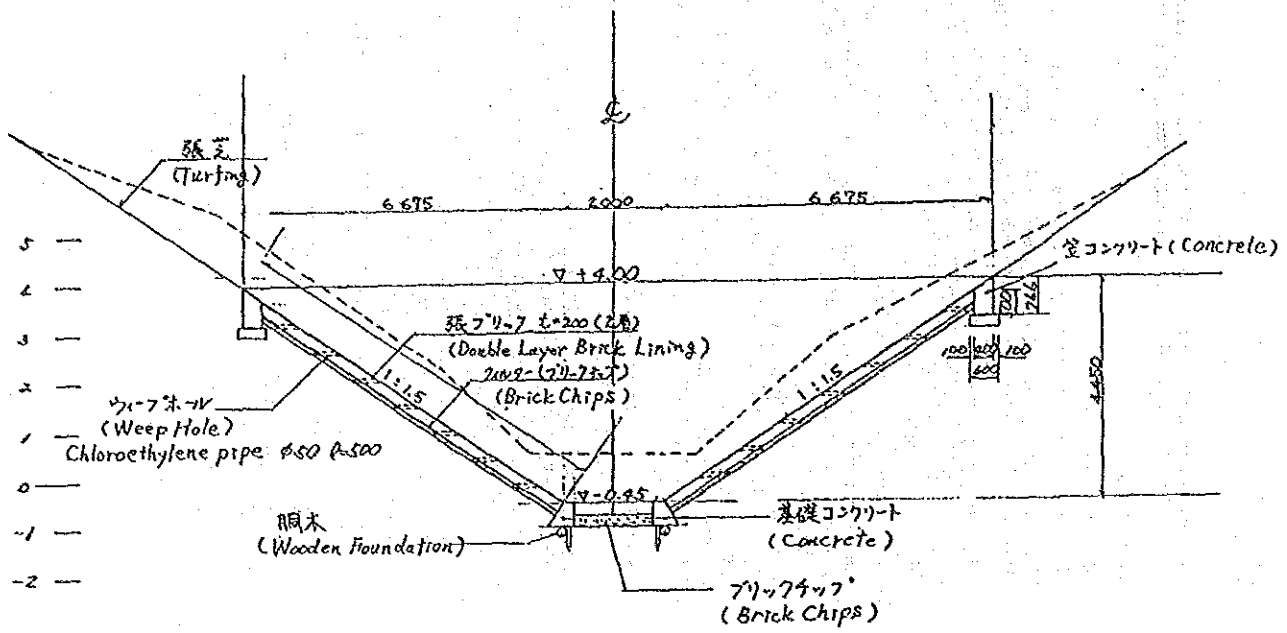
Figure - 5 TYPICAL CROSS SECTION OF INTAKE CANAL
SCALE 1 : 100

The canal is about 6 - 7 m high in its slope height, and many parts of slope eroded and portions partly collapsed are found out in its slopes.

The study team judges that the slope damages of Intake Canal might be due to duplication of the following affective factors.

- Collapse or sliding of slope caused by repetition of water flow and up and down of water level by tide in dry season and by drainage water in rainy season
- Cutting waterway slope steeper than the upper slope at re-excavation of the canal bed on maintenance work
- Leaving the re-excavated soil with an unstable condition near by or in the slope of the canal.
- Erosion due to the natural drainage water from surrounding areas (lower parts of slope)
- Soft soil in geological factor. (related to water content)
- Erosion caused by cozing the under-ground water out of slope.

- Recutting the existing slope to remove the loose earth on it and to lower the level of canal bed
- Protecting the cut slope by brick lining with weep holes for the under ground water behind it to ooze out
- Placing a wooden beam foundation under the concrete bases because of soft ground on the bed.
- Stability of slope will be analyzed in home office work in Japan based on the results of geological and soil investigation

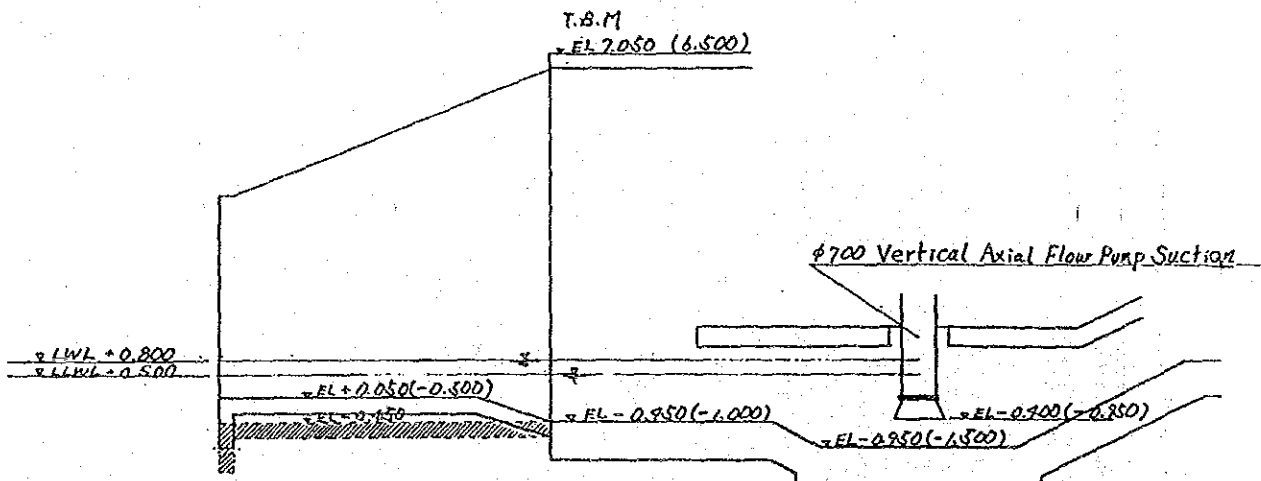
Figure - 6 PART ELEVATIONS AT PUMPING STATION

- 1) The Team explained that as the existing pumping station has been built 55 cm higher than the exact design level, this caused difficulty on water supply in the irrigation season. The Team thereby proposed that difficulty relating to pumping station might be almost cleared away by removing the river side inlet (apron) which makes an obstacle at the inflow of the water, 50 cm down from its existing level. The Team, therefore, proposed the method shown in Annex 2-C in the Minutes of Meeting for a basic design plan of improvement of Inlet of the Pumping Station. The counterpart mentioned that the existing pumping equipment is systematized automatically to stop the pumping operation at the water level of + 0.80 m. (actually this level corresponds to 1.35 m). As an improvement to the present difficulty on water supply, the Team further proposed that the resetting the float switch down to a lower position will make it possible to operate the pump much longer than before.

The both members above have basically understood that a difficulty at operation of irrigation is caused by a fact that the entry part of the Pumping Station was built 0.55 m higher than the original design level.
