VI. STUDY ON THE GATE LEAVES AND RELATED FACILITIES

6-1-2 The Present Condition of Gate

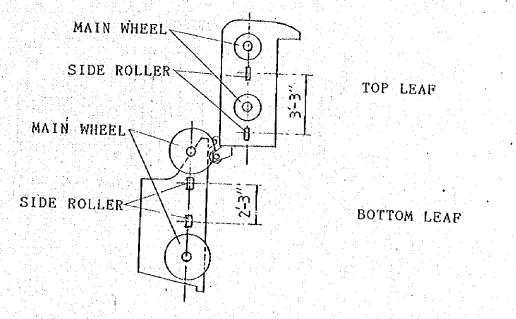
(1) The position of side rollers

The inclination of the gate is impossible to control, since the distance between side rollers is small, especially that of bottom leaf is very small.

In cases where the distance between guides is more than 45'. 0, it is impossible to control the inclination of the gate, when the gate is rubbing against the guides.

The Rubber or both sides will be badly damaged.

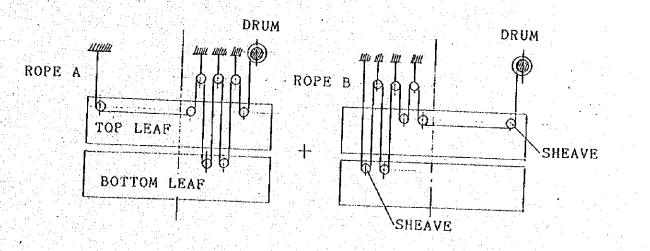
(2) Wiring
Wiring system of the existing gate is used for single leaf gate, which is a very rare case.
The reasons above are as follows:
① The efficiency of wiring is not good, because of the many rope sheaves.
② Smooth operation for double leaf gate is impossible because of the complex wiring mechanism, which normally causes the inclination of the gate due to the unbalance of the both sides wire rope tension and due to the sheave effeciency. This gate is so designed as to minimize, the above unbalance as much as possible, however, it will be impossible to avoid the gate leaf cannot be expected due to

the disturbance of the rubber seal raising ahead and lowering at the hoist drum side.

Accordingly, the existing wiring mechanism is not recommended for the double leaf gate complex sealing system.
