THE STUDY OF ROAD IMPROVEMENT  
BETWEEN SANTA BARBARA AND BELLA VISTA  
IN  
THE REPUBLIC OF BOLIVIA

FINAL REPORT

VOLUME I  
(ENGINEERING)

MARCH 1991

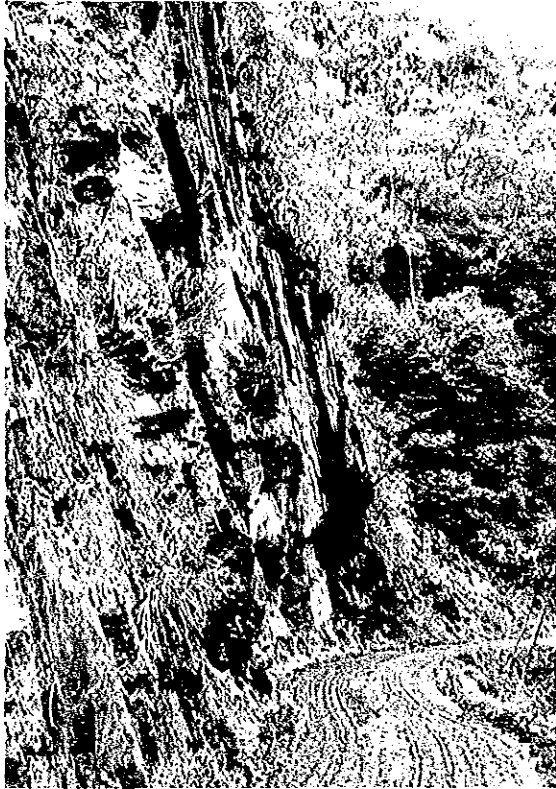
**Photo-4**

Aspect showing the narrow width and insufficient drainage facility on the present road at a location about 14 km from the point of origin.

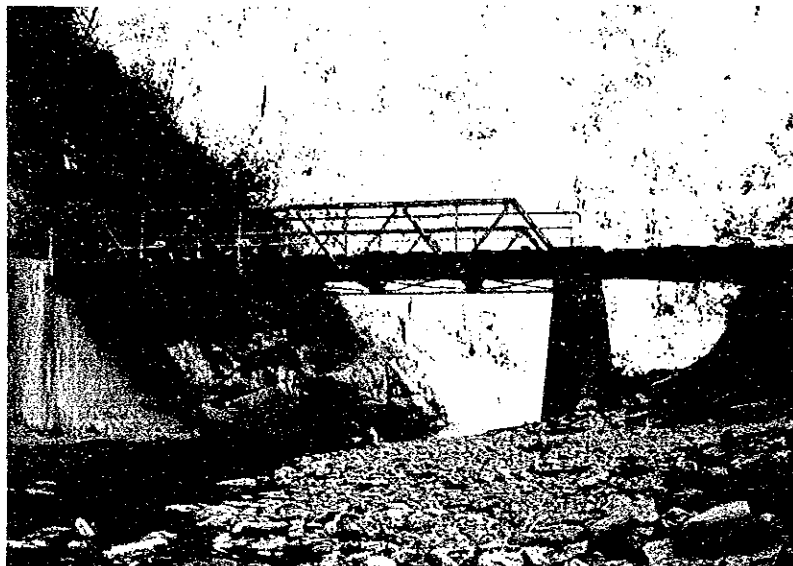
**Photo-6**

Scene of the present truss bridge near Puerto León. The bridge is old and rotten and wooden slabs have been used in temporary treatment.

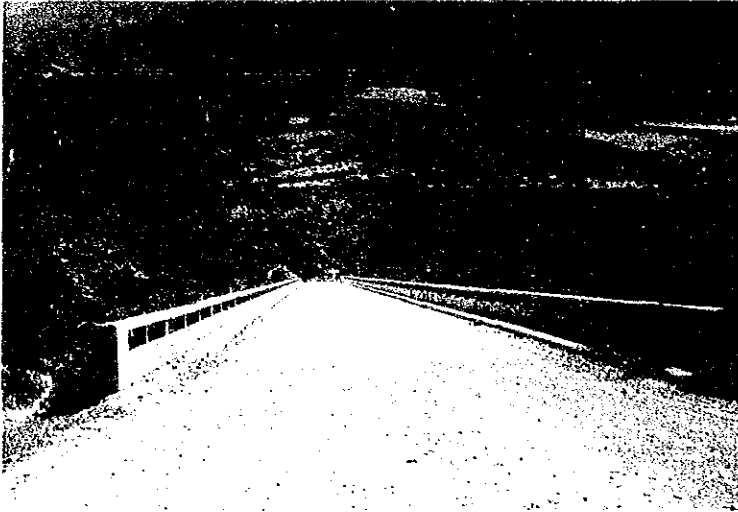
**Photo-10**

Yara Bridge constructed near the village of Yara. Only this bridge does not require reconstruction or improvement in the whole extension of the Study Road.

In other concrete bridges, only hair cracks were seen. Meanwhile, the Yara bridge is in good condition with regard to both the slab and girder.

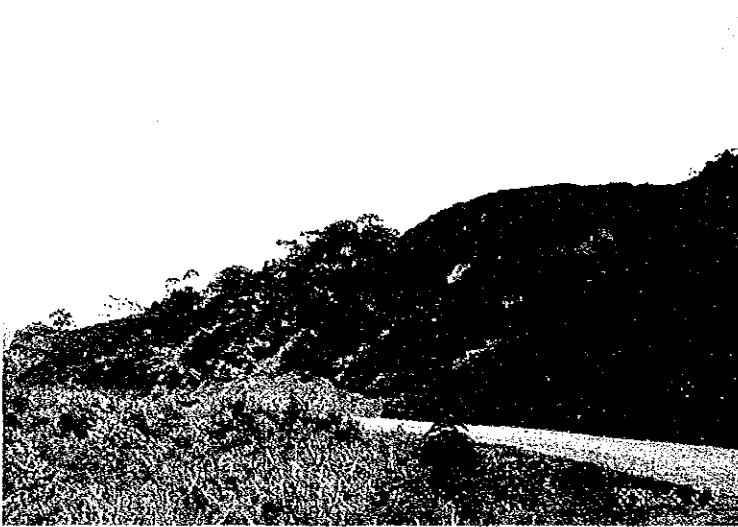
**Photo-11**

Scene of the location 116 km from the point of origin, where landslides occur now and then.

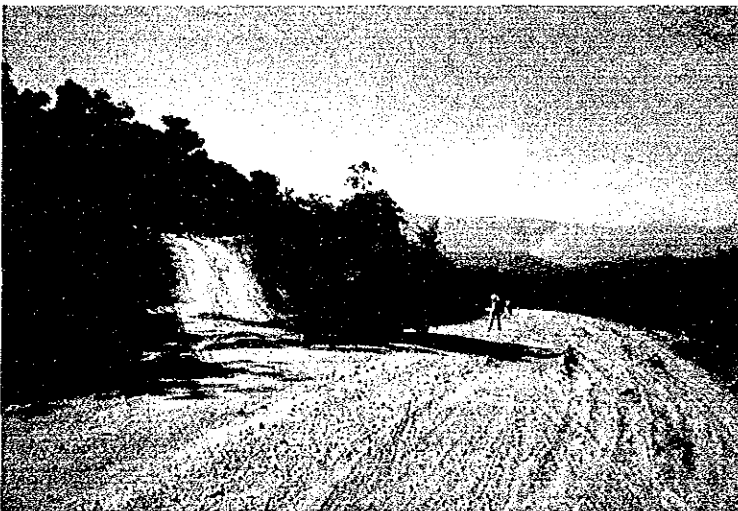
**Photo-12**

Scene of the present road condition at Bella Vista (terminal point of the Study Road). The road in the foreground of this photo has been already improved by the SNC.

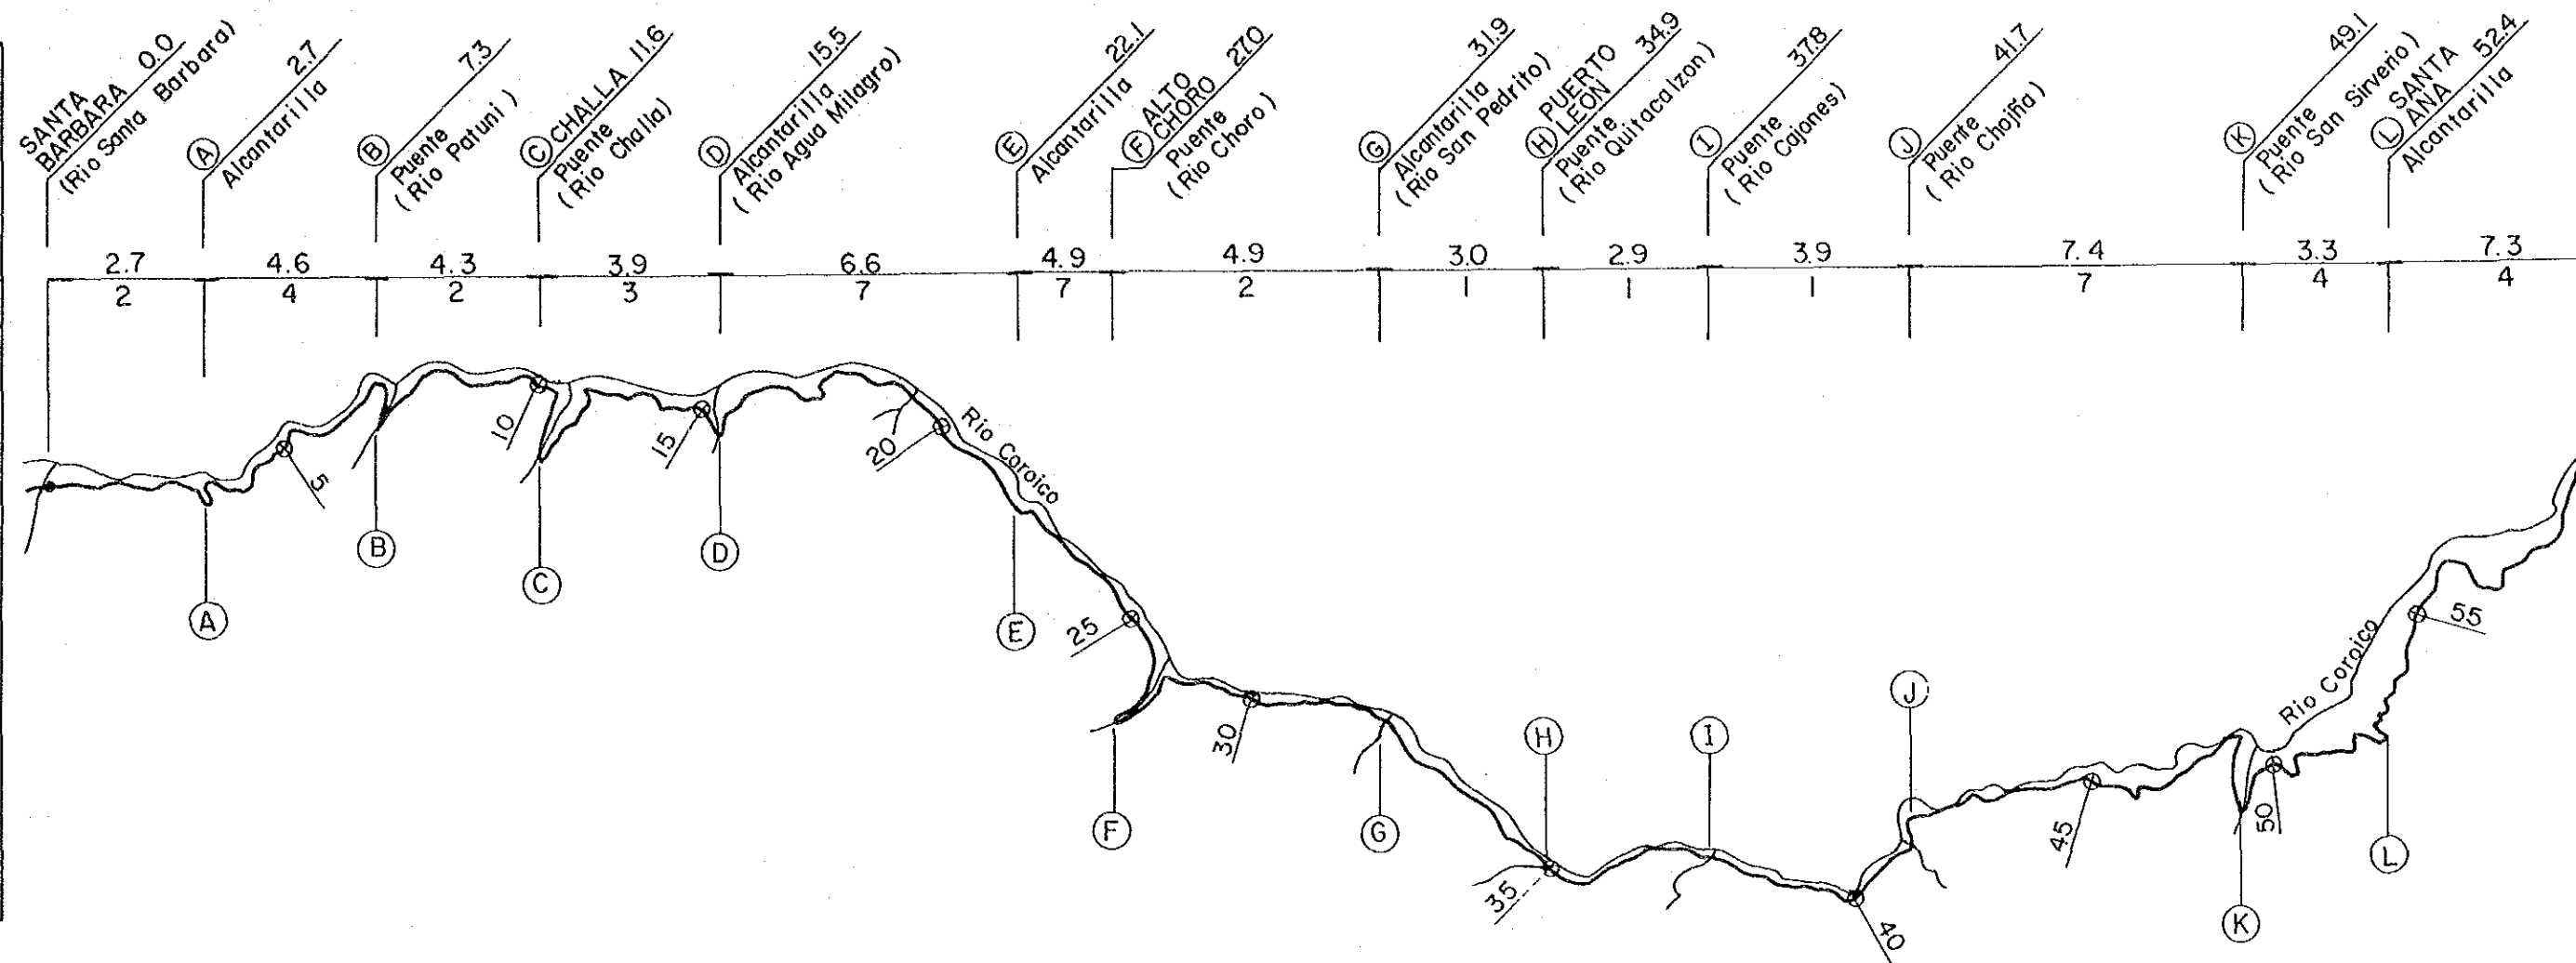
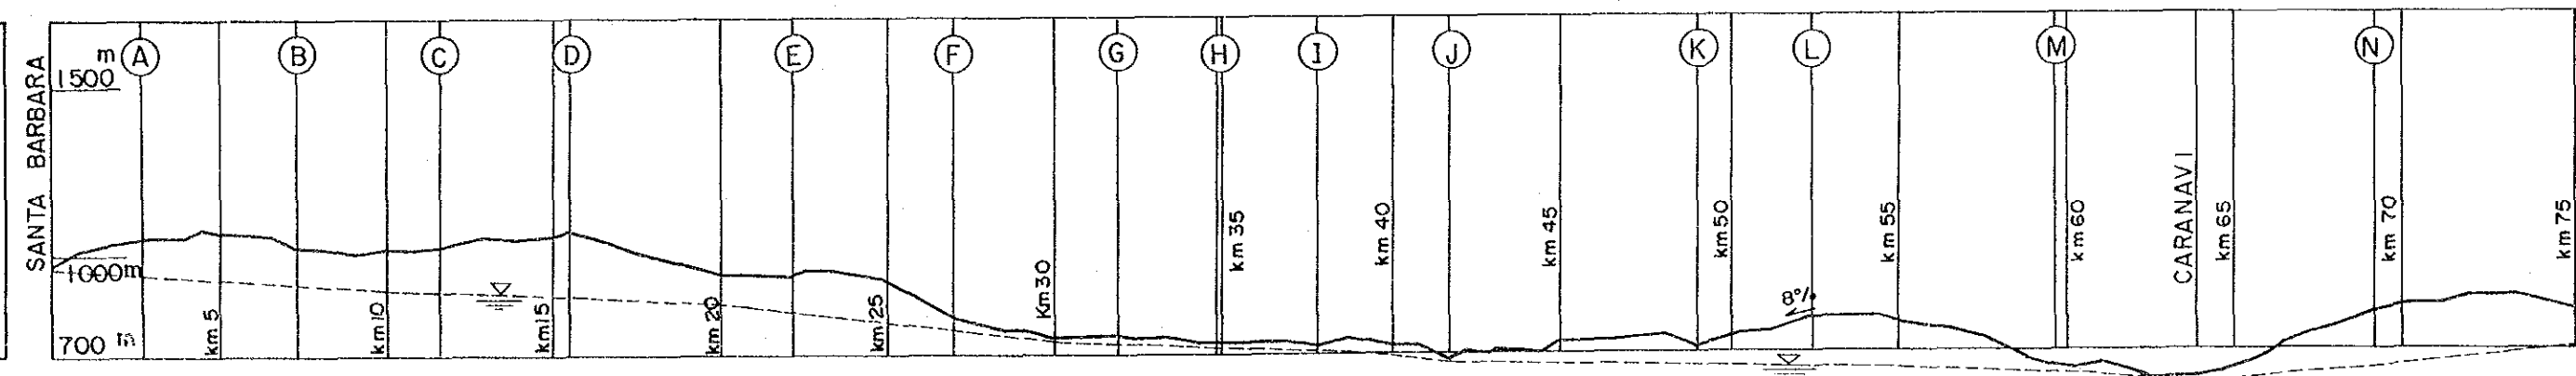
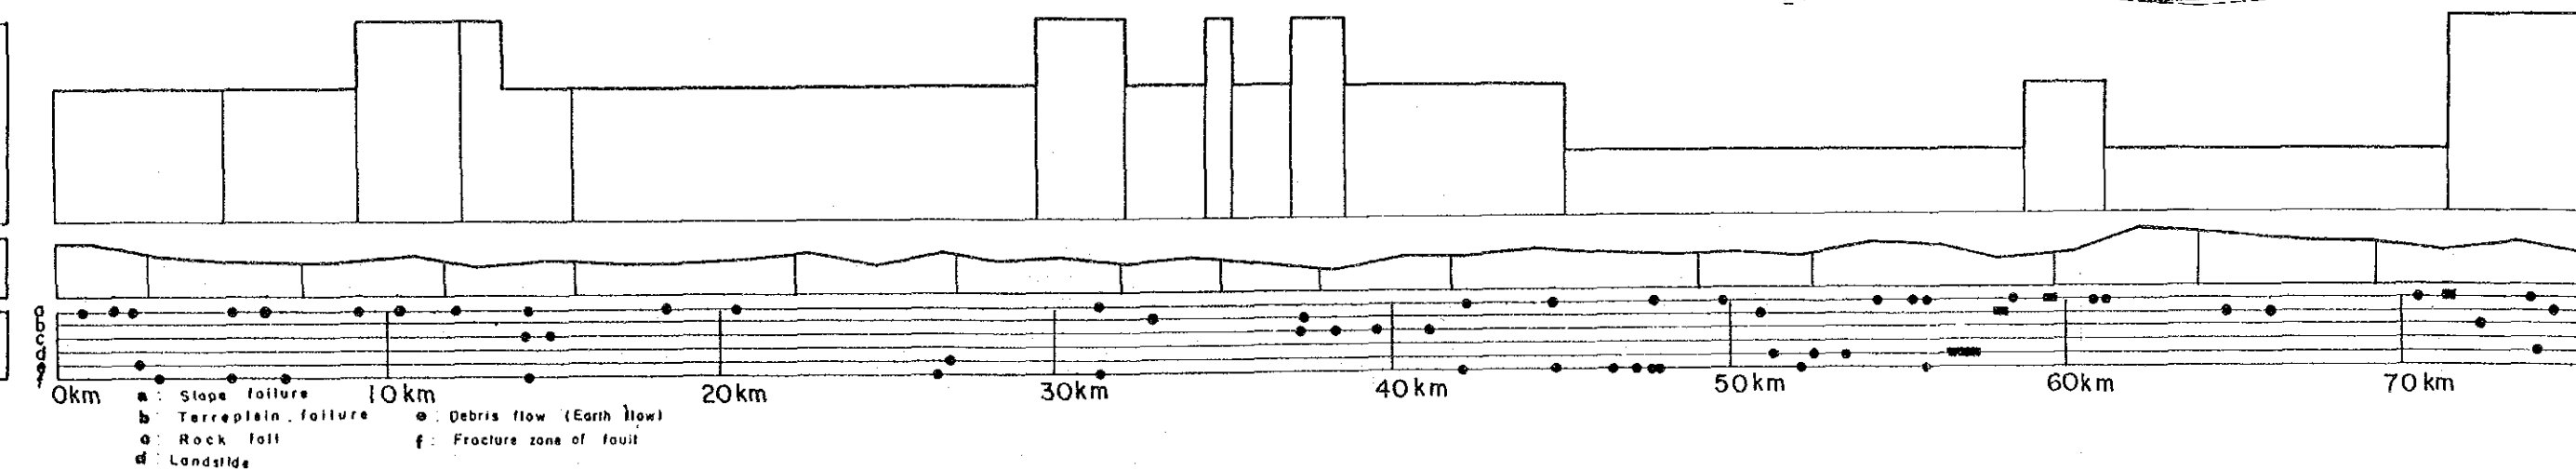
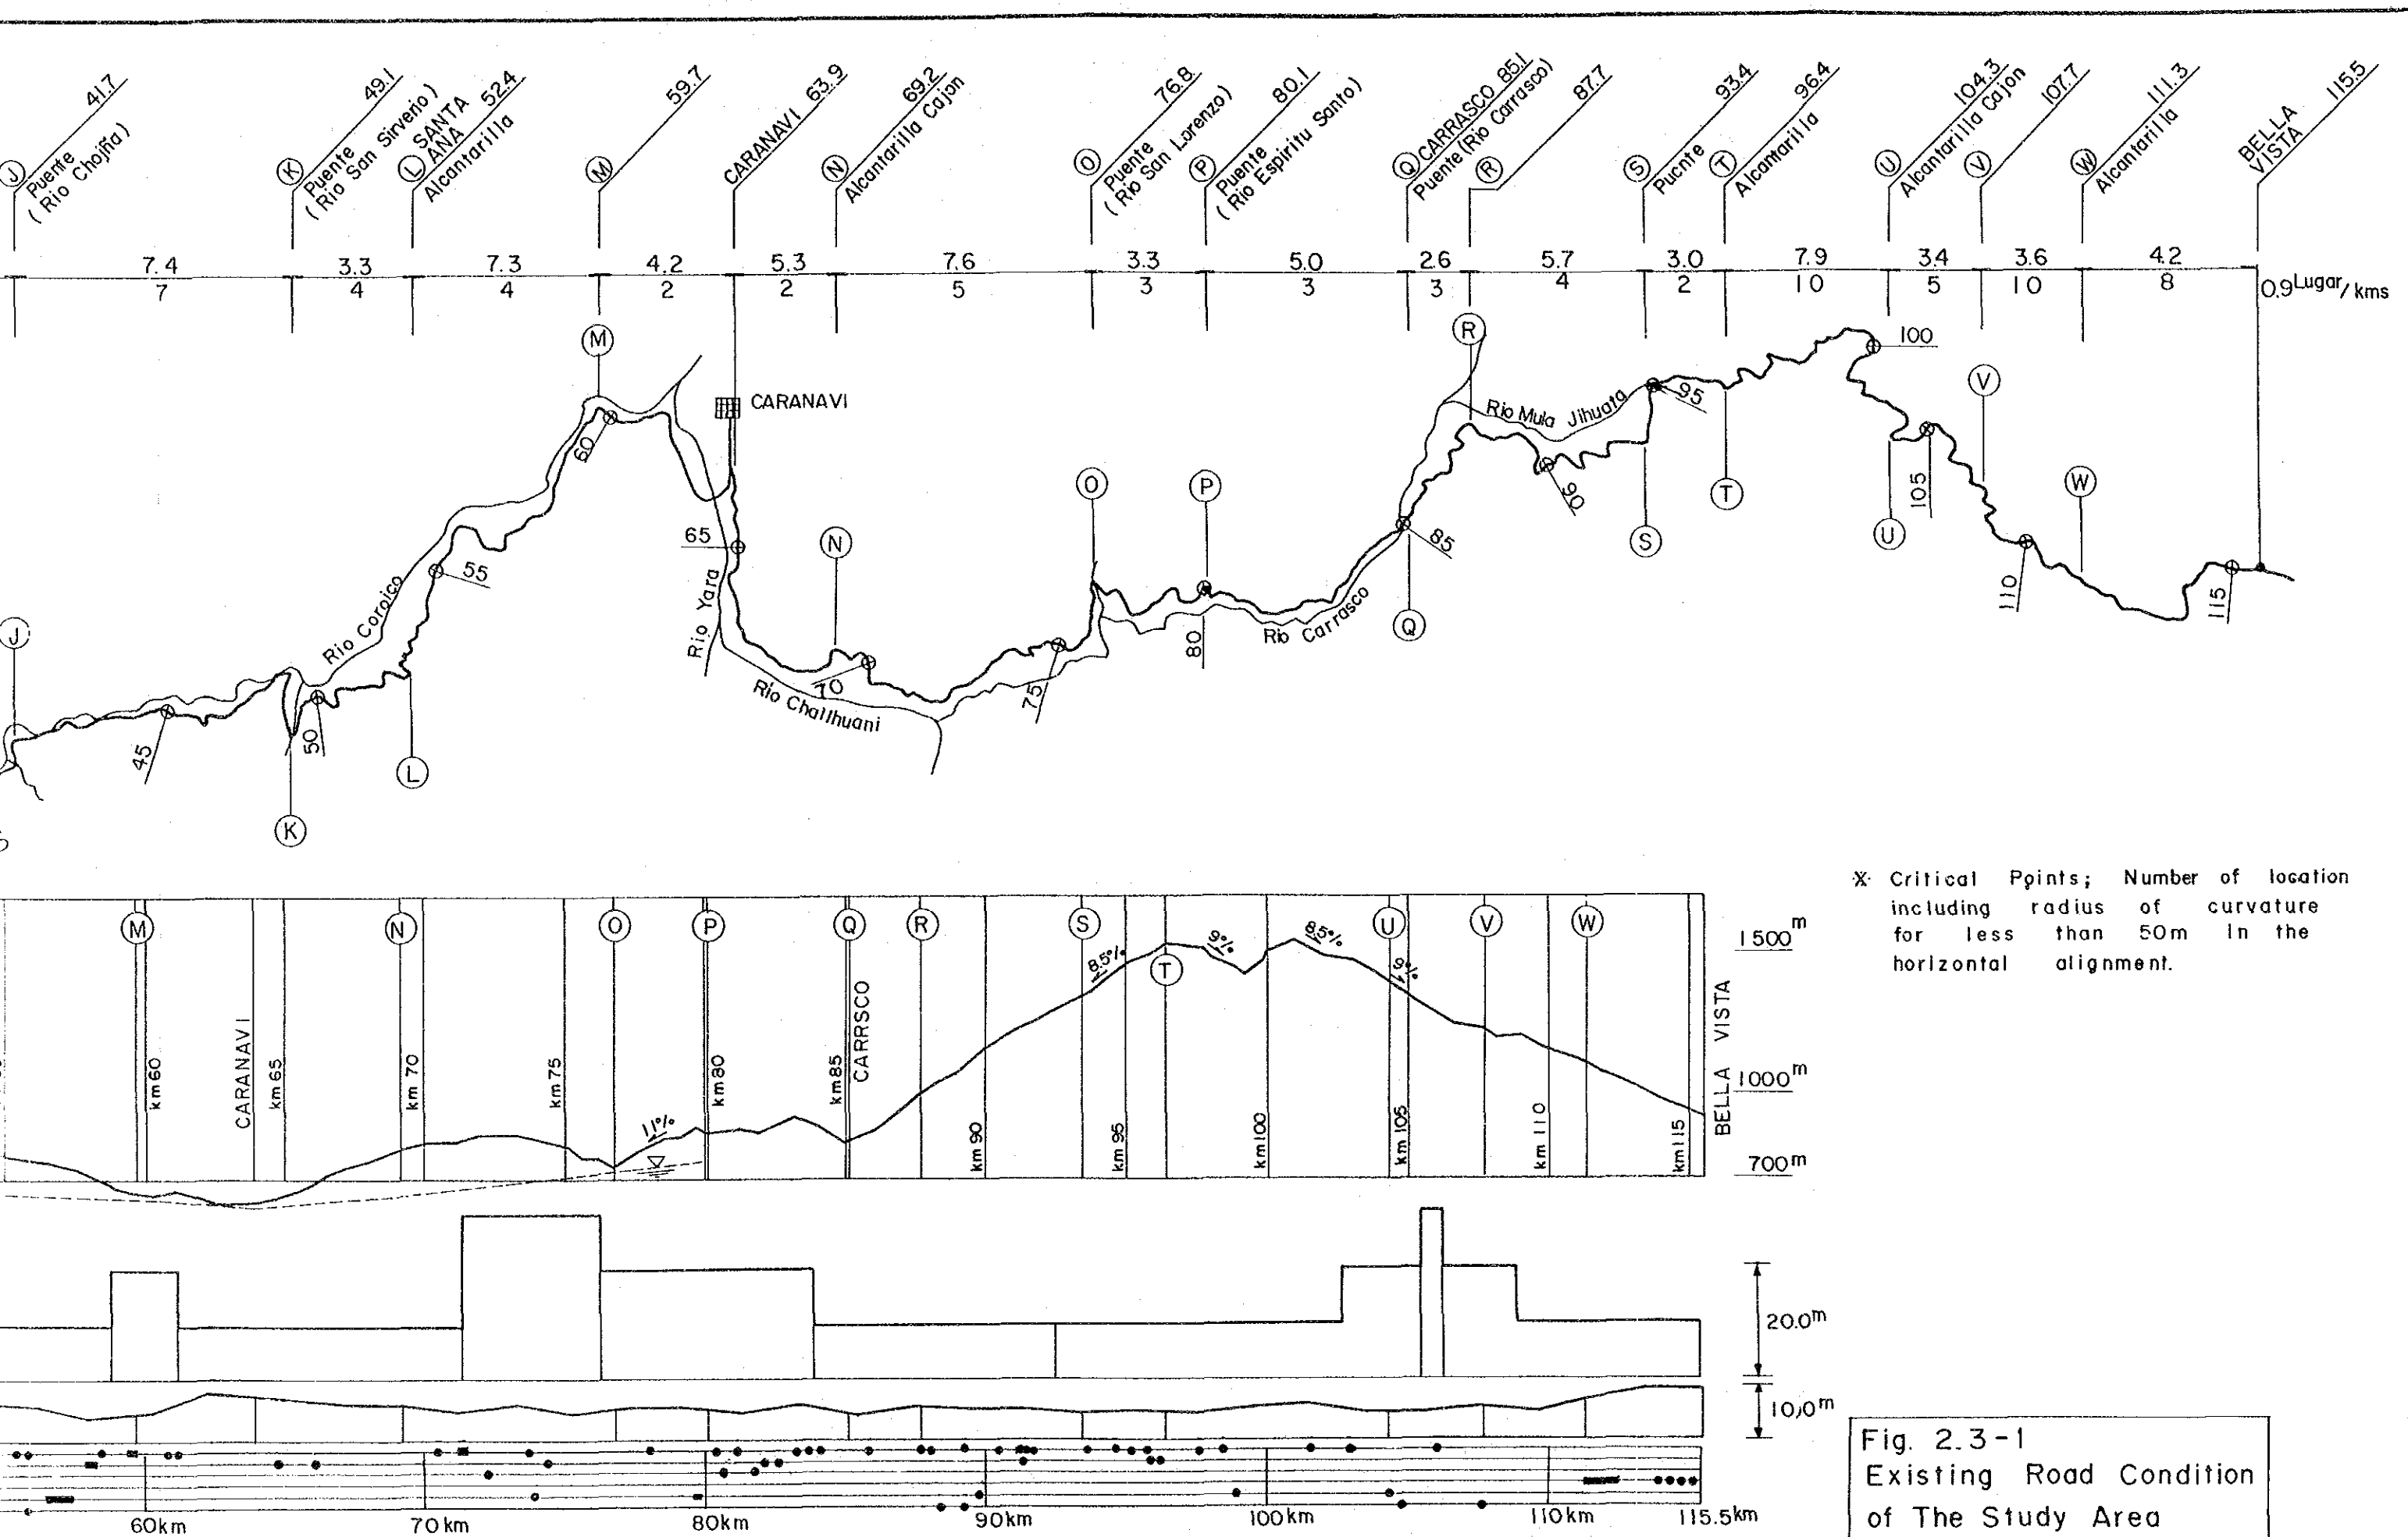
Fig. 2.3-1  
Existing Road Condition  
of The Study Area

X: Critical Points; Number of location including radius of curvature for less than 50m in the horizontal alignment.

The actual horizontal alignment for the existing road was found to be not very good. That is, there exist hardly no straight sections and many substandard curves with small radii throughout the study section, from Santa Bárbara to Bella Vista. As a result, sight distance for drivers is too short causing numerous traffic accidents.

Actual width of the existing road including road shoulder throughout the study section is illustrated in Fig. 2.3-1. Table 2.3-8 shows the summarized results.

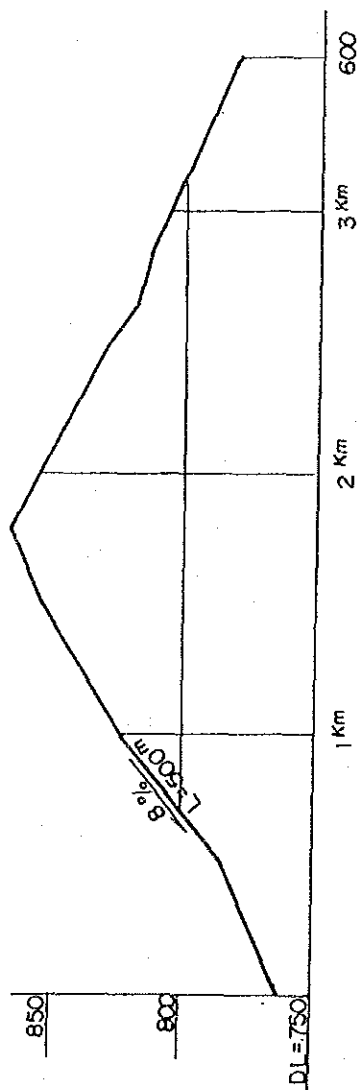
Fig.2.3-2 Profile around Point L

A schematic profile of the existing road in this area is shown in Fig. 2.3-2. The maximum vertical gradient and its continuous length are more than 8 % and 500 m, respectively. In this section, it was observed that driving speed of a car went down to less than 25 km/h.

The road climbs up to the top of the hill, although it looks not to be necessary, and the better route passing through lower hillside can be easily found, observing the surrounding landscape.
