SWIM PROJECT PROFILE		File No. : 136
Regist. No. : Agency No. : BSWM-47	Name: SAN MARCOS SWIP	
Region: 2	Province: QUIRINO	Municipality: CABARRQUIS
Present Status: 1. Pre-F/S() ② F/S(1985) ③ D/D(1985)		
Purpose: Major : Irrigation Incidental : IF, FC, WM		
Project Feature:

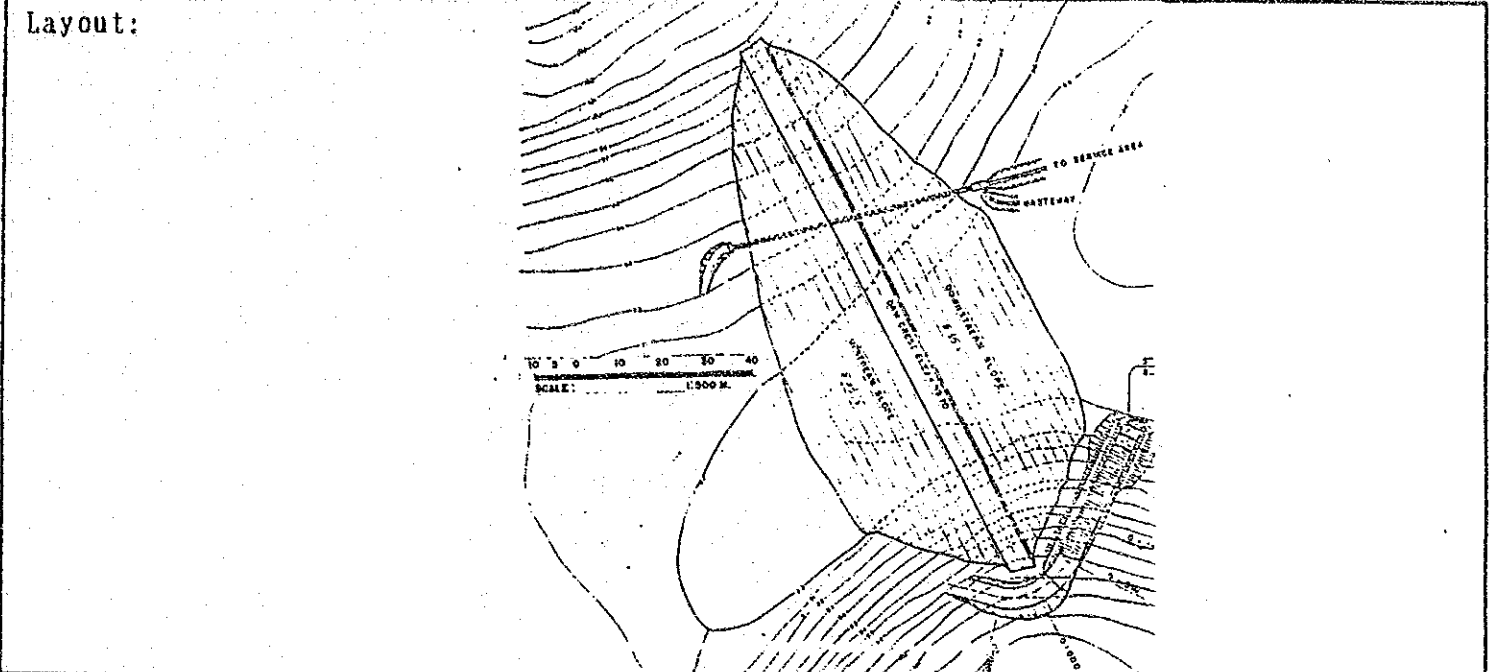
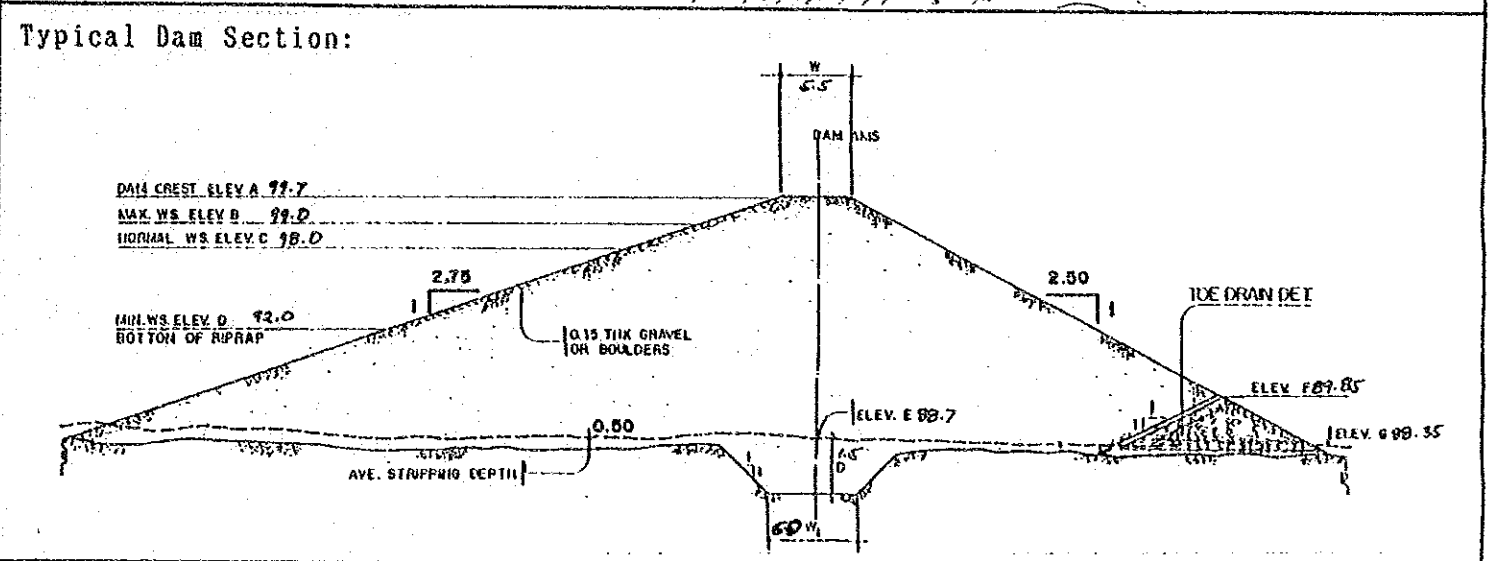
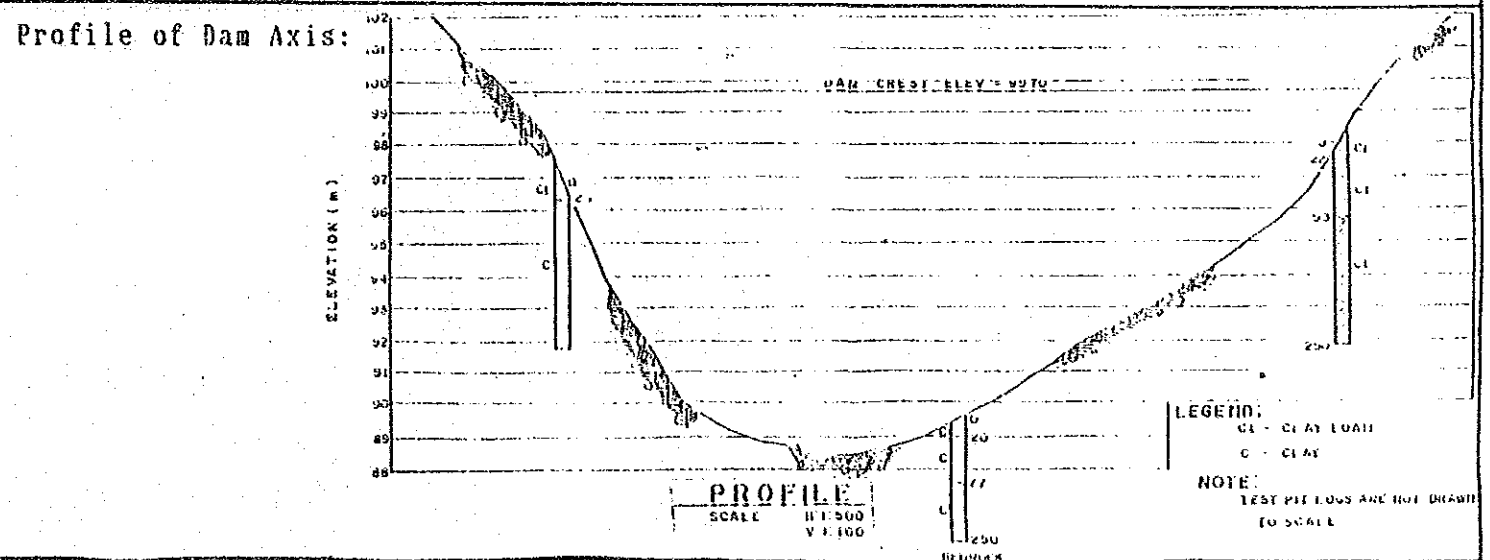
6. Inland Fishery	Annual Production	6 ton/year
Technical Assessment:		
1. Survey and Investigation:		
Depth of test pit or auger boring is not enough.		
Bearing capacity and permeability are not measured.		
Available volume for dam embankment shall be studied before construction.

2. Planning		
Environmental conservation plan is not formulated.		
3. Design		
Depth of core trench shall be modified during construction.		
Stability of upstream slope of the dam shall be checked.		
Weir shall be provided in the spillway.

Note: Silty clay with 2.5 m depth is piled up on the sand stone and shale.

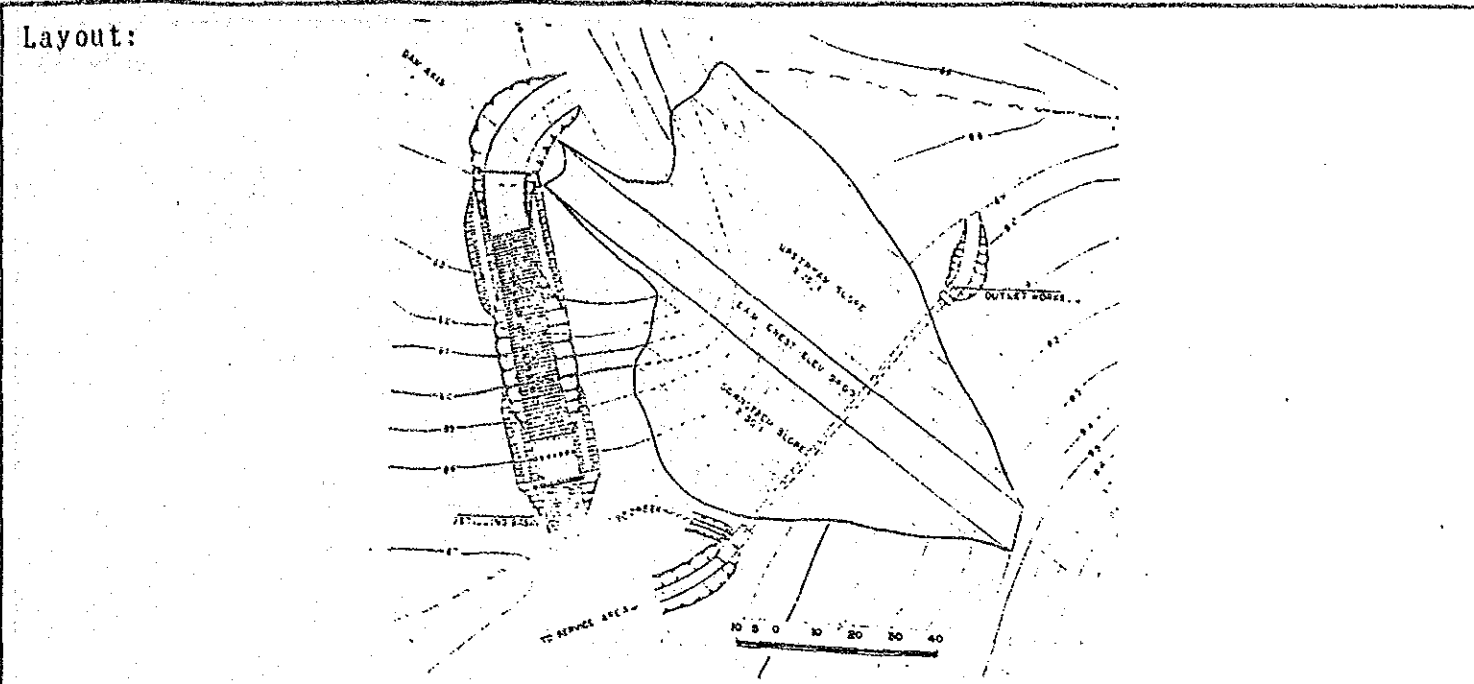
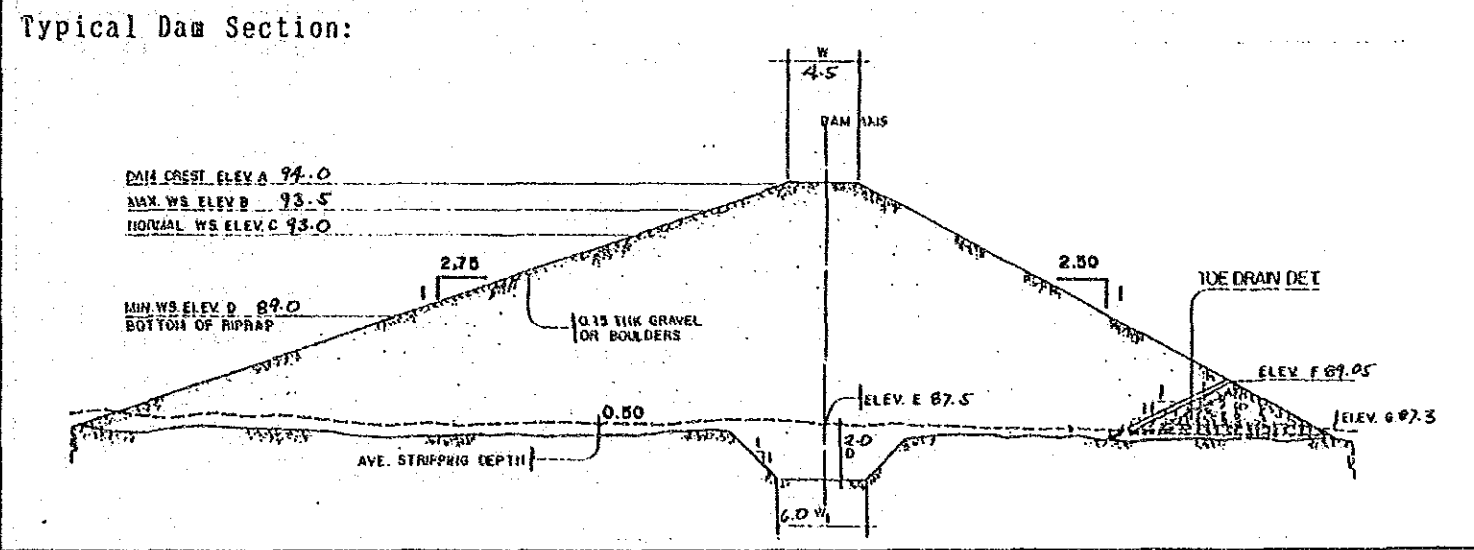
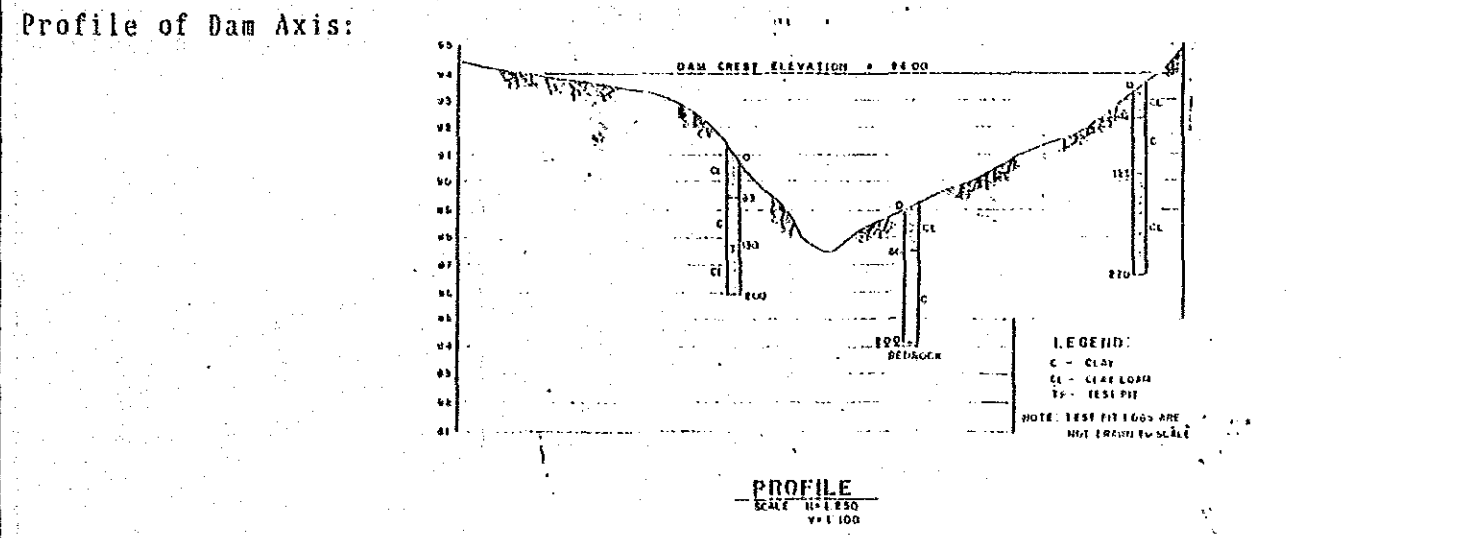
6. Inland Fishery	: Annual Production	: 5 ton/year
Technical Assessment:		
1. Survey and Investigation: Depth of test pit or auger boring is not enough. Bearing capacity and permeability are not measured. Available volume for dam embankment shall be studied before construction.

2. Planning Environmental conservation plan is not formulated.		
3. Design Depth of core trench shall be modified during construction. Stability of upstream slope of the dam shall be checked. Weir shall be provided in the spillway.

Note: Silty clay with 2.0 m depth is piled up on the sand stone and shale.

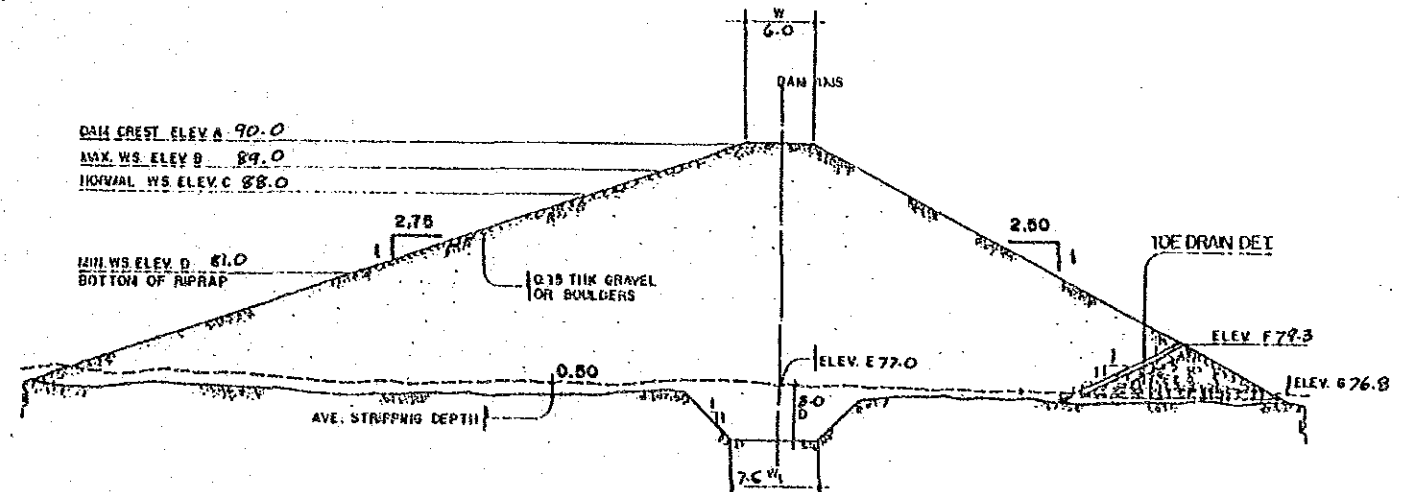
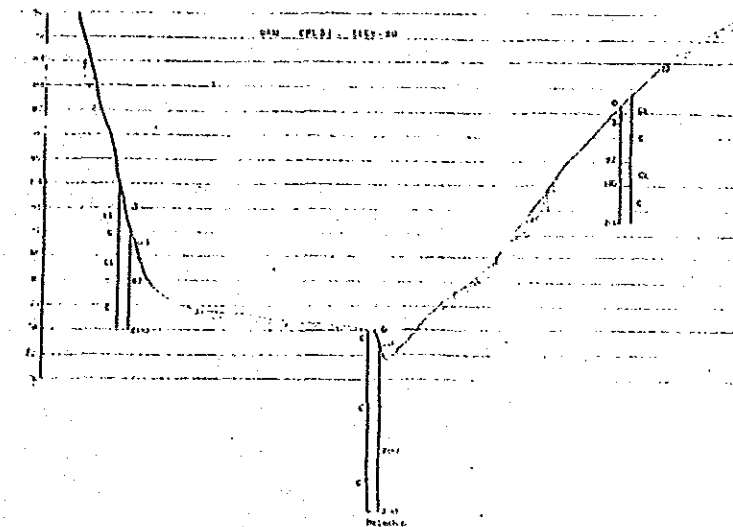
2. Planning Environmental conservation plan is not formulated.		
3. Design Depth of core trench shall be modified during construction. Stability of upstream slope of the dam shall be checked. Freeboard is not enough. Weir shall be provided in the spillway. Center line of the spillway shall be shifted to left side.

Silty clay with 3.0 m depth is piled up on the sand stone and shale. Additional 0.5 m freeboard is necessary.

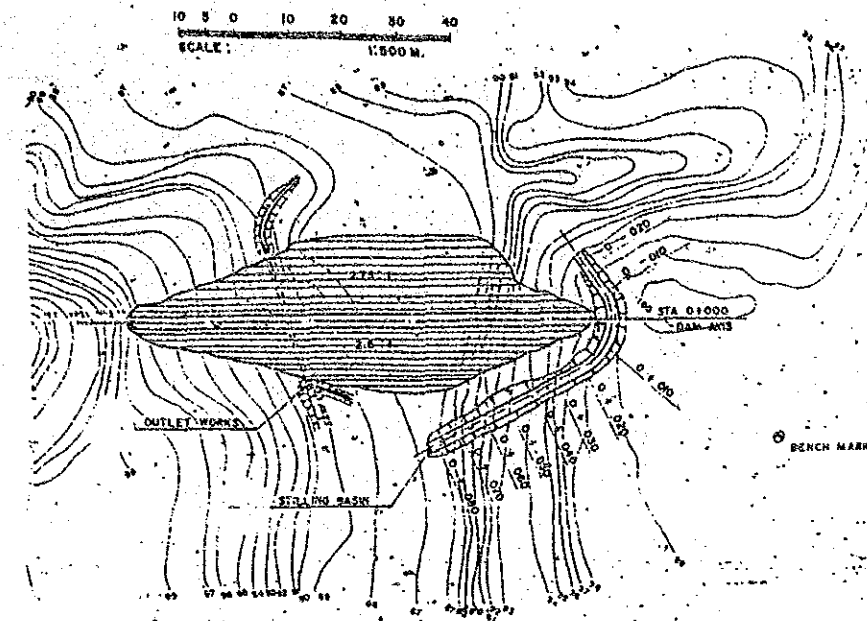
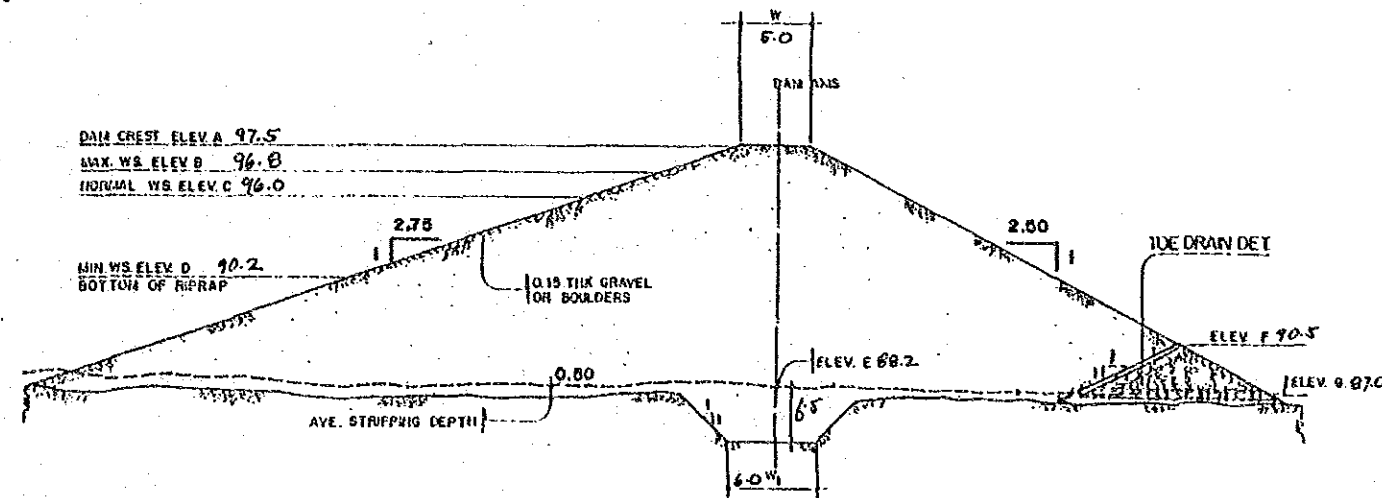
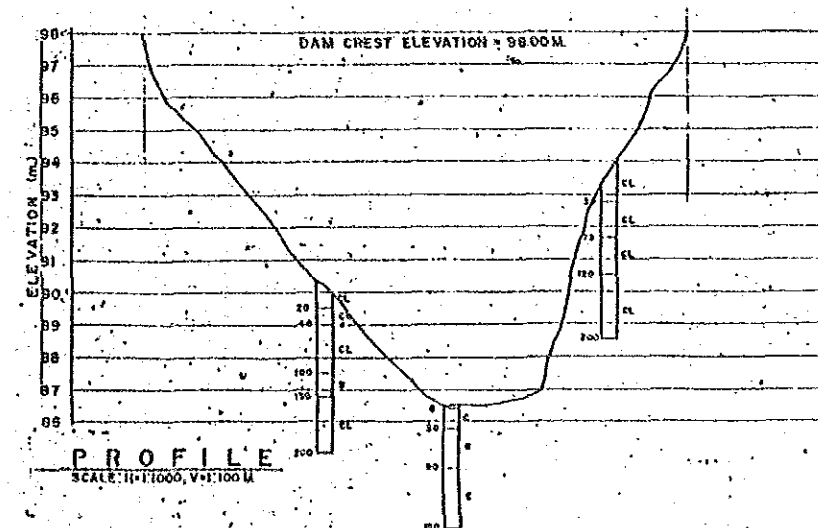
Terrace gravel underlies clay blanket with 2.0 m depth. Investigation on the clay distribution as natural blanket shall be carried out. Additional 1.0 m freeboard is necessary.

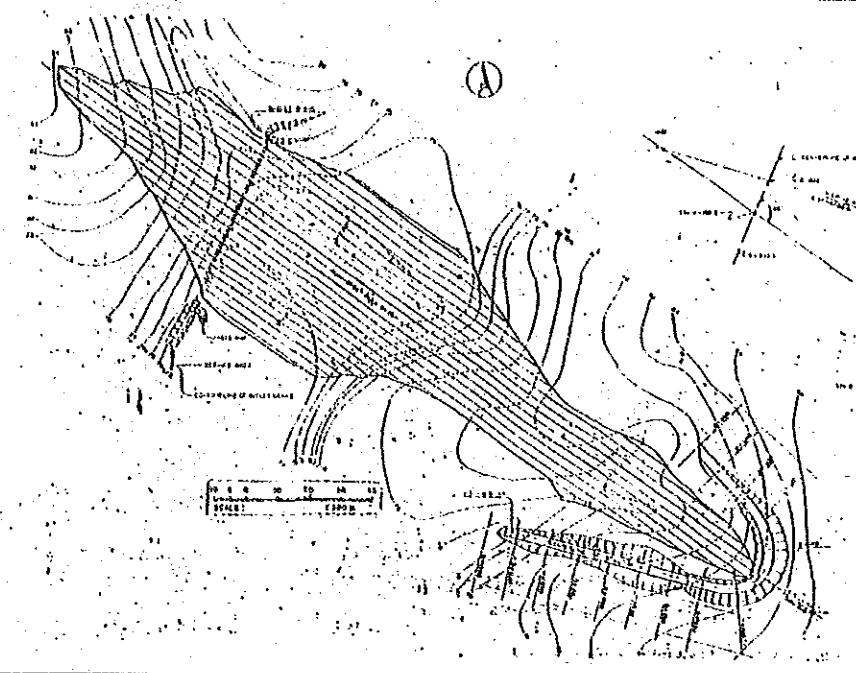
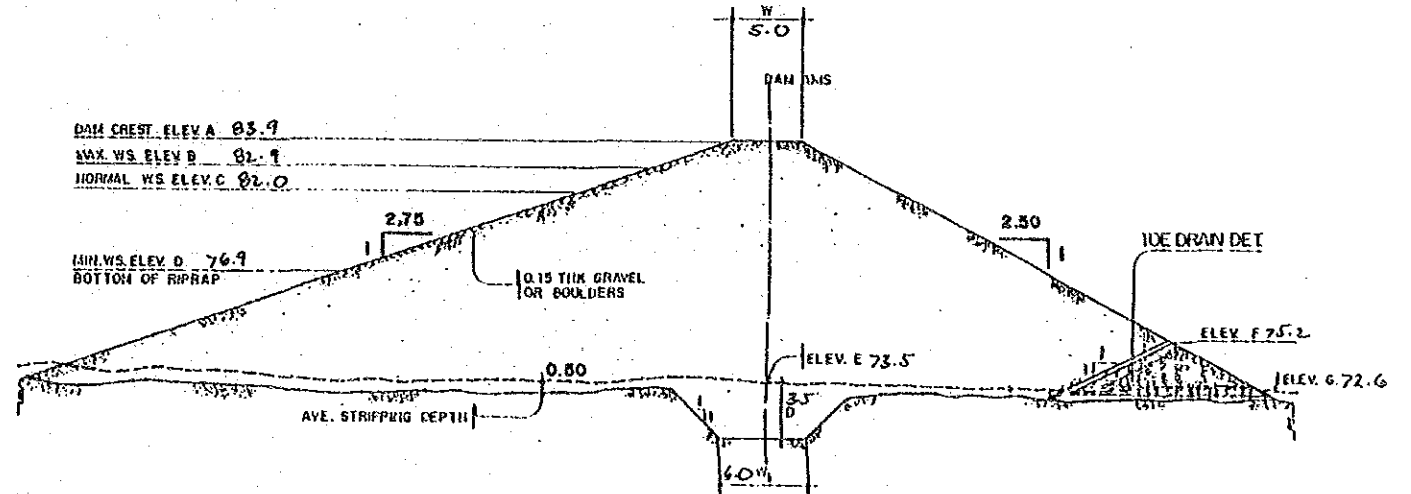
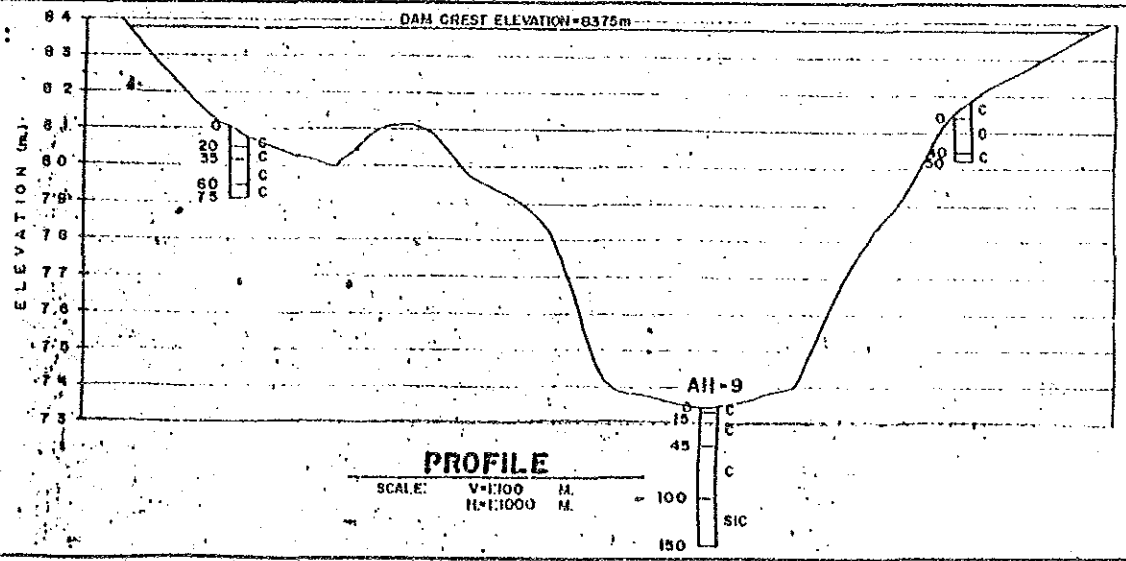
Note: Conglomerate, of which matrix is coarse-grained and calcareous sandy, underlies top soil with 0.5 m. Seepage through foundation shall be noticed. Additional 0.5 m freeboard is necessary.

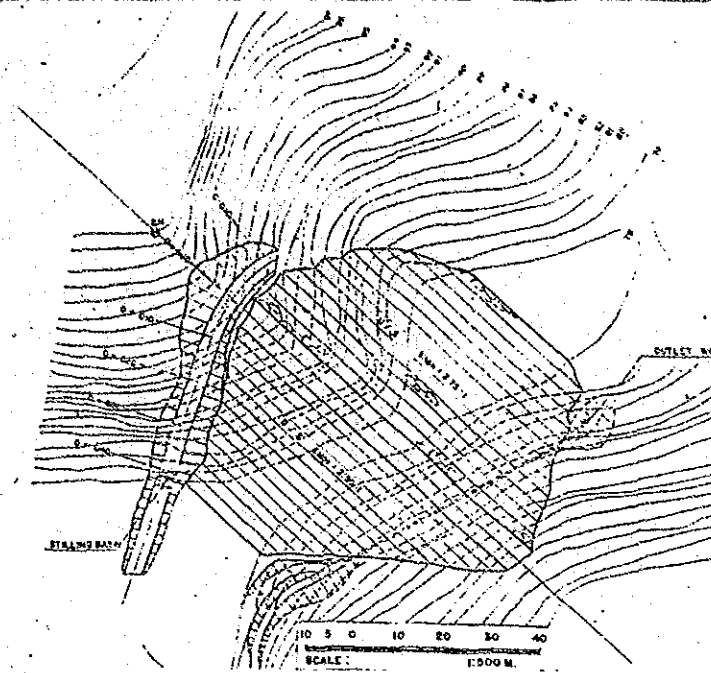
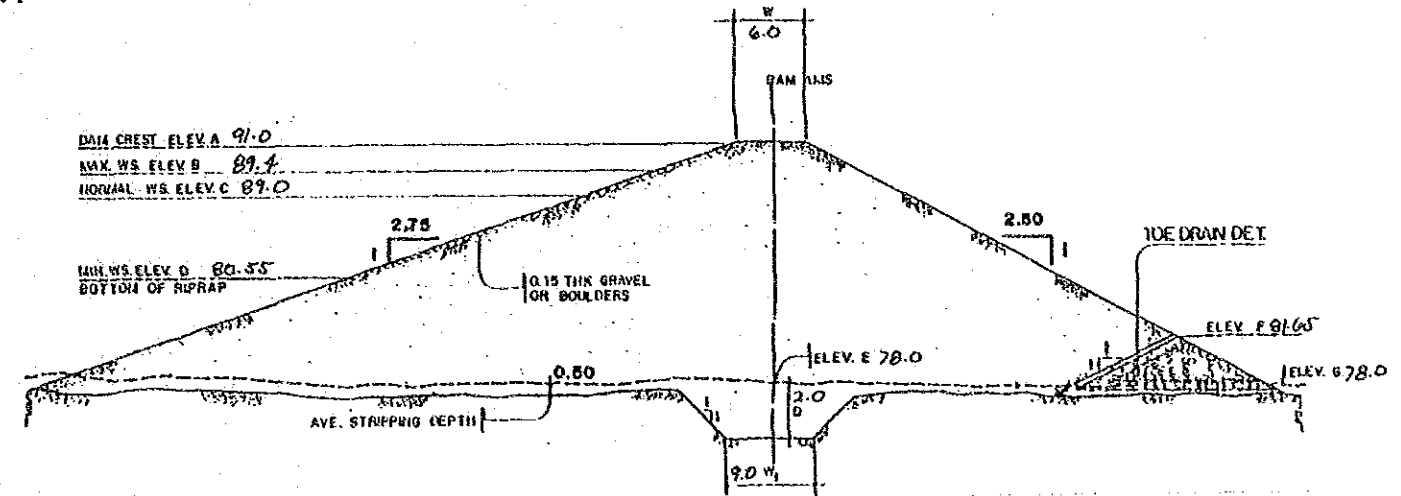
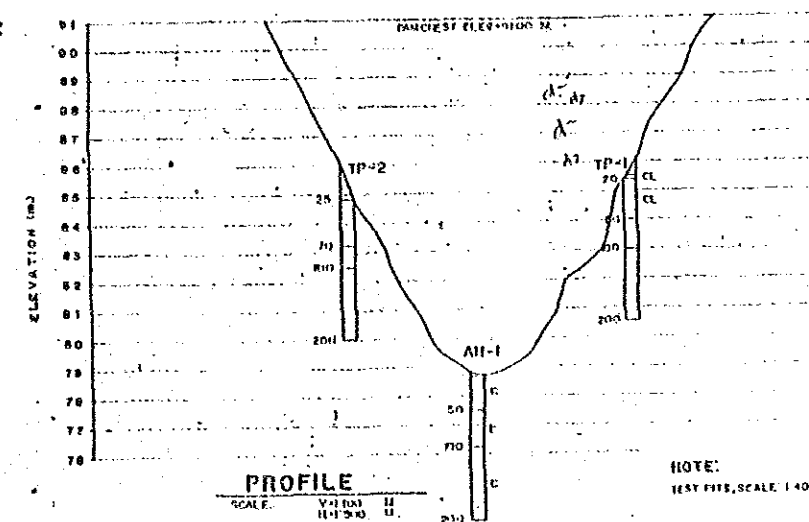
Clay with 2.0 m depth is piled up on sand stone, shale and conglomerate. Additional 0.5 m freeboard is necessary.

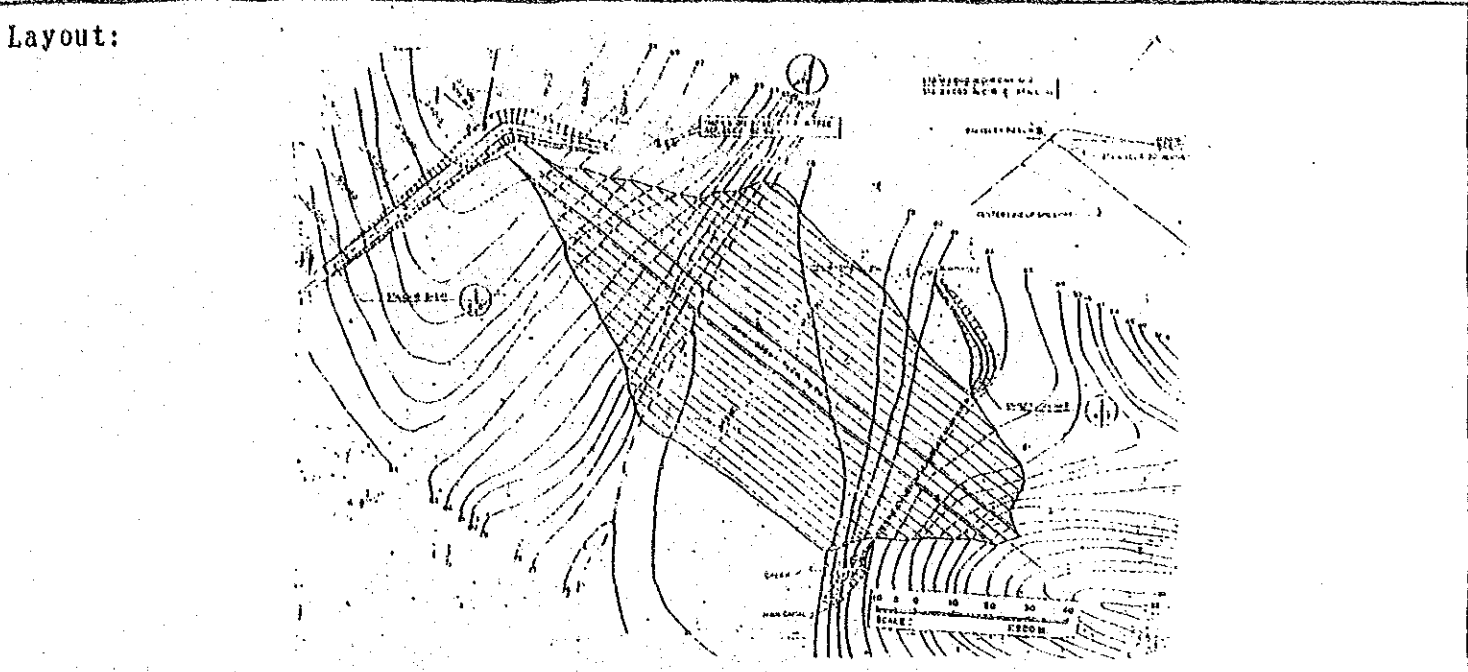
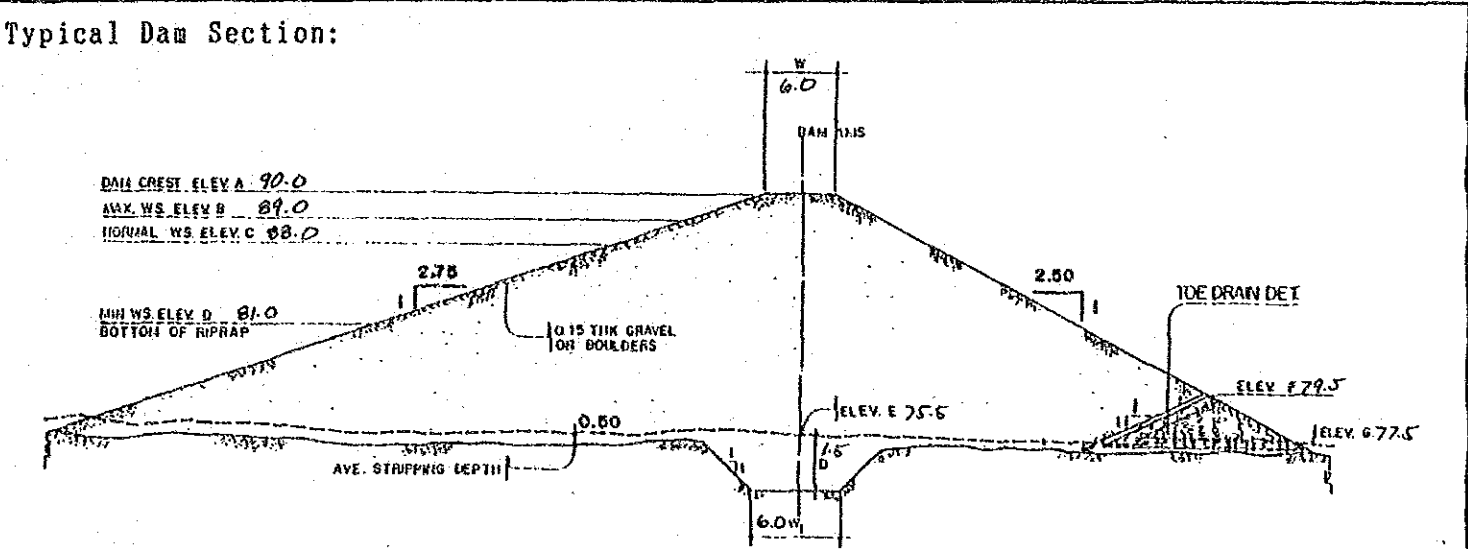
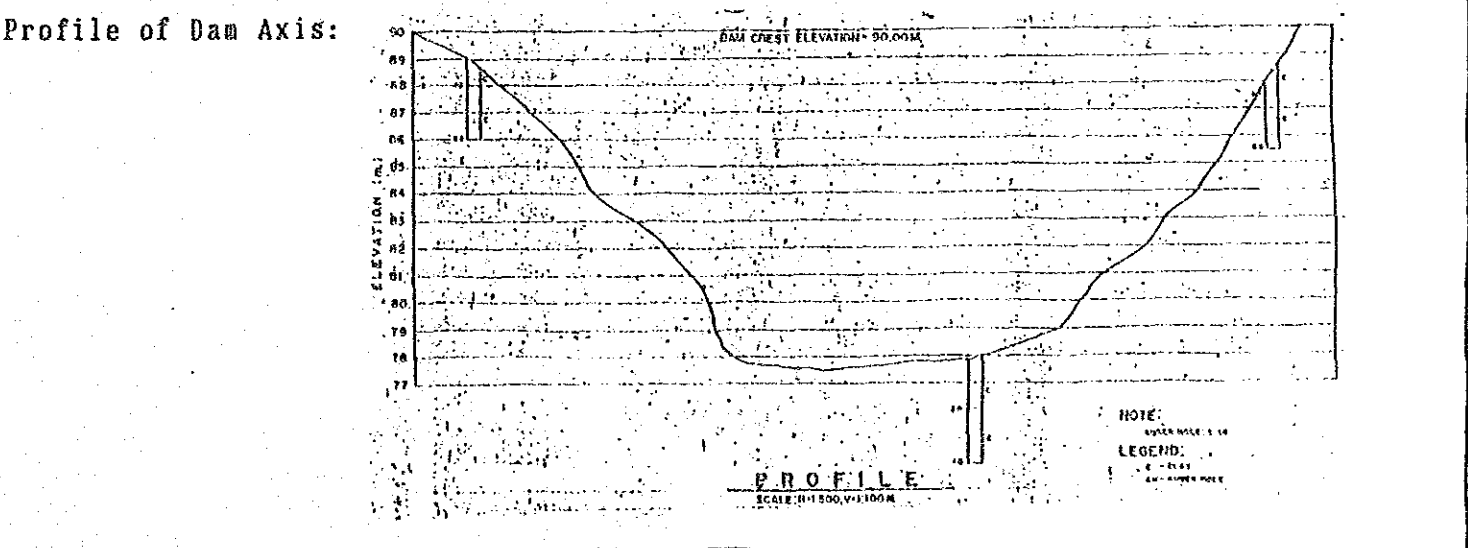
Note: Clay layer, which covers conglomerate, is 0.4 m depth.
So there is some anxiety about permeability in the foundation.

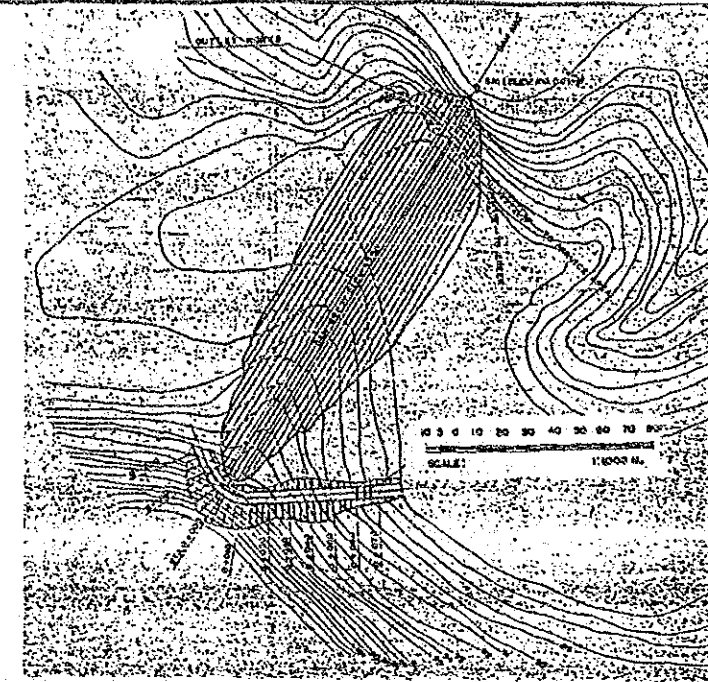
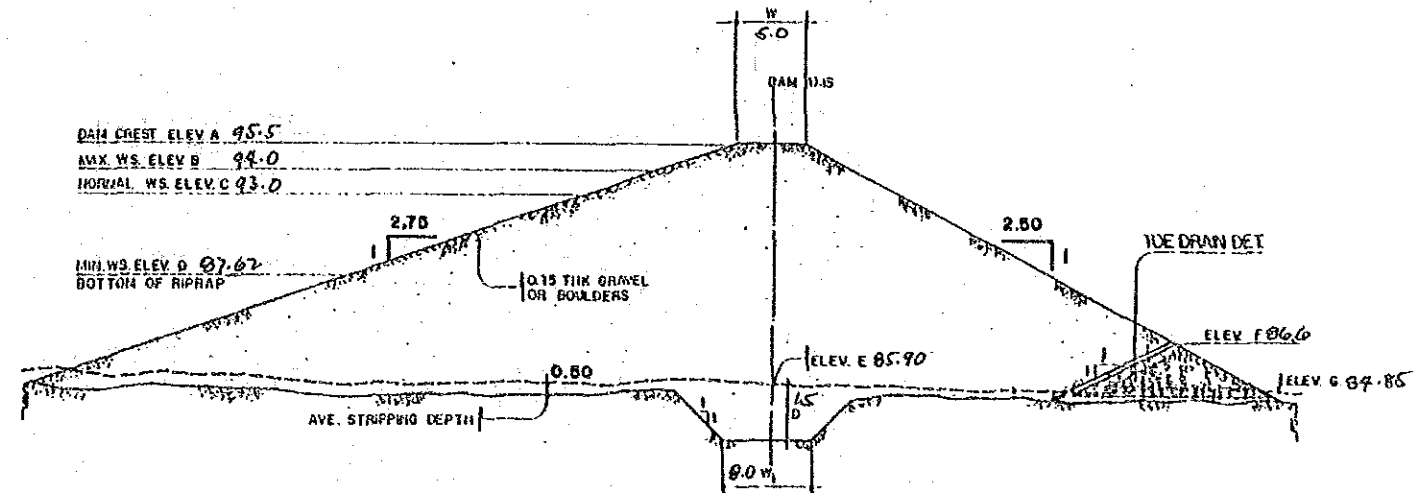
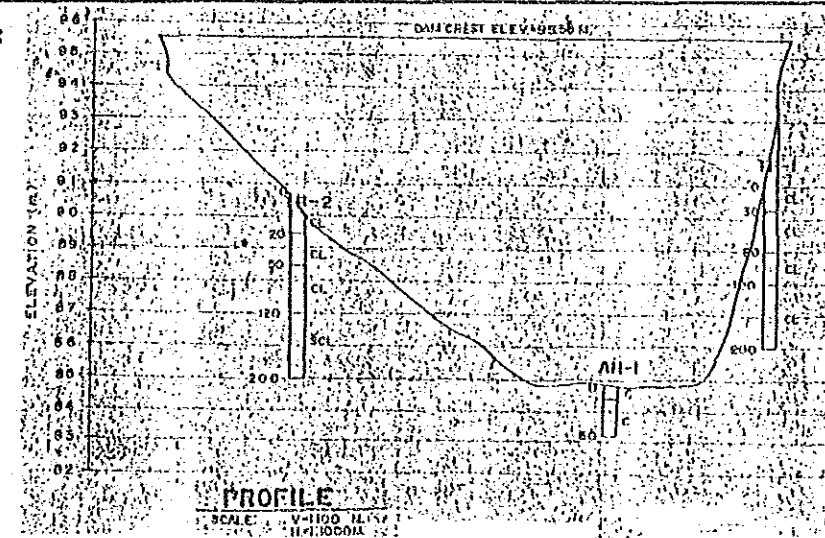
Note: Terrace gravel underlies high weathered sandy clay with 2.0 m depth. Attention have to be paid to the spring water found 200 m upstream. Additional 0.5 m freeboard is necessary.

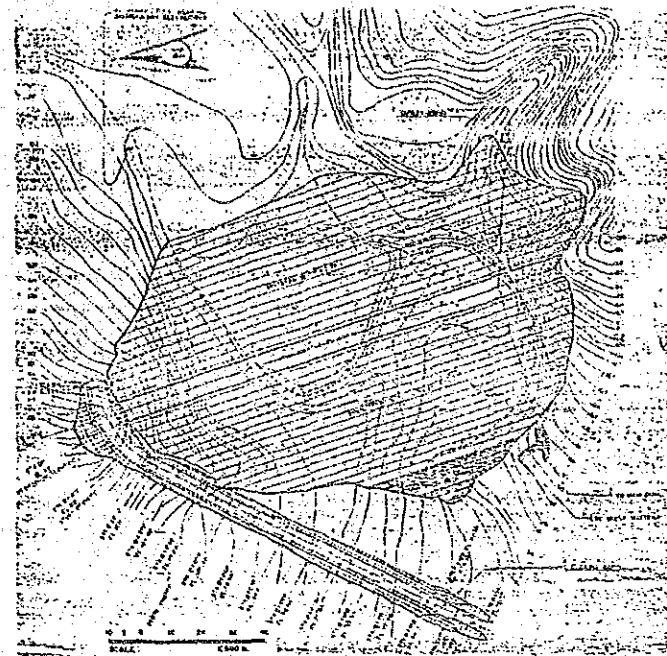
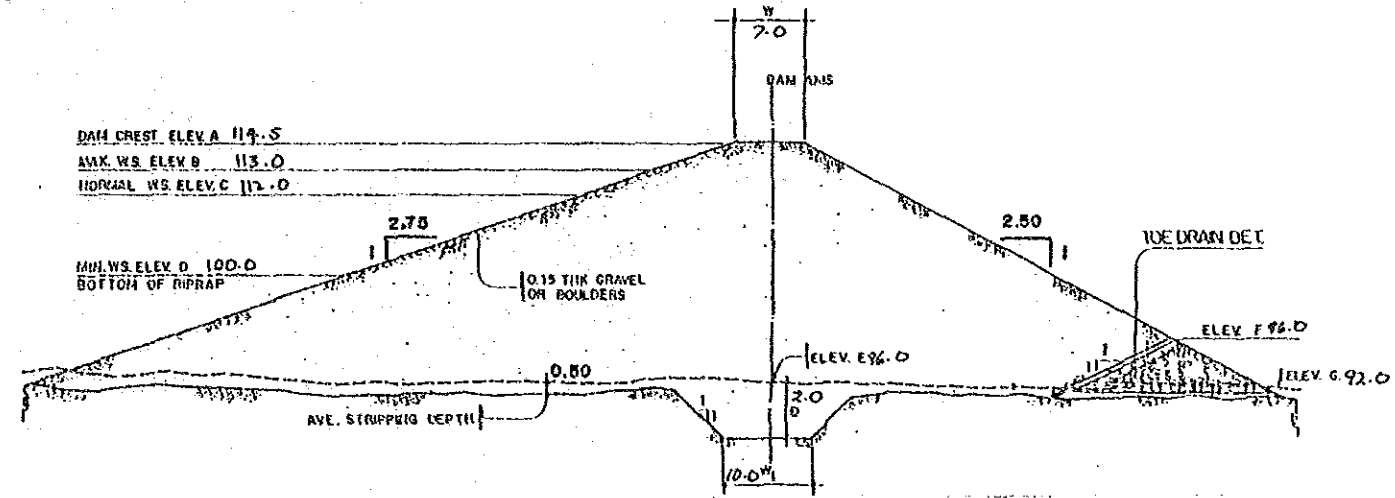
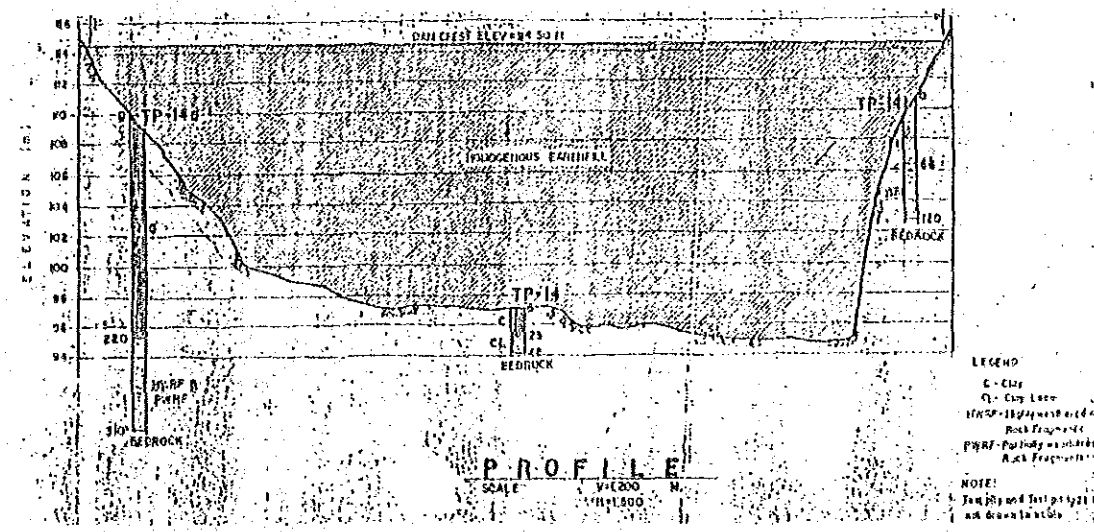
2. Planning		
Environmental conservation plan is not formulated.		
Project planning shall be re-formulated.		
3. Design		
Stability of upstream slope of the dam shall be checked.		
Design discharge shall be estimated based on 100 year's flood or more.		
Center line of the spillway shall be shifted to right side.		
Center line of supercritical flow portion shall be straight.		
Weir shall be provided in the spillway.		
Center line of conduit is recommended to be straight.

Note: Foundation rock is metamorphic grey wacke. Confirmation of permeability in the grey wacke and depth of up layer's clay shall be done.
