3.1.4 Method for Implementation and Evaluation

3.2 SELECTION OF STUDY SECTIONS

3.4.2 Problem Identification

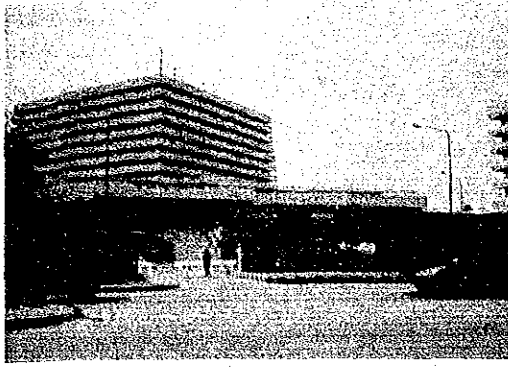
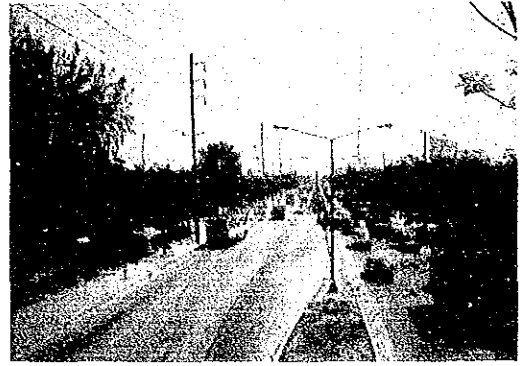
Study Section S-2: Phumiphol Adulyadet Hospital (R1)

Confusion is caused by vehicles entering, existing and taking U-turns in front of the hospital.

The problem on S-2 is that there is confusion between entering/exiting vehicles and vehicles making U-turns in front of the hospital. A possible countermeasure to solve this problem is to install traffic signals with coordinated control of the new and existing signals located near this site.

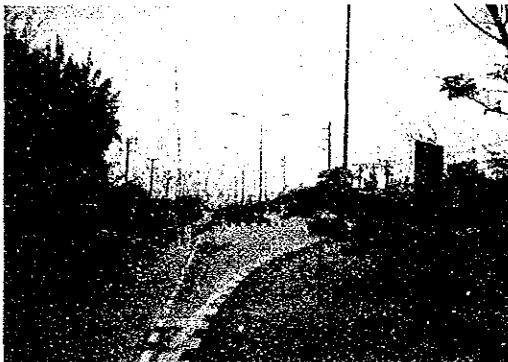
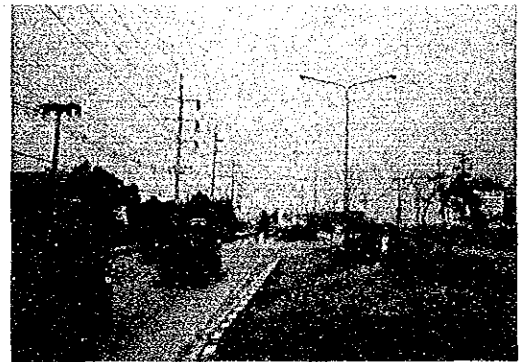
Study Section S-32: Noppharat Ratchathani Hospital (R304)

S-32 has similar problems to S-2. This is the intersection of R304 and a feeder road to a hospital approximately 60 m to the west. Signal installation at the intersection of R304 (S-32-1) is considered necessary because the present traffic volume fully warrants this, as shown in Figure 3.12. On the other hand, at the intersection of the hospital (S-32-2) traffic signals are not proposed because the present traffic volume, shown in Figure 3.13, is not large enough.

In this study, simultaneous-type signals were proposed for both sites for the same reasons as for site S-2.
