Fig. 4-6-4 The Model of Tailing Dam Stability Analysis

Fig. 4-6-5 A Result of Tailing Dam Stability Analysis (1)

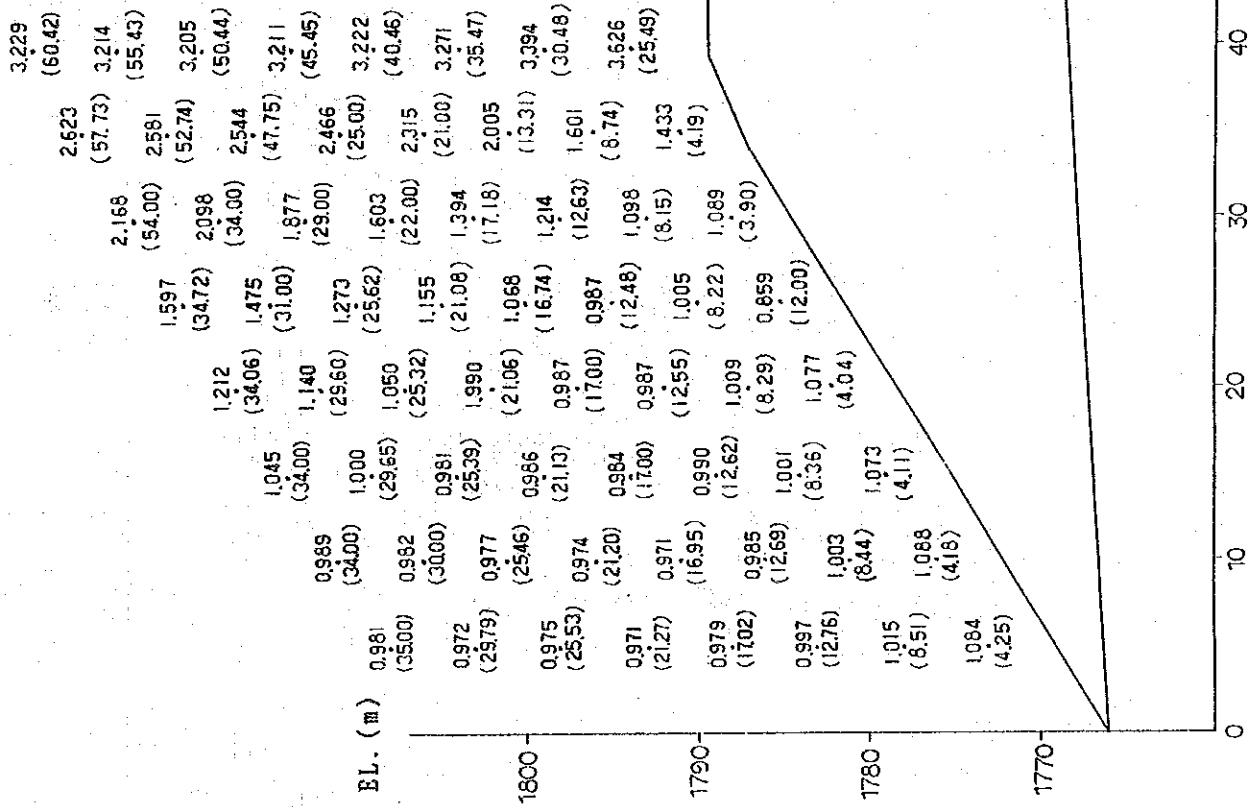
(DURING EARTHQUAKE : KH = 0.00 )

MINIMUM FACTOR OF SAFETY

X = 25.00 m  
 Y = 1795.00 m  
 R = 12.00 m  
 MR = 1562.197 tf-m  
 MD = 1817.977 tf-m  
 FS = MR / Ms = 0.8593

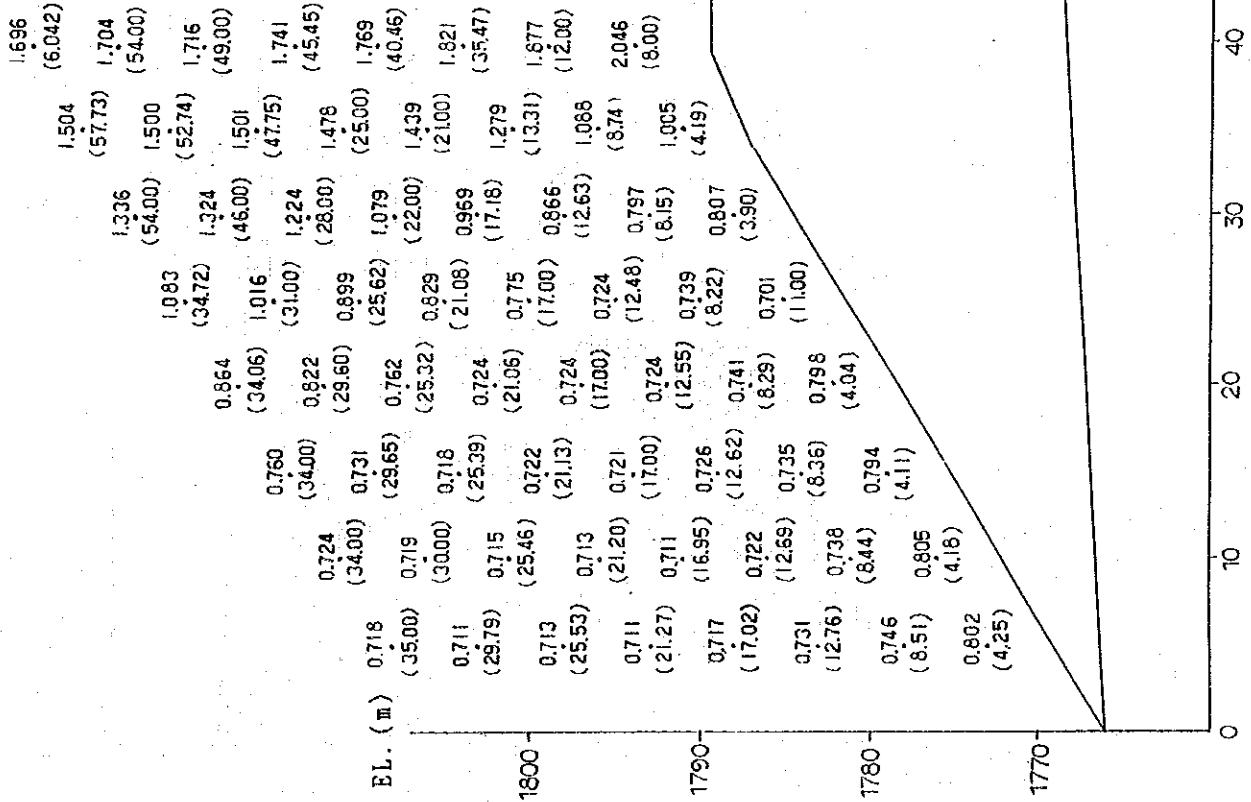
Fig. 4-6-7 A Result of Tailing Dam Stability Analysis (3)

(DURING EARTHQUAKE : KH = 0.15 )

MINIMUM FACTOR OF SAFETY

X = 25.00 m  
 Y = 1785.00 m  
 R = 11.00 m  
 Mr = 1139.282 tf-m  
 Md = 1625.844 tf-m  
 Fs = Mr/Md = 0.7007

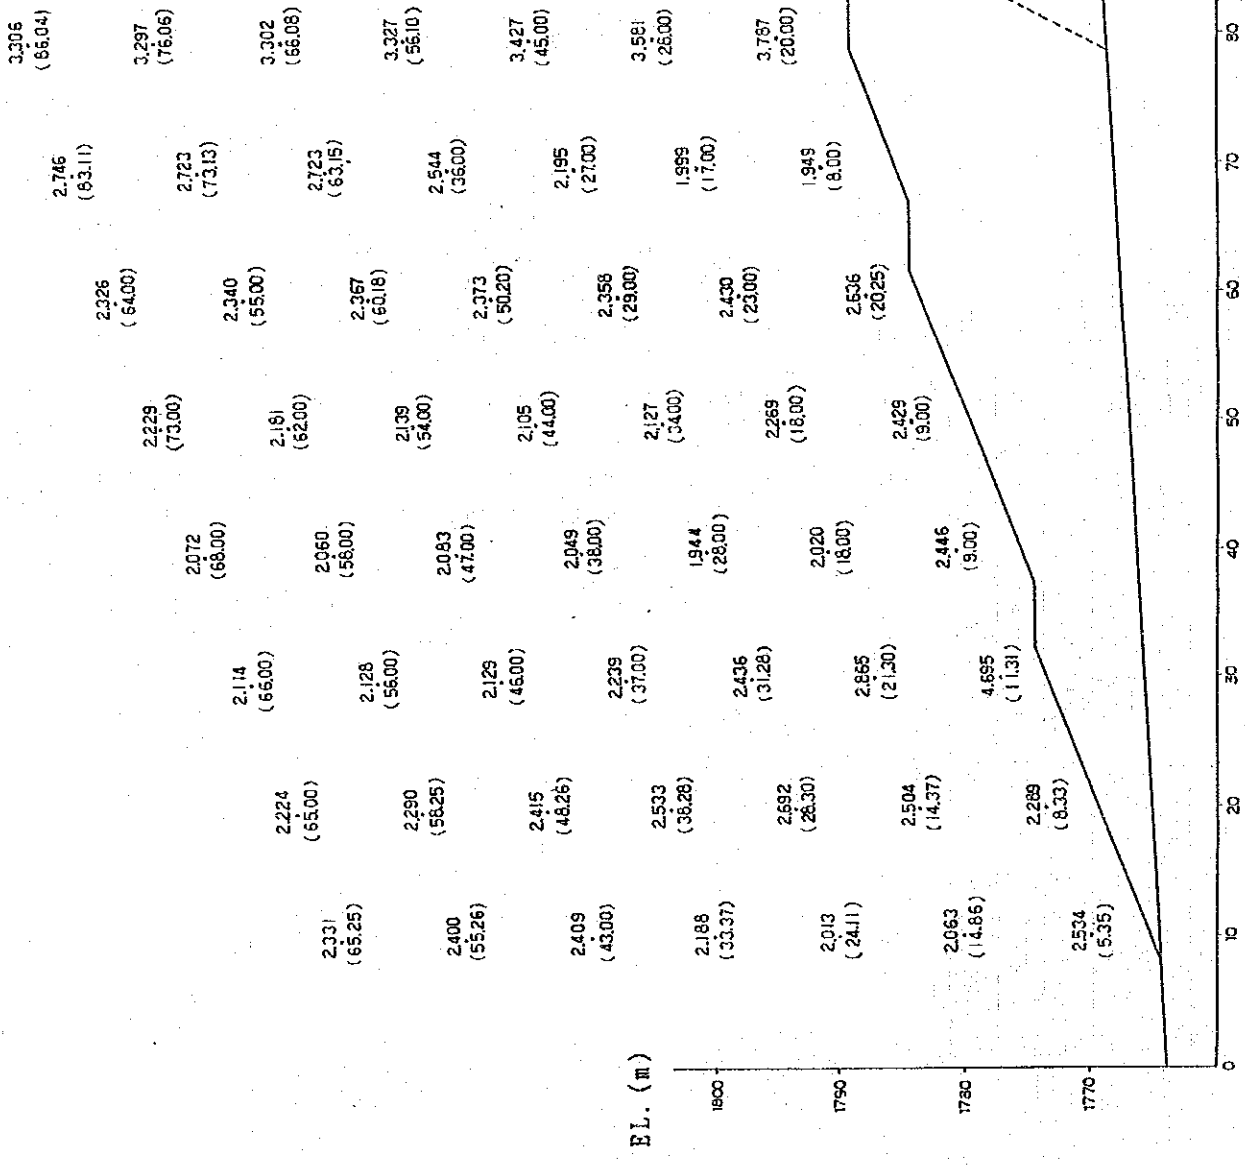
Fig. 4-9-3 A Result of Tailing Dam Stability Analysis (1)

(DURING EARTHQUAKE : KH = 0.00)

MINIMUM FACTOR OF SAFETY

X = 60.00 m  
 Y = 1857.86 m  
 R = 72.45 m  
 Mr = 23.787 tf-m  
 Mo = 12.459 tf-m  
 Fs = Mr/Mo = 1.9092

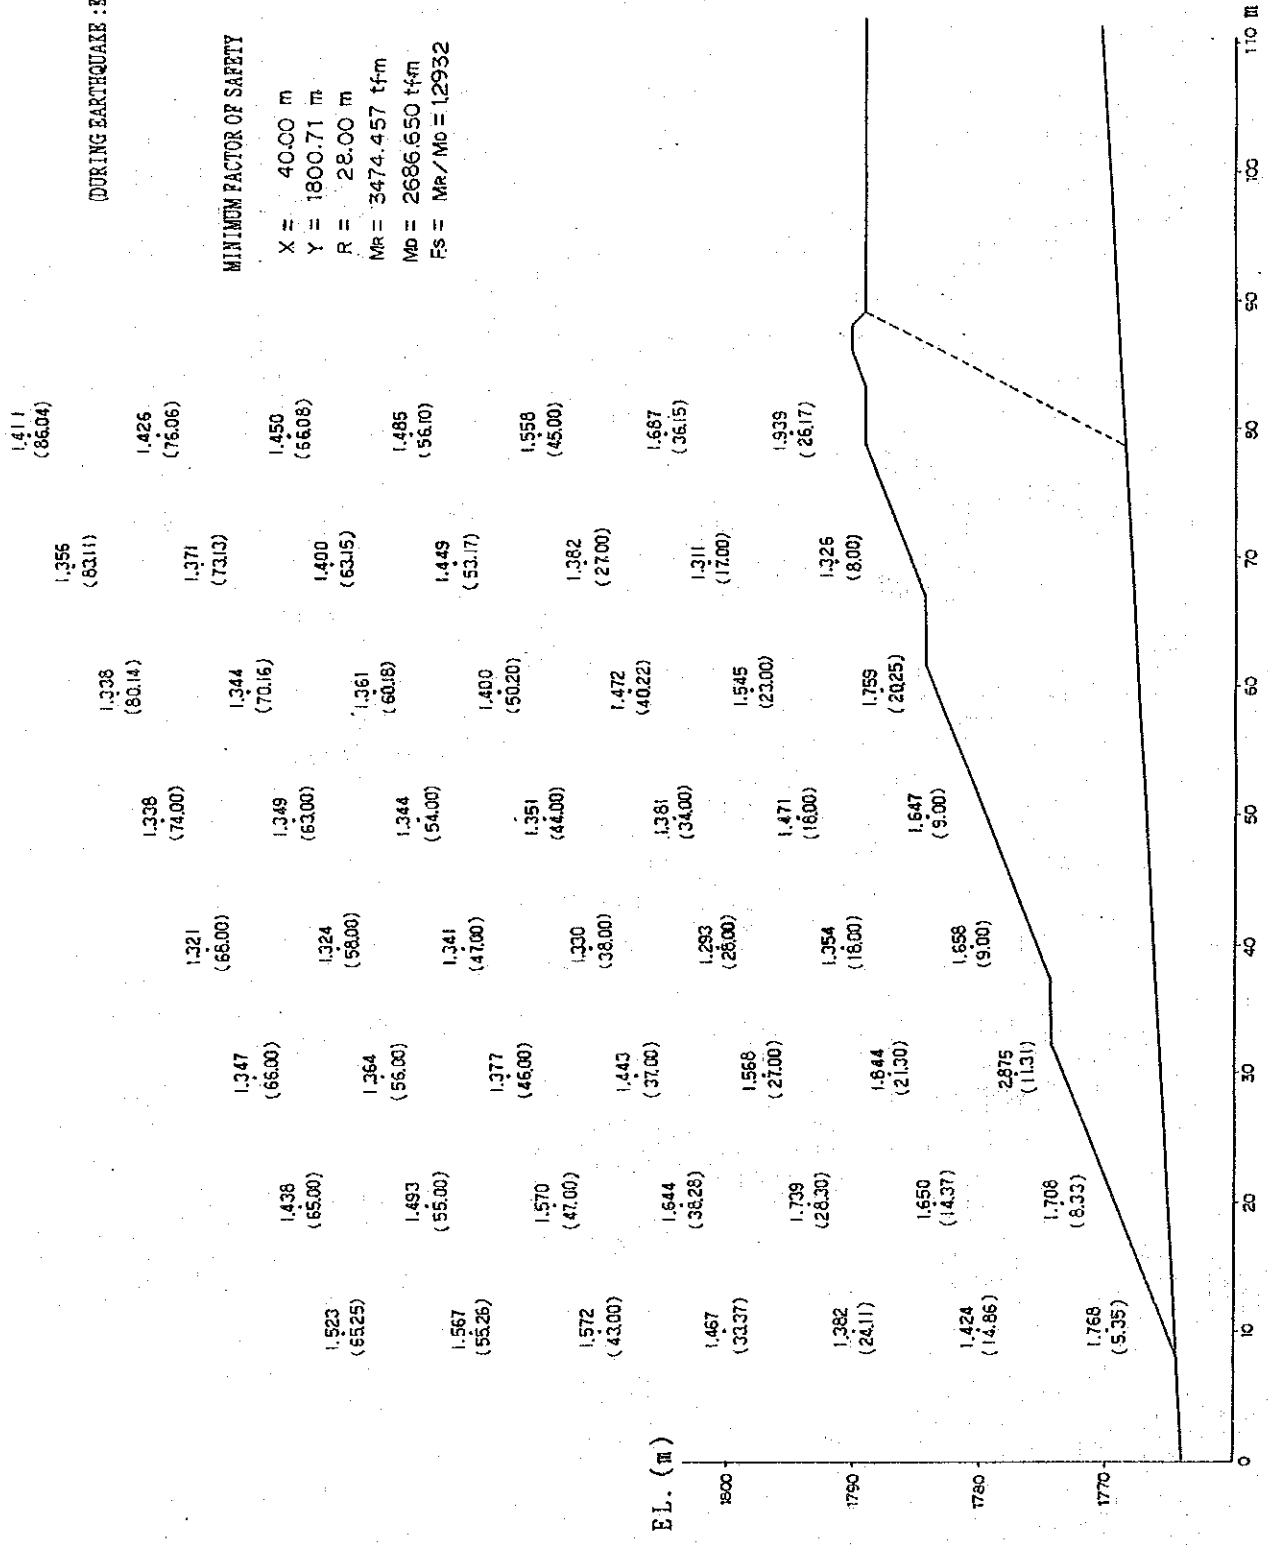
Fig. 4-9-5 A Result of Tailing Dam Stability Analysis (3)

(DURING EARTHQUAKE: KH=0.15)

MINIMUM FACTOR OF SAFETY

X = 40.00 m  
 Y = 1800.71 m  
 R = 28.00 m  
 Mr = 3474.457 tfm  
 Mb = 2686.650 tfm  
 Fs = Mr/Mb = 1.2932
