1991 POWER DEVELOPMENT PROGRAM

第5章 フィリピン電力会社の概要

5.1 フィリピン電力会社の歴史

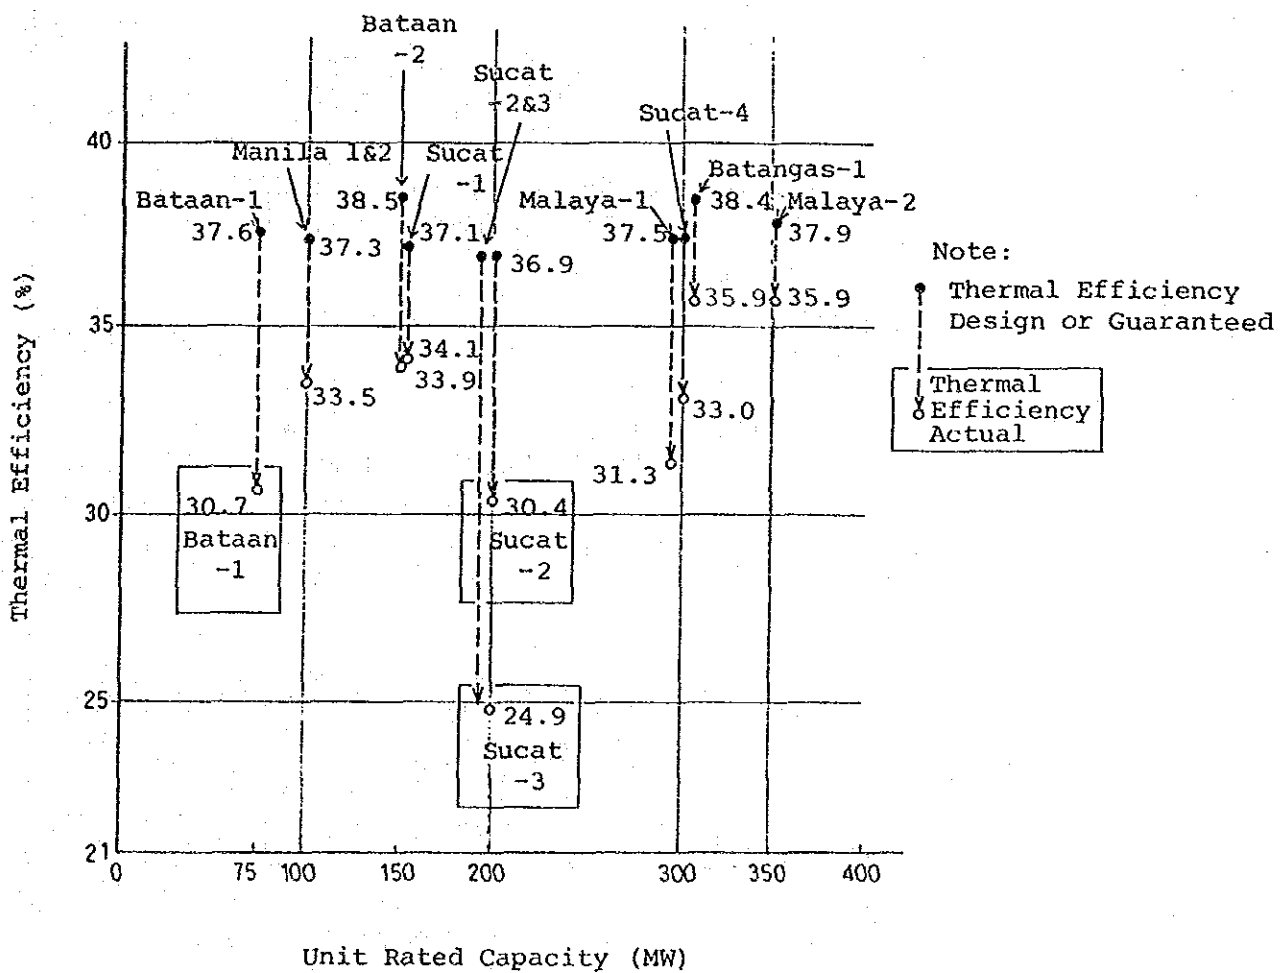
Fig. 6-1-1 火力発電所熱効率の現状 (1991年6月現在)

Fig. 6-1-1は、Table 6-1-3 火力発電所の熱消費率一覧表から熱効率をプロットしたものである。すべてのユニットの熱消費率（又は熱効率）が経年劣化のため、設計値又は保証値よりも悪くなっている。（Table 6-1-3、c/a 参照、c=現在値、a=設計値又は保証値、いずれも熱消費率）

ワースト 3は、Sucac 3号 (c/a=1.483)、Bataan 1号 (c/a=1.226)及びSucac 2号 (c/a=1.214)である。

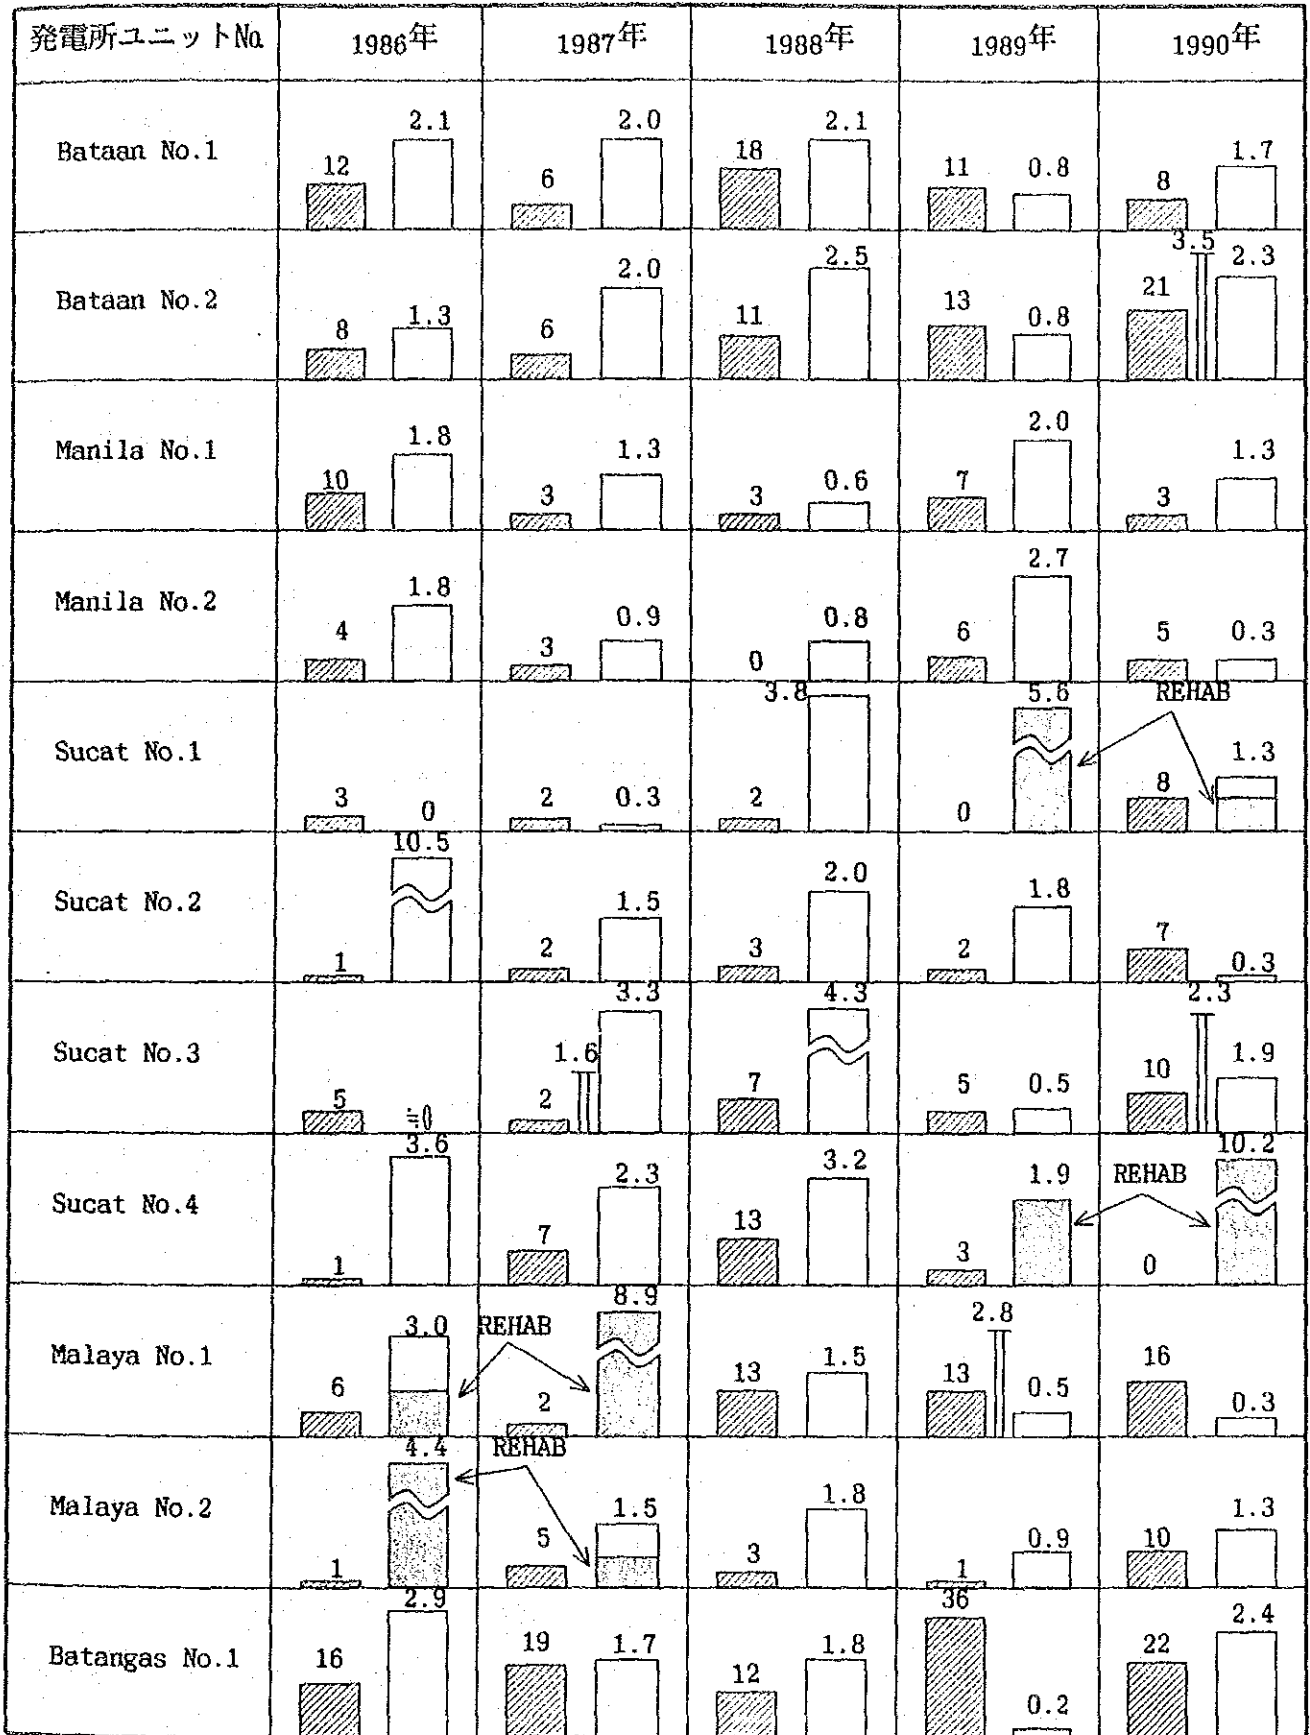
Fig. 6-1-2 年間事故停止回数及び保守停止時間 (月数で表示)

定期点検修理(年に1回)は、NAPOCORの計画においては、従来型(ドラム型)ユニットでは40日、貫流型ユニット及び石炭火力では60日が平均日数である。従って図表上における年間保修停止時間が1.3ヵ月~2.0ヵ月の間であれば各ユニットの運転年数を考え合わせると、特に異常とは言えない。これを超える年間保修停止を経験しているユニットは、事故や経年劣化に起因する修理を必要としたと言える。

- a. Bataan 2号は、事故停止回数が増加傾向にあり、保修停止時間も長くなる傾向が見られる。
- b. Sucat 2号及び3号は、年間保修停止時間が3ヵ月を超えた年がある。また、それまで比較的少なかった年間事故停止回数が増加する兆候が見える。

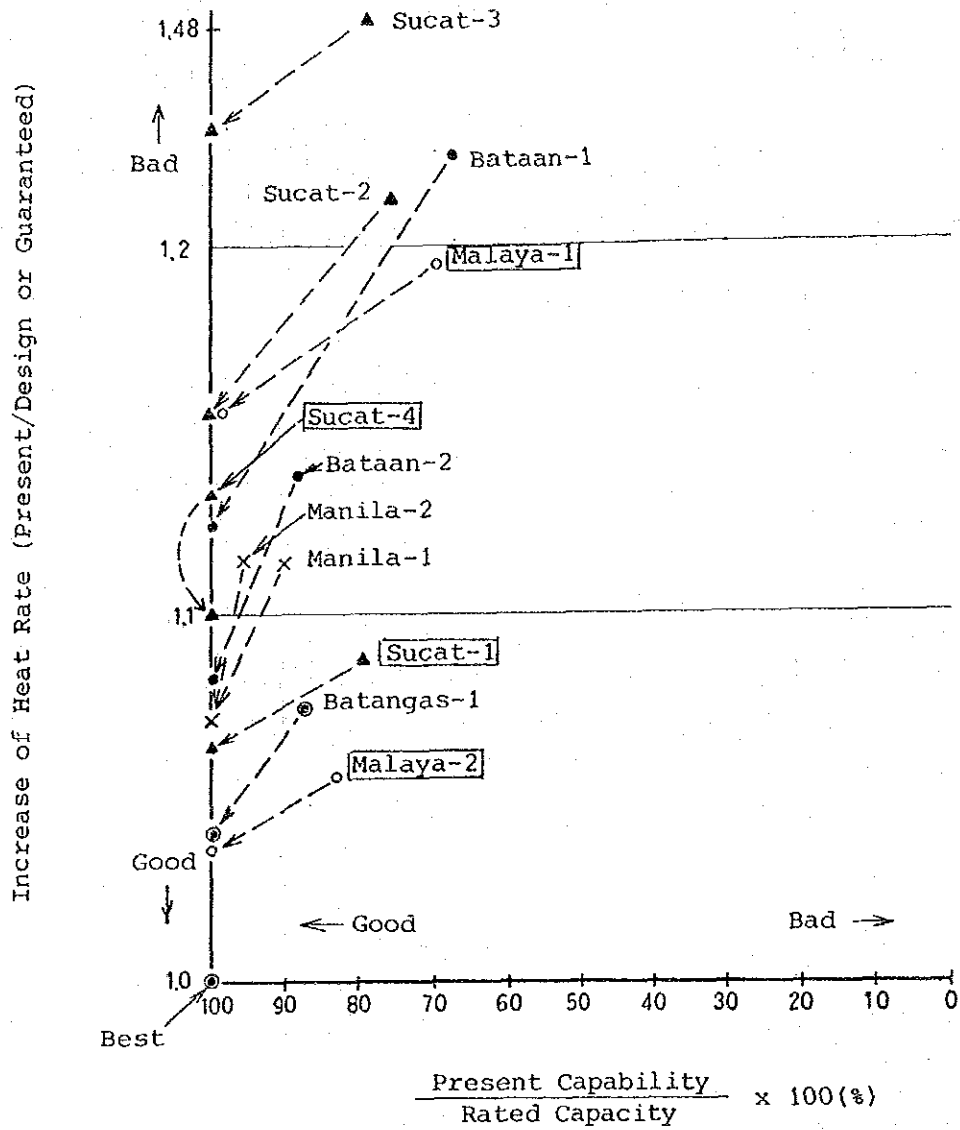
Fig. 6-1-3 火力発電所の現状 (出力及び熱消費率)

これらのユニットは、全般的に経年劣化が進行しており、適切なリハビリテーション又は計画保守が必要である。
