## 資料 4 討議議事録

第 1 回討議議事録

MINUTES OF DISCUSSIONS  
ON  
THE BASIC DESIGN STUDY ON THE PROJECT  
FOR  
REHABILITATION OF THE AMBATALE TREATMENT PLANT  
IN  
THE DEMOCRATIC SOCIALIST REPUBLIC OF SRI LANKA

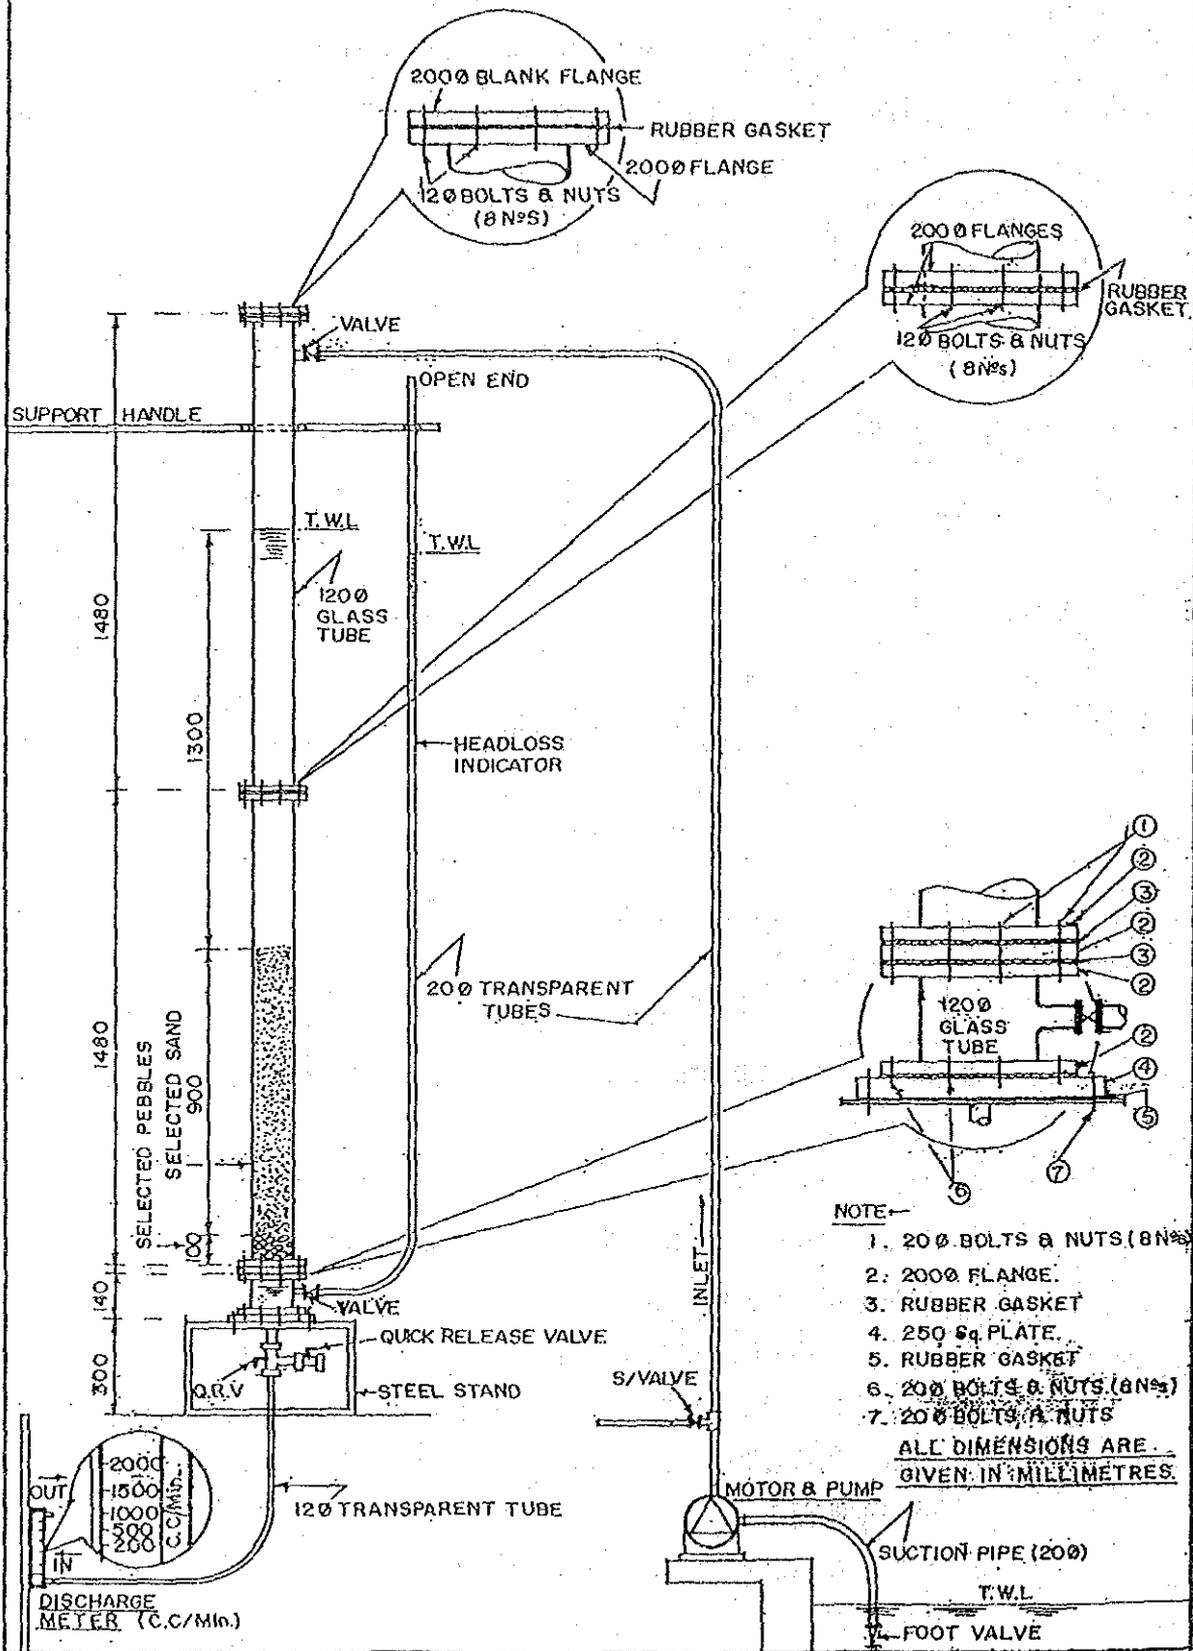
# PILOT FILTER

- ② Run 1 はろ過継続時間28時間にてろ過水水質が3.2NTUとなり「ス」国飲料水基準を越えた。
- ③ Run 2 はろ過継続時間が49時間で圧損、ろ過水水質共満足な状態であった。
- ④ Run 3 は現場の事情により、ろ過継続時間23時間にて実験を中止したが、結果は満足ゆくものであった。
- ⑤ Run 4 はろ過継続時間33時間にて、圧損が1.32mとなった。
- ⑥ Run 5 はろ過継続時間48時間で圧損、ろ過水水質共に満足な状態であった。
- ⑦ Run 6 はろ過継続時間36時間にて、ろ過水水質が2.2NTUとなり「ス」国飲料水基準を越えた。
- ⑧ Run 7 はろ過継続時間41時間にてろ過水水質が2.1NTUとなり「ス」国飲料水基準を越えた。
