DEPARTMENT OF PUBLIC WORKS AND HIGHWAYS
REPUBLIC OF THE PHILIPPINES

FEASIBILITY STUDY
ON
PAN-PHILIPPINE HIGHWAY REHABILITATION PROJECT
(MINDANAO SECTION)

FINAL REPORT
DRAWINGS

MAY 1995

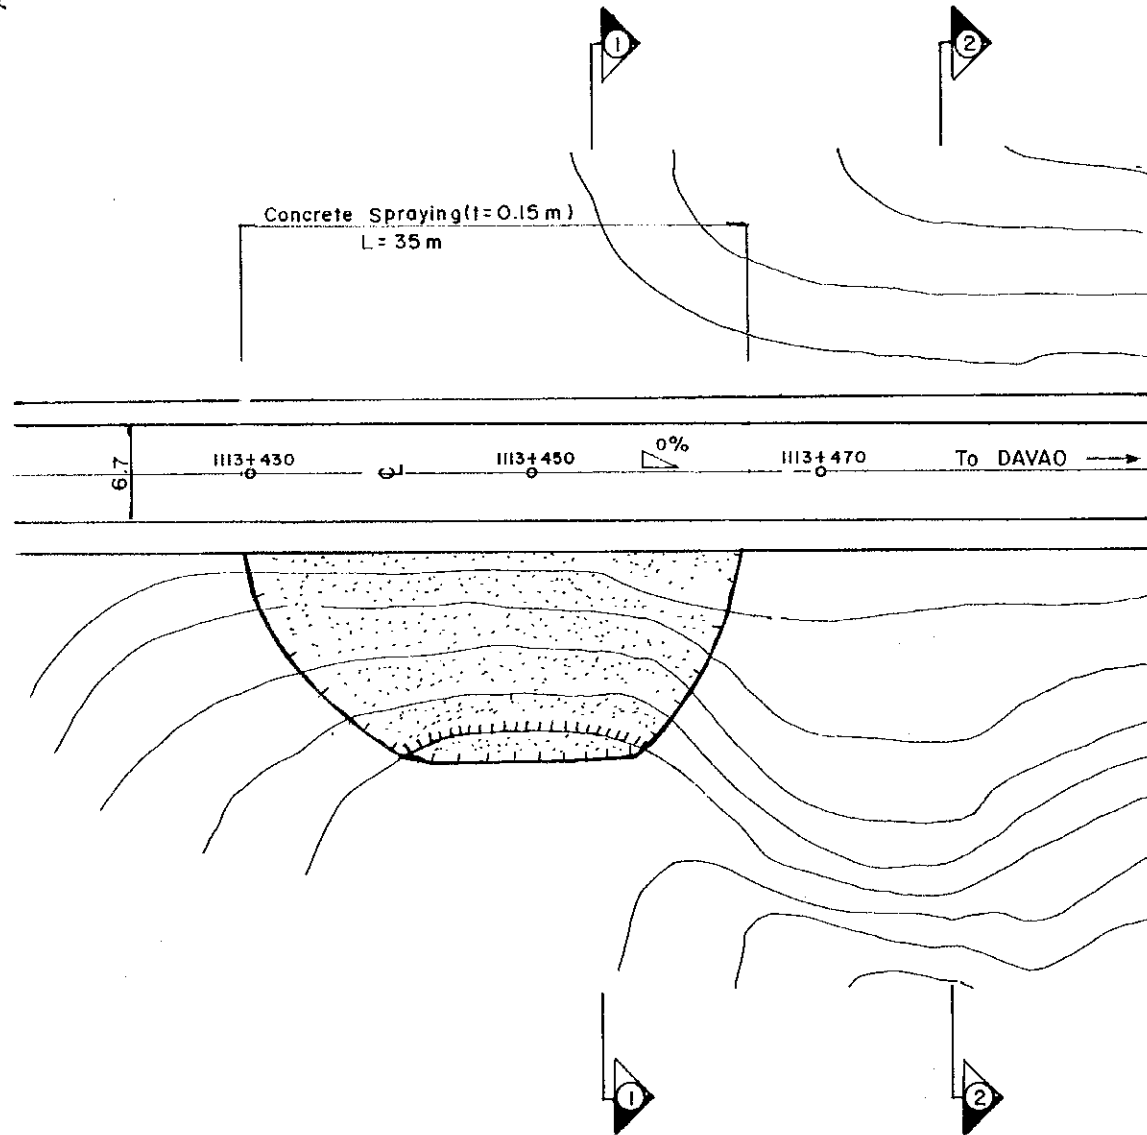
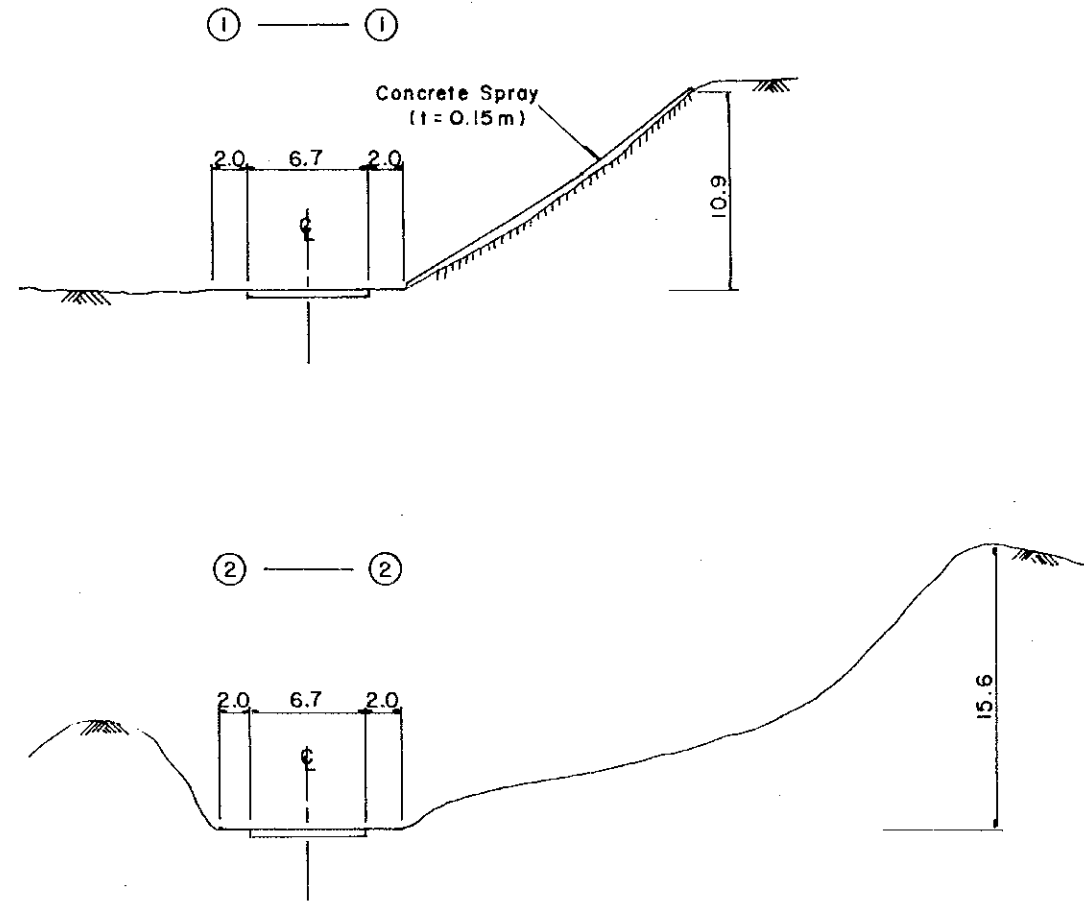
Cause of Disaster:

- 1) Failure in layer of severely weathered andesite.
- 2) Infiltration of water into cracks which precipitated weathering of andesite.

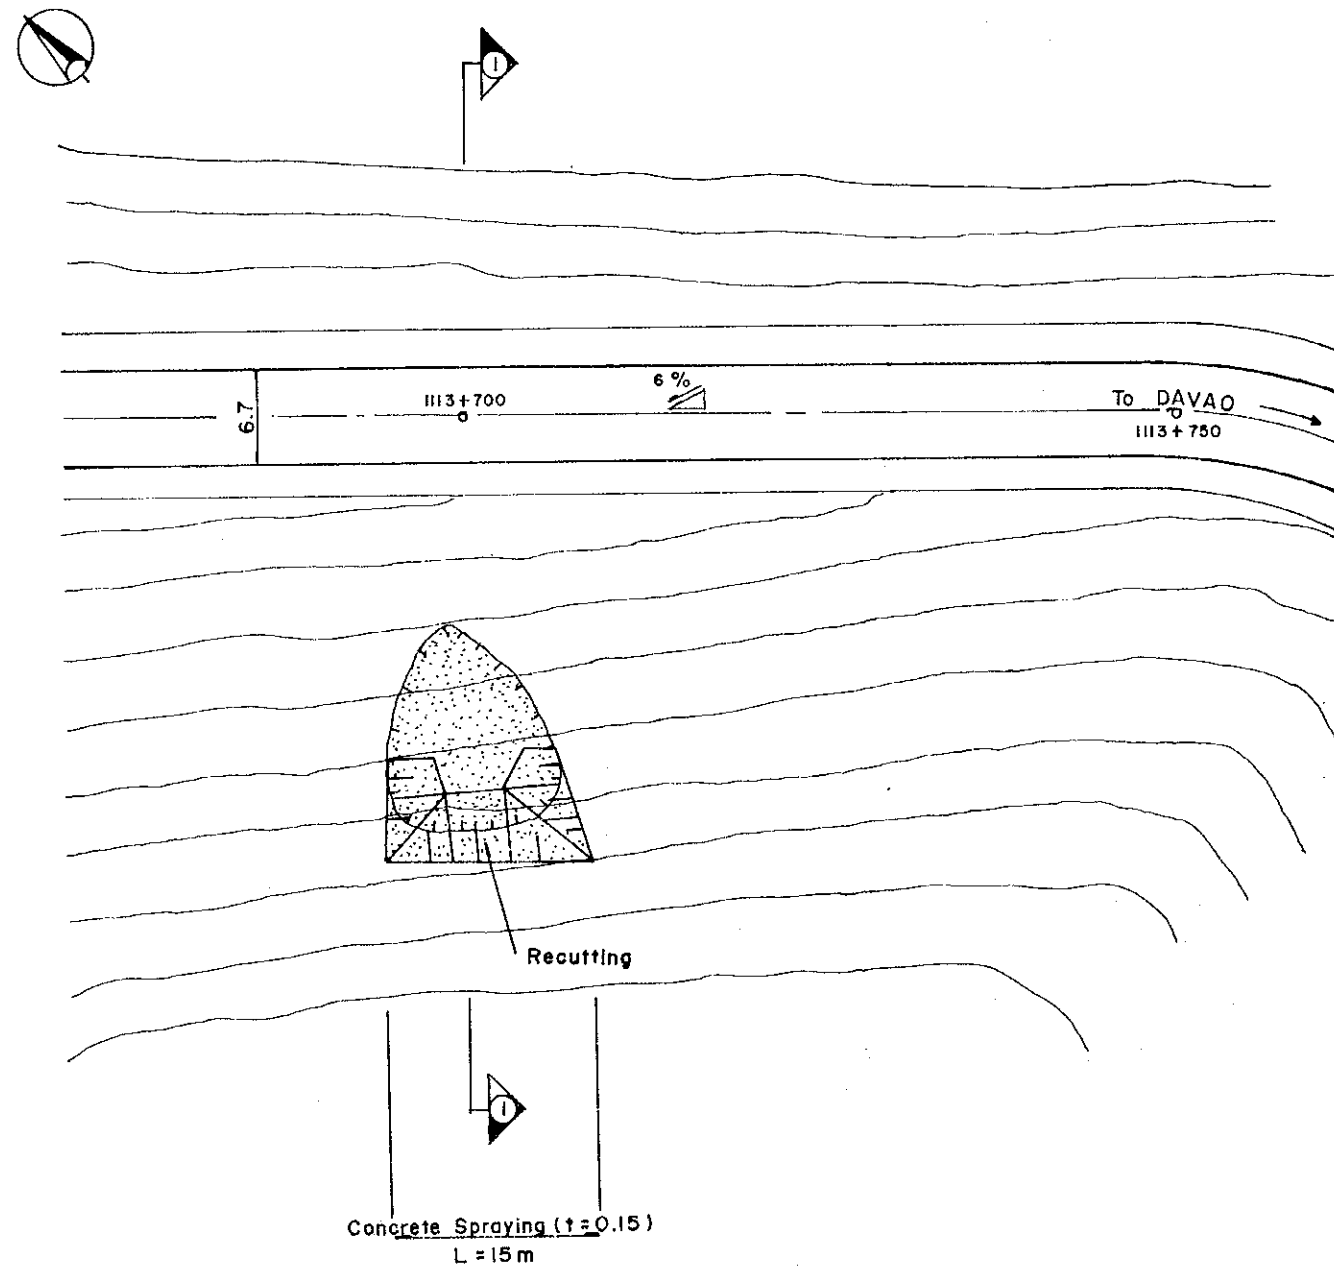
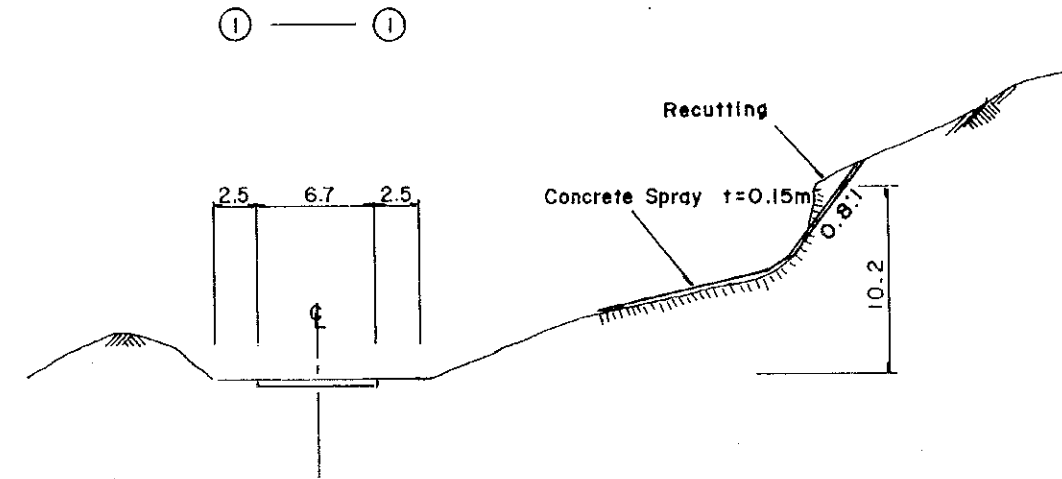
Cause of Disaster:

- 1) Failure in layer of severely weathered andesite.
- 2) Infiltration of water into cracks which induced wedge-shaped failures.

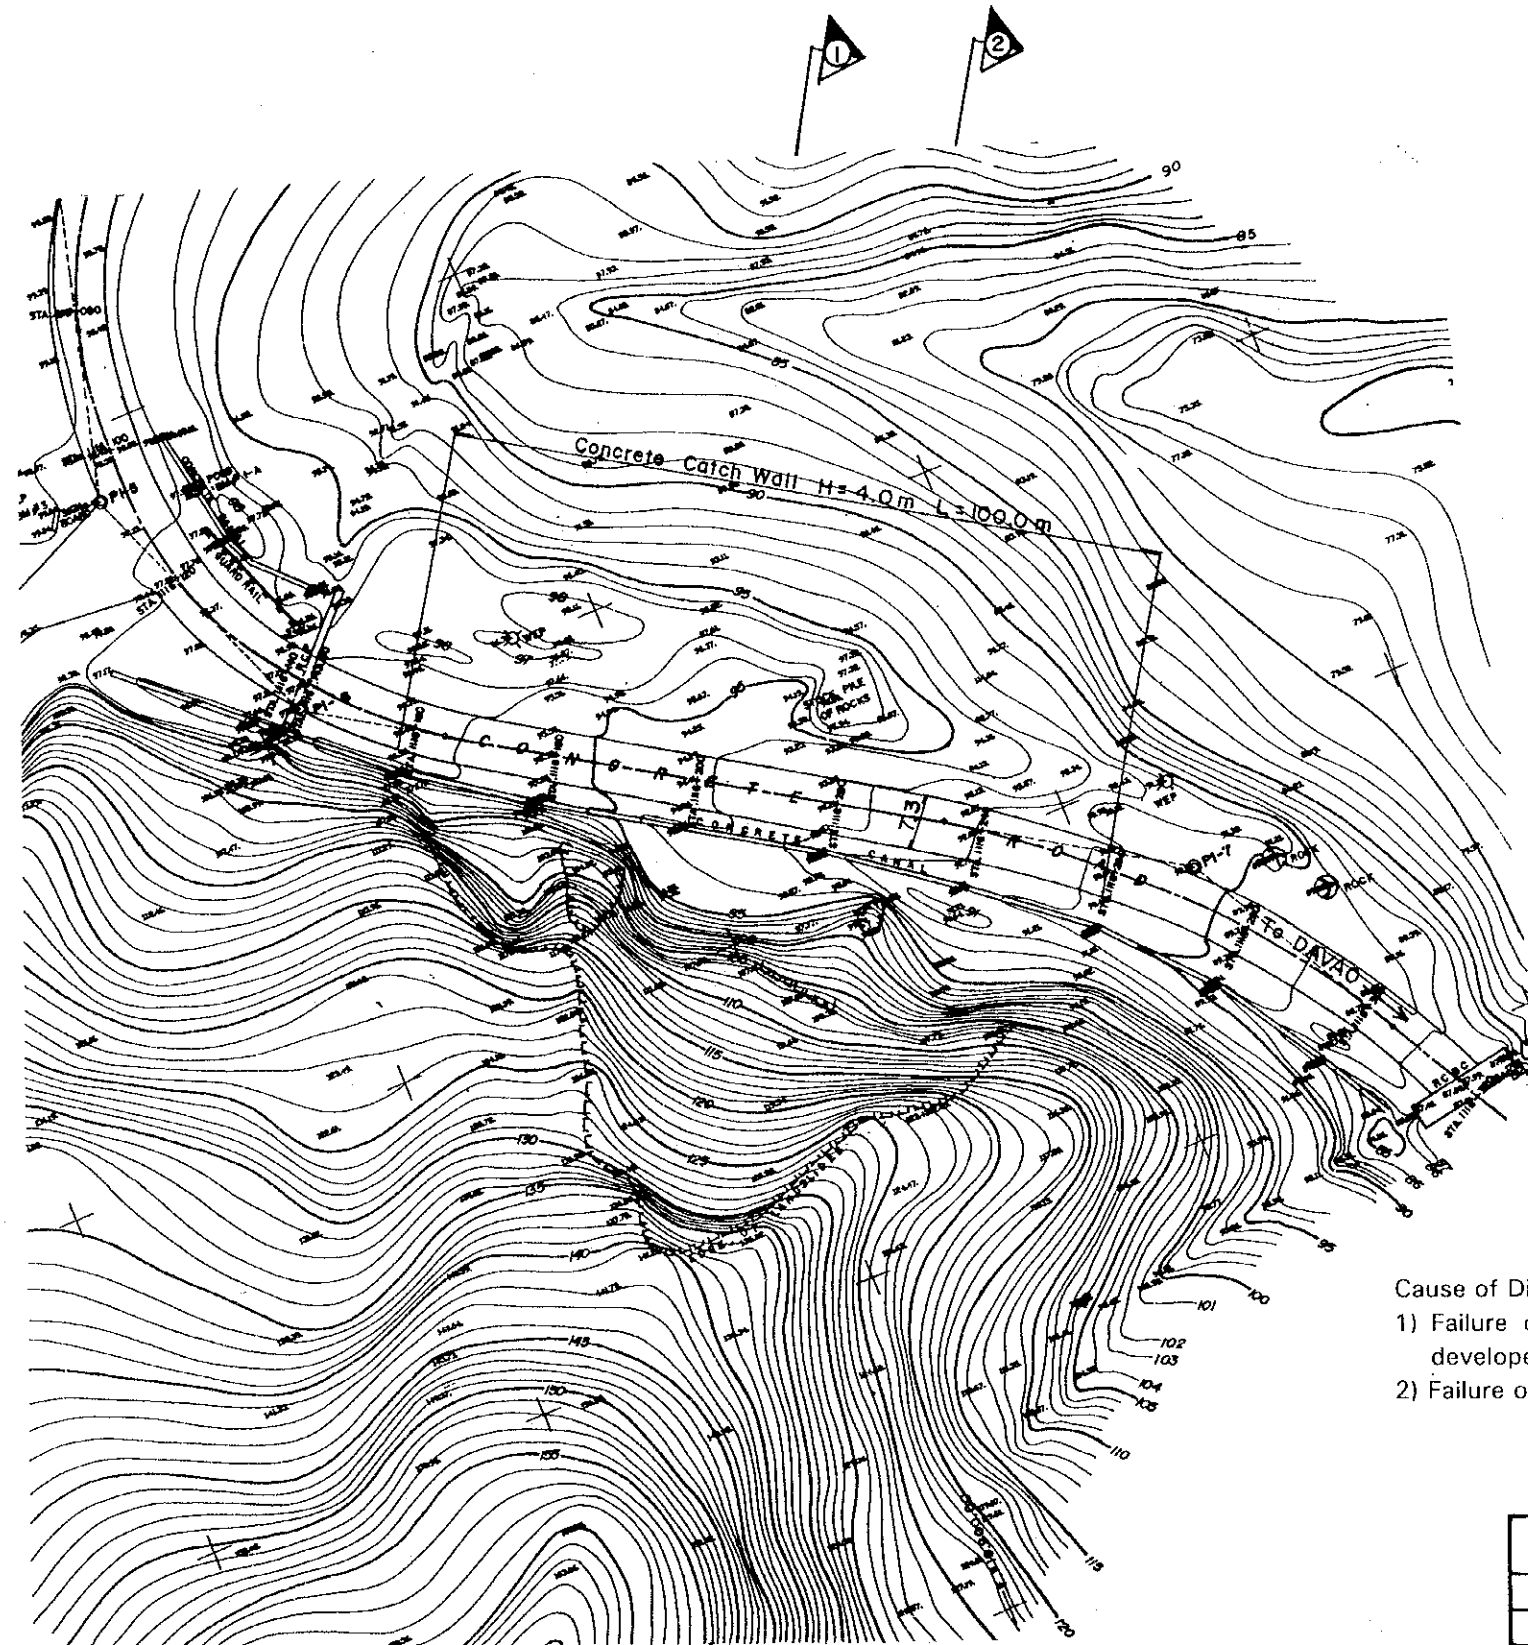
DRAWING NO.
S-3(1/2)

Cause of Disaster:

- 1) Infiltration of water into boundary surface between the inclined ground and embankment.
- 2) Effect of ground water.
- 3) Embankment slope with an unstable grade.

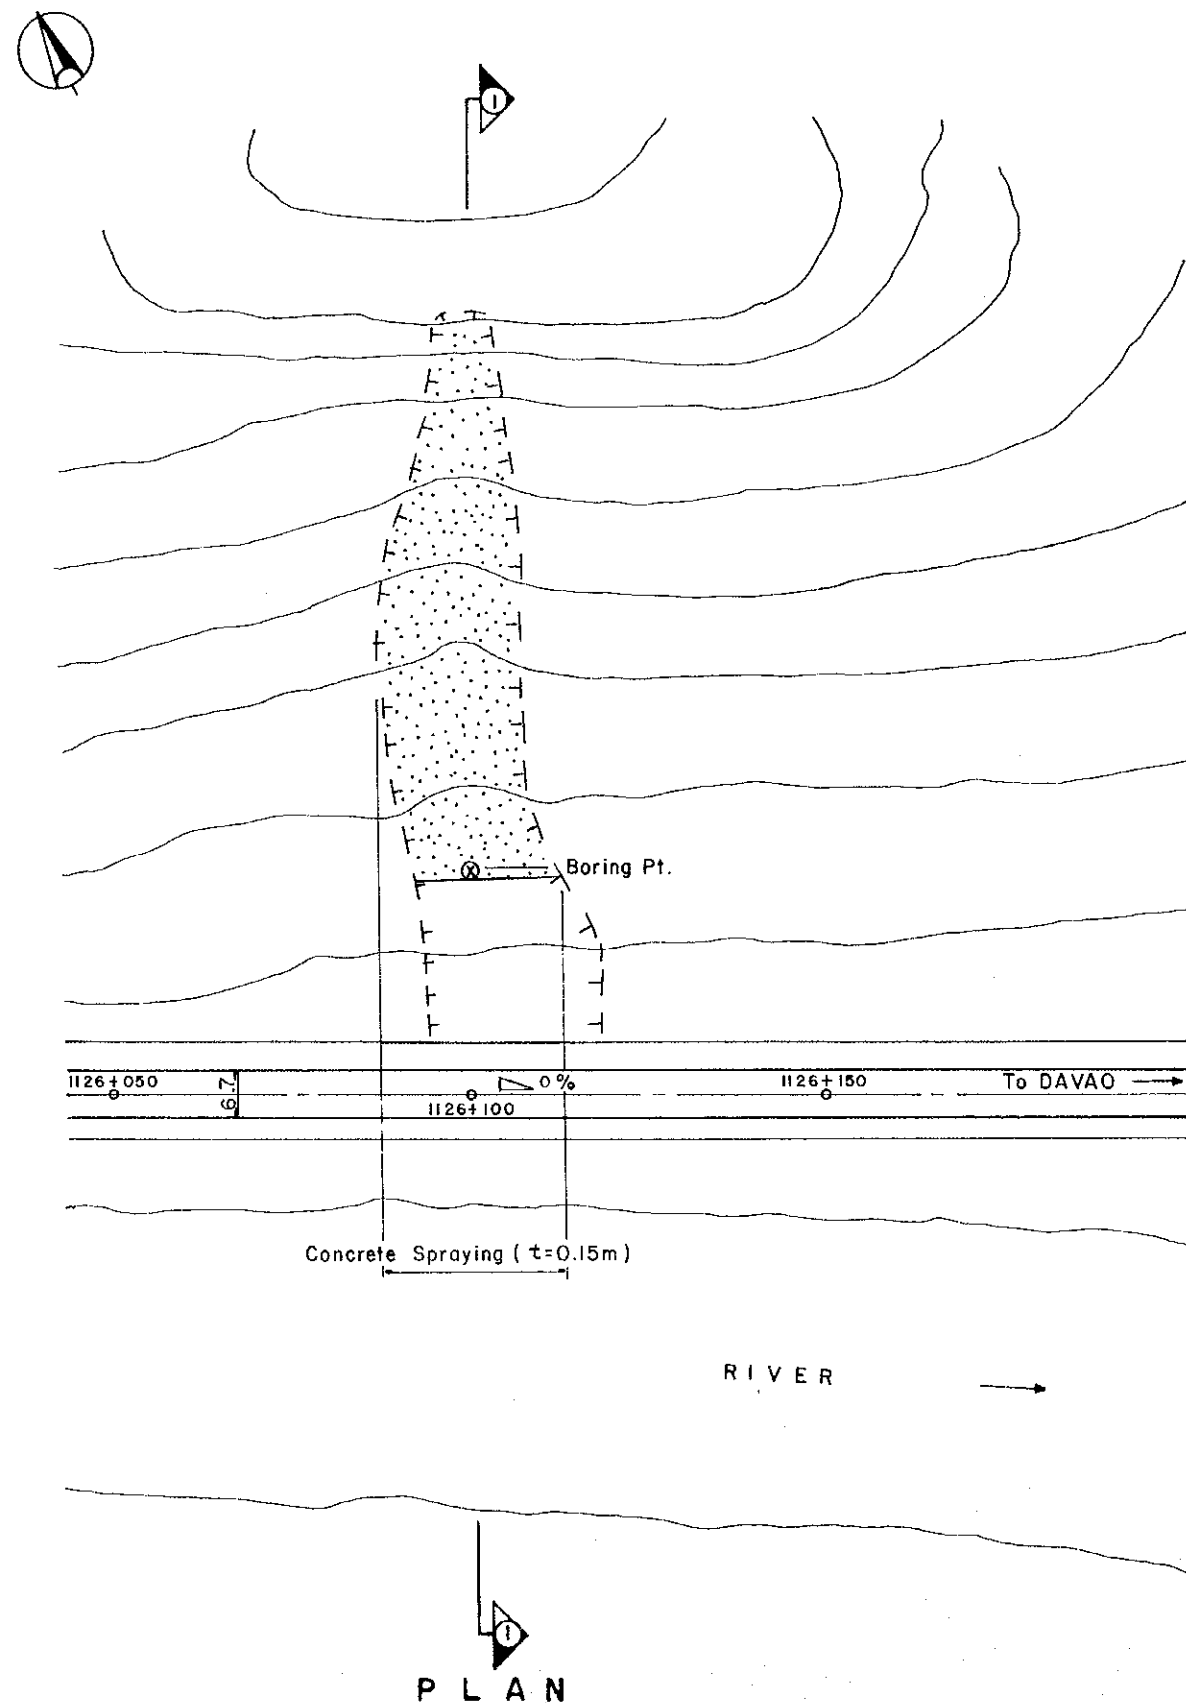
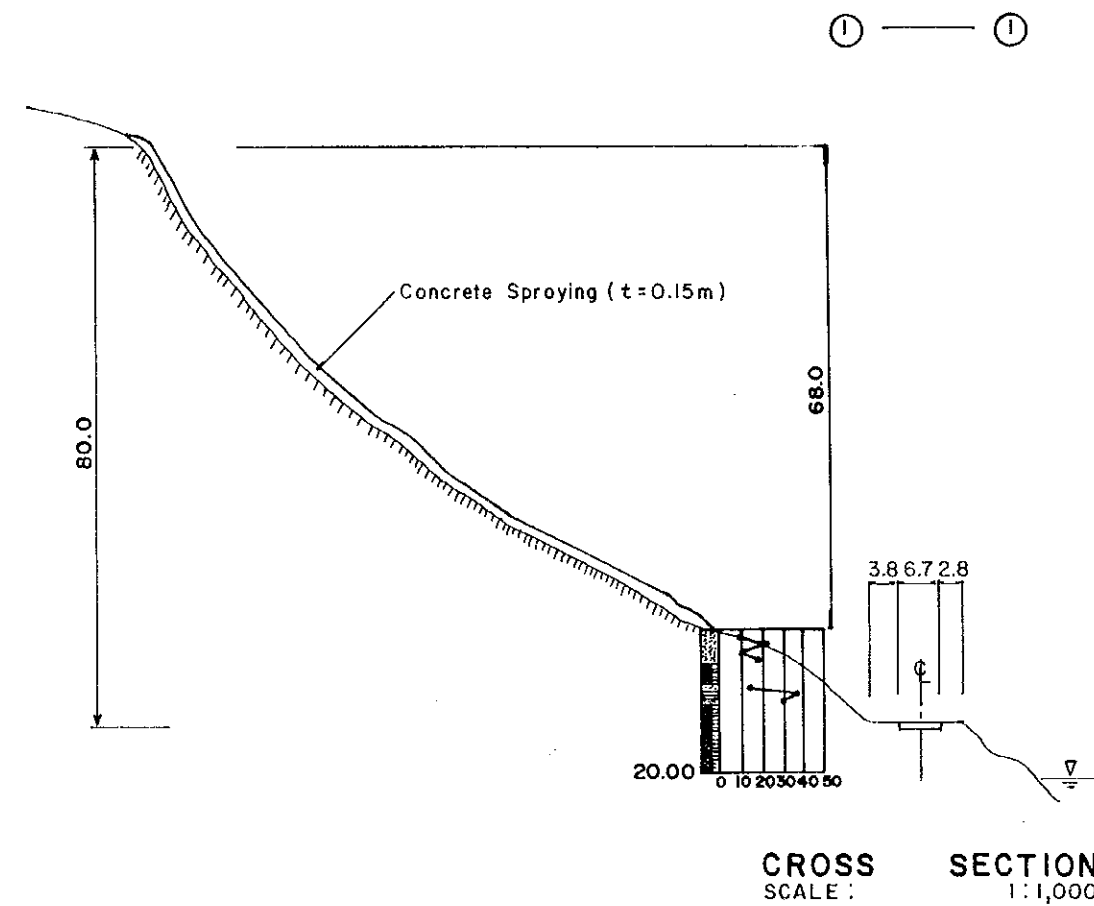
DRAWING NO.
S-4(2/2)

Cause of Disaster:

- 1) Failure of surface layer along cracks in sandstone which have been developed in the direction towards road.
- 2) Failure of large slope with a steep grade.

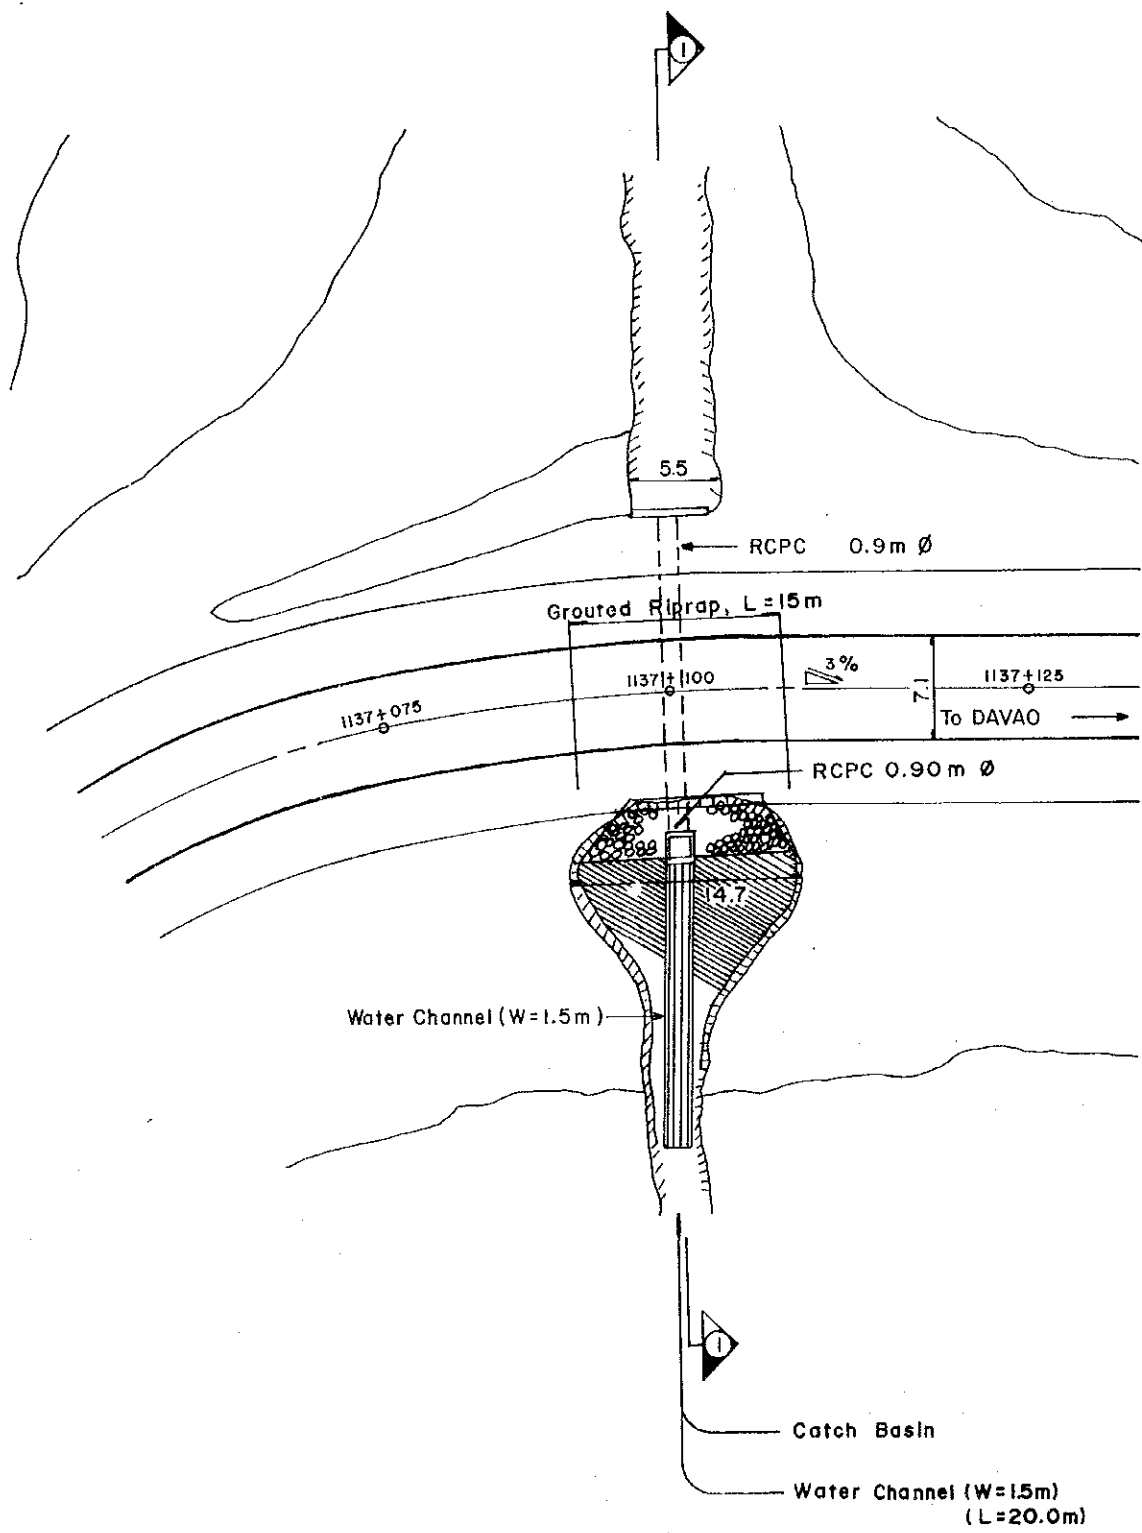
Cause of Disaster:
1) Scouring by flow of river with flood stage.
2) Creek overflowing and scouring the embankment.

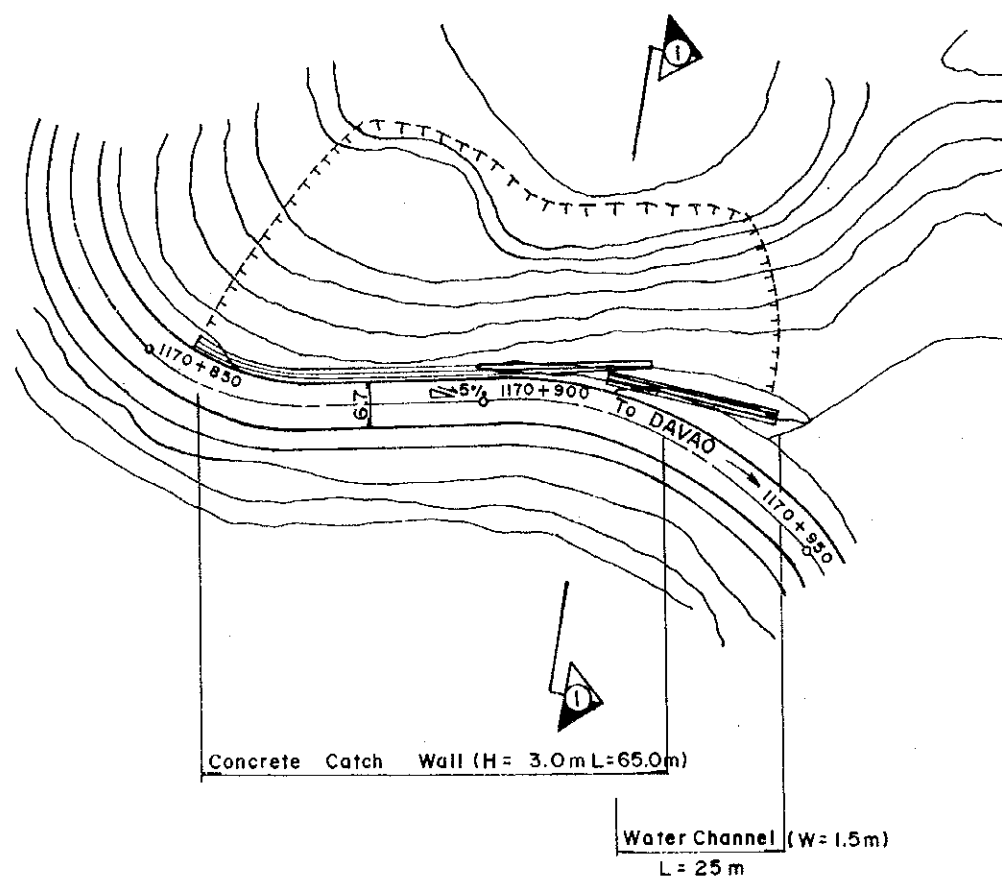
Cause of Disaster:
1) Failure due to exfoliation of limestone.

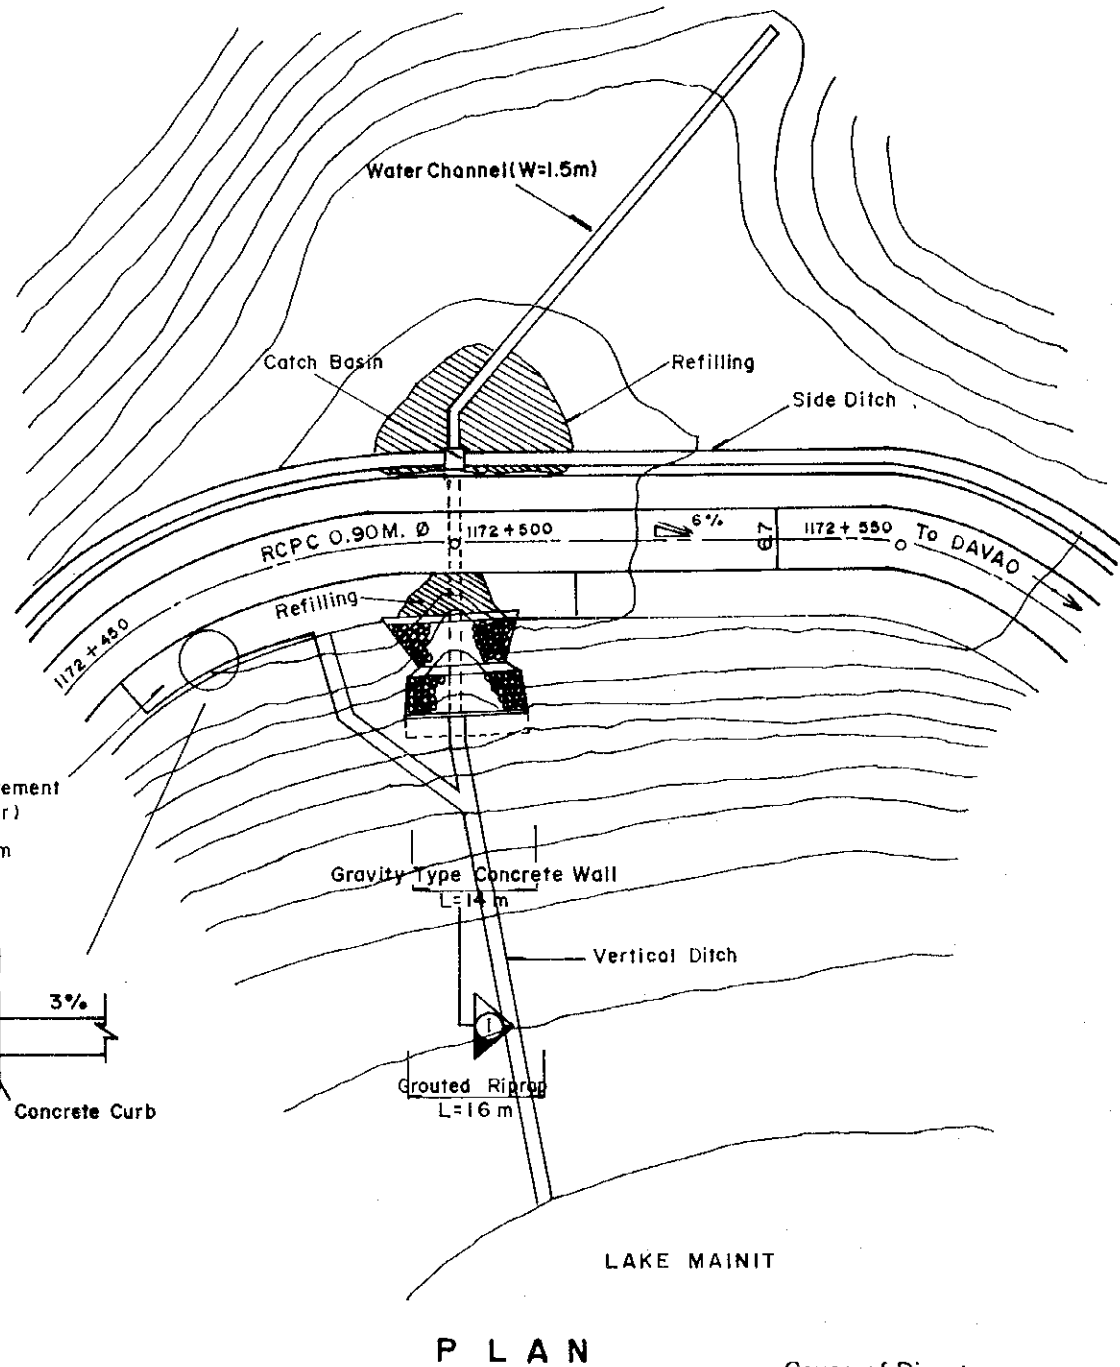
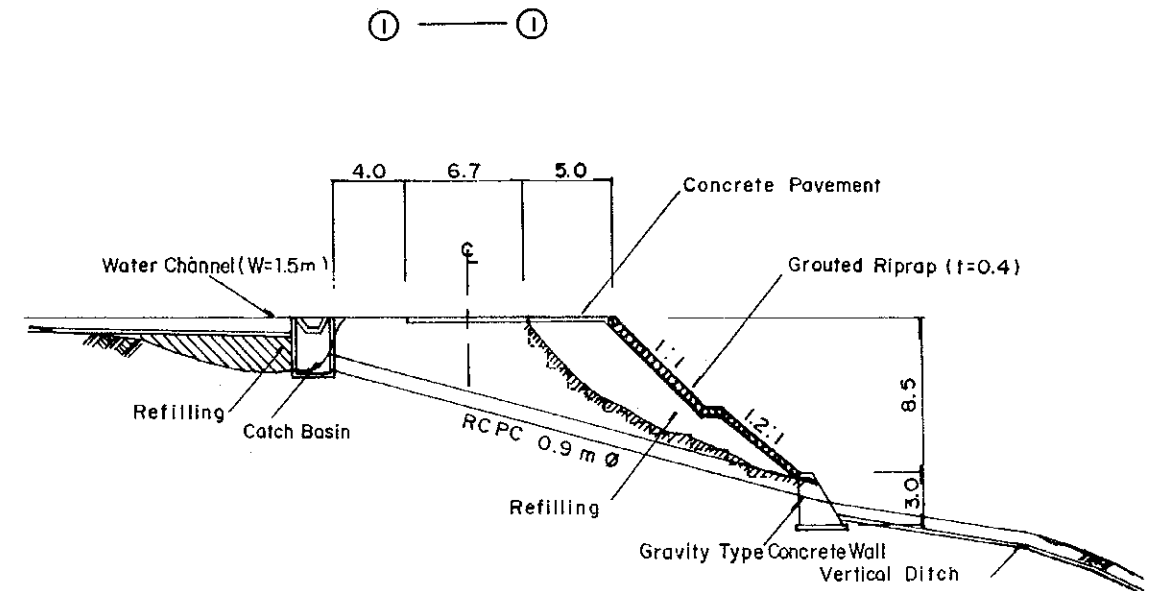
Cause of Disaster:

- 1) Insufficient compaction of embankment.
- 2) Creek which overflowed and scoured the embankment.
- 3) Embankment slope with an unstable grade.

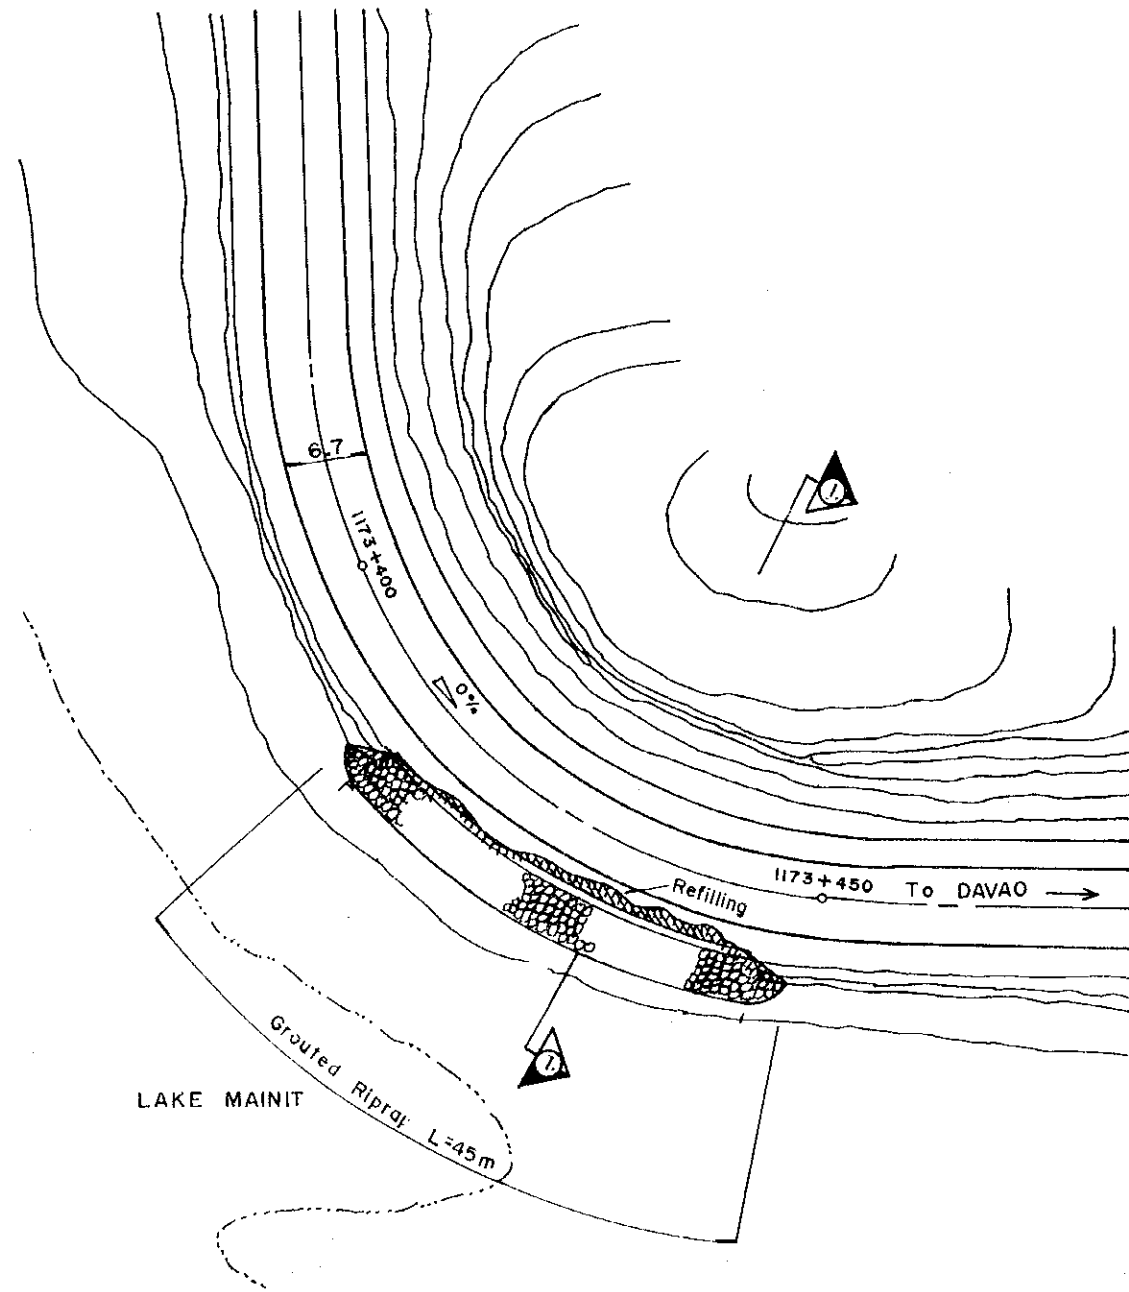
Cause of Disaster:

- 1) Erosion by water of lake with flood stage.

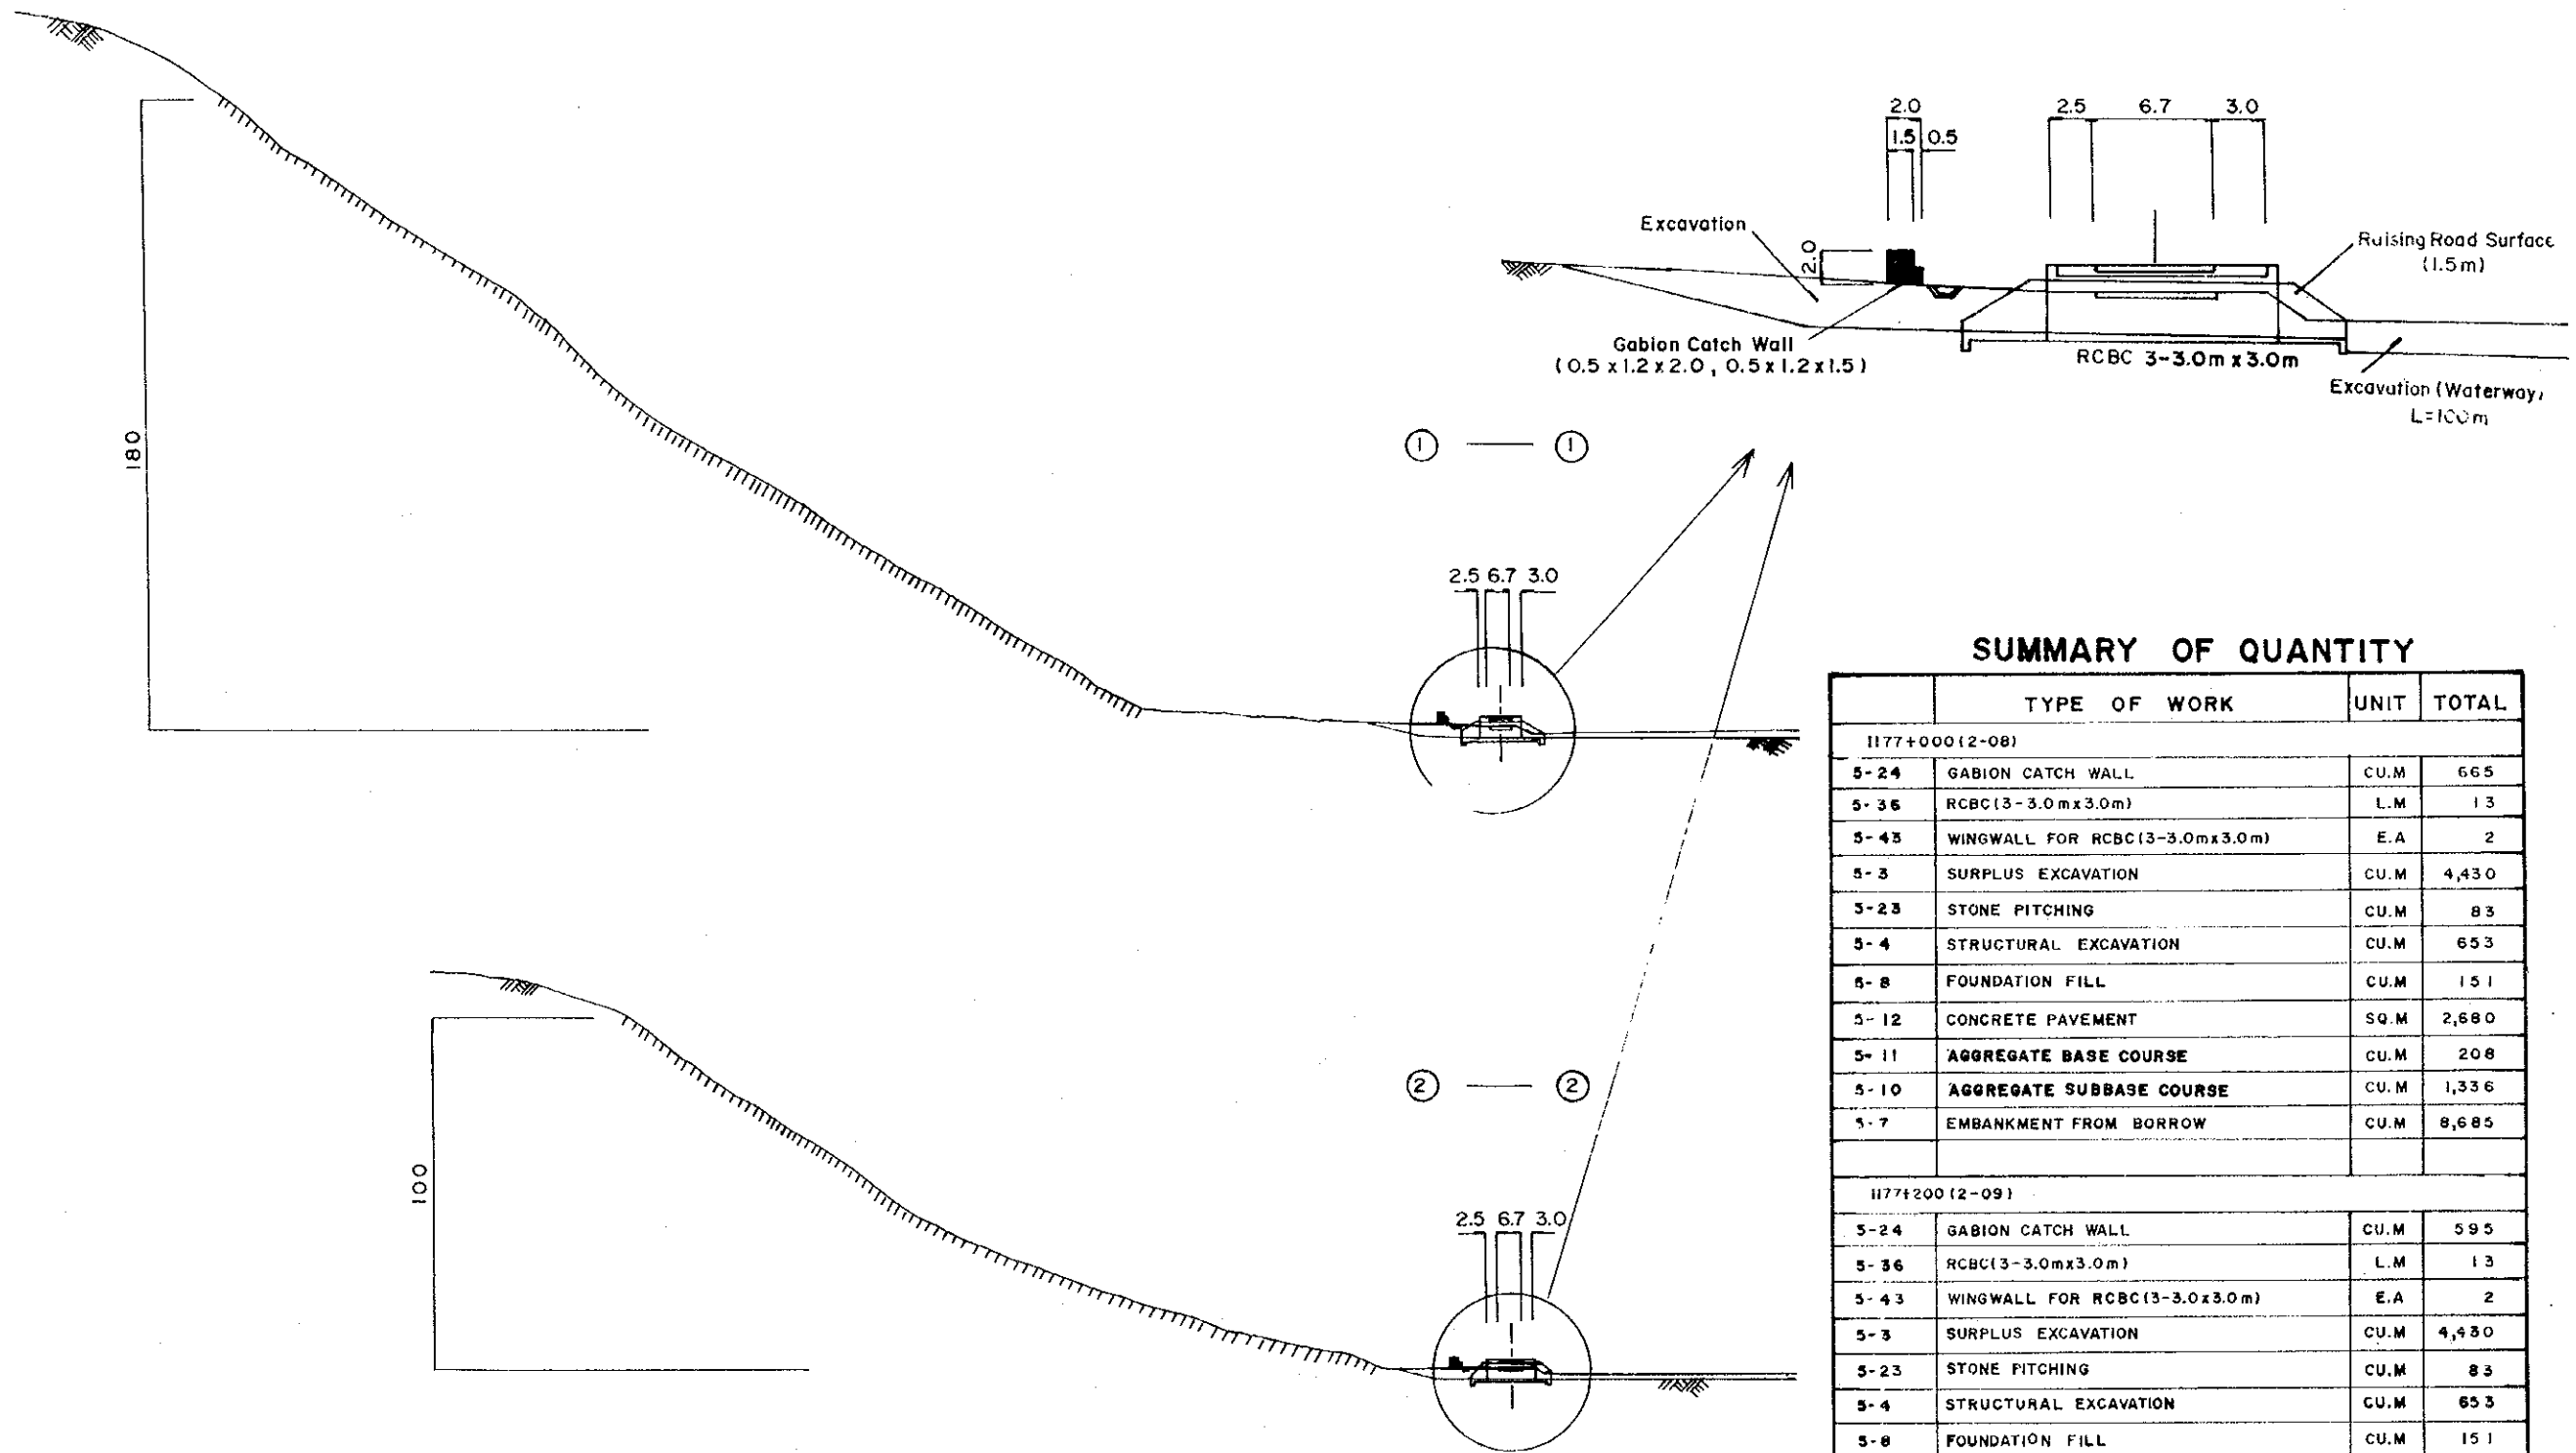
DRAWING NO.
S-12(1/2)

Cause of Disaster:

- 1) Flow of debris supplied by slope failures, deposited on the side of hill and flashed down by heavy rain.

- 1) Flow of debris supplied by slope failures, deposited on the side of hill and flashed down by heavy rain.
- 2) Insufficient drainage capacity of pipe culvert and poor maintenance.

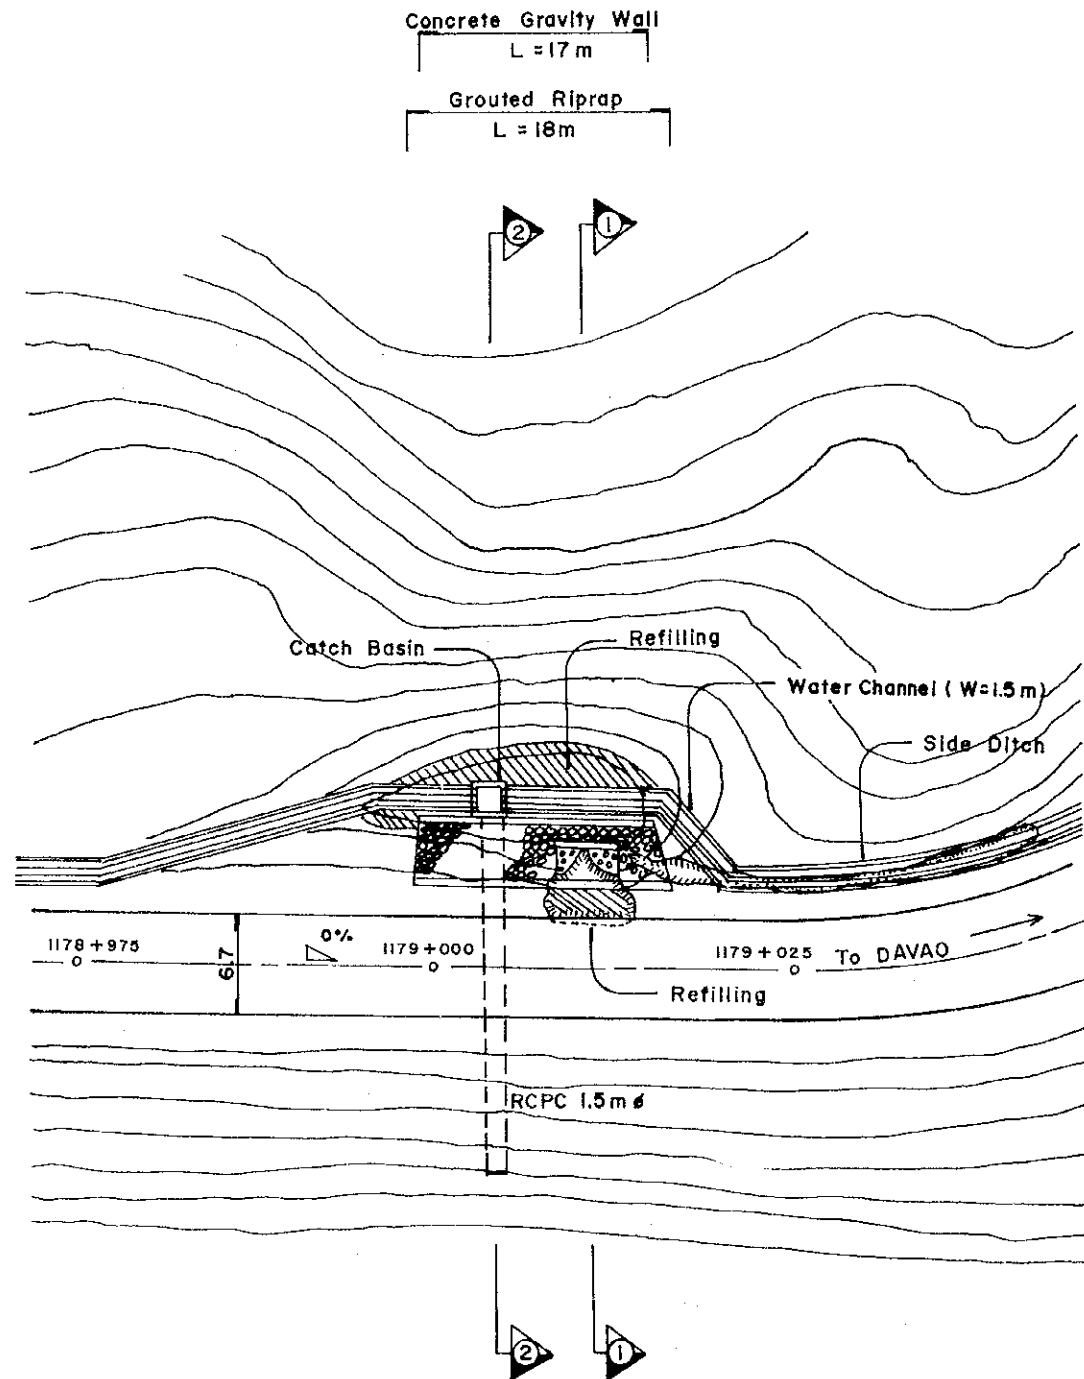
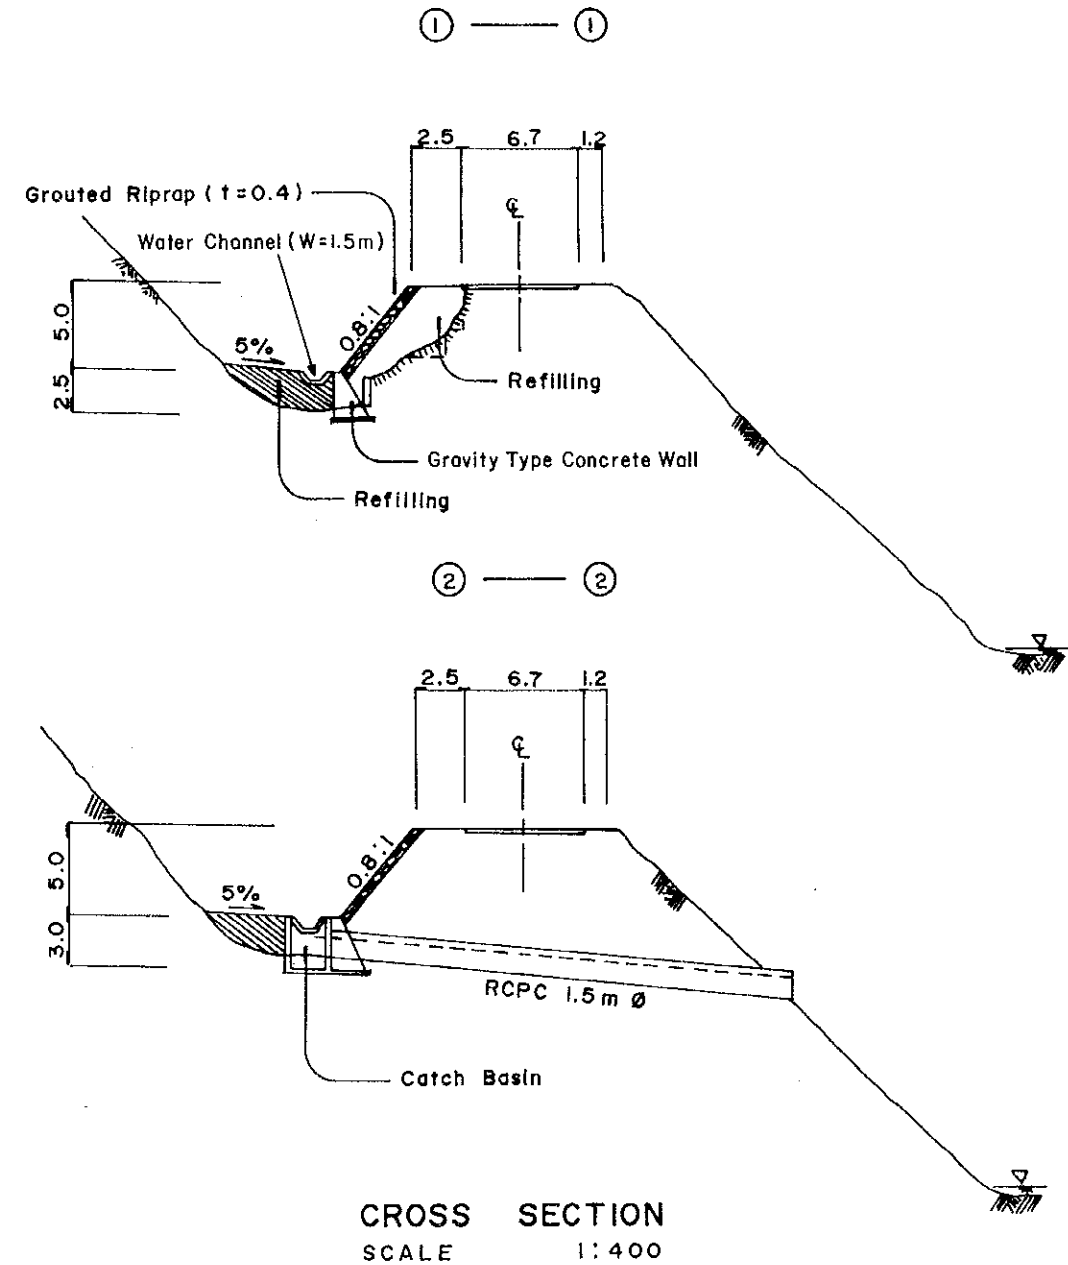
Cause of Disaster:

- 1) Effect of ground water.
- 2) Infiltration of water into boundary surface between the inclined ground and embankment.
- 3) Insufficient drainage capacity of pipe culvert.
