DEPARTMENT OF PUBLIC WORKS AND HIGHWAYS
REPUBLIC OF THE PHILIPPINES

FEASIBILITY STUDY
ON
PAN-PHILIPPINE HIGHWAY REHABILITATION PROJECT
(MINDANAO SECTION)

FINAL REPORT
DRAWINGS

MAY 1995

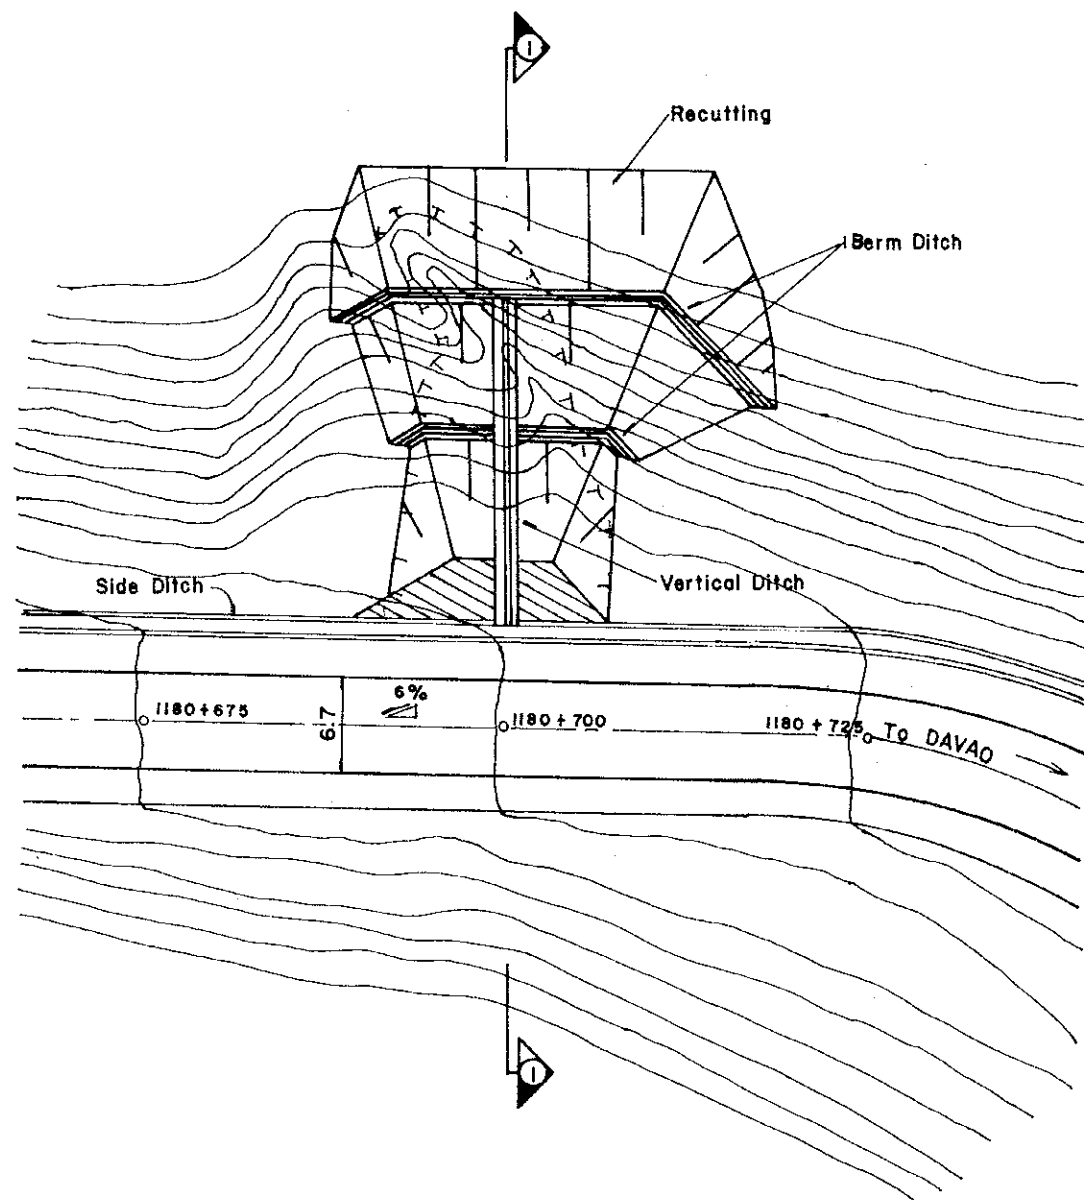
Cause of Disaster:

- 1) Surface failure of granite which has been severely weathered by rain.

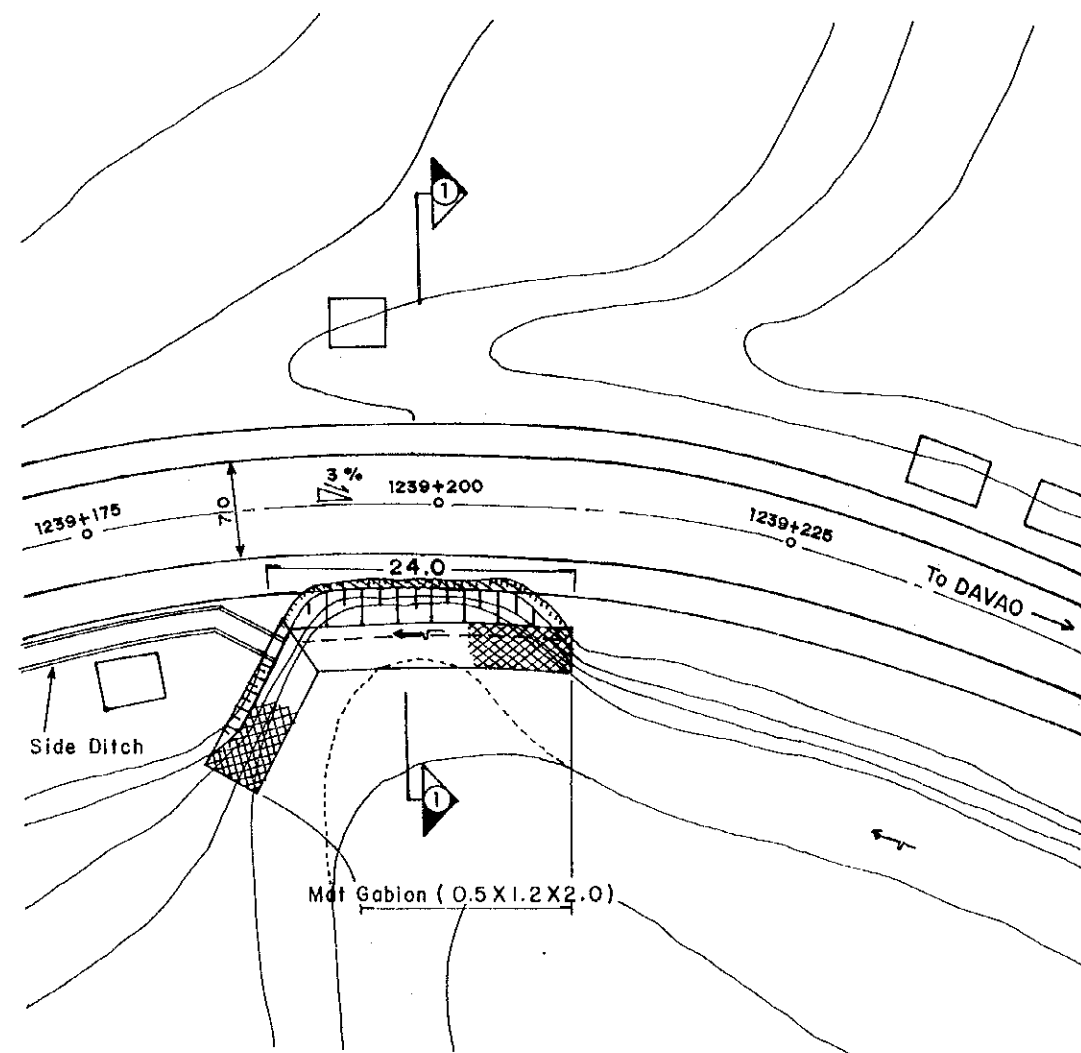
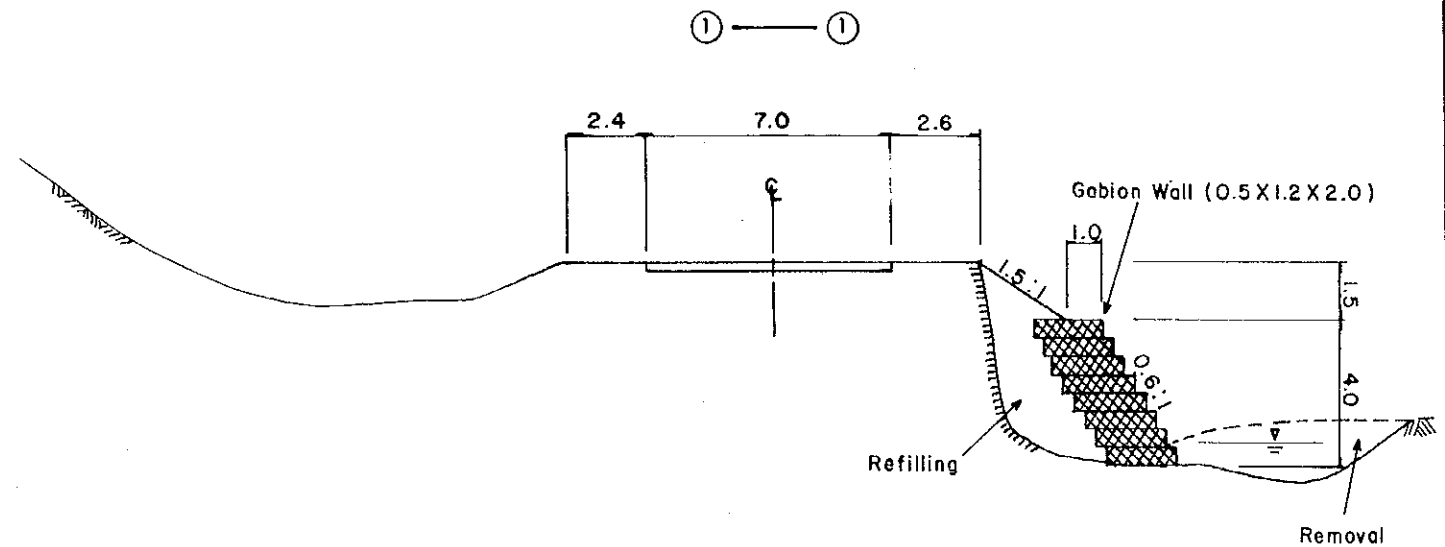
Cause of Disaster:

- 1) Scouring by flow of river with flood stage.
- 2) Erosion due to concentrated surface water on the curved portion of road.
- 3) Embankment slope with an unstable grade.

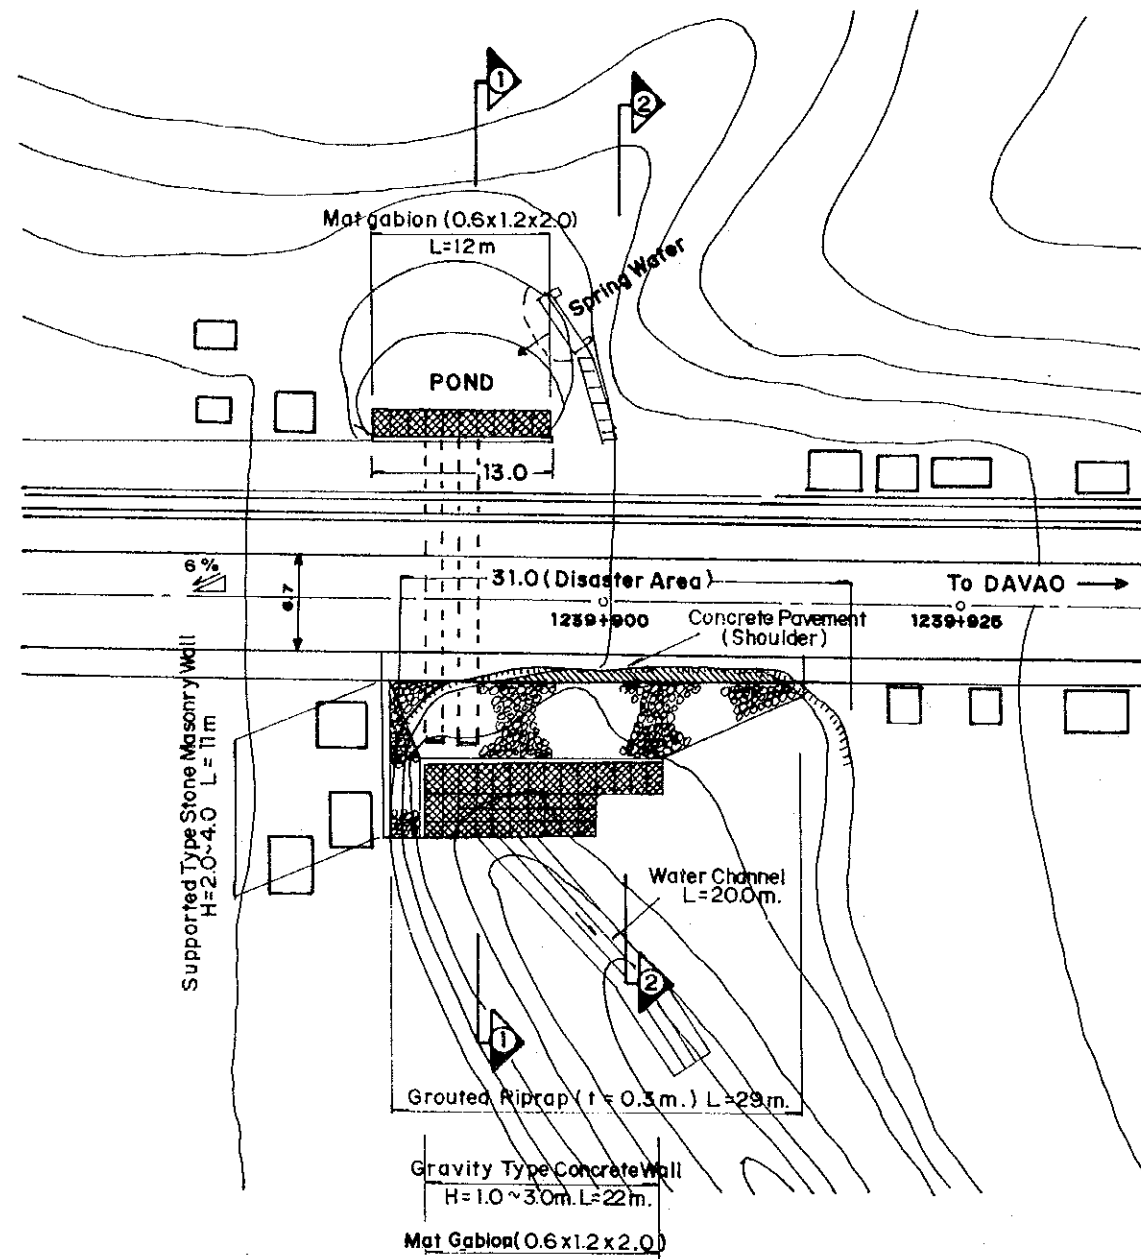
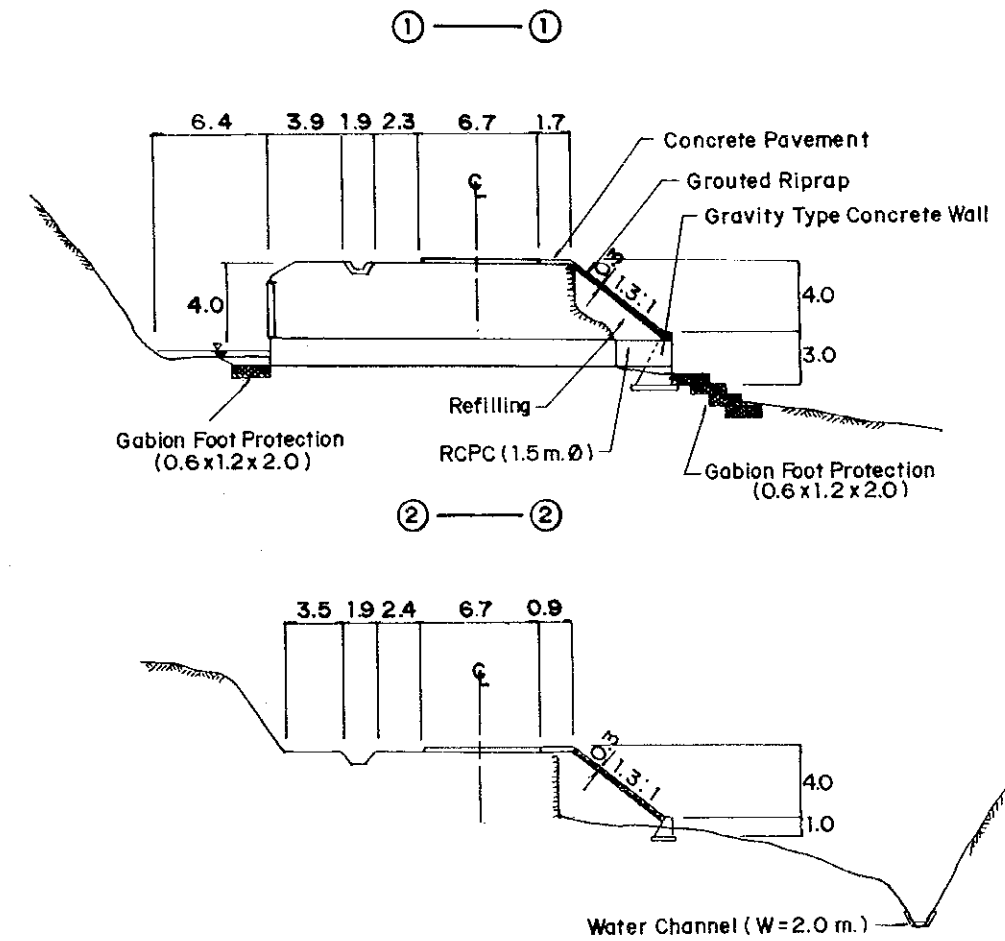
Cause of Disaster:

- 1) Inadequate out-let facility of pipe culvert.

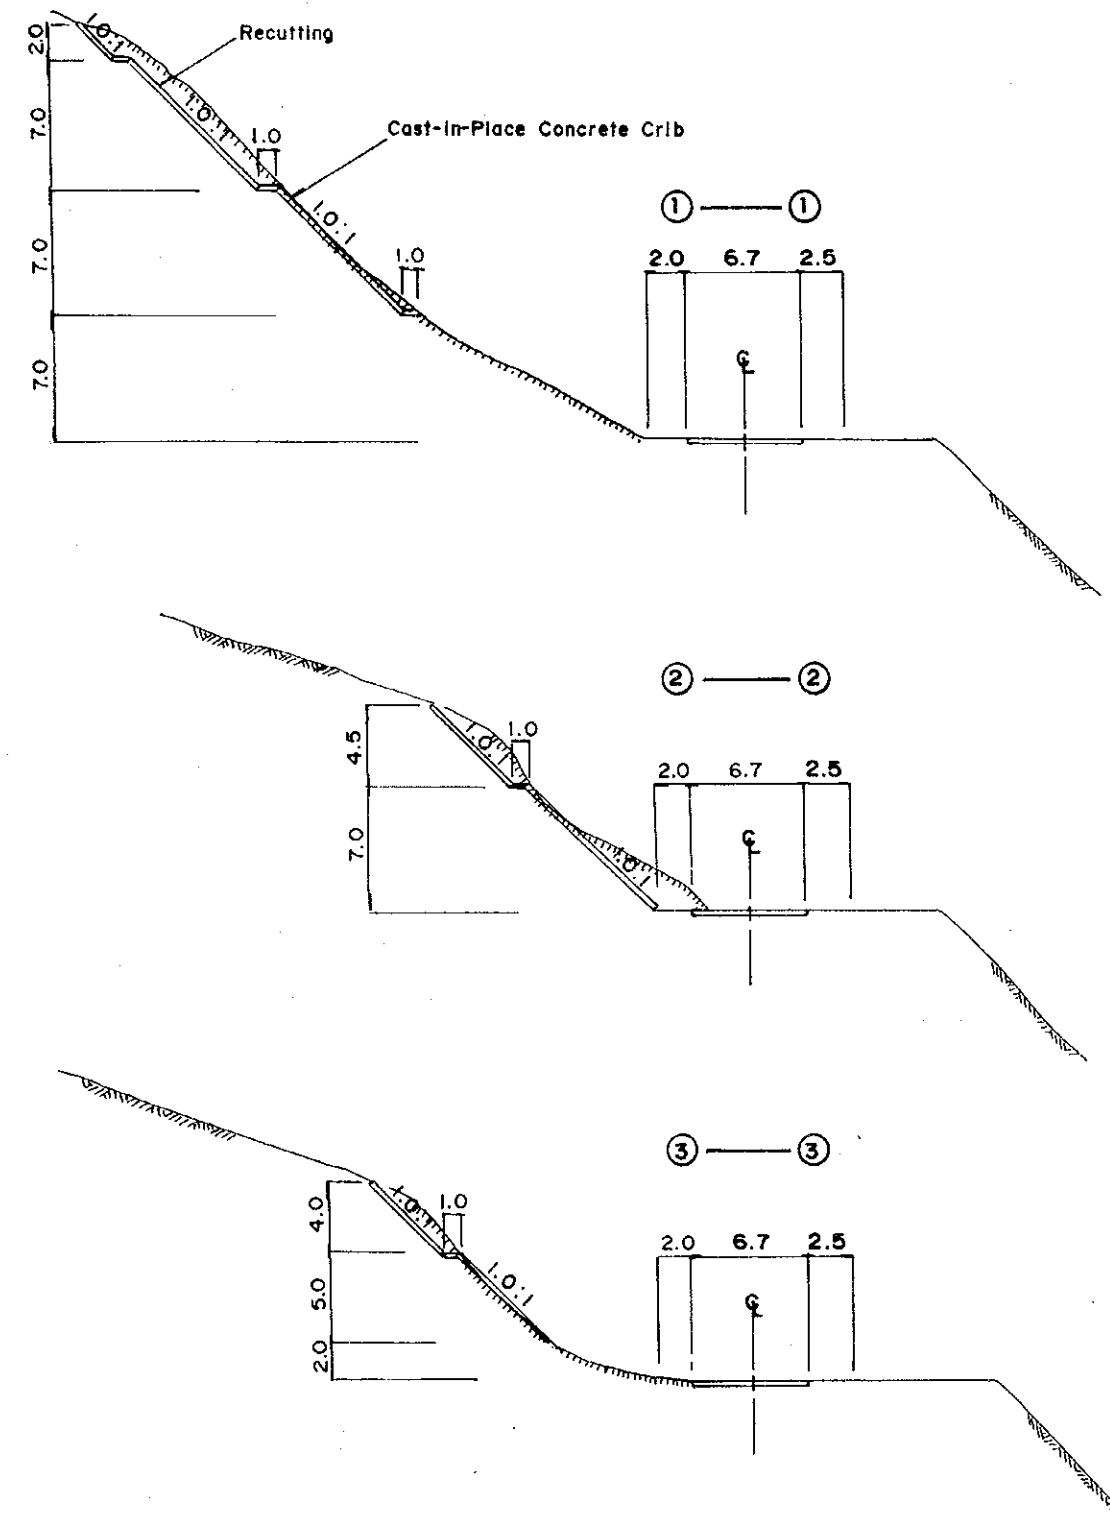
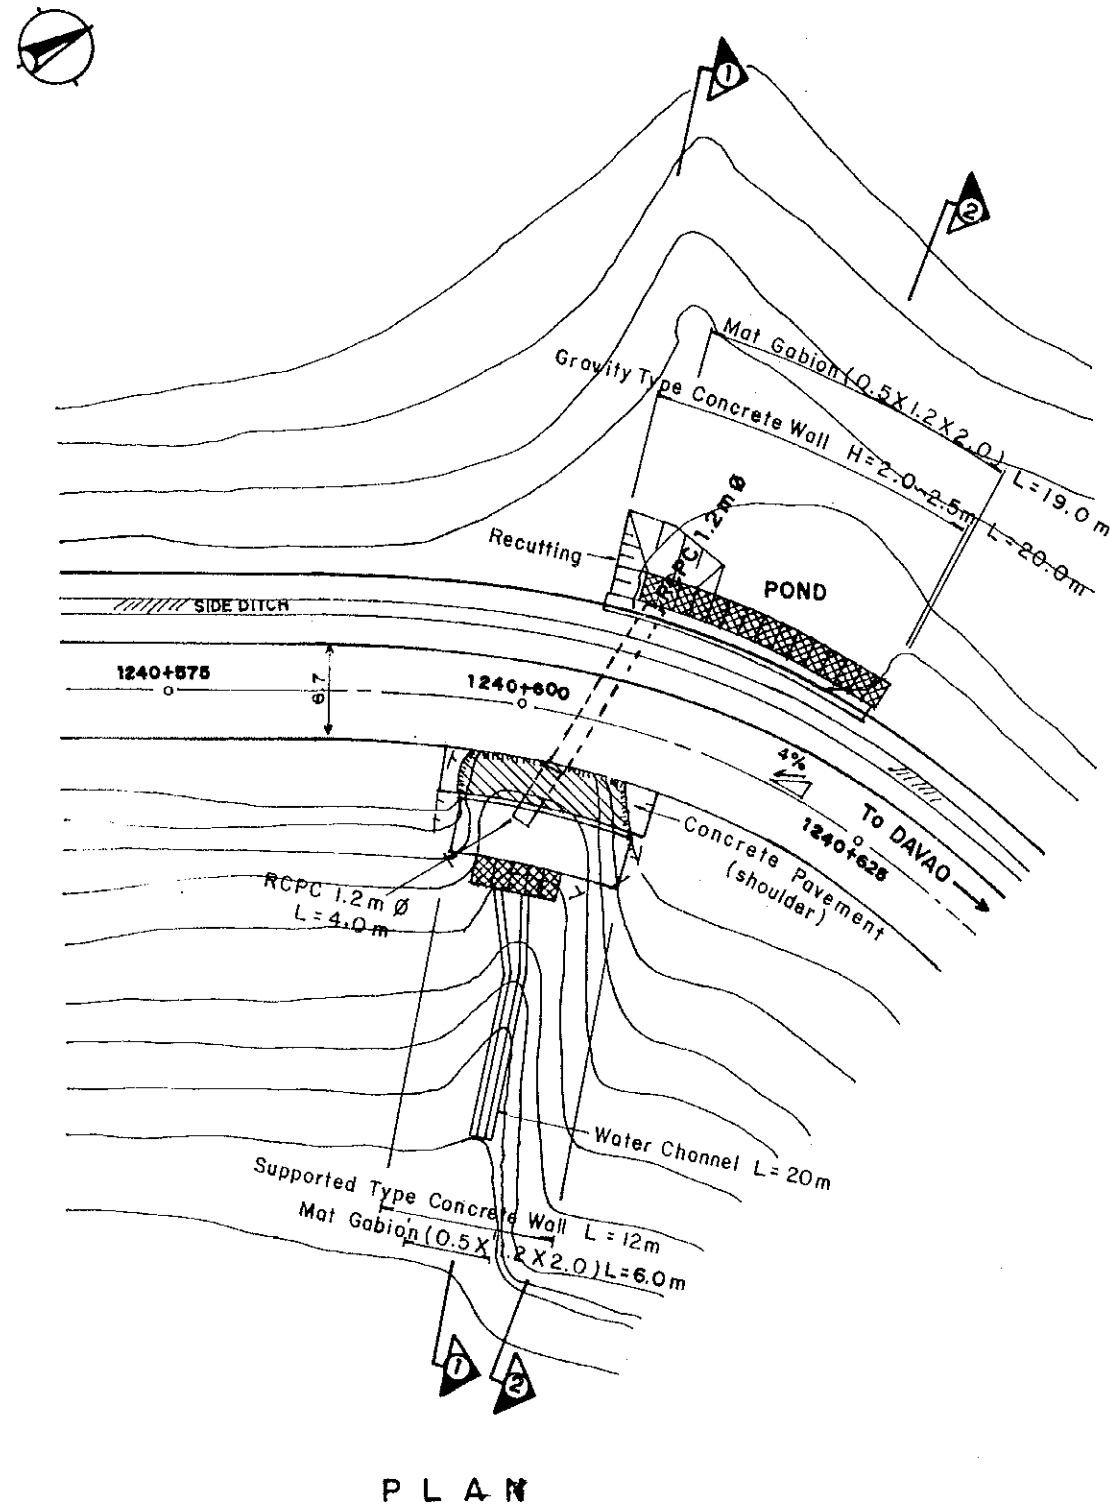
Cause of Disaster:

- 1) Surface failure induced by rain in layer of severely weathered mudstone.

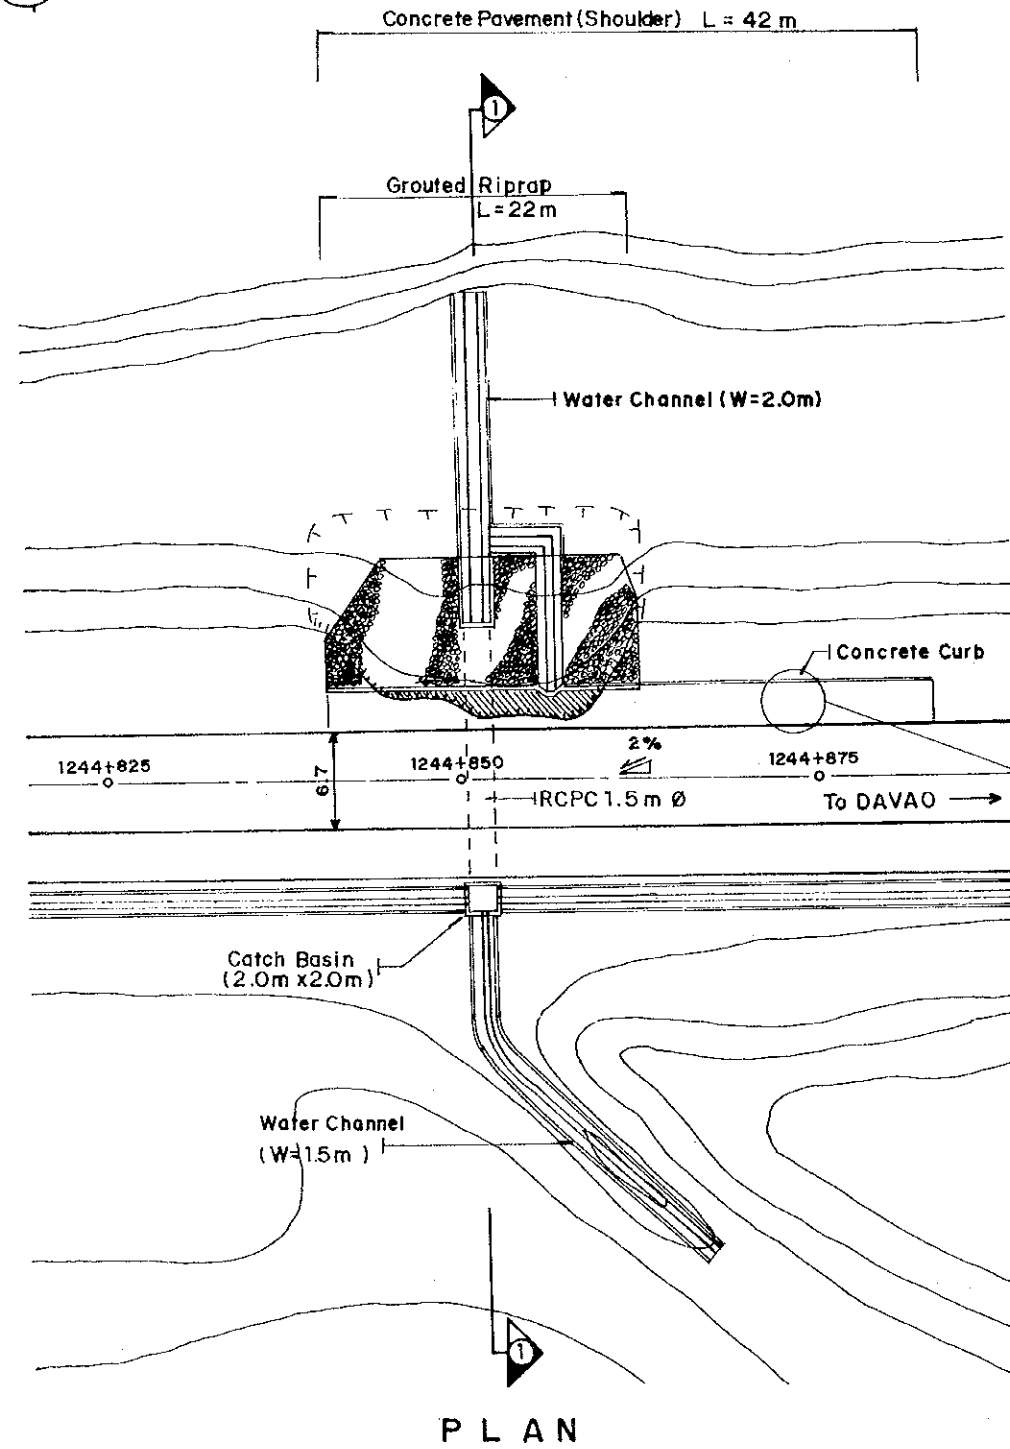
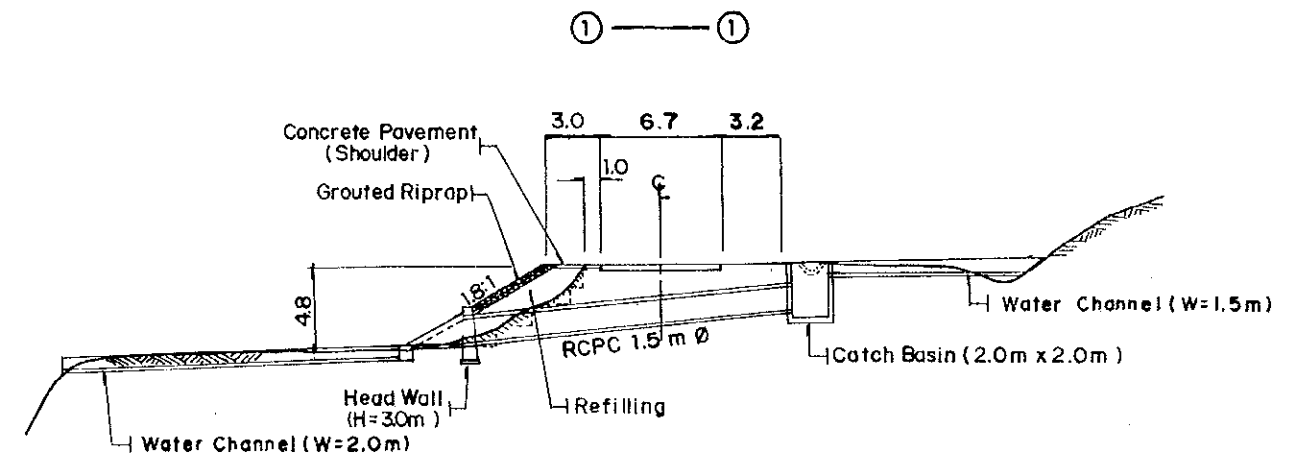
Cause of Disaster:
1) Water drained from hill side and stream of creek which overflowed and scoured the embankment.

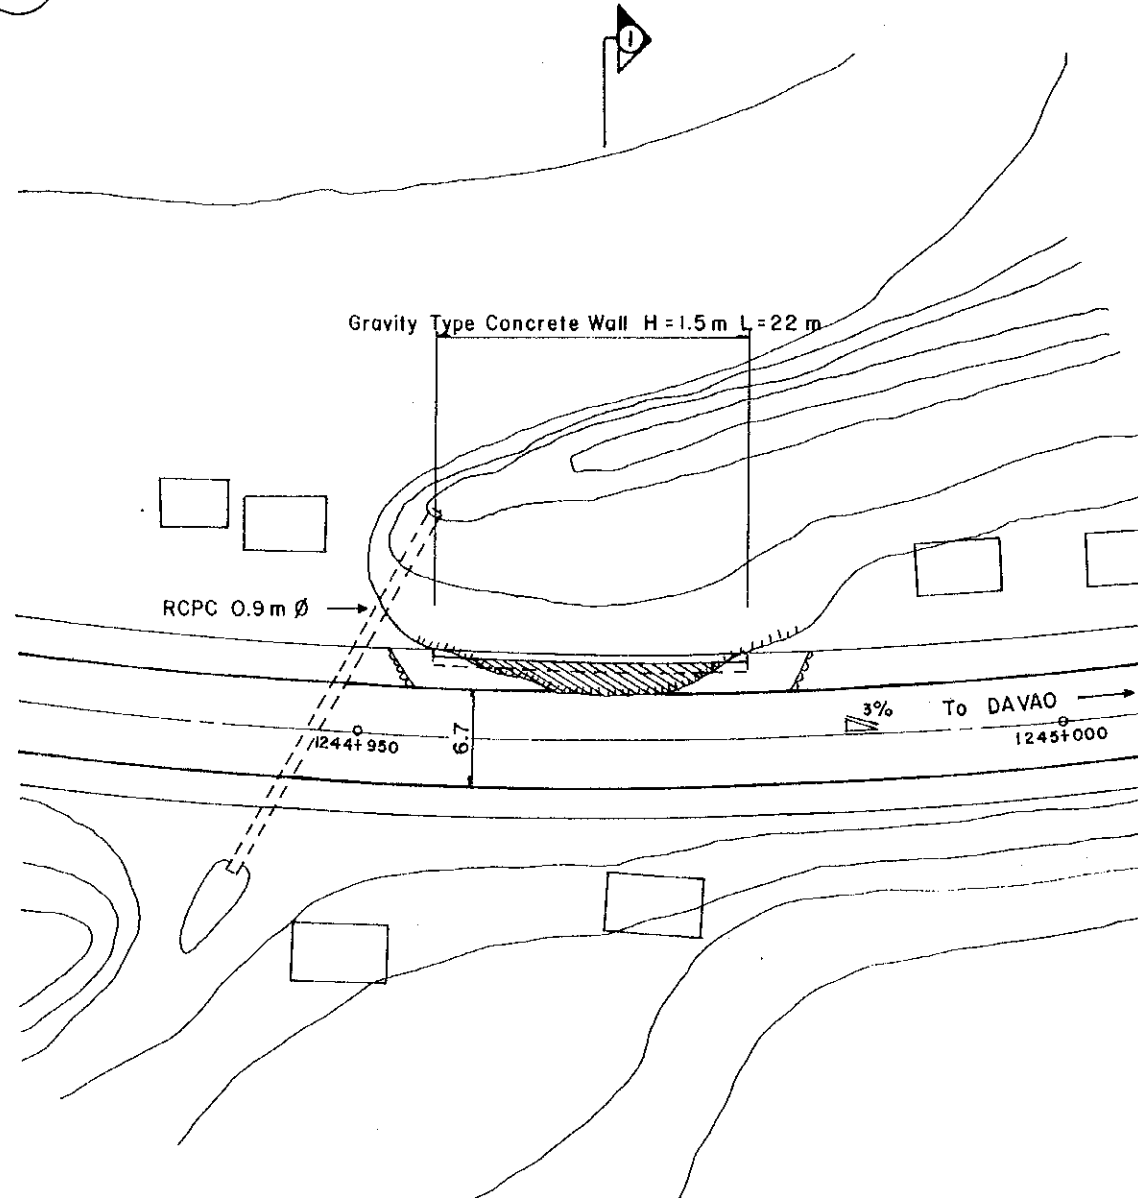
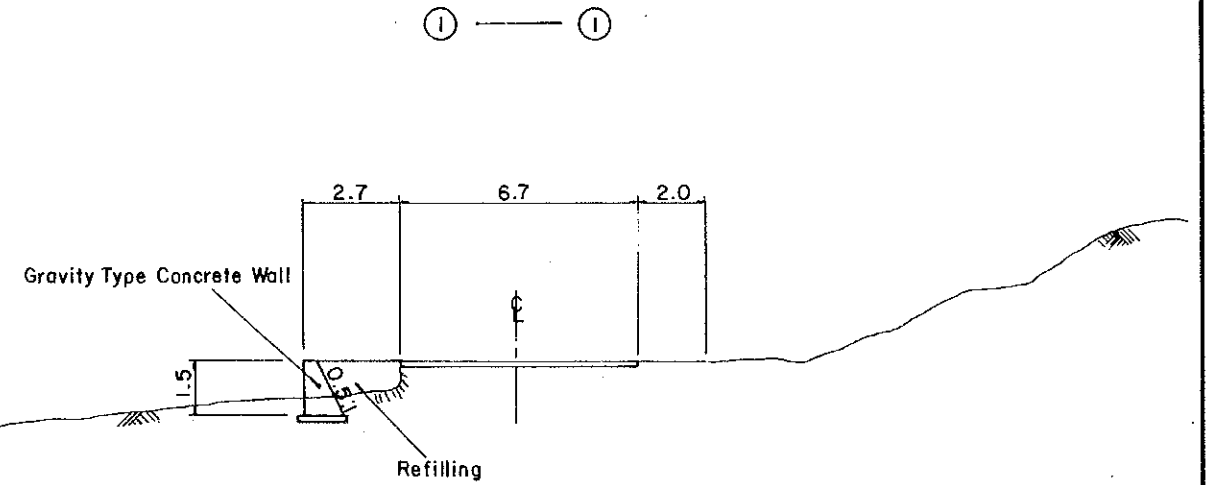
Cause of Disaster:

- 1) Scouring by water which was drained from valley and road surface and concentrated on the slope due to the geometric formation of road.

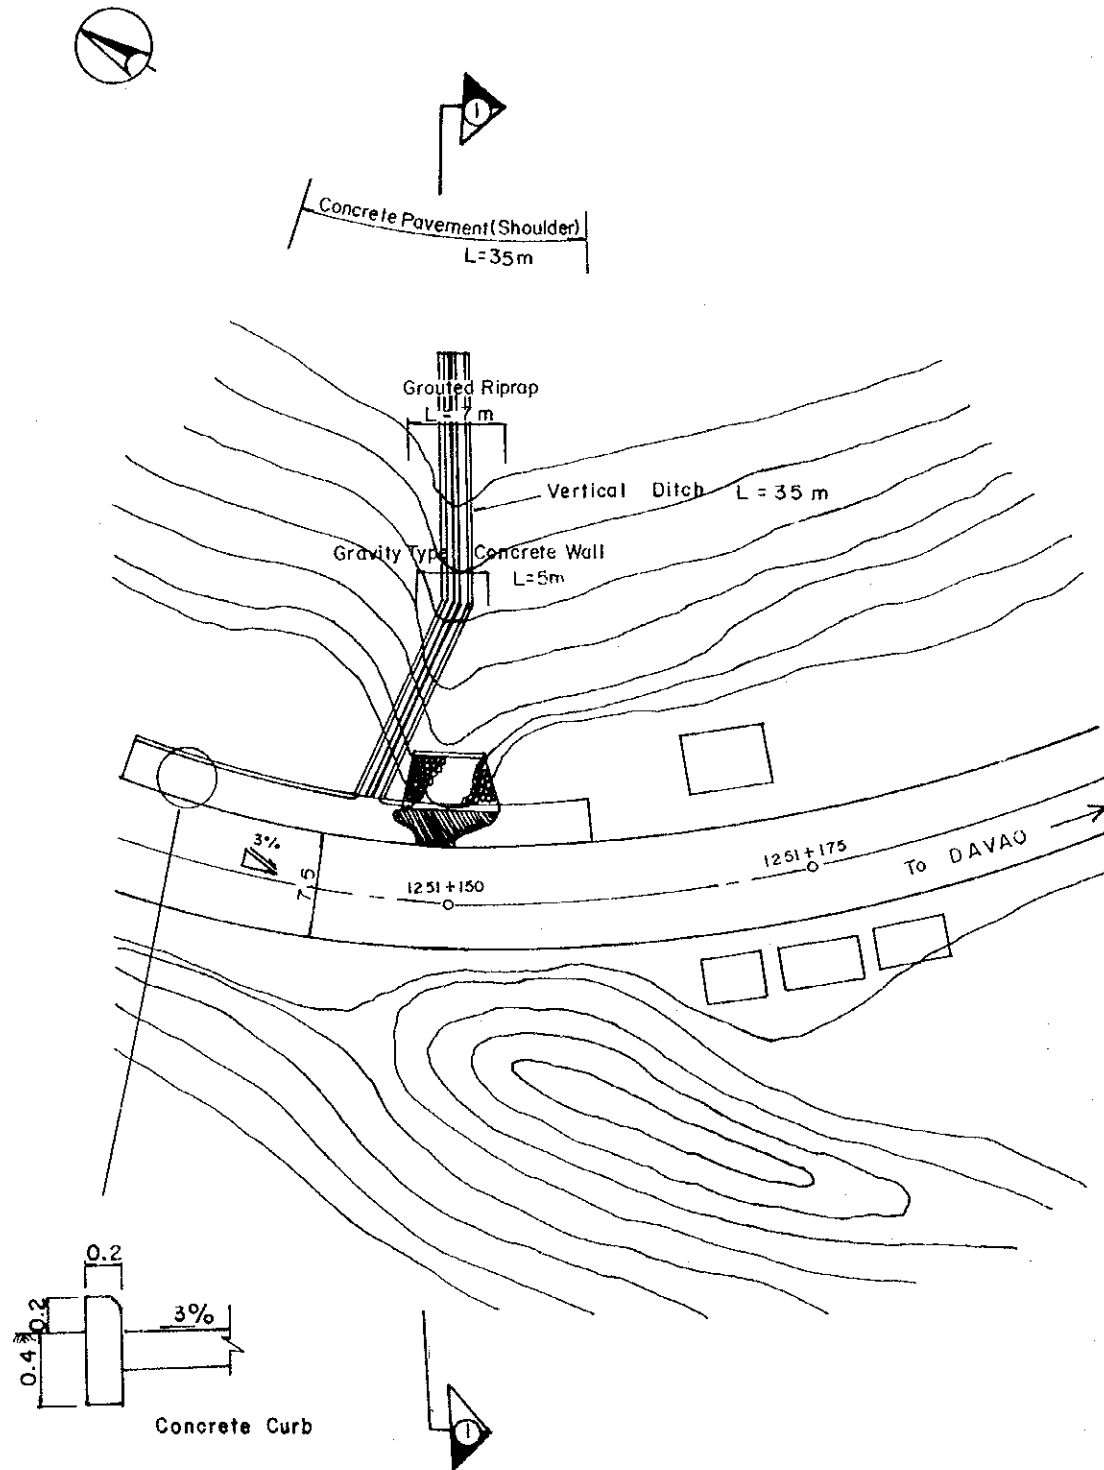
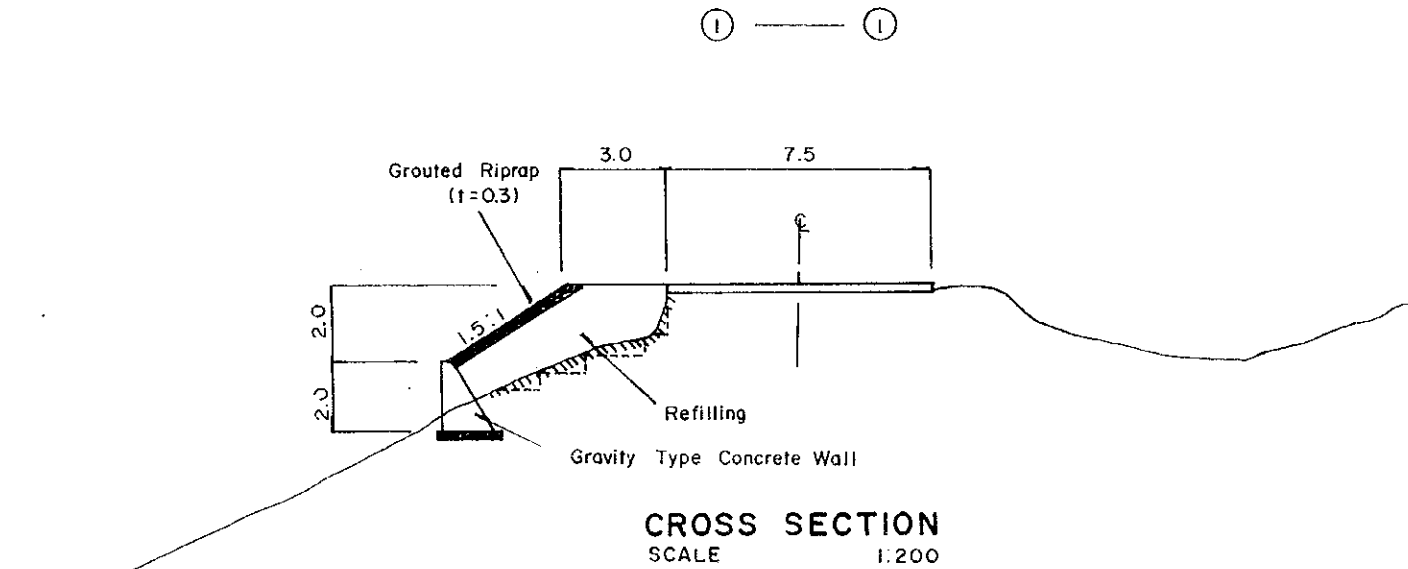
Cause of Disaster:

- 1) Erosion due to concentrated surface water on the curved portion of road.
- 2) Embankment slope with an unstable grade.

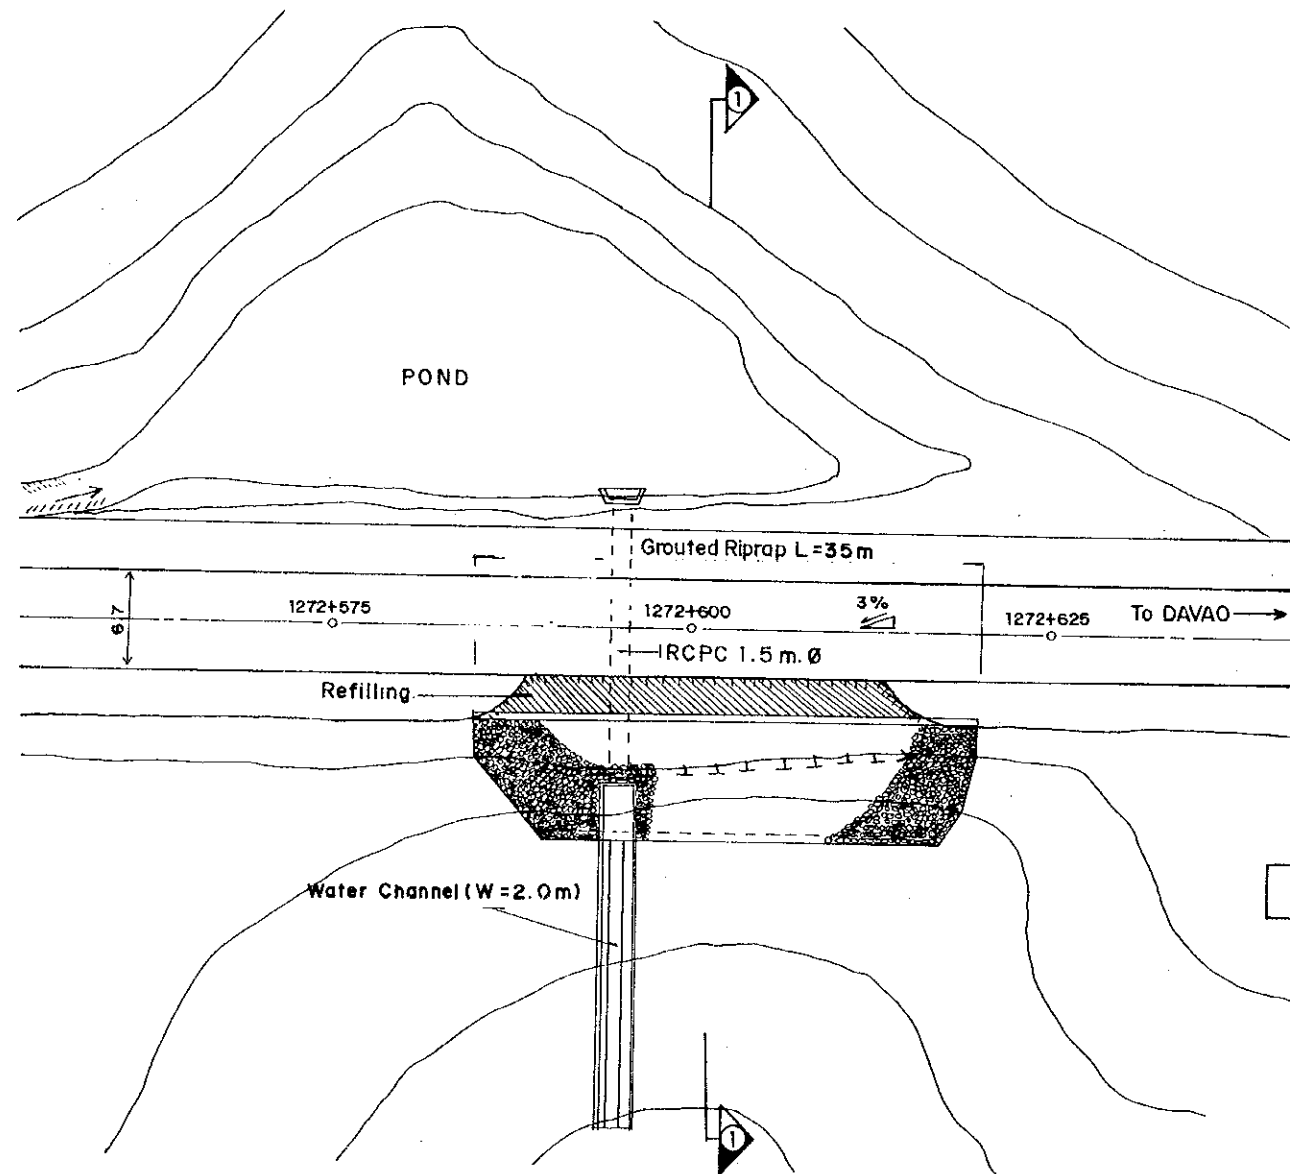
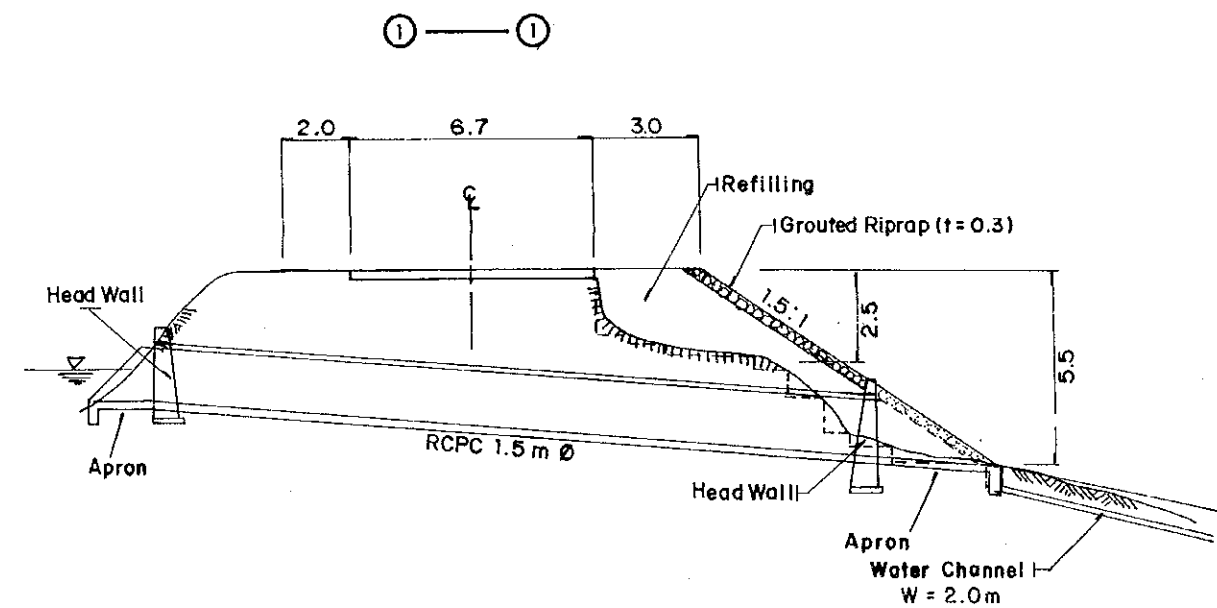
Cause of Disaster:

- 1) Insufficient compaction of embankment.
- 2) Pond which overflowed and scoured the embankment.

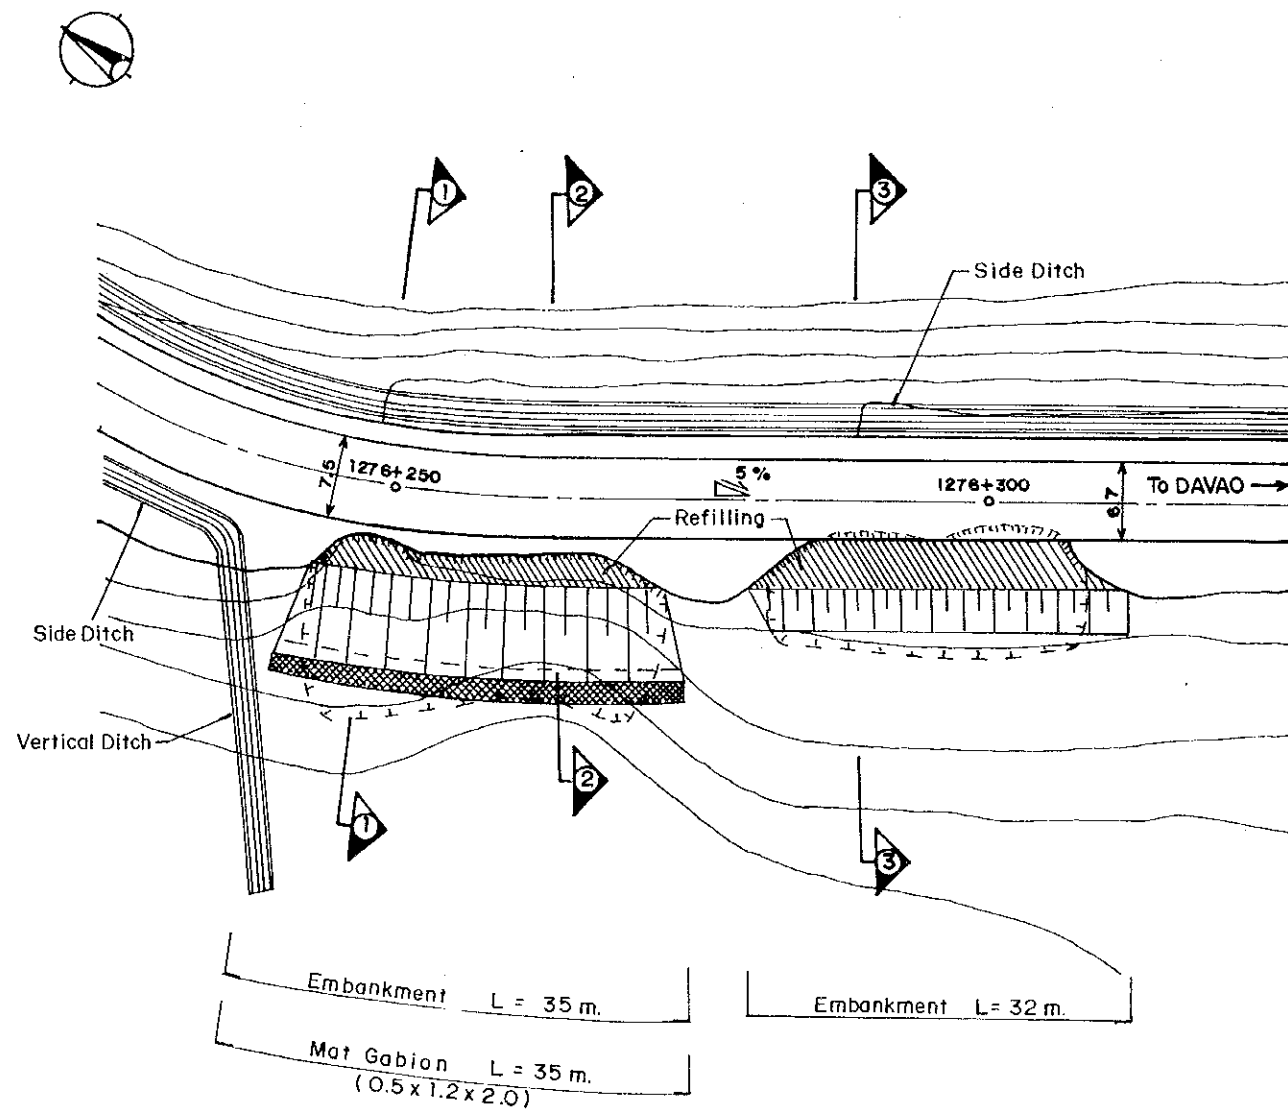
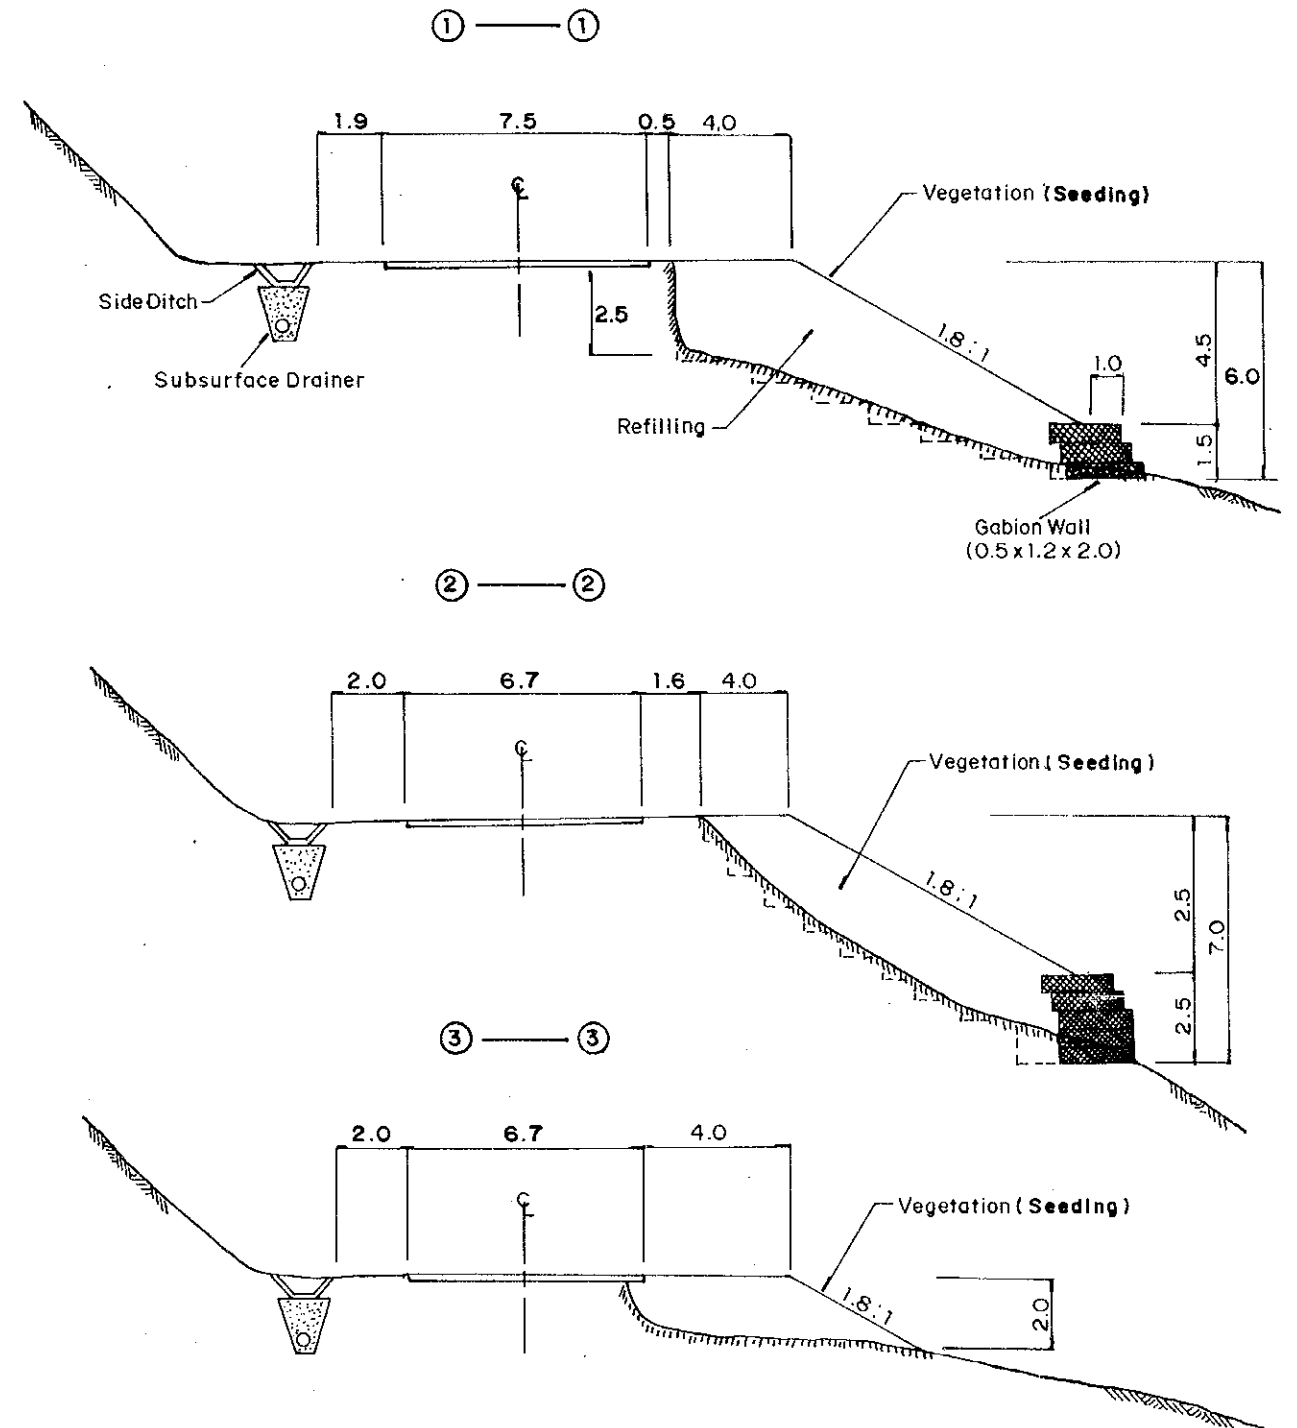
Cause of Disaster:

- 1) Infiltration of water into boundary surface between the inclined ground and embankment.
- 2) Effect of ground water.
