DEPARTMENT OF PUBLIC WORKS AND HIGHWAYS
REPUBLIC OF THE PHILIPPINES

FEASIBILITY STUDY
ON
PAN-PHILIPPINE HIGHWAY REHABILITATION PROJECT
(MINDANAO SECTION)

FINAL REPORT
DRAWINGS

MAY 1995

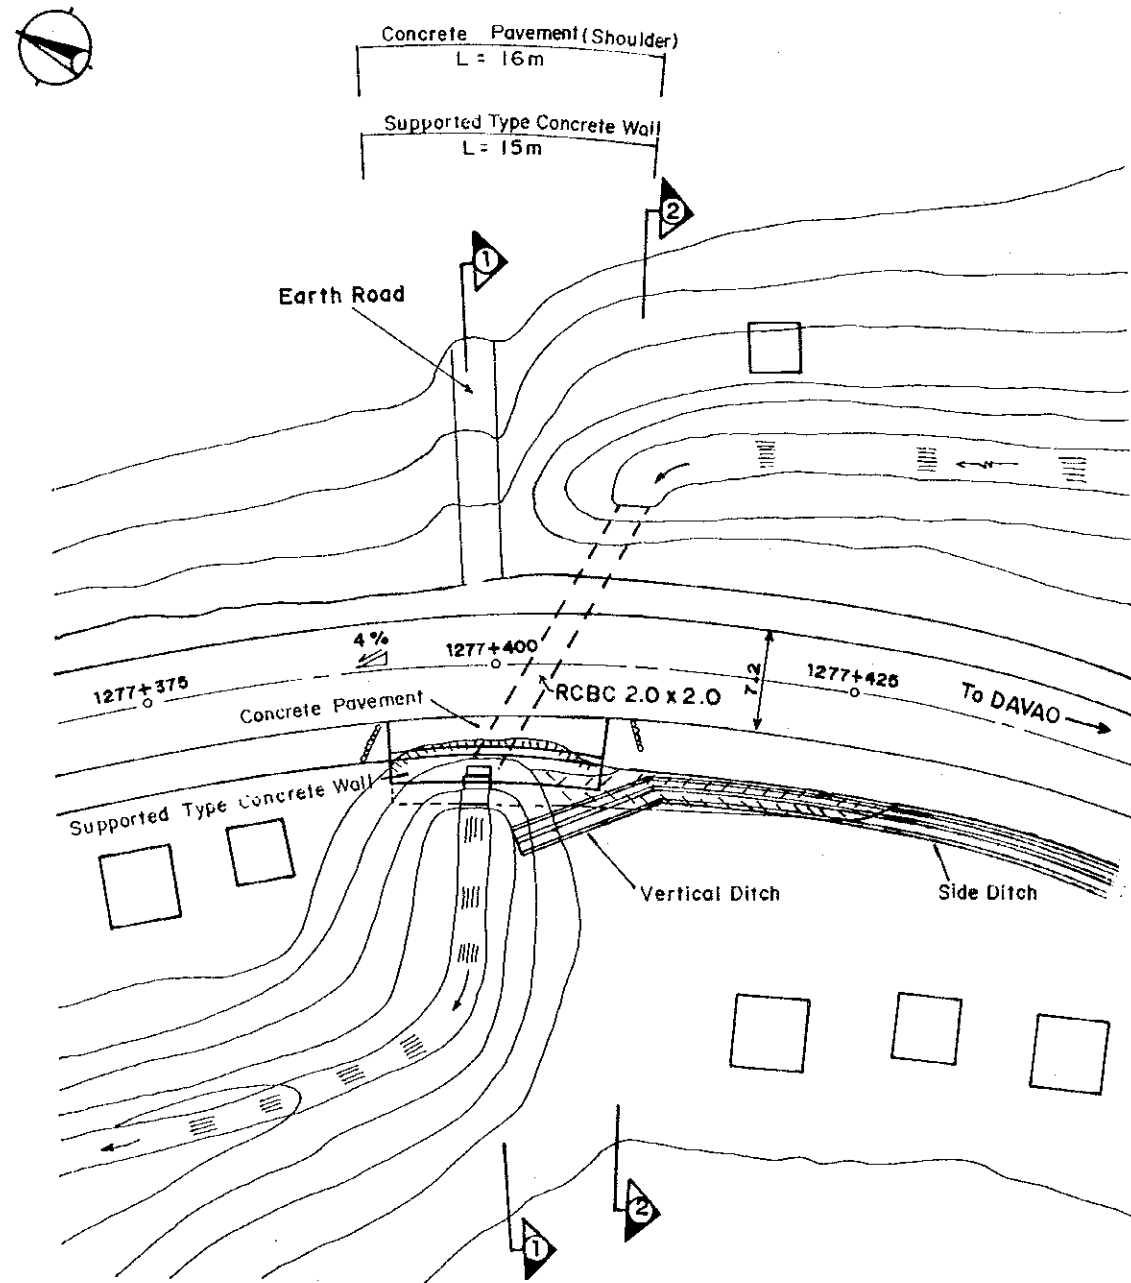
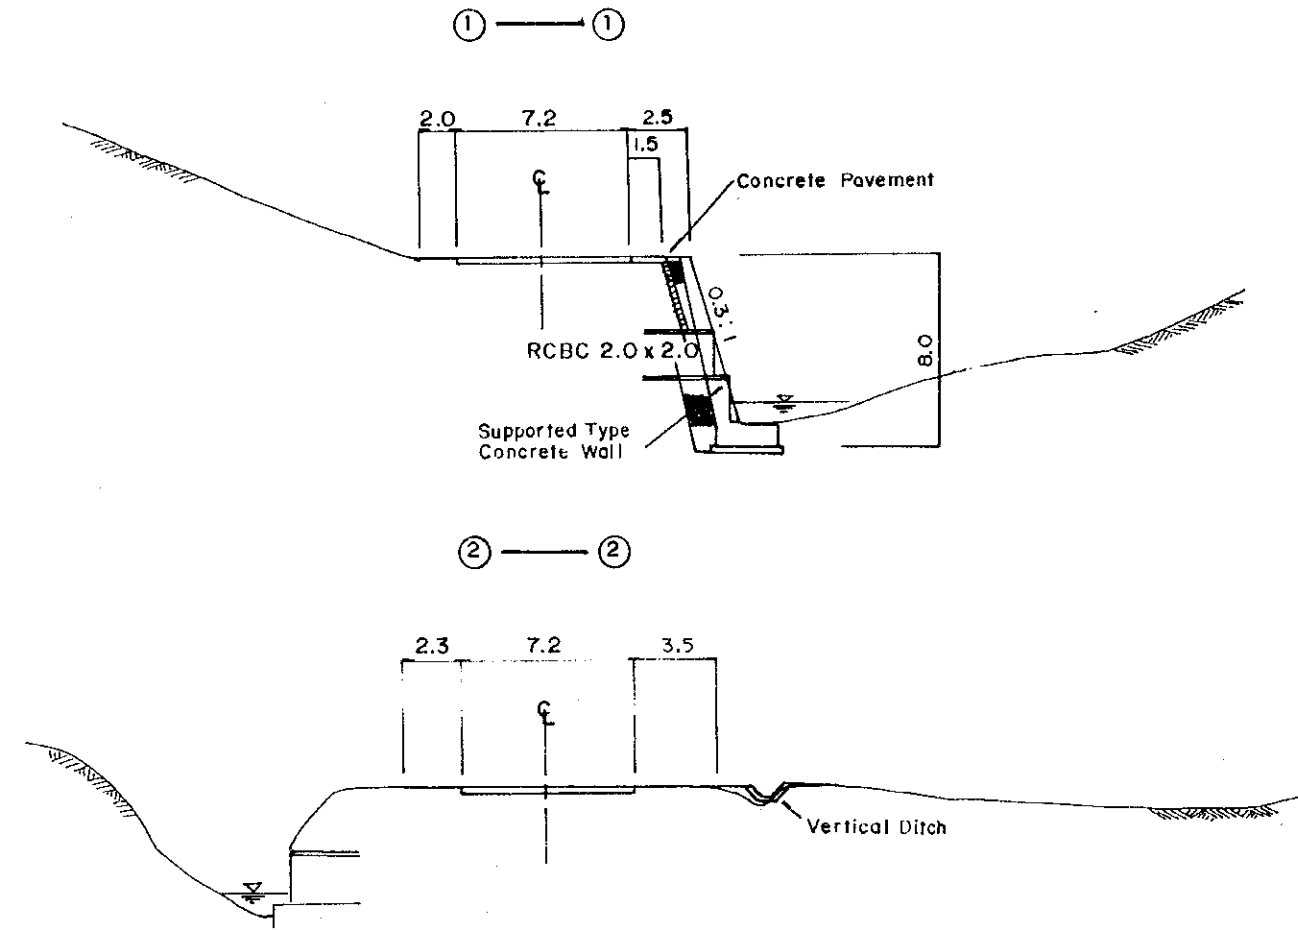
Cause of Disaster:

- 1) Infiltration of water into boundary surface between the ground and embankment.
- 2) Effect of ground water.

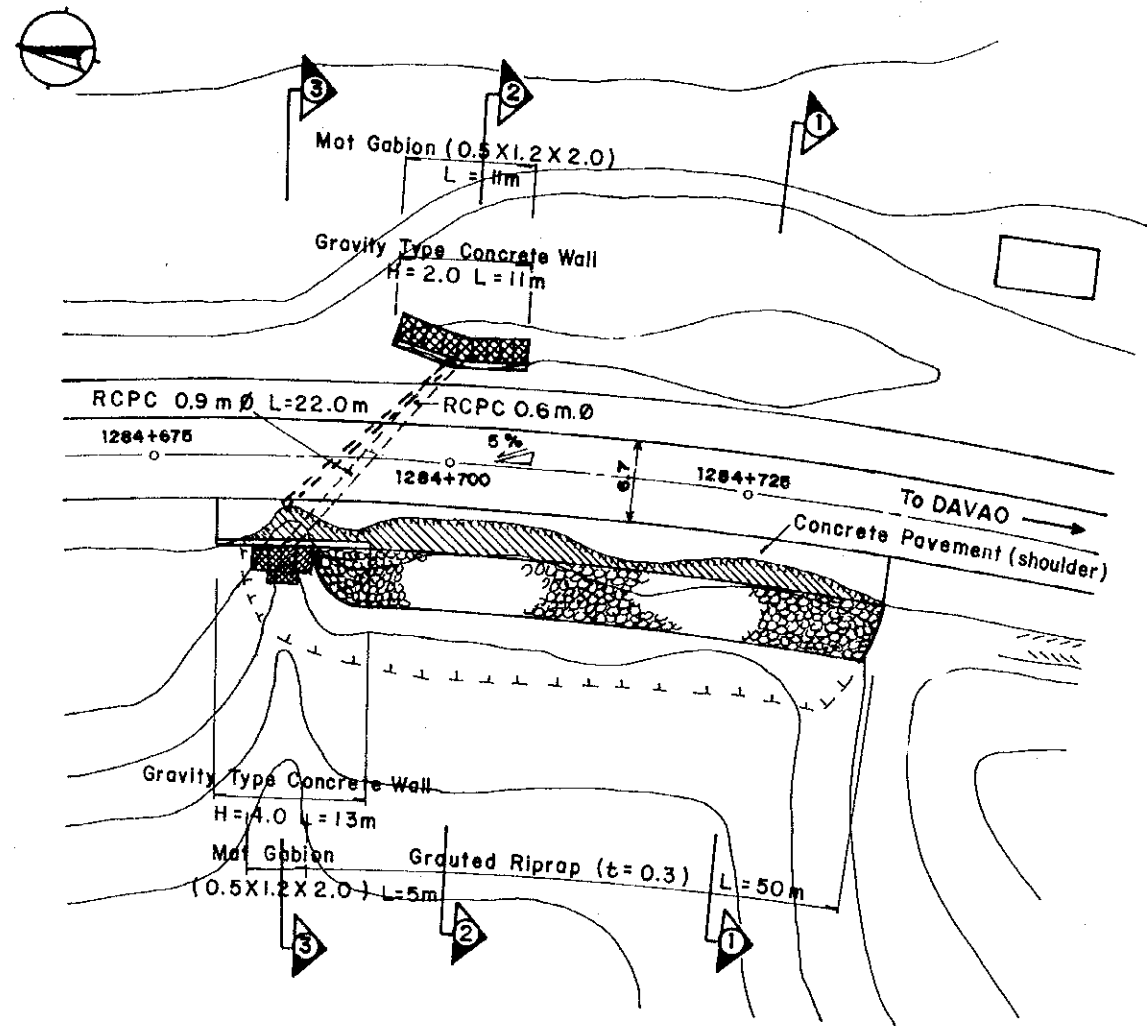
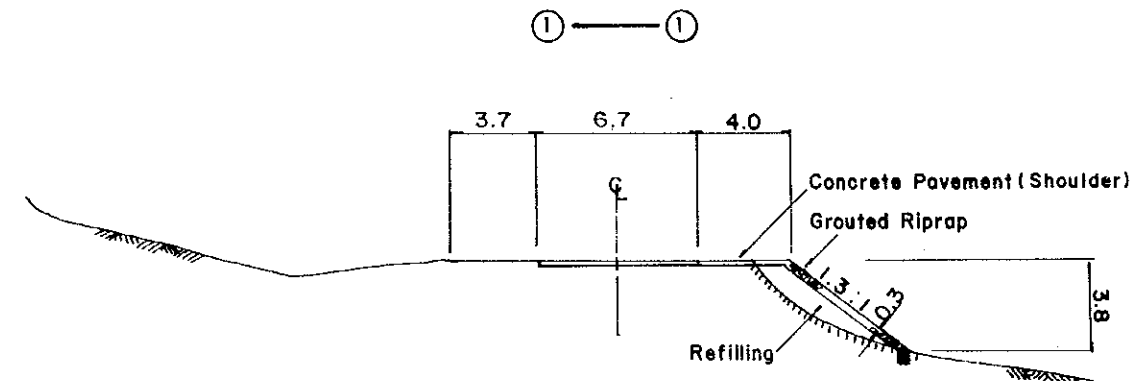
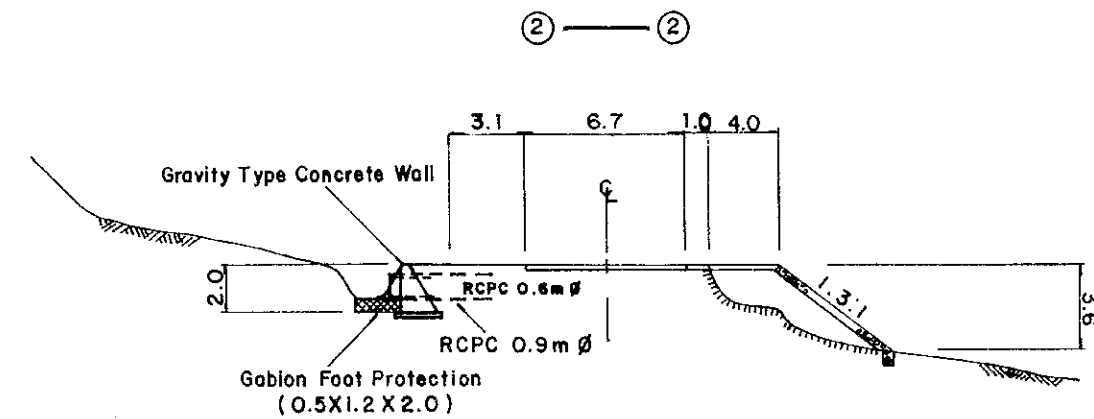
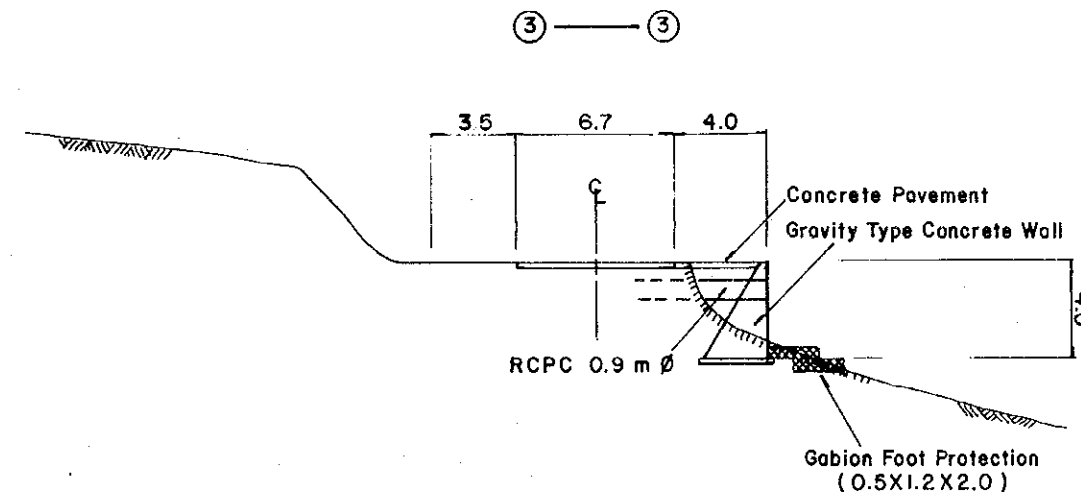
Cause of Disaster:

- 1) Insufficient drainage capacity of pipe culvert.
- 2) Inadequate inlet facility of pipe culvert.
