バングラデシュ人民共和国  
 第3次多目的サイクロンシェルター建設計画  
 基本設計調査報告書

バングラデシュ人民共和国  
第3次多目的サイクロンシェルター建設計画  
基本設計調査報告書

〔資料10. サイト状況確認調査結果〕  
〔資料11. 自然条件調査結果〕

平成7年10月

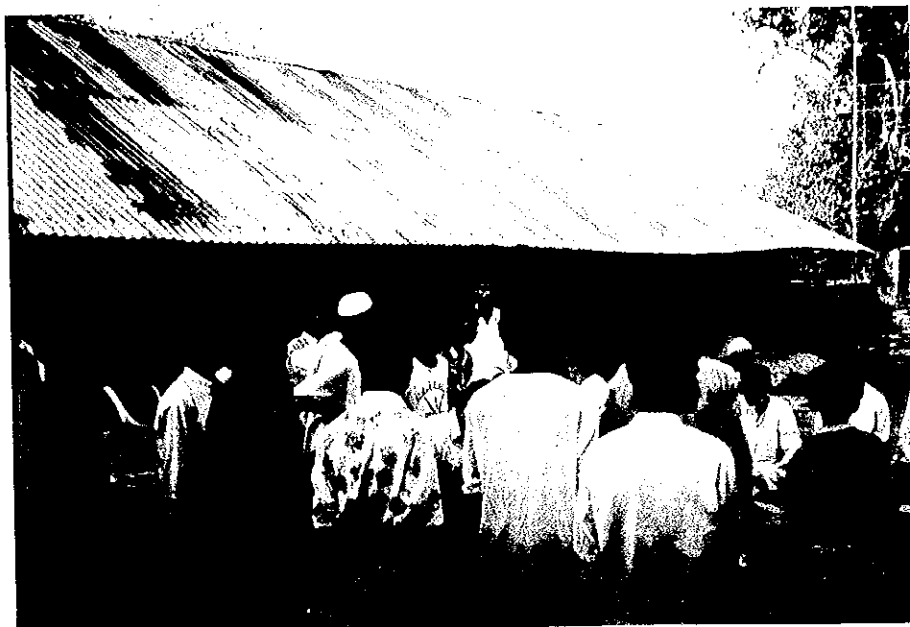
3) School Building : *1* no(s) (Floor Area: *15.2* m × *5.3* m = *80.56* m<sup>2</sup>)  
 4) Type of Building : RC, Brick, *Wooden*  
 5) Building conditions : Good, Not so good, *Bad* (*7* years after built)

校舎全景

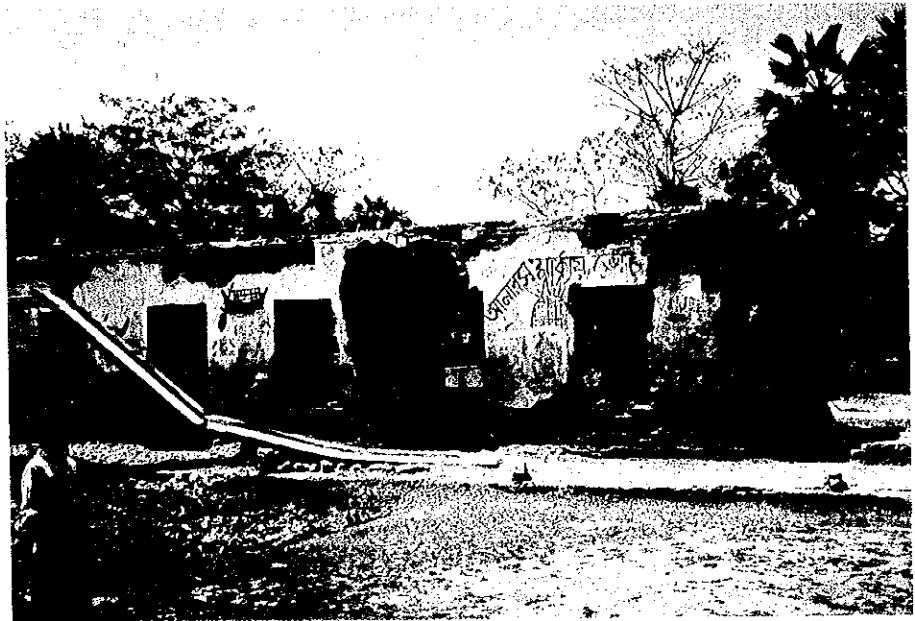
学校敷地内にある  
廃屋（要撤去）

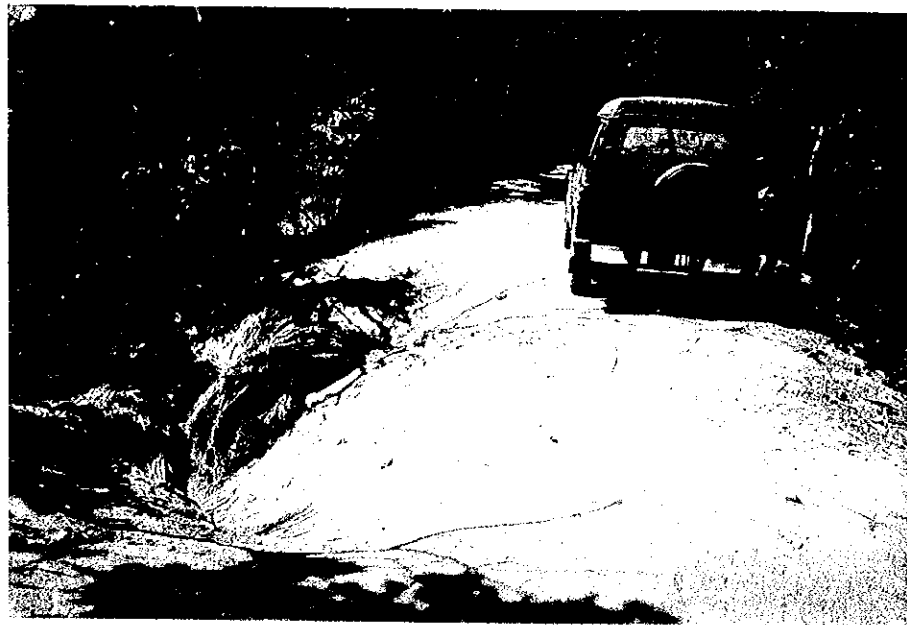
アクセス道路に沿って  
深い水路あり
