5. Cost Estimation Borne by the Receipient Country

A2-1 Bridge Construction (3/3) Cost Estimation Borne By Viet Nam

7. Overview of Bridge Site Survey Results

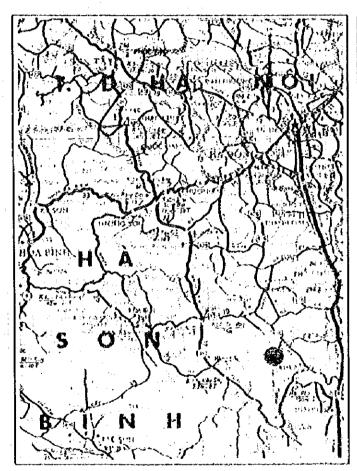
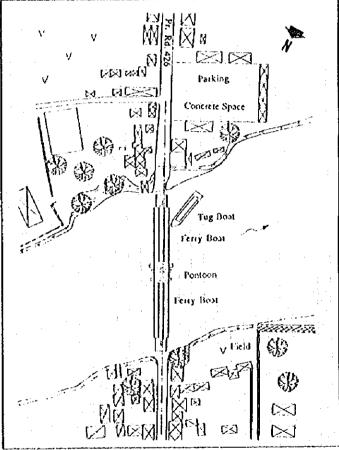
No. 1 DUC KHE BRIDGE

Ha Tay Province My Duc District Huong Son County Super Structure: Temporary Pontoon Bridge & Steel Plate

Access road is in good condition.

River width is 70 m to 80 m therefore 300 ton class ships are navigable.

Currently a temporary pontoon bridge is used, therefore only pedestrians

can pass over the bridge.

This temporary pontoon bridge has been in use since 1970.

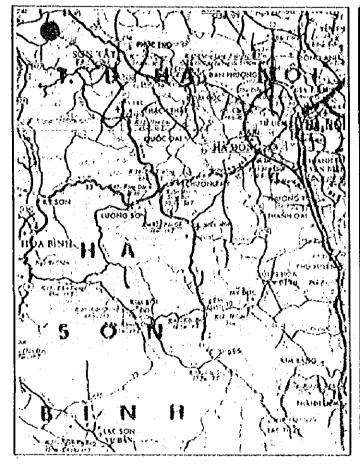
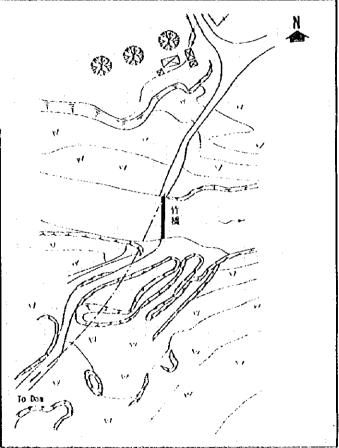
No. 3 CHUOC BRIDGE

Ha Tay Province Ba Vi District Can Linh County Super Structure : Pedestrian Bamboo Bridge (Private

Enterprise) Temporary Bamboo Bridge 50.0 m

- Bridge site is tocated 50 km from Ha Noi. This bridge is a pedestrian
- Bridge site is located 50 km from tra two. This ortuge is a processimal bamboo bridge.

Access road is in good condition. The nature of the soil in the area is mixed cobble stone. There is no hindrance for construction.

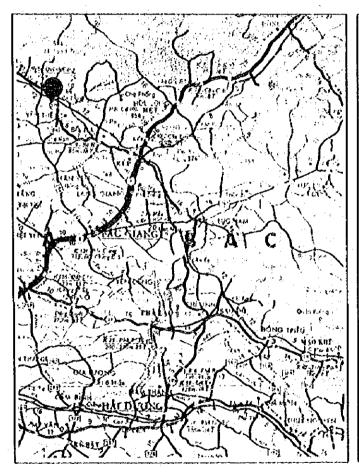
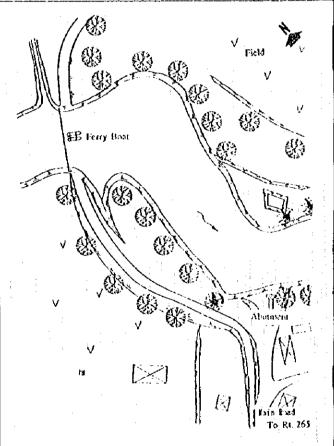
No. 4 DONG VUONG BRIDGE

Ha Bac Province Yen The District Dong Vuong County Super Structure : Temporary Bamboo Bridge (Dry Season) Perry Boal (Rainy Season)

The Vehicle impossible pass through on the bridge during dry season cause by brook (L=20 m) before 500 m from proposed bridge point.

Local government had bridge plan and started construction, therefore only right bank abutment was constructed. Construction was suspended due to financial difficulties.

Pedestrians use bamboo bridge as detour road during dry season Ferry boat used during rainy season.
No problem for temporary yard. The nature of the soil is terrace deposit and in good condition (gravelly soil).
Existing road height is around 10 m from river bed.

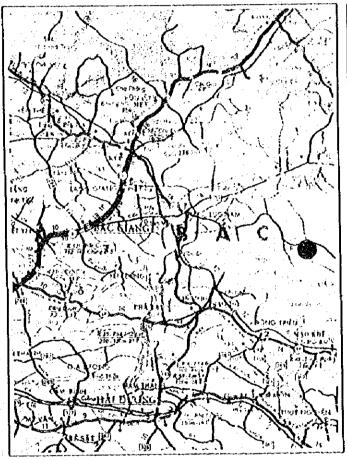
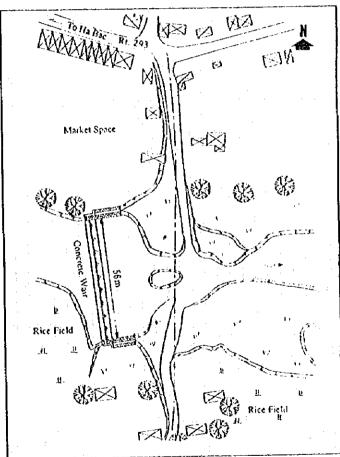
No. 5 DONG DINH BRIDGE

- About two hours from Bac Giang to the bridge site.
 On the way Luc Nam river is crossed by ferry boat.
 On the way there are around 2 km of poor road. Difficulty in vehicle irrespective of season.
 There is no bridge on site

- There is no bridge on site
 Vehicles possible across the river bed only in dry season.
 People cross a weir upstream in rainy season. Closed to all traffic during flood season. Bridge site is located in mountain valley.
 River bed is saindy gravel (alluvium).
 Site area is of hard terrace deposit.
 No problem for temporary yard.

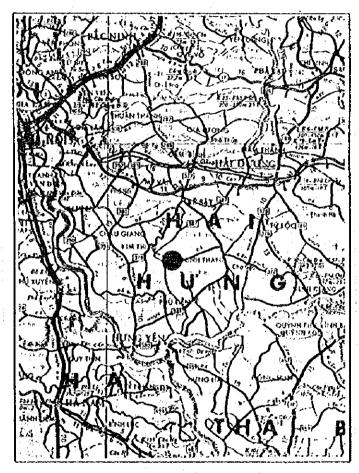
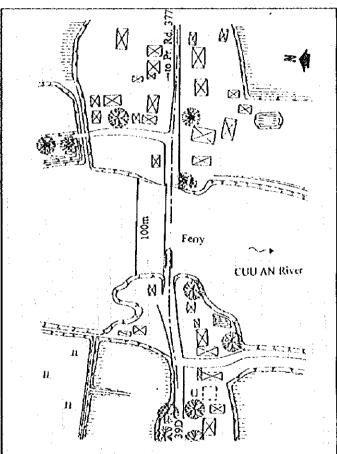
NO. 6 TU O BRIDGE

Super Structure : Destroyed Sub Structure : -

Ferry is available in place of bridge crossing.

Access road to the site is in bad conditin, in particular after rain fall.

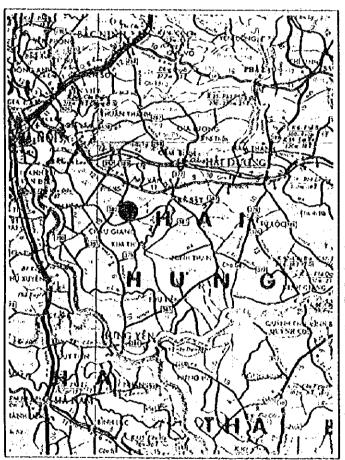
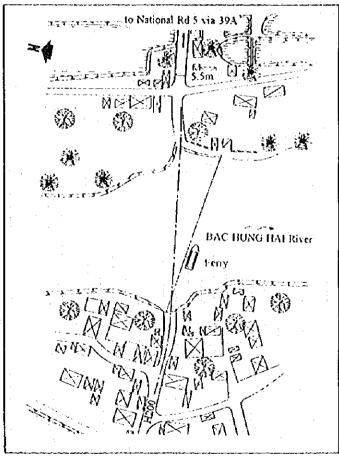
NO. 8 HAU BRIDGE

- Local residents have a ferry service.

Access road to bridge site is in bad condition, only land cruiser can reach the site by land (12 km from My Van).

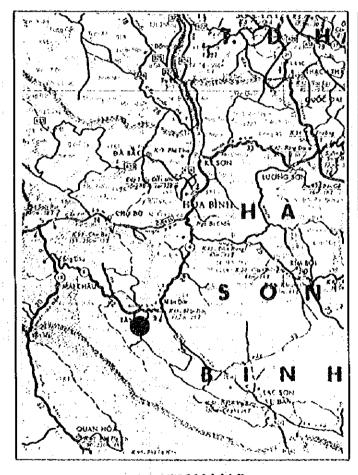
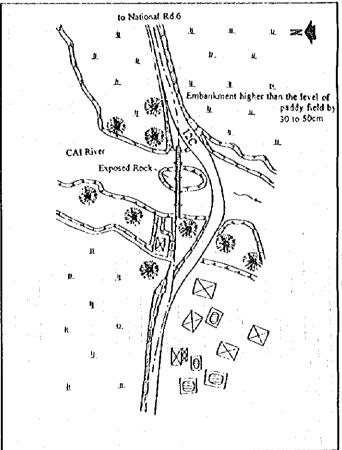
NO. 9 BEN THE BRIDGE

- Temporary bridge is for pedestrians, bicycle and Motorbike, automobiles cross the river bed only in dry season.

Rocks are exposed on river bed. Spread foundation can be applied.

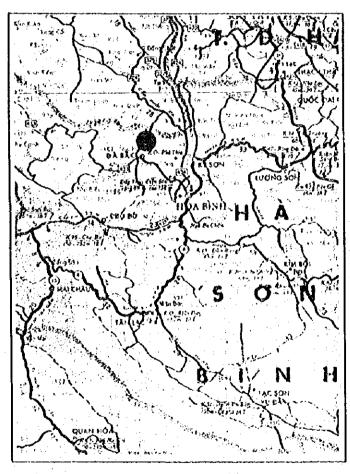
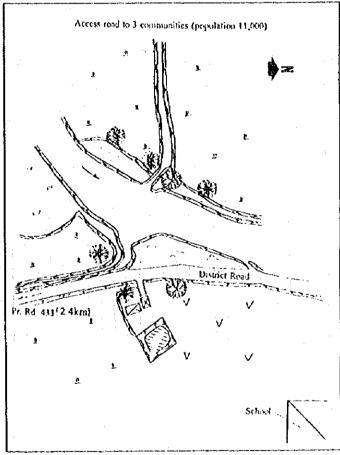
NO. 10 TINH BRIDGE

- When water level is high, most traffic makes a detour at 3 km upstream. The traffic is open to pedestrians and to heavy vehicles at present, in the dry season.

Traffic to three communities is blocked by the river.

Rocks are exposed on river bed. Spread foundation is likely to be applicable.

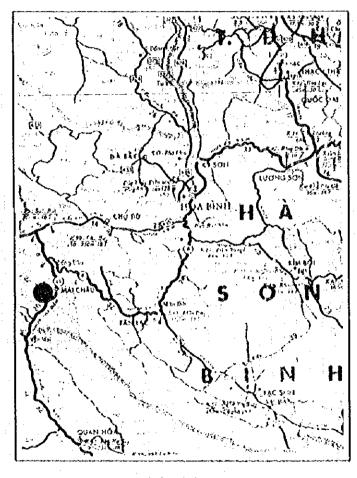
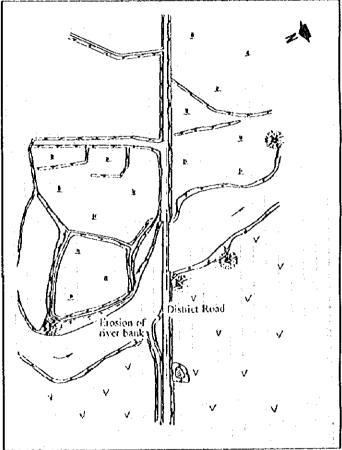
NO. 11 LAC BRIDGE

P: Hoa Binh D: Lac Son C: Tong Dau Super Structure : Wooden Bridge Sub Structure : Stone Masonry

- A minority community is located along the access road.
 The river bends at the bridge site.
 Sub-soil is likely to be clay sediment.
 Access road will be improved soon after completion of a proposed bridge.

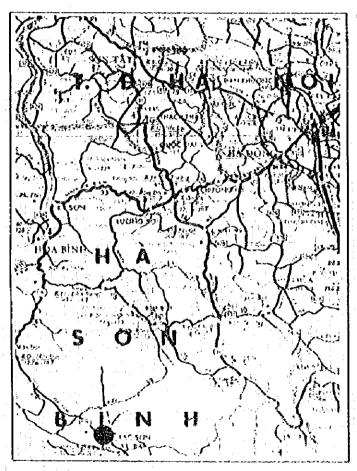
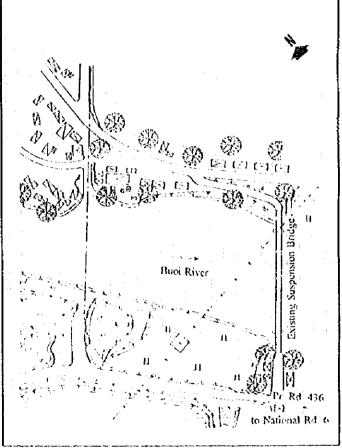
NO. 12 VU BAN BRIDGE

P: Hoa Binh D: Lac Son C: Lien Vu Super Structure : Steel Suspension Bridge Sub Structure : Stone Masonry

Existing bridge is a suspension bridge built at approximately 20 m above the surface of the river.

At present, passage is only open to Motorbike riders and pedestrians.

Depth of cover soil is expected to be less than a few meters. Spread foundation is applicable.

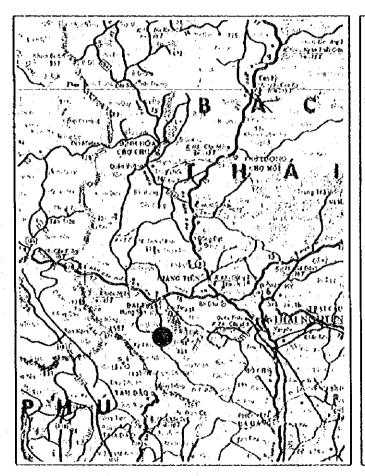
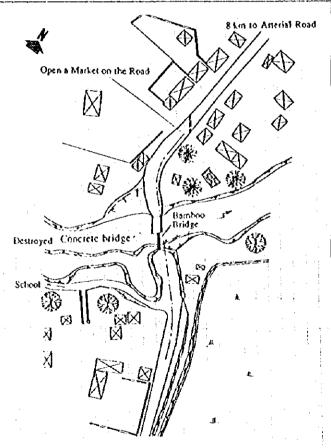
NO. 13 KY PHU BRIDGE

Bac Thai Province Dal Tu District Ky Phu County Super Structure: Half Damaged Temporary Wooden

Concrete bridge was destroyed due to scouring.

Only pedestrians and motorbikes can cross the bamboo bridge.

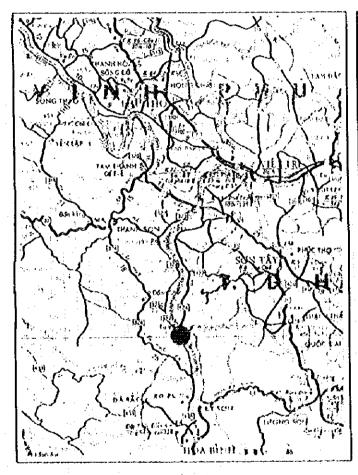
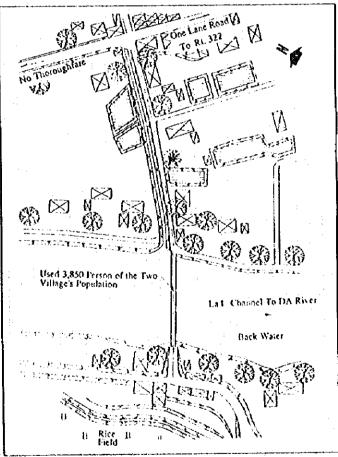
NO. 15 LUONG NHA BRIDGE

County
Super Structure: Plate Girder (Concrete Slab)
Sub Structure: Pilebent (H Steel Girder)
Bridge Length: 41.5 in (70 in When Log Bridge is Included)

4 hours via Viet Thi from Ha Noi to bridge site.
Access road to the site is one lane and unpaved road.
Substructure of existing bridge has bad damage and Log Bridge is connected to both sides of river, therefore only pedestrians and motorbikes can pass over the bridge. Site is located along DA river.
DA river is tributary of Red river therefore equipment and materials for bridge will be transported by boat.
The nature of the soil is deposit from DA river (clay soil).
High water level is near deck slab during flood season.
Difference of water levels in flood season and in dry season is abou 5 m.

Superstructure was washed out by flood in August.

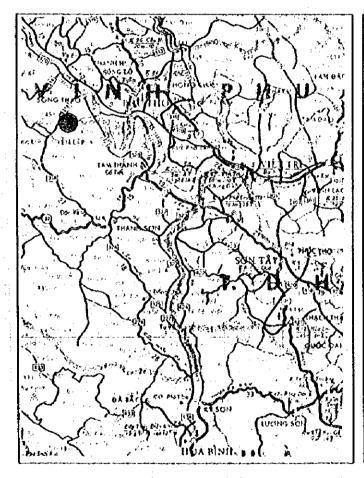
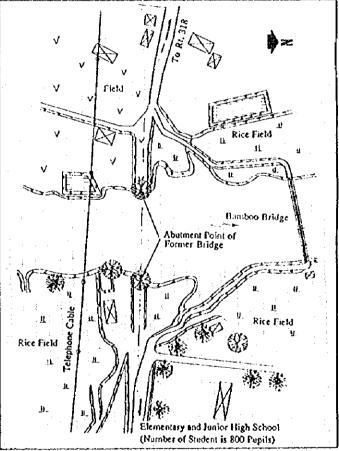
NO. 16 SUONG BRIDGE

Vinh Phu Province Songu Thao District Puong Lung County Super Structure: Temporary Bamboo Bridge

Access road to the site is in poor condition during rainy season. However, 10 ton trucks are accessible to the site.

Rocks are exposed upstream, therefore spread foundation can be applied.

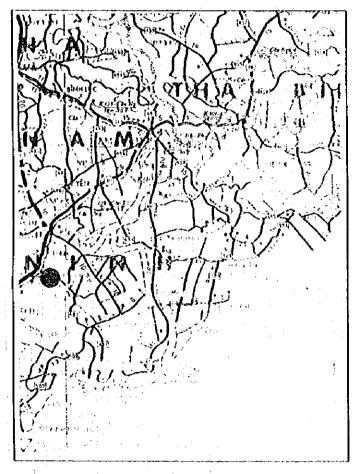
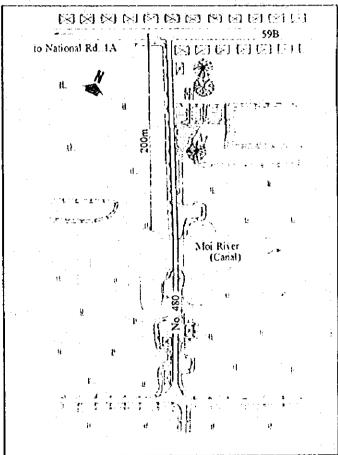
P: Ninh Binh D: Yen Mo C: Yen Hoa Super Structure : Concrete (Heavily Damaged) Sub Structure : Pilebent

- The width of the road is about 3 m.
 The length from the access road to the bridge site is approximately 200 m.
 Existing bridge has been heavily damaged and automobile traffic is injussible.
 At the time of flooding in 1994, the access road was inundate.

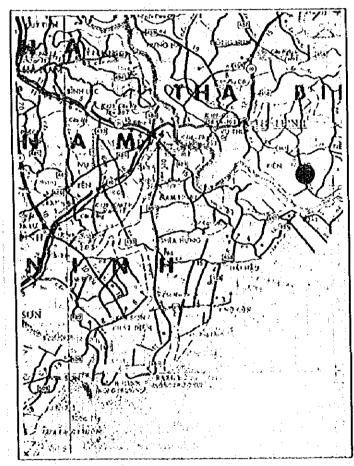
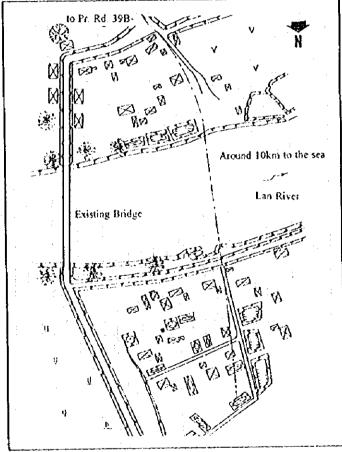
The surface of access road is in good condition.
Two bridges on access road have the load limit of 5 tons.
Deck slab and girder of the bridge are severely damaged.
The bridge site is accessible by boat (20 ~ 25 ton).
Sub-soil is presumed to be the sediment of the Red River.
Proposed bridge crosses as teh river downstream of existing bridge by

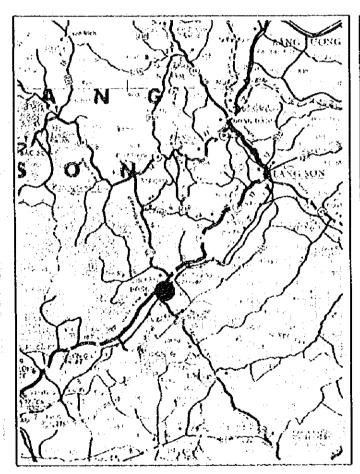
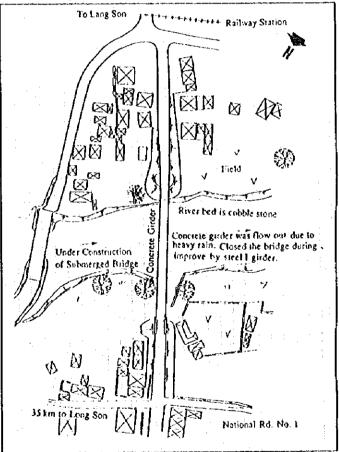
- The bridge is located in a town of Dong Mo district on the way to Land Son by National Highway No. 1
 This bridge is made of concrete. However, it is severely damaged due to
- flooding. Existing bridge was improved but bridge has been heavily damaged and vehicle traffic is interrupted.
 Fields are flooded every year (around 5 m up).
 River bed is gravely sand.
 Possible difficulty in obtaining temporary yard.

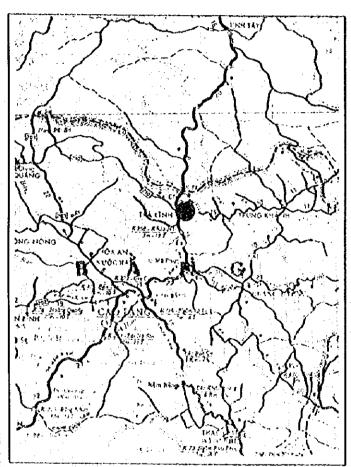
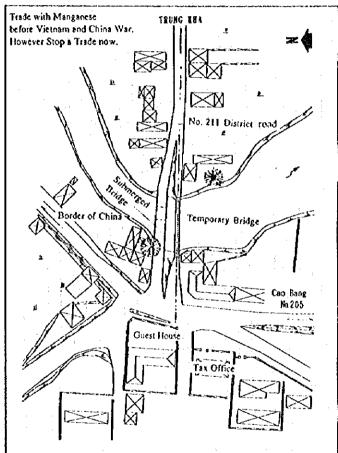
- Pedestrians and motor-cycle cross use temporary bridge in all seasons.
 Old bridge was destroyed in 1979 during the war.
 Lowest temperature is around 4 °C during winter season.

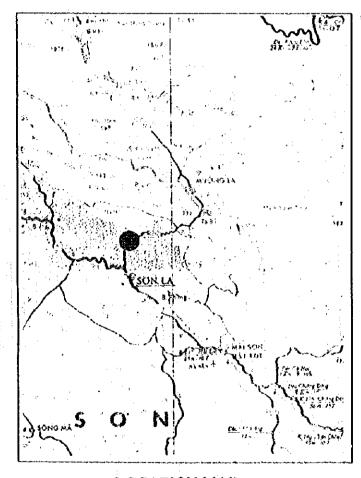
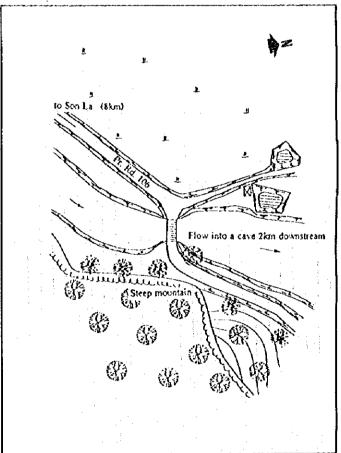
NO. 29 BAN AI BRIDGE

- Existing abutment is in good condition and can support new giders.

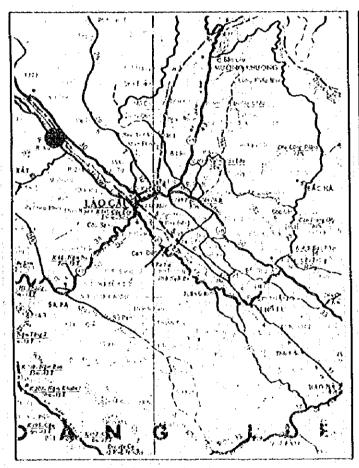
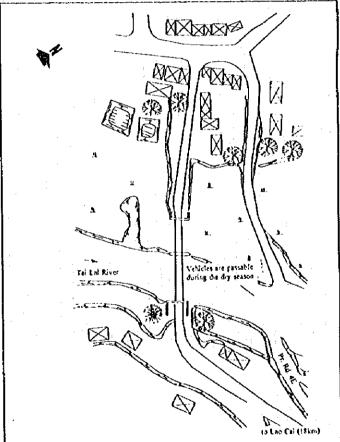
Former bridge was damaged during the war between Vietnam and China.

Existing abutments and pier are likely to be reusable after some repair work.

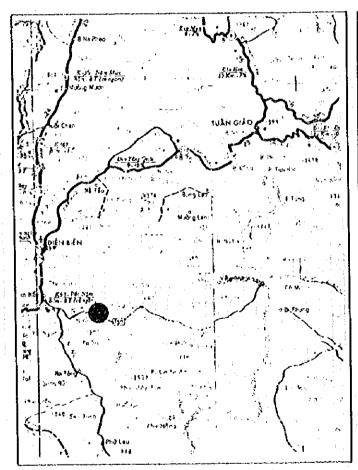
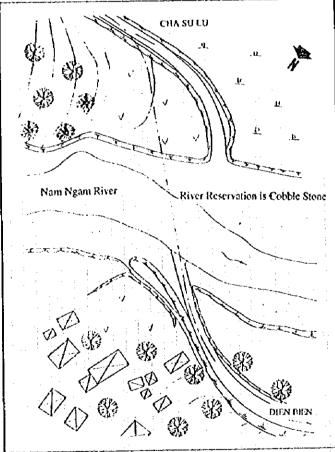
- From Dien Bien City to the site it takes one hour by jeep.
 Old bridge was washed away in 1993.
 Condition of access road is very poor, especially in rainy season.
 Improvement of the road will be completed by 1998.
 Vehicles can pass the river in dry season only.
 Alignment of new bridge crossing is limited by the topographic conditions.
