Corrosion on main beams

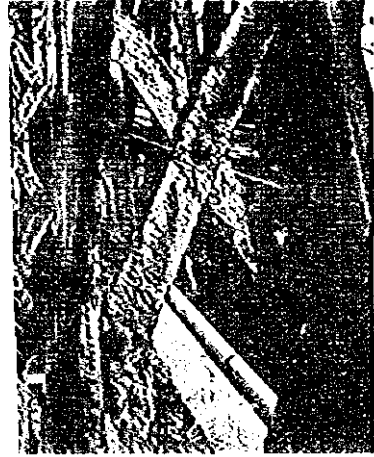
Corrosion

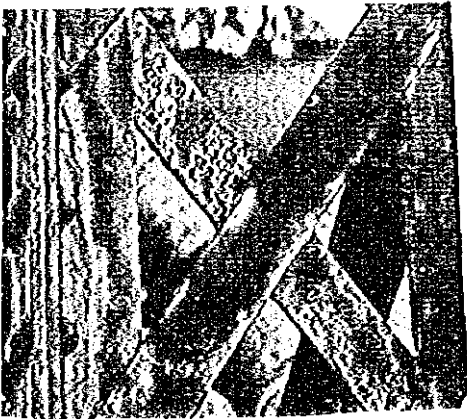
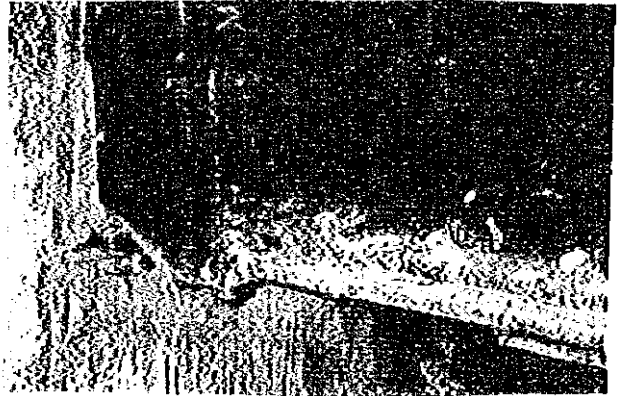
Rusting

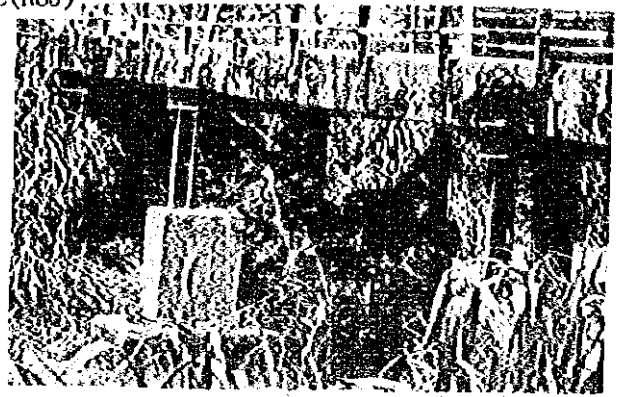
Inclined

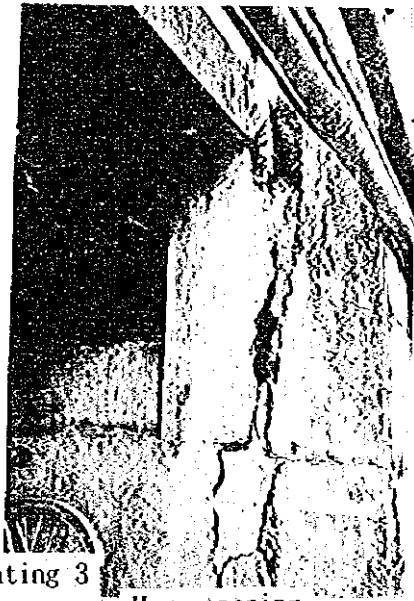
Huge opening

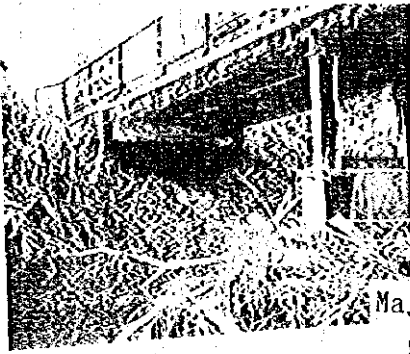
Foundation

Major scoring

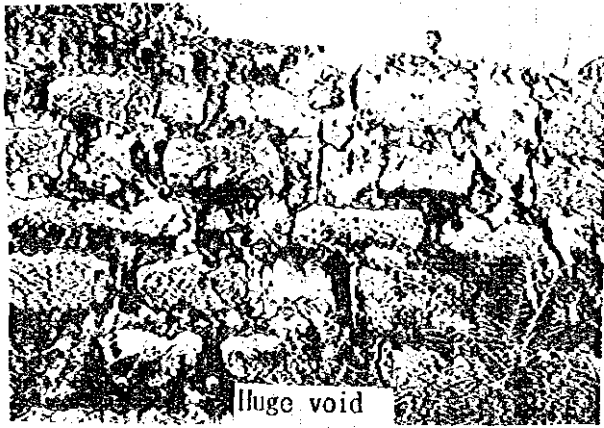
Wingwall

Huge void

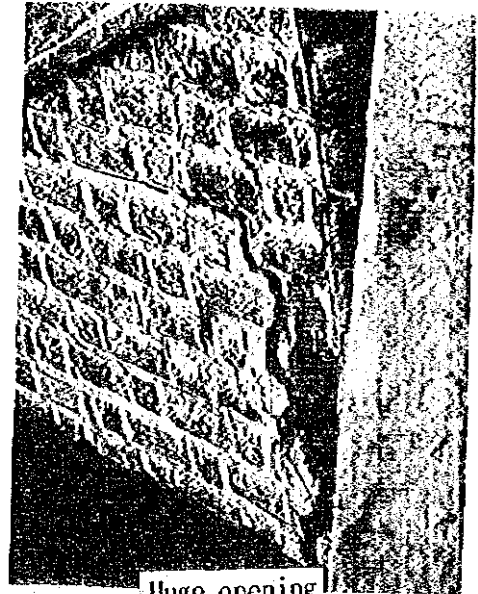
Huge opening

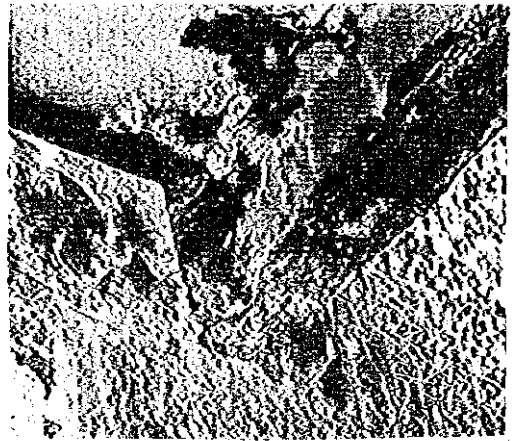
Structural defect

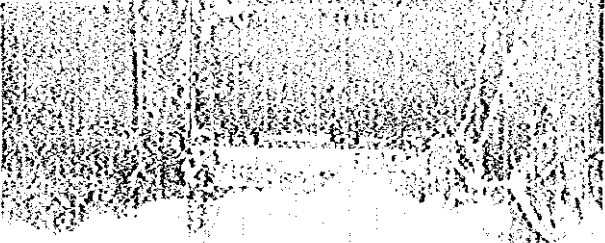
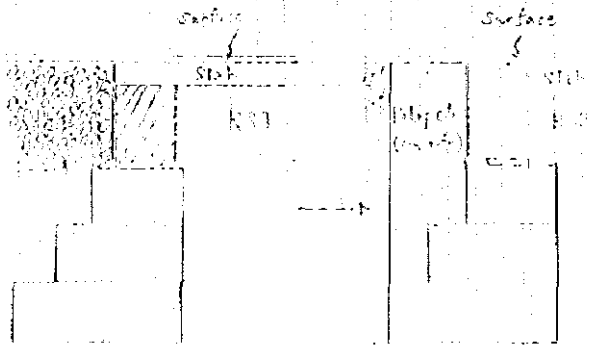
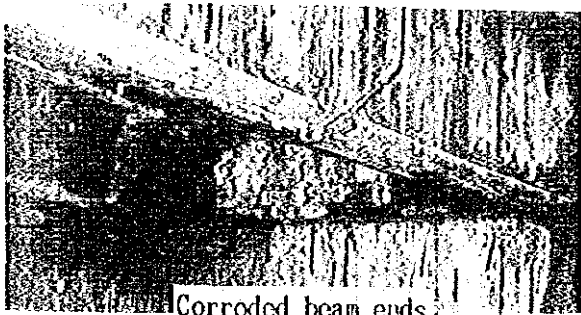
Very corroded

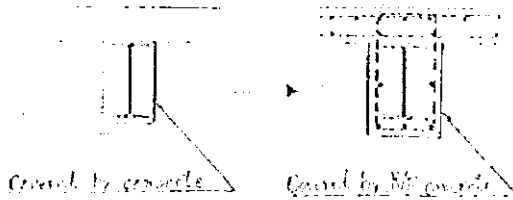
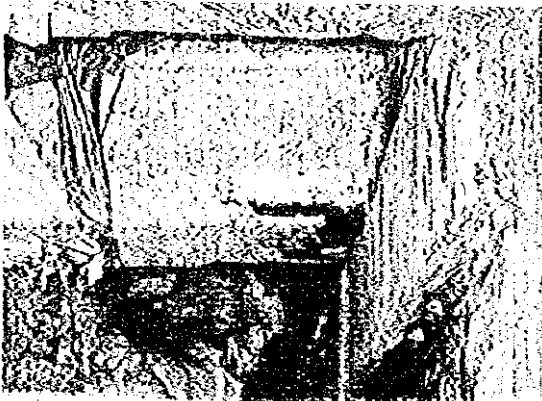
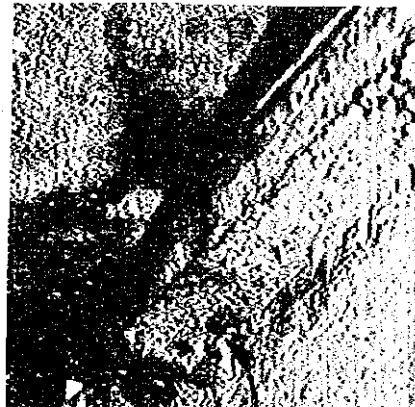
Corroded beam ends

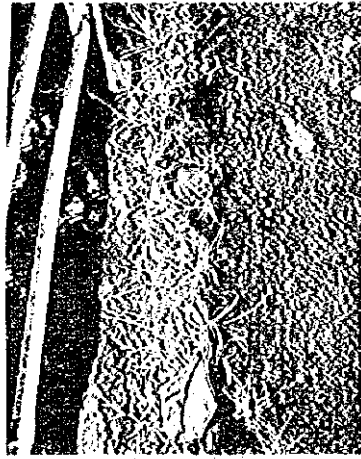
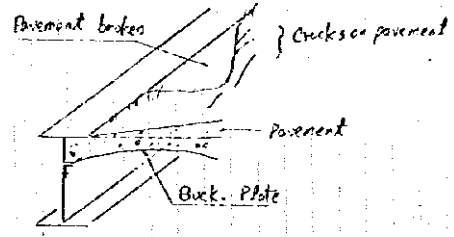
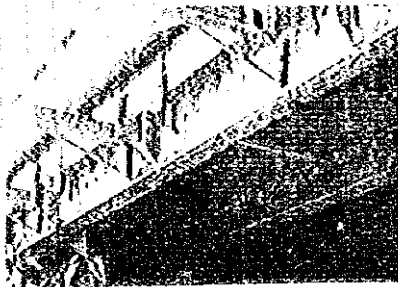
Structural defect

- Upper Flang of Main Beam corroded.
- Lower Flang of Main Beam corroded.
