## 6.3 EVALUATION OF EXISTING AIRPORT FACILITIES

Table 6.3.1 Evaluation of Existing Facilities at Iloilo Airport

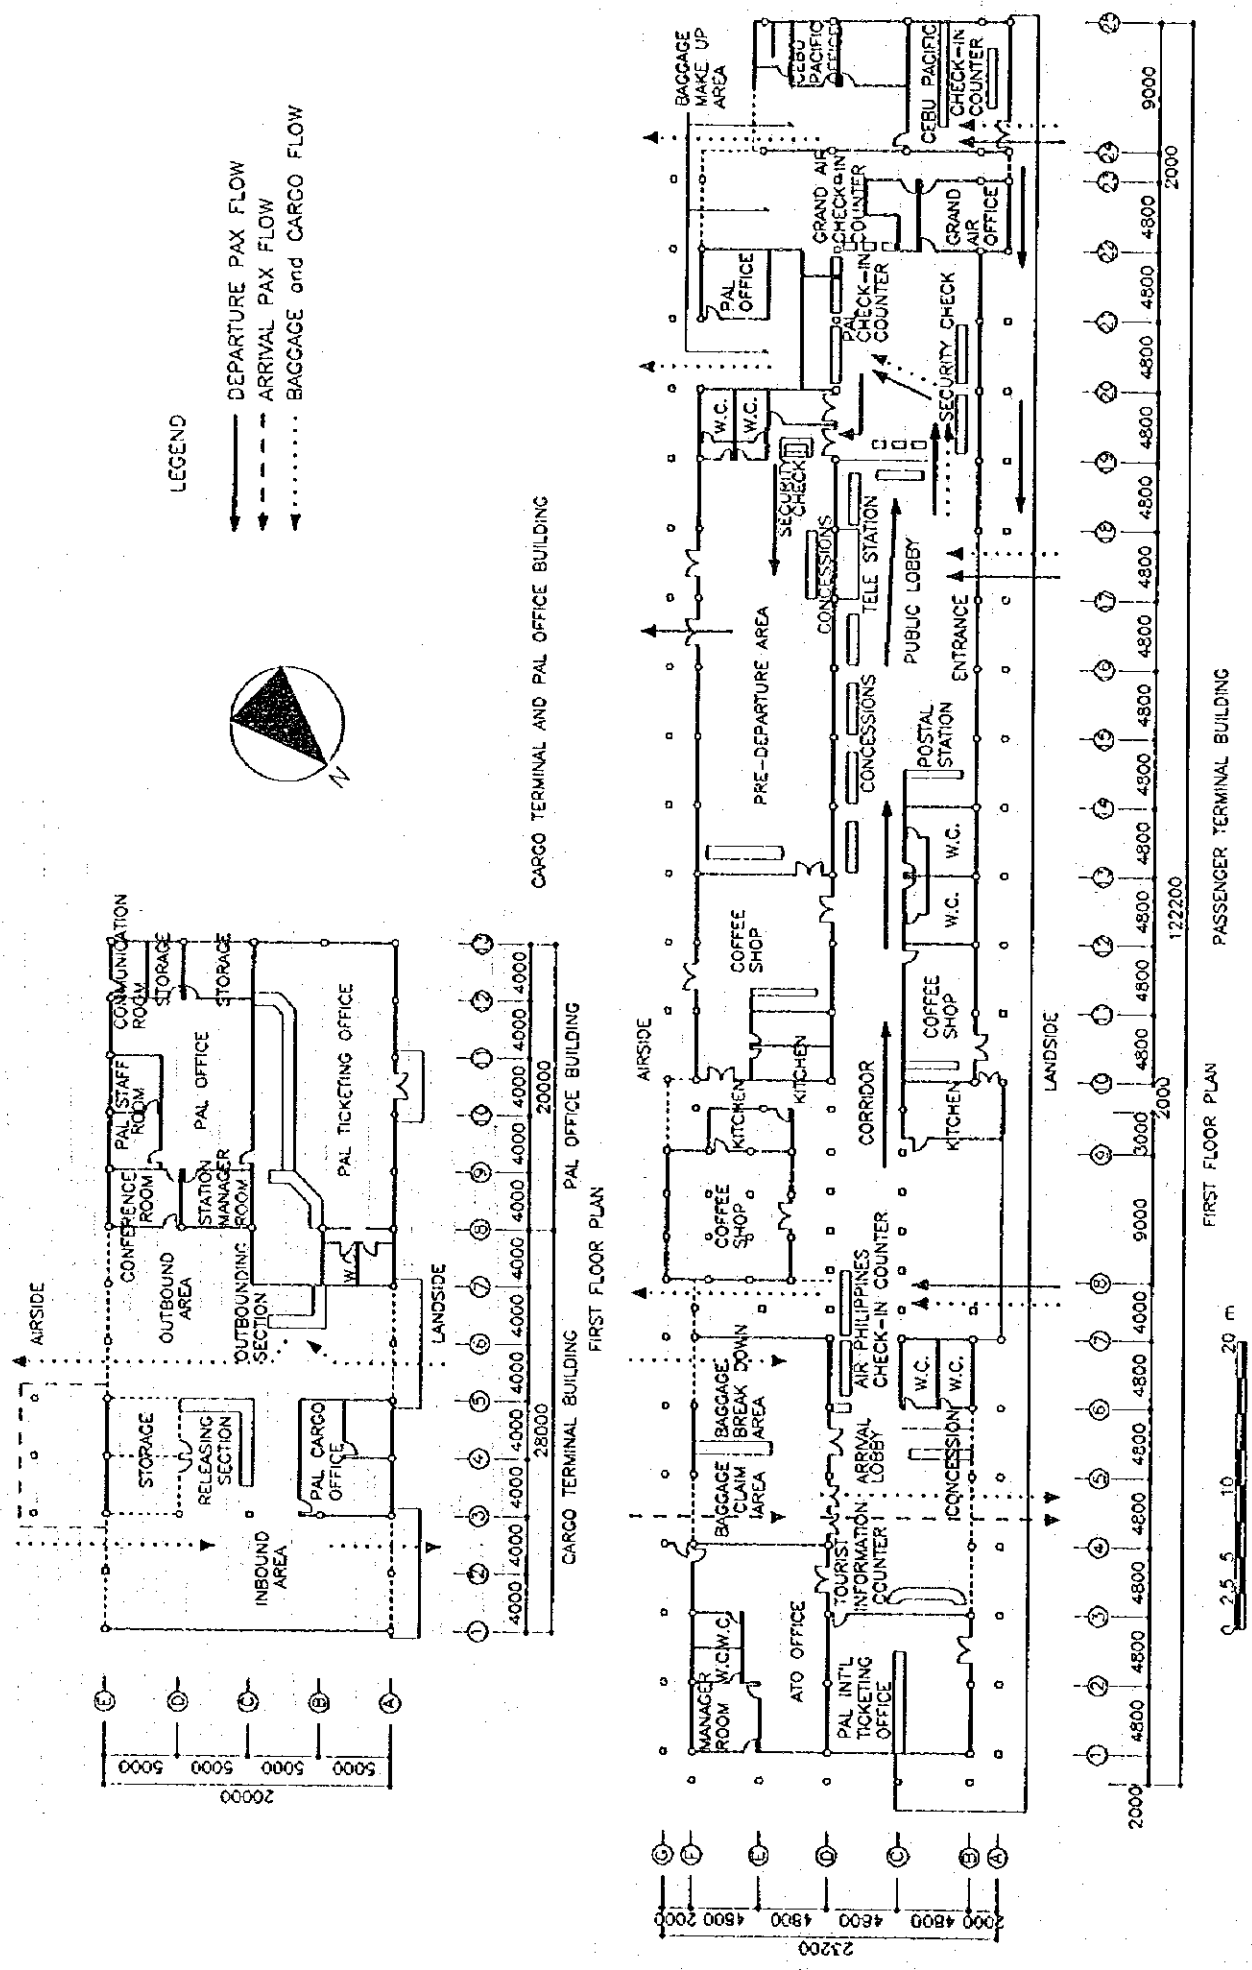
Figure 6.3.1 Passenger and Cargo Terminal Building

The terminal building is one story of a reinforced concrete structure and has a total floor area of about 2,200 sq.m. The terminal building accommodates arrival and departure areas and administration area. Three airlines, PAL, Cebu Pacific and Air Philippines, are operating in the terminal building. Soon a new airline, Grand Air, is scheduled to operate. The floor plan of the terminal building is shown in Figure 6.3.1. The administration area with about 140 sq.m is located in the northern part of the terminal building, next to baggage claim area. The floor space for the administration office is not sufficient. The structure of the terminal building is generally in good conditions.

Departing and arriving passengers flows, including baggage flow are shown in Figure 6.3.1. Actual conditions of the major terminal components are compared with the standard requirements in order to evaluate the existing terminal building. As a result, there are many insufficient spaces and facilities at the existing terminal building as shown in Table 6.3.2 below.

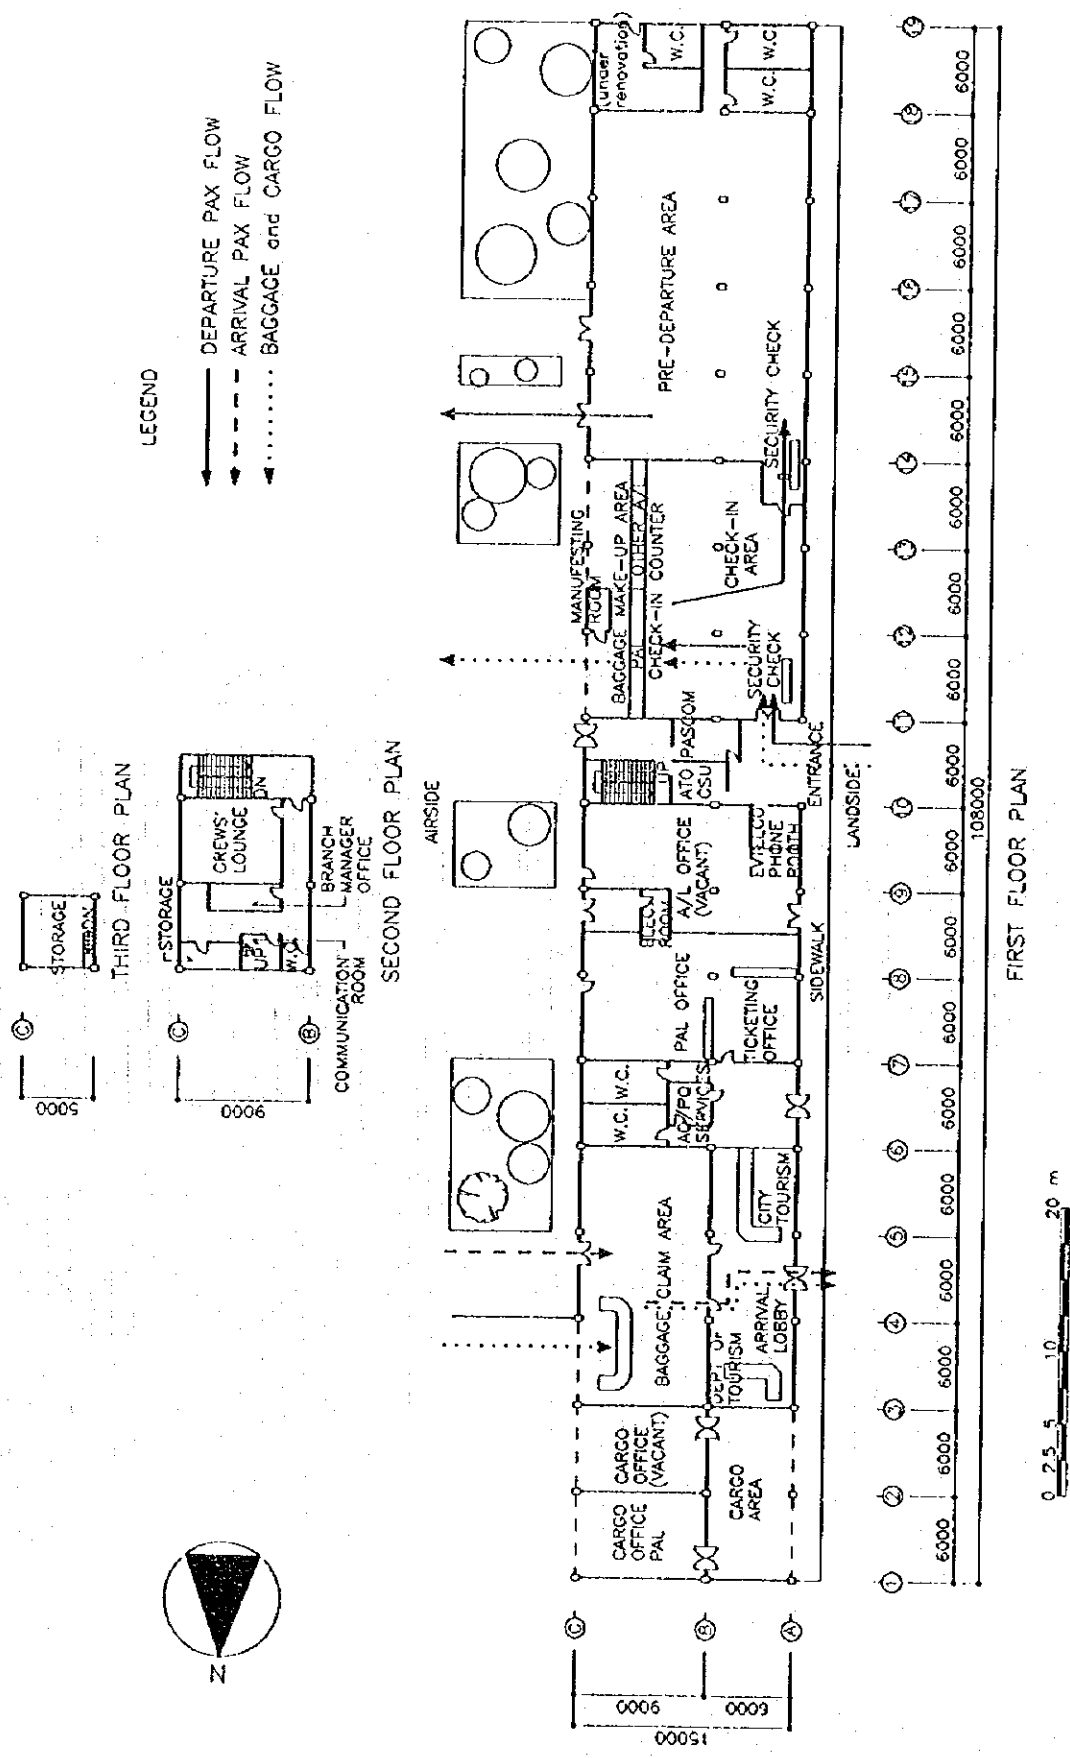
Figure 7.3.1 Passenger and Cargo Terminal Building

PAL is operating in the terminal building and two new airlines, Cebu Pacific and Grand Air, are scheduled to operate daily flights between Manila and Tacloban. In connection with two airlines operations, PAL has a plan to renovate its check-in counters and baggage make up area.

As previously stated in Section 4.4, the unit floor area of 10 sq.m per peak hour passenger is considered adequate for estimating the required floor area for the passenger terminal building. Since the current peak hour passengers in two ways are estimated to be 280 passengers based on the current flight schedule, the required floor area is estimated to be 2,800 sq.m, which indicates that the present available floor area of 1,080 sq.m is far from sufficient even for the present peak hour passenger volume.
