**THE STUDY ON WATER SUPPLY FOR
SEVEN TOWNS IN EASTER PROVINCE
IN THE REPUBLIC OF KENYA**

EXISTING WATER SUPPLY FACILITIES IN MERU

**APPENDIX C SURVEY OF EXISTING
WATER SUPPLY FACILITIES IN MERU TOWN**

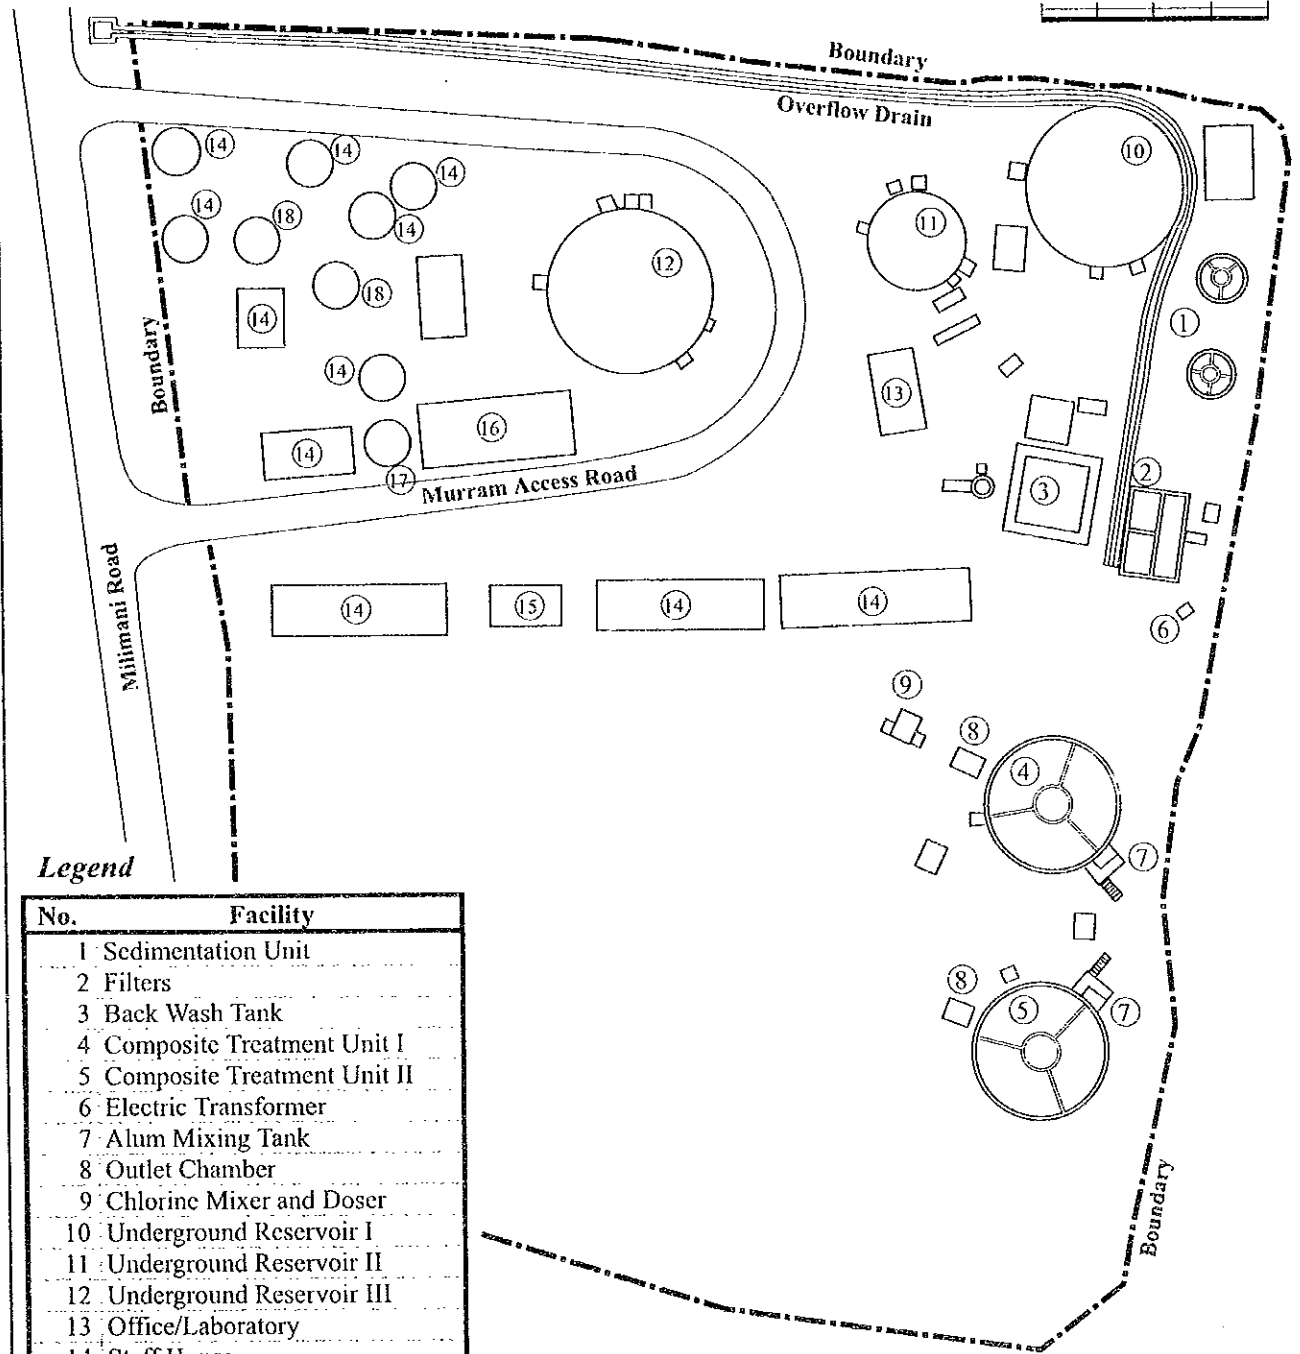
Milimani Waterwoks

The Treatment Works are located in Milimani Area, supplying the treated water to the low level distribution zones. *Figure C2-1* shows a general plan of the Treatment Works and a table below outlines the component facilities and the present conditions with our evaluation.

COMPONENT	EVALUATION
TW - 1	Sedimentation Unit Capacity 225 m ³ /day circular horizontal flow sedimentation Unit built in 1952.	In fair structural condition. Silted up. Presently not in use.
	Circular filtration unit for sedimentation unit built in 1952.	Not in use for more than 10 years.
	Circular composite treatment unit capacity 225 m ³ /d. Built in 1956.	In fair structural condition. Presently not in use.
TW - 2	Filtration Units Capacity 1,992 m ³ /day. Two units of surface area 8.3 m ² each. Built in 1978.	In good structural condition. Operating under overloaded condition as Raw Water is filled to the top of unit 1 and overflows to unit 2.
	(Backwashing for both filters done simultaneously on daily basis).	Surplus overflow from unit 2 measured as 2,700 m ³ /d.
	Inlet chamber for line from Kathita:	3 Nos. 150 mm dia. sluice valves leaking. No covers.
	Inlet chamber for line from Gatabora.	1 No. 150 mm dia. sluice valve. leaking.

Inlets to filter units:	150 mm dia. GI pipe supported partly over steel covers for valve channel. 4 Nos. 150 mm dia. Sluice Valves leaking. uPVC underdrainage pipes for unit 2 partly broken.
	Outlet chambers:	1 chamber broken. 4 Nos. 150 mm dia. sluice valves leaking.
BT - 1	Backwash tank 1 (for 'Old' Treatment Units) Pressed steel elevated tank of capacity 13 m ³ . Built in 1956.	In good structural condition presently not in use. 50 mm dia. sluice valve on inlet leaking. Backwash pipe has burst. There is no ball float valve.
BT - 2	Backwash tank 2 (for filters and 'new' treatment units). Pressed steel elevated tank of capacity 77m ³ . Built in 1980.	Tank has leak in one bottom panel, otherwise in good structural condition. 300mm dia. sluice valve on outlet is leaking. There is no ball float valve. Scour pipe is broken at threaded end and is not supported. 75mm dia. sluice valve on scour pipe is not working.

Component	Evaluation
ST - 1	<p>Storage Tank 1 Underground masonry tank capacity 265m³. Filtered water from TW-2 and TW-4 are stored.</p> <p>i) 2 Nos. inlet chambers (No chamber or sluice valve for third inlet).</p> <p>ii) 1 No. outlet chamber iii) Scour pipe iv) Overflow pipe 150mm dia 0.5m from soffit of tank.</p>	<p>Tank is in good structural condition.</p> <p>There are no ball float valves for 3 Nos. inlets.</p> <p>1 No. 150mm dia sluice valve is tight to operate. Covers for both chambers are missing.</p> <p>1 No. 150mm dia. sluice valve is leaking Not provided.</p> <p>Overflowing continuously during period of observation.</p>
ST - 2	<p>Storage Tank 2 Underground masonry tank capacity 91m³. Filtered water from TW-2 are stored.</p> <p>i) 3 Nos. inlets</p> <p>ii) 3 Nos. outlets</p> <p>iii) Scour</p> <p>Storage Tank 3 Underground masonry tank capacity 455m³. Filtered water from TW-2 and TW-3 are stored.</p> <p>i) 4 Nos. inlet chambers (2 Nos. inlet presently not in use) ii) 3 Nos. outlet chamber iii) Scour and overflow</p> <p>Office and Laboratory One masonry building with 2 rooms Chemical store masonry building 3.8m x 2.8m internal.</p> <p>Site Works 1) The site is fenced with barbed wire on cedar posts and hedge grown in parts. ii) Gates provided at entrance and exit to site iii) Internal drains iv) Security lighting</p>	<p>Tank in good structural condition.</p> <p>Only 1 presently in use. Cover for chamber missing 150mm dia. No ball float valve. Sluice valve condition.</p> <p>1 No. 150mm dia. sluice valve rusty and 1 No. leaking, 1 No. 75mm dia. sluice valve broken.</p> <p>1 No. 75mm dia. sluice valve broken</p> <p>Tank walls have cracks and leaks over a half perimeter of tank.</p> <p>No ball float valves</p> <p>1 No. 150mm dia. sluice valve is rusted. 1 No. 150mm dia. sluice valve is rusted. 2 Nos. 75mm dia. sluice valves are rusted.</p> <p>Office has basic furniture. Laboratory has negligible equipment. Tests done only for Residual Chlorine and pH. Building is in poor state. Storage of up to 100 bags alum and 60 bags chlorine.</p> <p>Fence is not in straight lines between corners. 30m fence broken. Gates are in good condition. Inadequate. Part of of drive way is eroded due to lack of drainage. In poor state.</p>

All facilities constructed at the treatment works except the sedimentation units built in 1952 are in operation. Measuring devices such as flow meters installed, however, are all broken because of an absence of the proper maintenance. Repair or rehabilitation are required at the following facilities and equipment.

- **Filtration Units**
4 nos of inlet valves, 150mm in diameter, shall be replaced
4 nos of outlet valves, 150mm in diameter, shall be replaced
- **Storage Tank 1**
One outlet valve with a diameter of 150mm to be replaced
- **Storage Tank 2**
Two outlet valves with a diameter of 75 and 150mm to be replaced
- **Storage Tank 3**
Leak repair of tank walls
- **Flow meters to be replaced or newly installed**

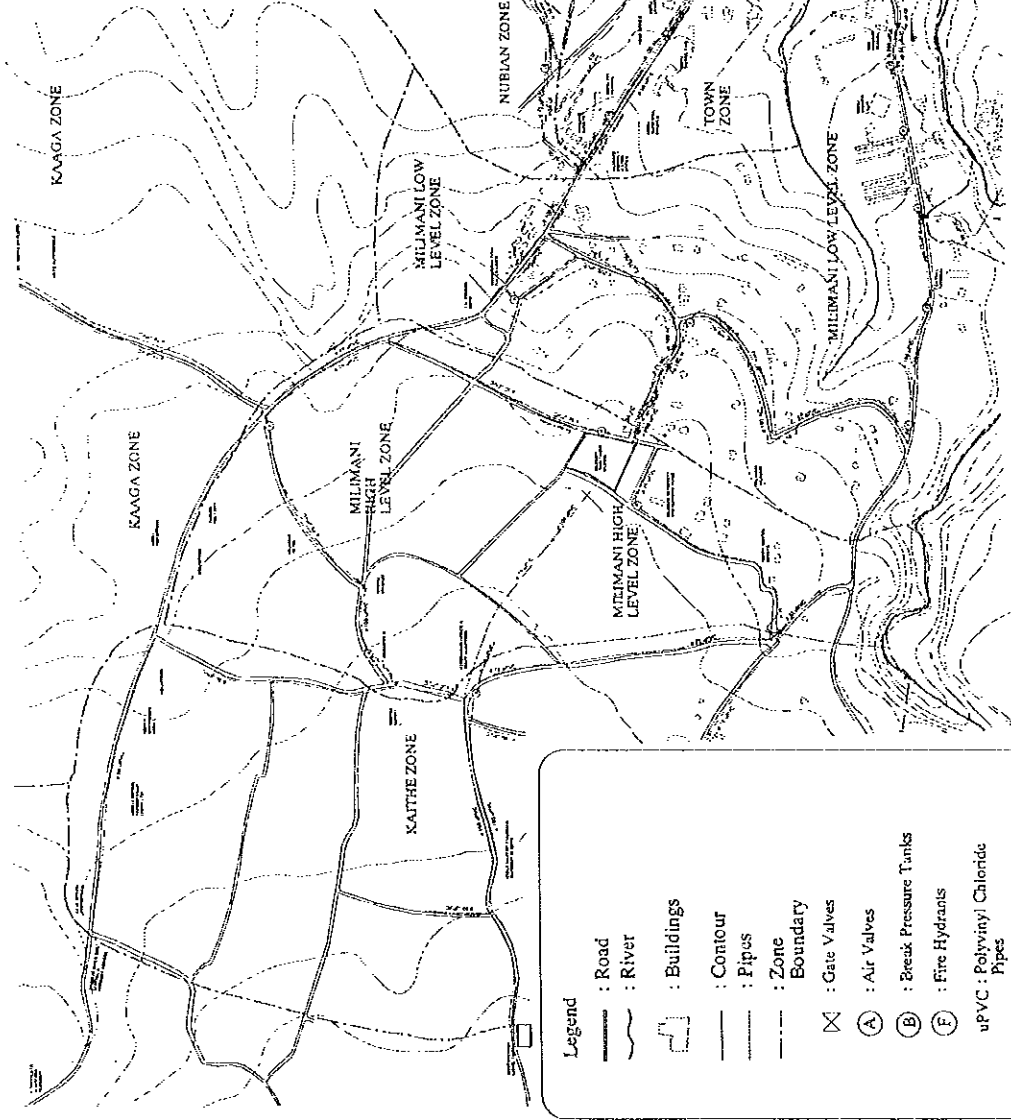
**Figure C2-2
Existing Distribution Pipe Network**

The distribution mains of PVC and GI are generally in good condition. Some AC and GI pipes laid in Town Zone are found in a shallow depth, which are prone to damage. Most AC pipes laid earlier are difficult to locate. Table below summarizes total length of the distribution and raw water transmission mains installed to date.

Our survey indicated that the visible leaks are taking place at the broken sluice valves. They are recommended to be replaced at an early stage of project development. This rehabilitation will benefit on significant water loss reduction at the distribution network.

Area	Scope of Rehabilitation
a. Milimani Zone	5 Nos. 150mm dia., 1 No. 75mm dia. and 1 No. 50mm dia. sluice valve need to be rehabilitated.
b. Town Zone	2 Nos. 100mm dia. 1 No. 75mm dia. and 1 No. 50mm dia. sluice valves need rehabilitation.
c Gakoromone Zone	2 Nos. 50mm dia. sluice valves need to repair.
