ANNEX 2

Photographs (Cerro Rico Mountain, Rivers and Ingenios)

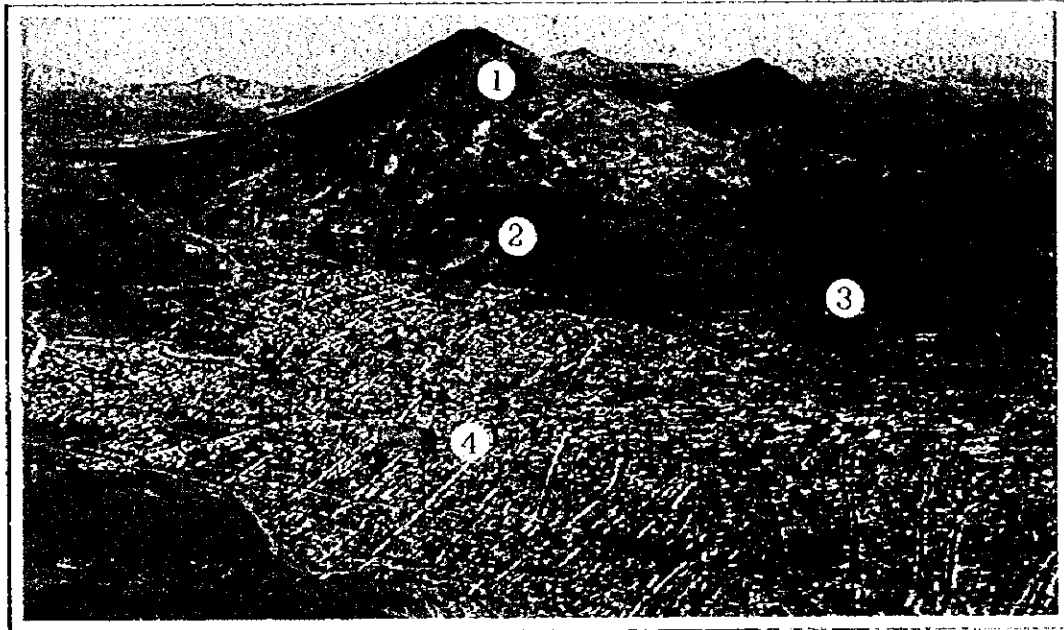
Photograph "Cerro Rico"

1. "Cerro Rico(*1)" mountain, "Pailaviri and Cooperative" mines and "Cerro Rico, etc." Desmonte(*2)
*1: rich mountain, *2: rejected ores
2. Abandoned "Pailaviri" Ingenio(*3) and its tailing pile
*3: concentrator (mineral processing plant)
3. "Diablo" Sucu(*4)
*4: primitive Sn gravity concentration tailing pile
4. The city of Potosi

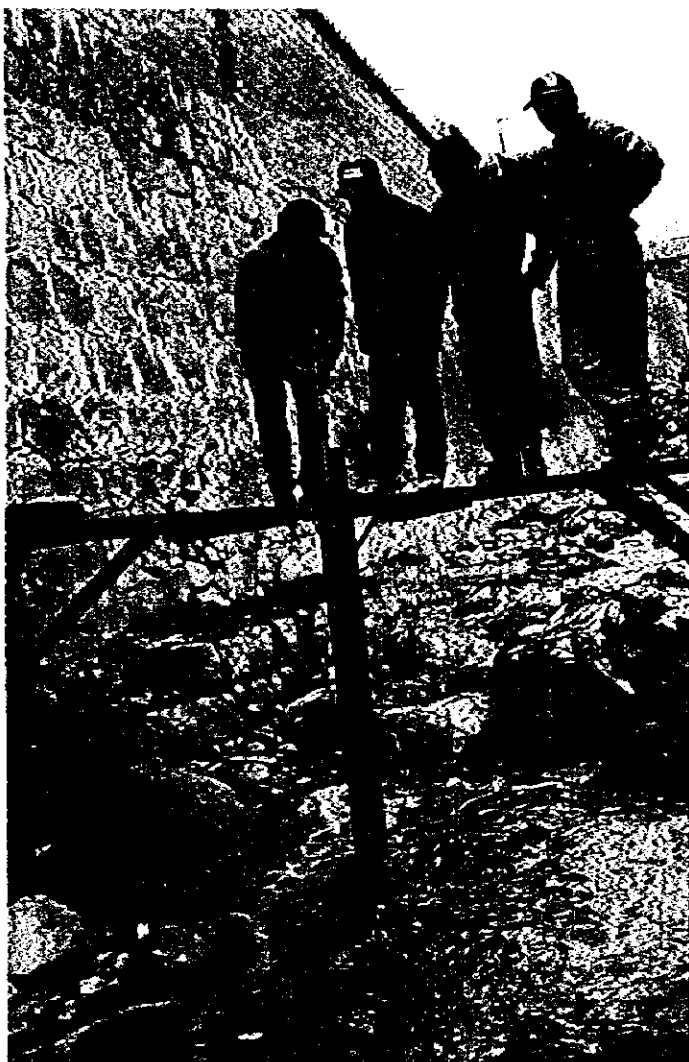
Photograph "Sampling at Contaminated Rivers" 2

Sampling point No. 6. Work bench for data monitoring.

The river water is heavily contaminated by tailings from many small Ingenios.

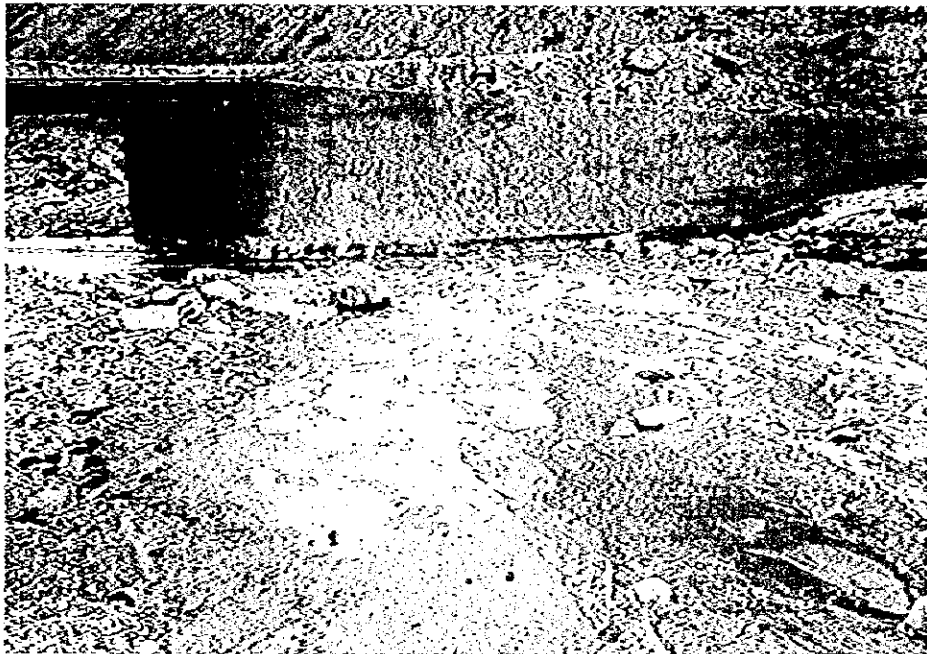
Photograph "Sampling at Contaminated Rivers" 6

Rio Alja mayu river. Sampling point No. 15.

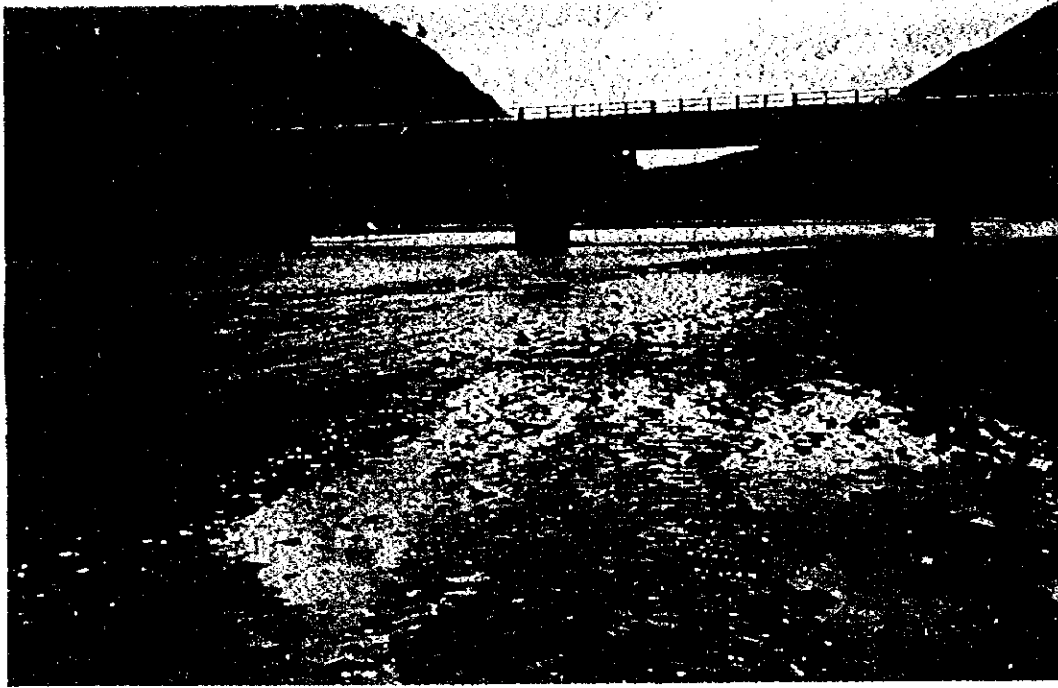
Photograph "Sampling at Contaminated Rivers" 7

Sampling point No. 25: "Puente Mendez" bridge.

Rainy season. The river is flushed many times after hard rain.

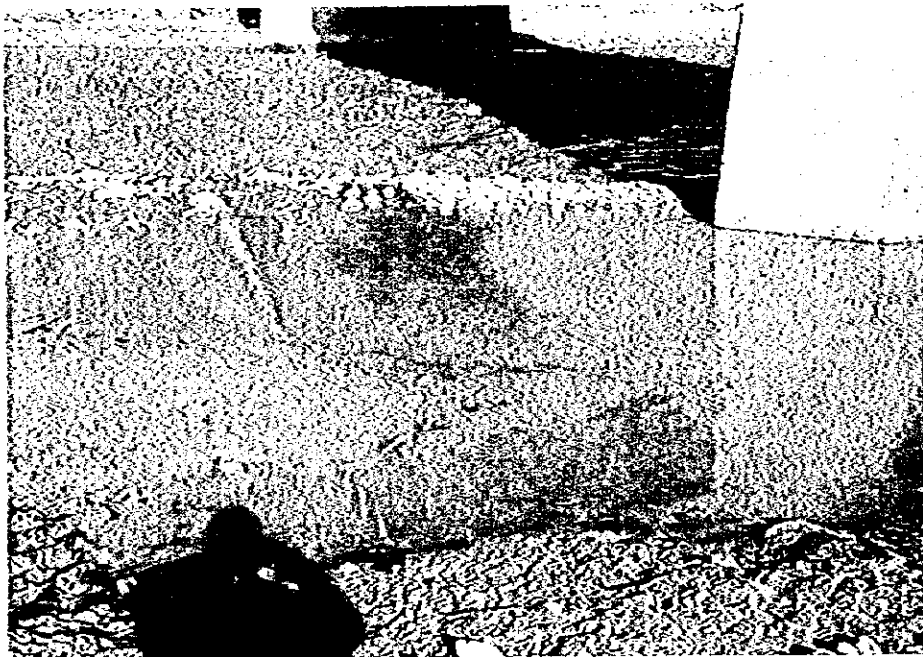
Photograph "Sampling at Contaminated Rivers" 8

Sampling point No. 25: "Puente Mendez" bridge.

Dry season. Accumulated sediment color is different from rainy season, largely affected by tailing from Ingenios.

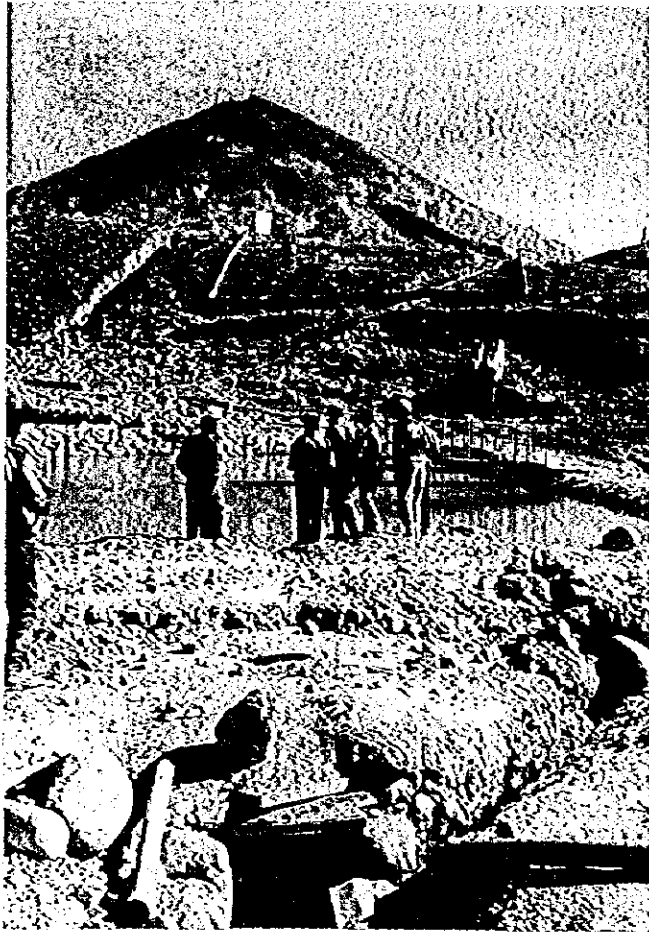
Photograph "Ingenios" 5

Typical individual tailing treatment facilities(at Del Sur) to get clarified water. Settled tailing is discharged to rivers.

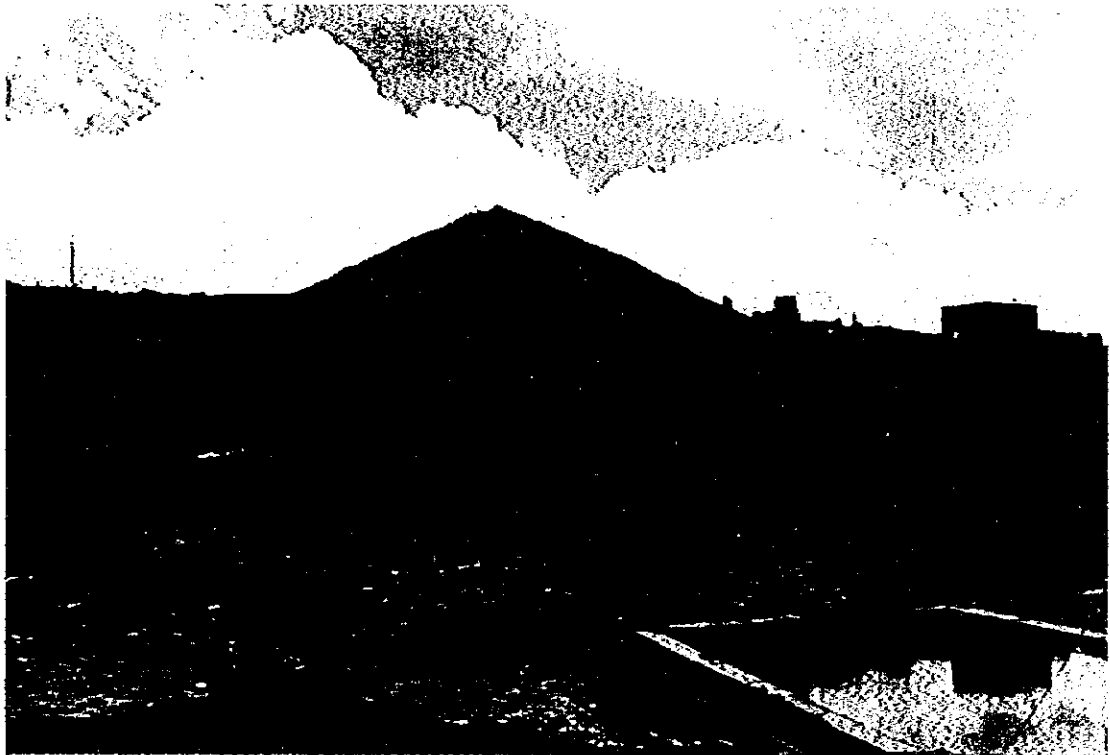
Photograph "Ingenios" 6

A abandoned Ingenio.
