### 6.2.18 Gas Compressor Station (Facility No. 14)

| Date: Jul99 | FEASIBILITY STUDY ON THE WASTEWATER TREATMENT PLANT OF SARAJEVO | Design Ref. No. |

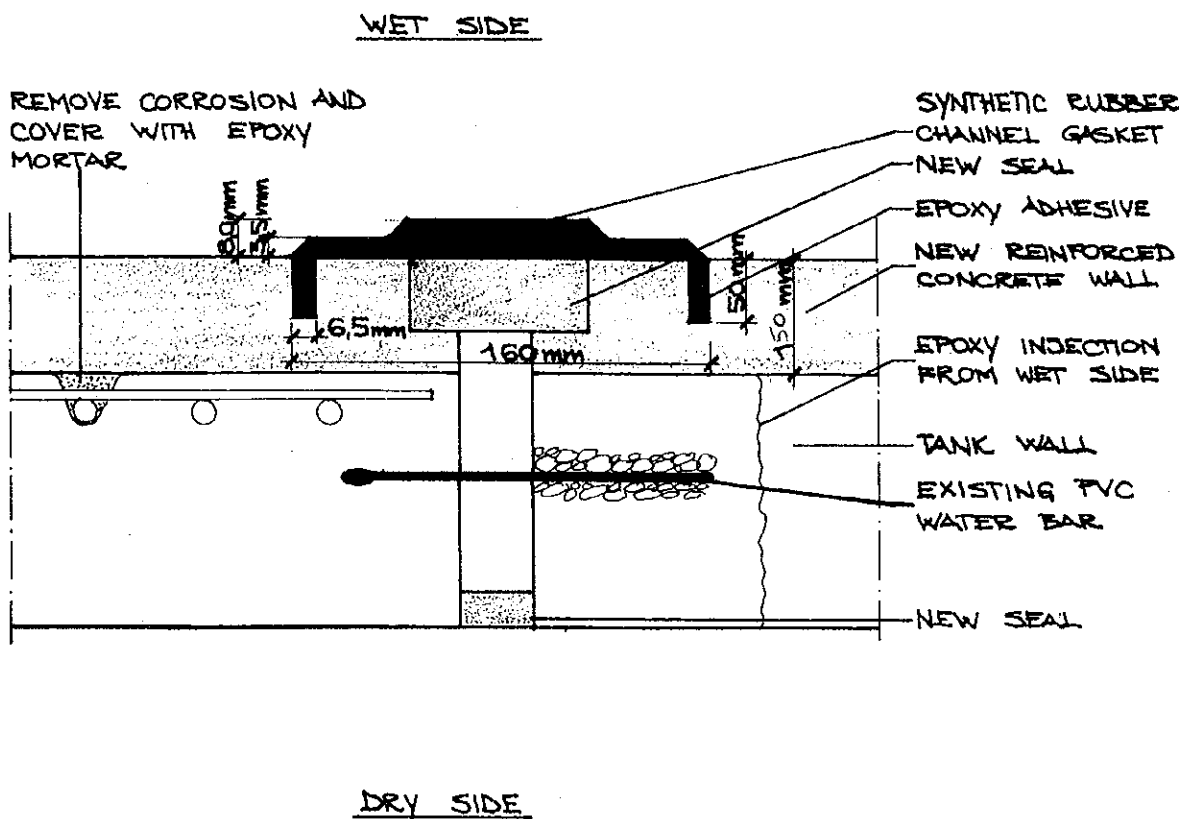
| Scale: N15 | Proposed Wall Repair - Typical Detail | Figure 6.1 |

| Facility Name | Structure | Condition Assessment | Recommended rehabilitation |
|---|---|--|--|
| | | Inside walls of tank have inadequate cover over reinforcement. Steel is corroded and exposed over most of the surface area. | Expose and treat all corroded reinforcing steel. Provide new concrete wall 150mm thick on inside face to increase cover and facilitate repair of expansion joints. Provide protective coating for high and low water levels. |

| Facility Name | Structure | Condition Assessment | Recommended rehabilitation |
|---|---|--|---|
| | | Inside walls of tank have inadequate cover over reinforcement. Steel is corroded and exposed over 40% of the surface area. | Expose and treat all corroded reinforcing steel. Provide new concrete wall 150mm thick on inside face to increase cover and facilitate repair of expansion joints. Provide protective coating 1 m either side of high and low water levels. |

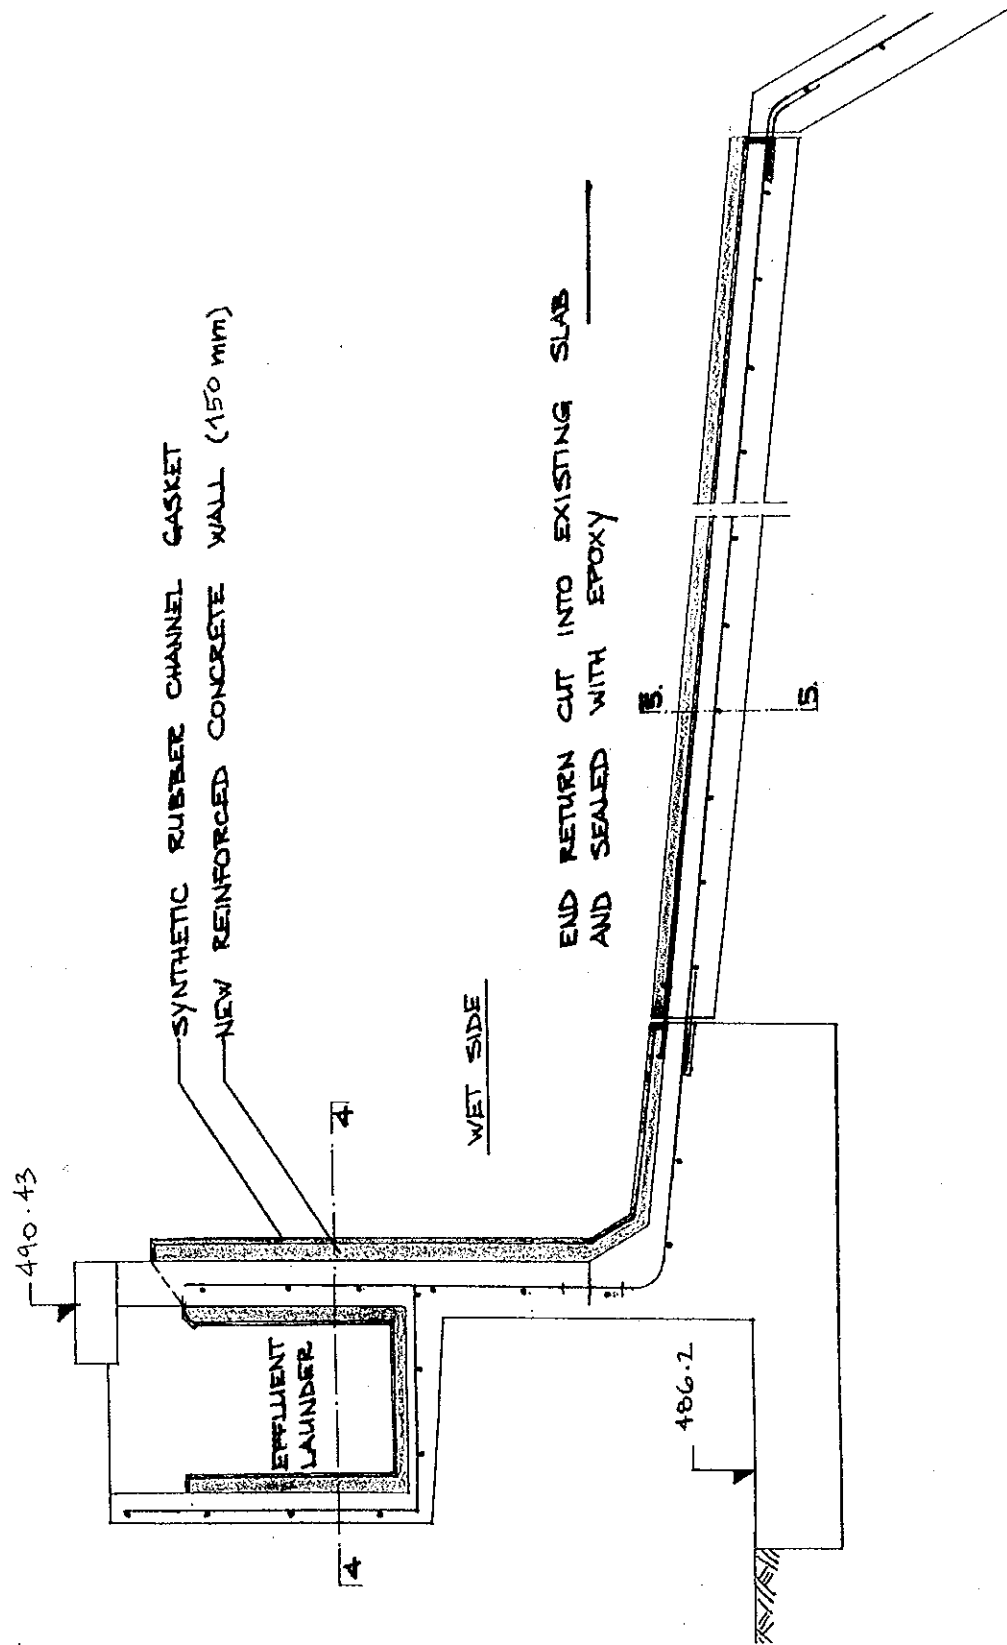
| Scale: NIS | Proposed Expansion Joint Repair- Typical Wall & Floor Section | Figure 6.2 |

| Facility Name | Structure | Condition Assessment | Recommended rehabilitation |
|---|---|--|--|
| | Tank walls | The hydraulic leakage test confirmed that leakage through cracks and expansion joints in the wall and overflow launder is excessive. Several of the cracks that were previously repaired are leaking. | Seal all cracks and construction joints including any that were previously repaired. Repair expansion joints. |

| Facility Name | Structure | Condition Assessment | Recommended rehabilitation |
|---|---|--|---|
| | Tank floors | The floor finish appears to be in good condition. The screed finish is cracked along the movement joint (normal) but is not delaminated. Leakage in floor joints is probable. | Remove existing screed mortar. Provide new expansion joint and 100 mm concrete floor over existing. |

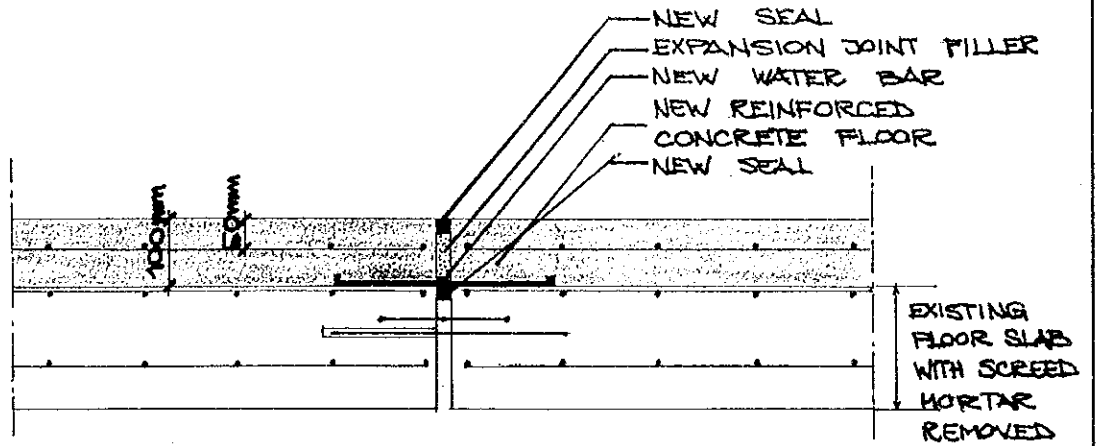
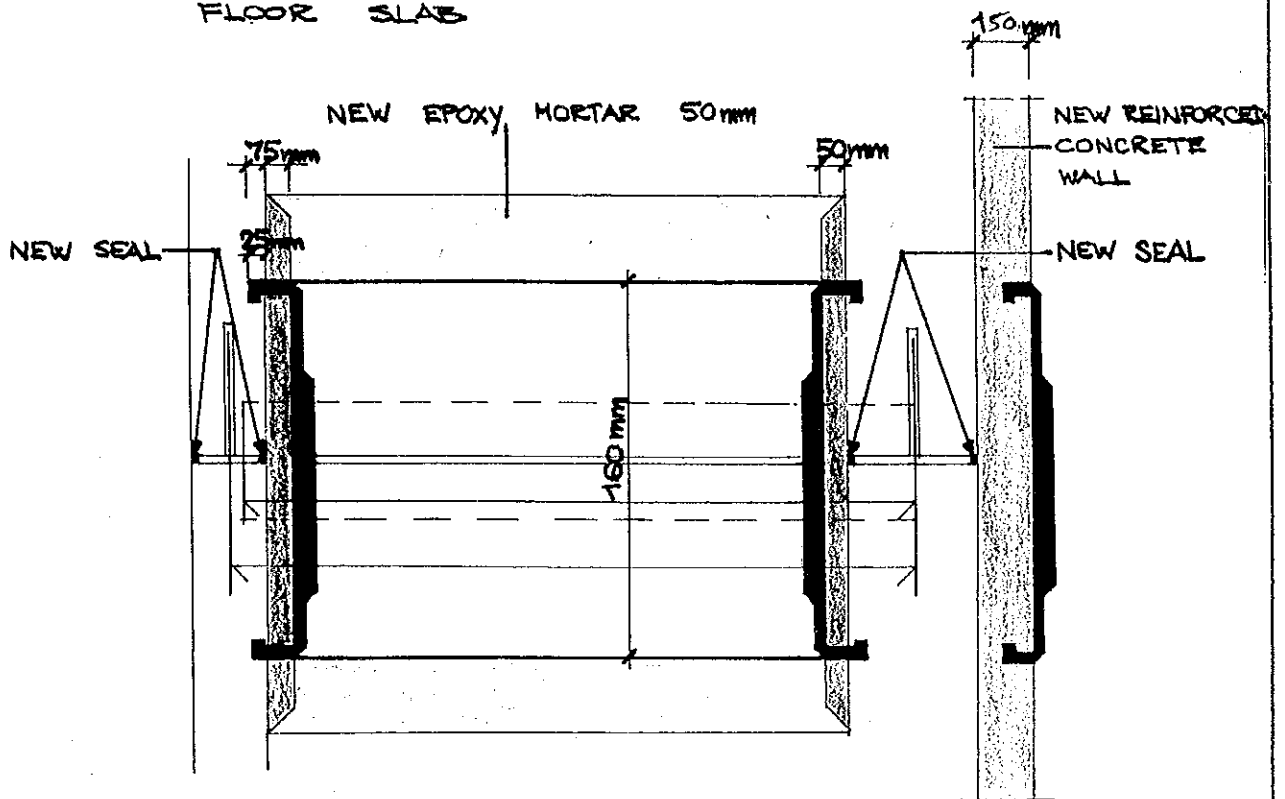
| Scale: NTS | Proposed Expansion Joint Repair- Typical Details | Figure 6.3 |

| Facility Name | Structure | Condition Assessment | Recommended rehabilitation |
|---|---|--|---|
| | Overflow Channel | Leakage was observed at all vertical & horizontal expansion joints and several deep cracks | Seal all cracks and construction joints. Repair expansion joints. |

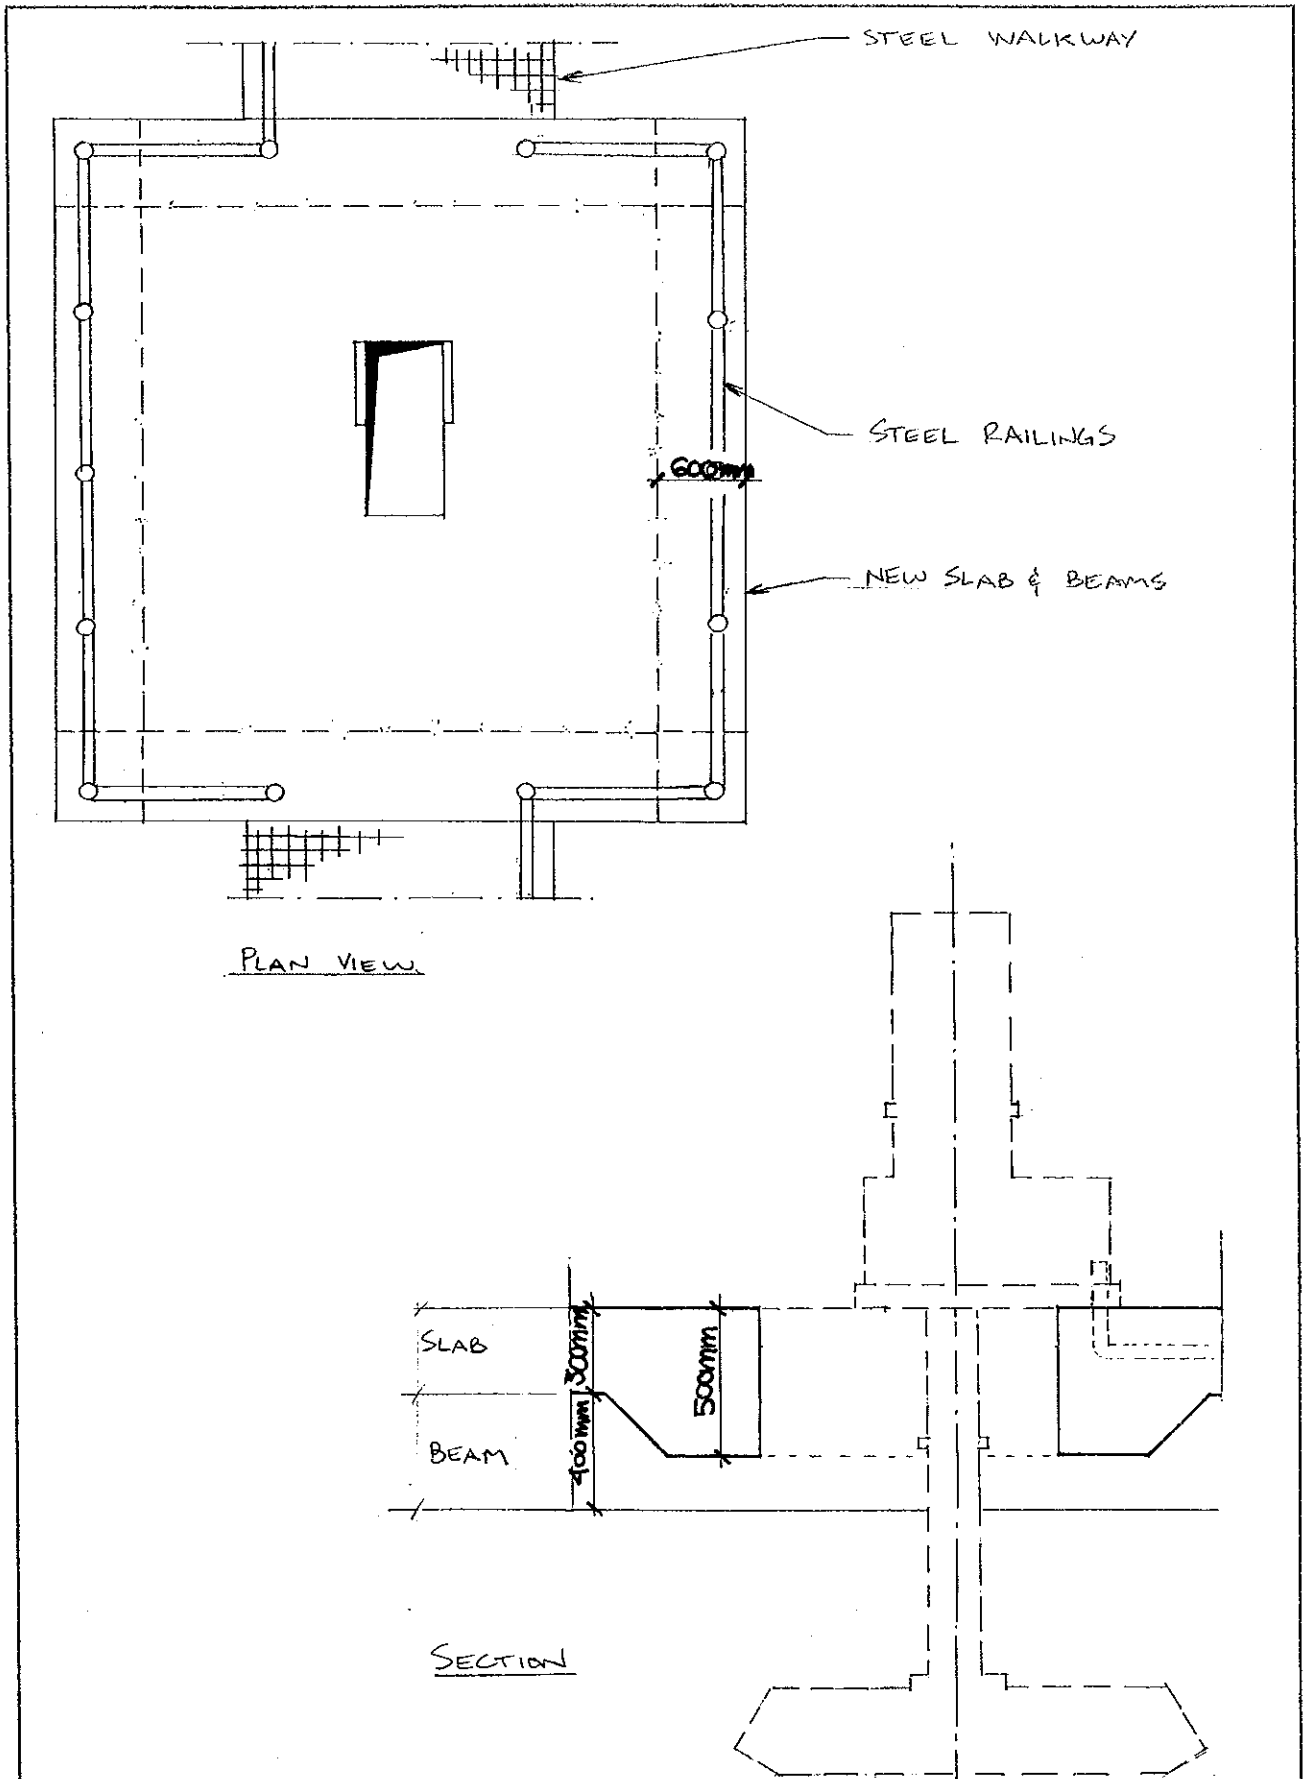
Figure 6.5

| Facility Name | Structure | Condition Assessment | Recommended rehabilitation |
|---|---|--|--|
| | Aerator slab | Frost damage caused by inadequate surface drainage and spray from aerator. Reinforcing steel is exposed and corroded. The 150mm slab does not have sufficient mass to dampen vibrations. | Remove existing slab and beams and reconstruct to larger dimensions. Coat underside of slab with epoxy resin finish. |

| Facility Name | Structure | Condition Assessment | Recommended rehabilitation |
|---|---|--|--|
| | | Inadequate floor pad for support of surface aerator. | Provide concrete base with vibration isolating pads. |

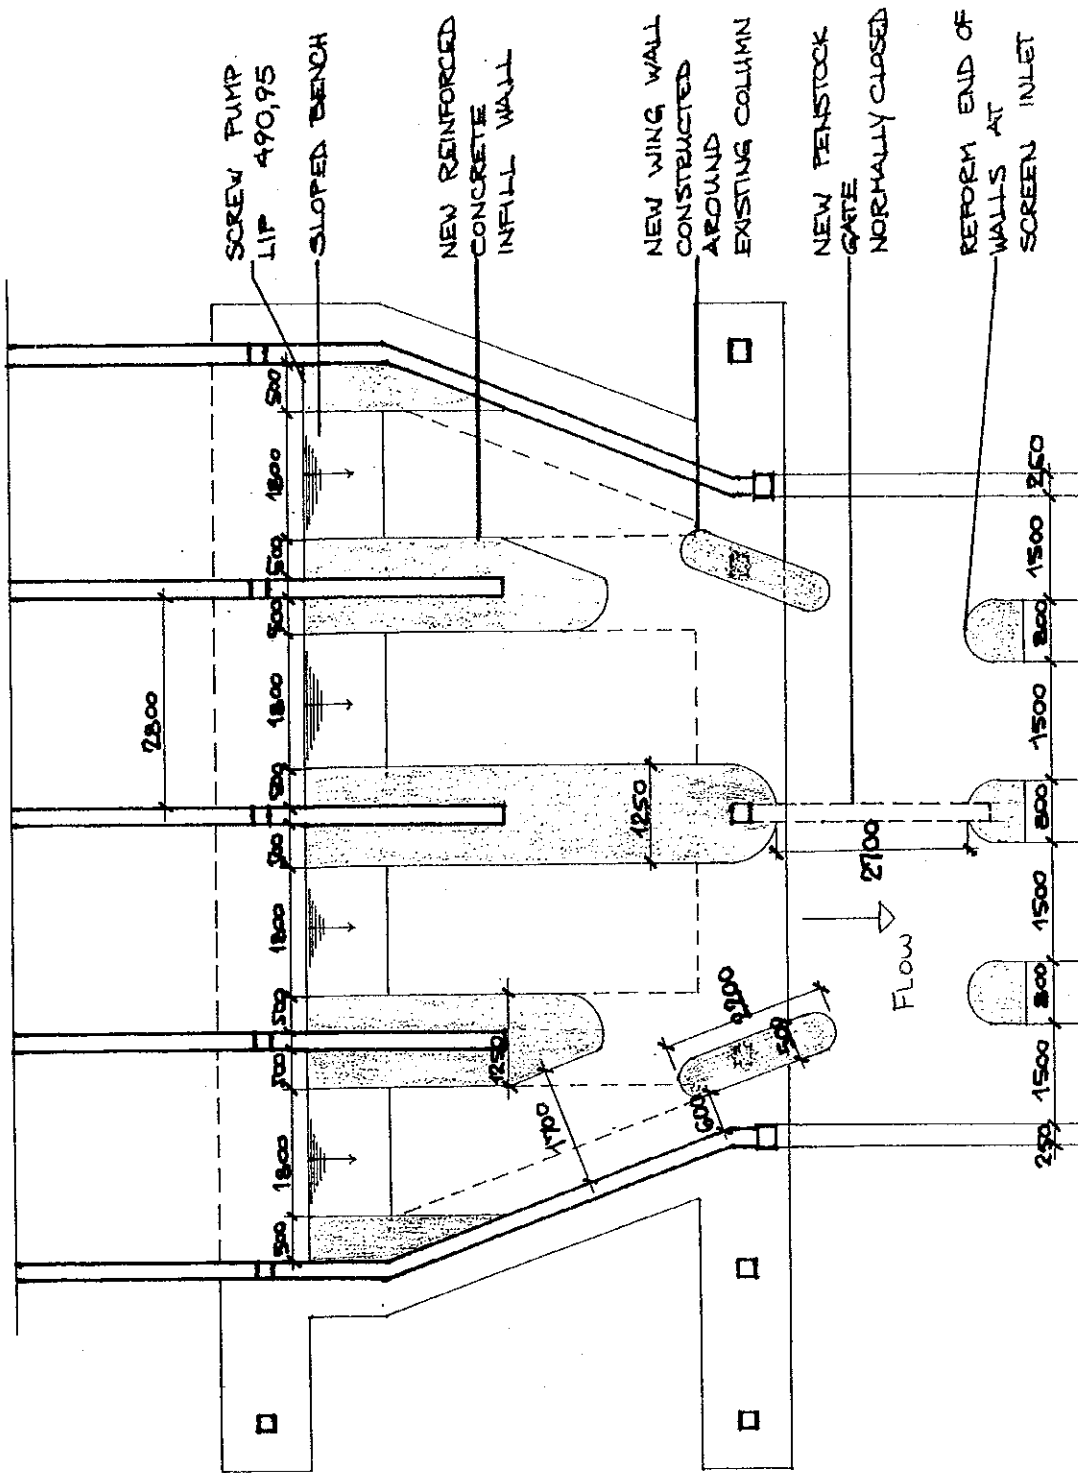
Figure 6.7(1)

| Facility Name | Structure | Condition Assessment | Recommended rehabilitation | |
|---|---|---|---|--|
| | | The wide cross section causes low velocities which results in excessive deposit of sediments. These sediments block screens and create operating difficulties. | Reduce the cross sectional area by forming new channels. Improve hydraulic conditions by extending wing walls to direct flow towards screens. | |
