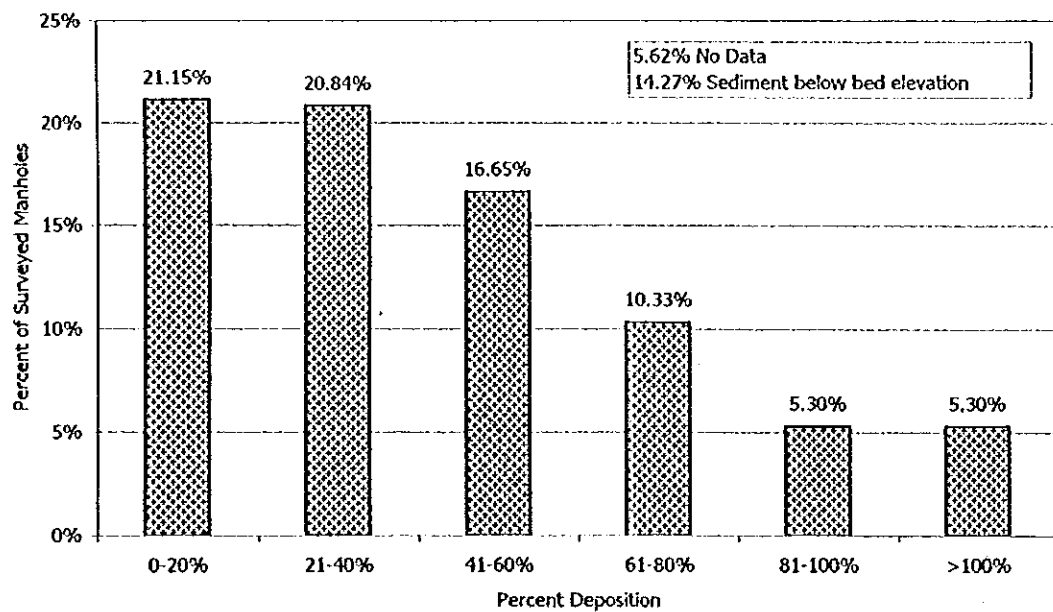
Figure 6.1 SEDIMENT DEPOSITION IN SURVEYED MANHOLES

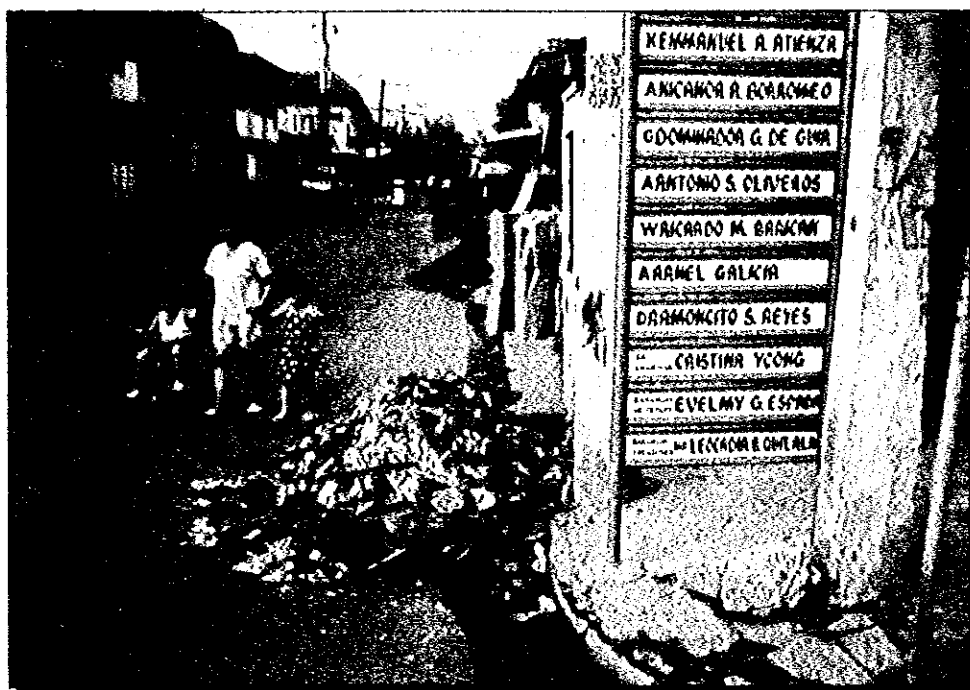
Photo 3 GARBAGE AND SEDIMENT (TAKEN AFTER FLOOD)

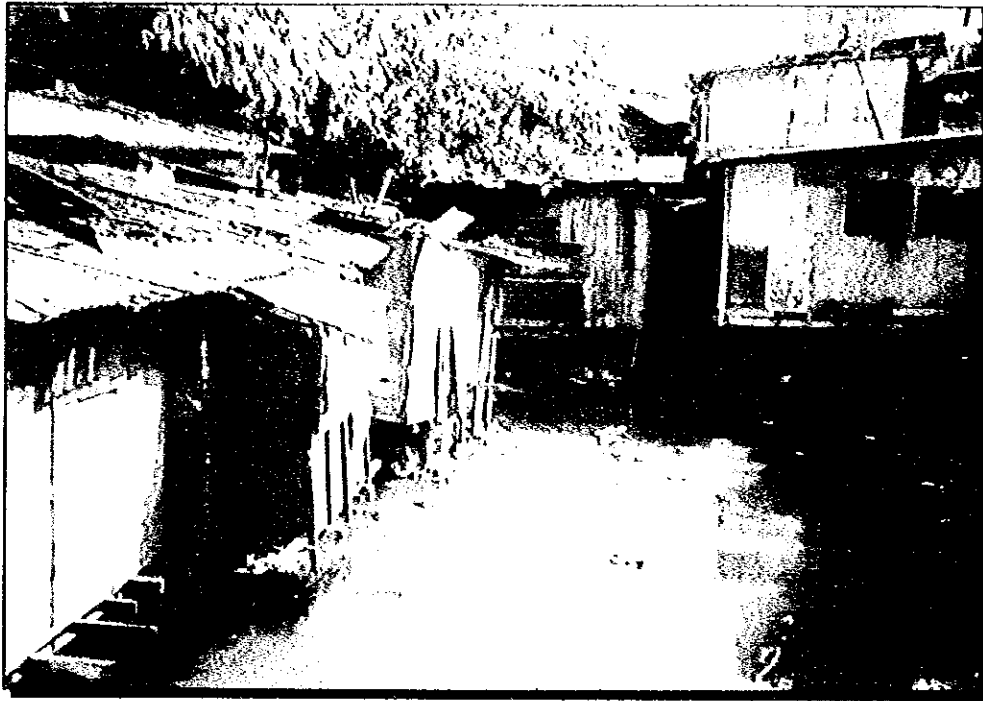
Photo 7 INFORMAL SETTLERS INSIDE ESTERO DE MAGDALENA (LA TORRE)

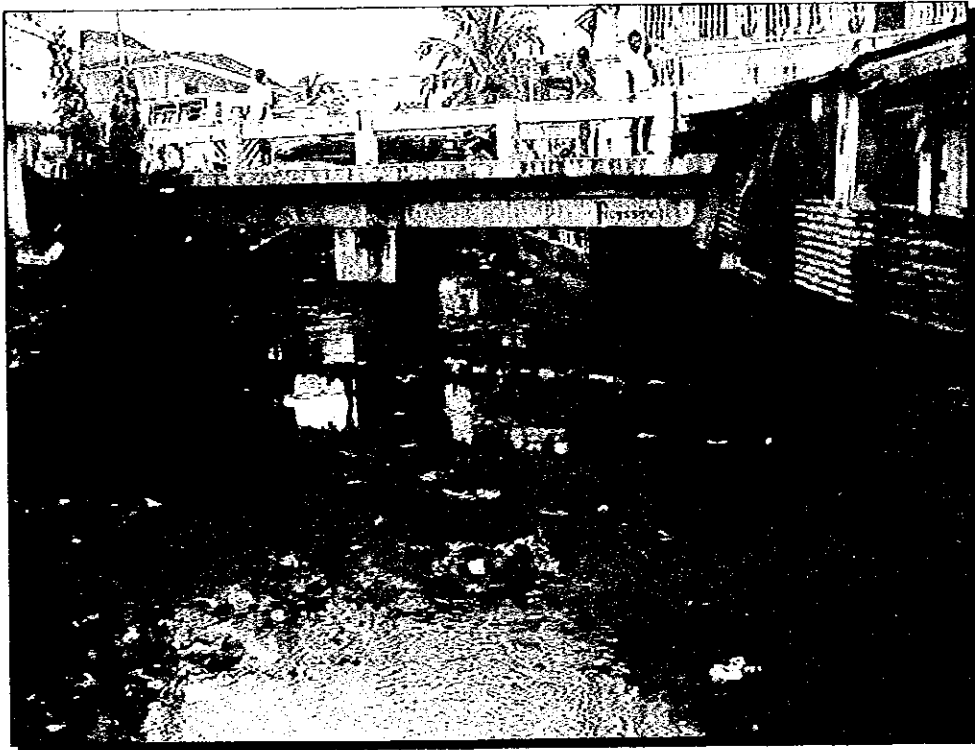
Photo 12 SEWER LINE CROSSING ESTERO DE CALUBCUB
