BASIC DESIGN STUDY REPORT
ON
THE PROJECT
FOR
IMPROVEMENT OF COASTAL FISHERIES DEVELOPMENT
IN
THE COMMONWEALTH OF DOMINICA

January 2001

JAPAN INTERNATIONAL COOPERATION AGENCY
ECOH CORPORATION

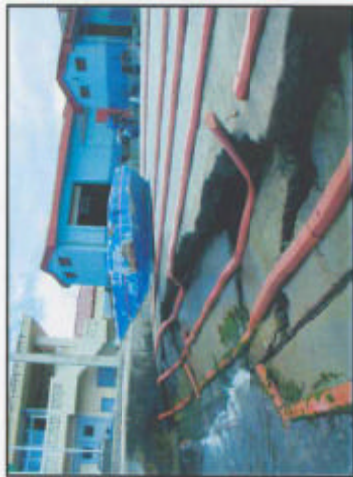
Photo-1 Damages at Slipway

- (6) Severe running back waves scored the foot area of slipway and the concrete blocks on the foot area were destroyed. The filling sand and stones of slipway was taken to the offshore and the concrete plates were left suspended. Severe waves attacked the concrete plates and those were broken and sunk down.

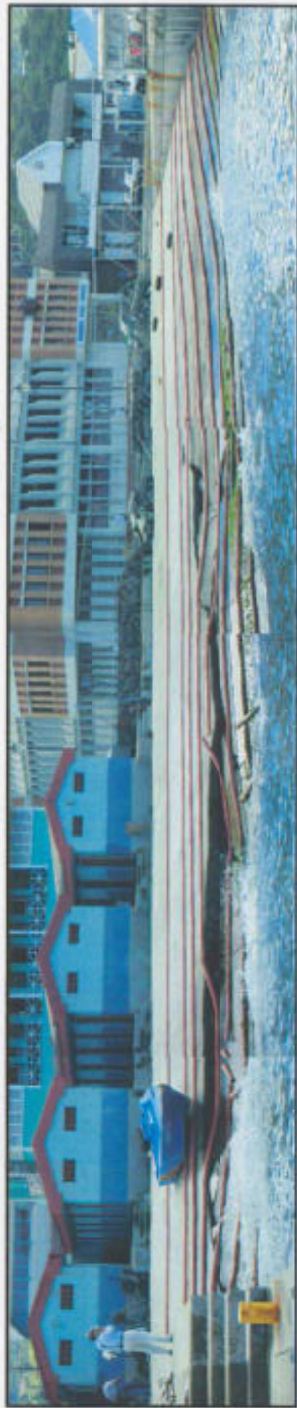
Photo-2 Damages at Slipway

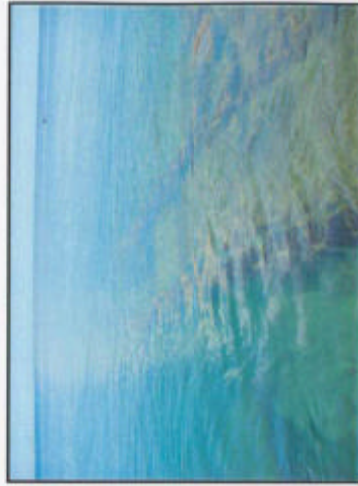
Photo-4 Damages at Sheet Piles of Submerged Groin

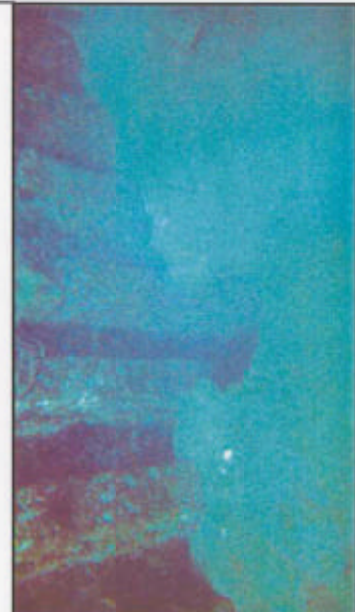
Photo-5 Pot Hole of Foot Protecting Underwater Concrete in front of Wharf

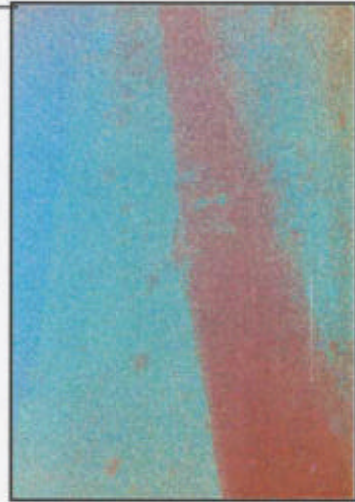
Photo-7 Damages at Point of Submerged Groin

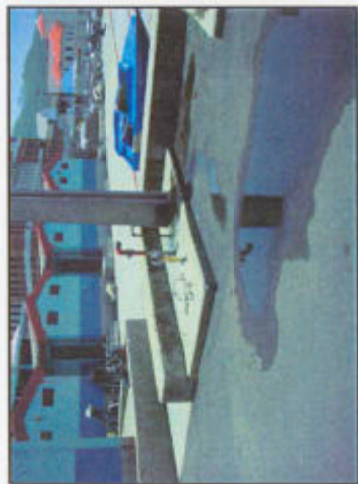
Photo-8 Lost Fuel Distributor at South-Western of Fisheries Center

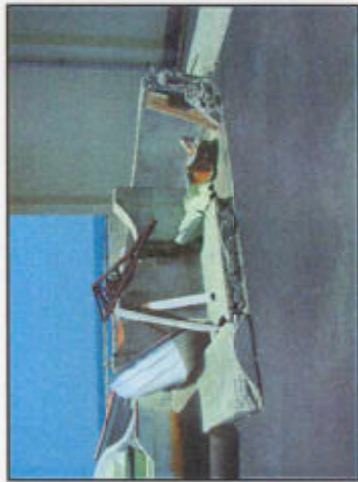
Photo-9 Lost and Damage Diesel Tank

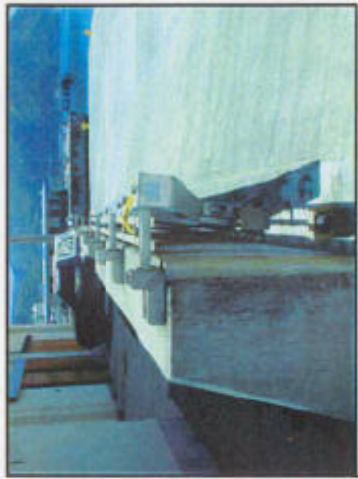
Photo-10 Damages Sliding Gate

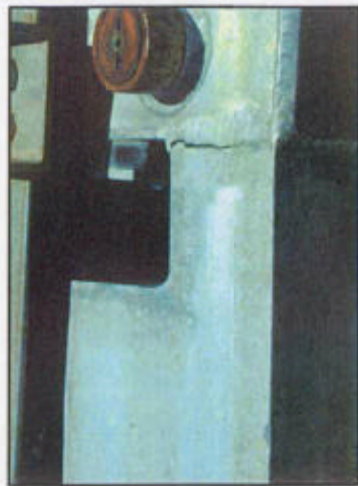
Photo-11 Damages Fook at Sliding Gate

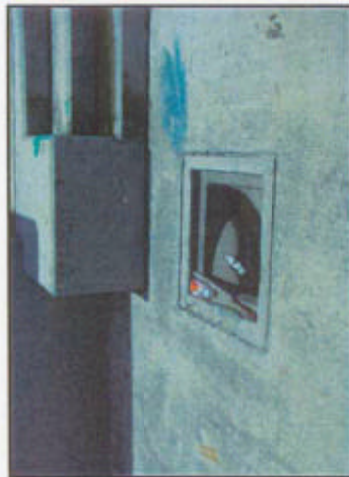
Photo-12 Lost Cover of Drain Pit

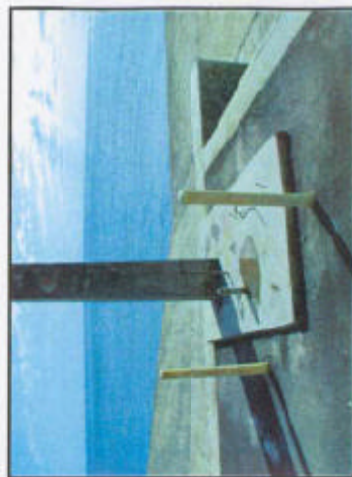
Photo-13 Lost Fuel Distributor at North-Western of Fisheries Center

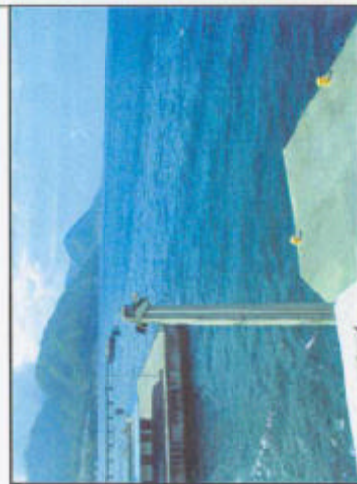
Photo-14 Damages Tip of Lighting Tower

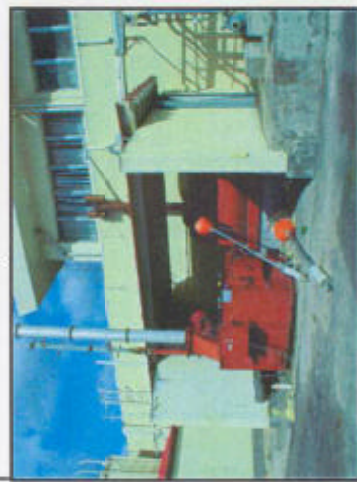
Photo-15 Damages Incinerator and Fish Waste Treatment Plant

- 3) Severe waves to be reached to the northern part of Fisheries Center was supposed to be protected if the parapet wall was settled to the end of stairs in the mooring basin. It is conceivable that damages of cooling towers and fish waste treatment plant etc, were minimum if the protection wall has been set there.

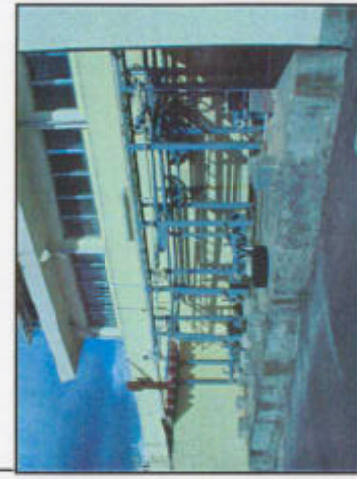
Photo-16 Lost Cooling Towers

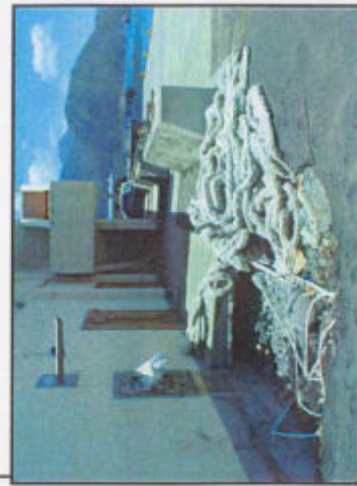
Photo-17 Damages Asphalt Pavement

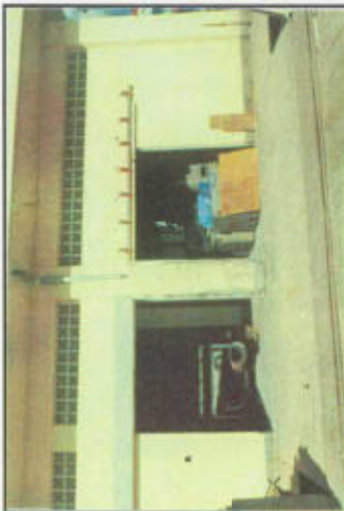
Photo-18 Lost Doors at Western Side of Fisheries Center

- 1) The parapet wall with gates, which is located on the landing wharf, served as a barrier to wave attack. Over flooding wave of it straightly struck the doors of Fishery Center. The allotment of gates and doors for convenience of landing the fish catches became with causes of damages inside the building.

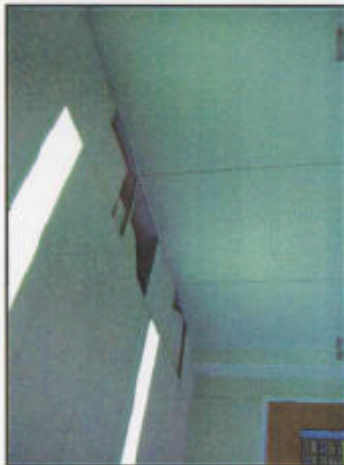
Photo-19 Damages Ceiling of Laboratory (1st Floor)

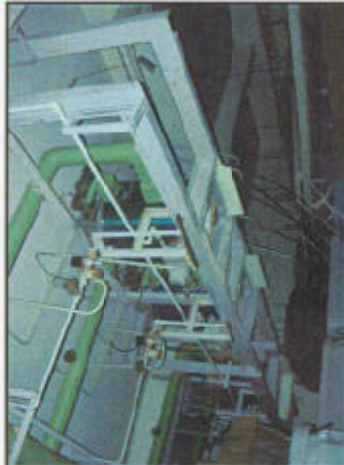
Photo-20 Exposing Pipes of Ice Making Plant at Ceiling on Ground Floor

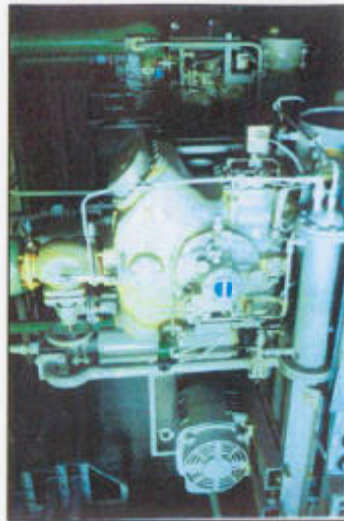
Photo-21 Damages Condensers and Motors at Machinery Room

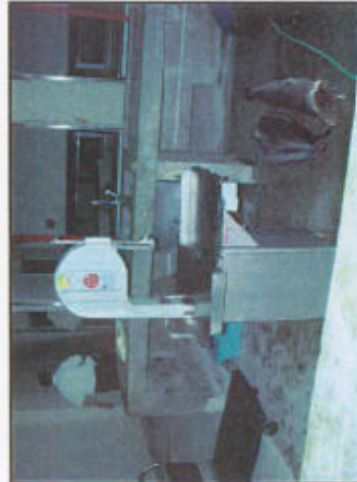
Photo-22 Damaged Band Saw Soaking with Sea Water

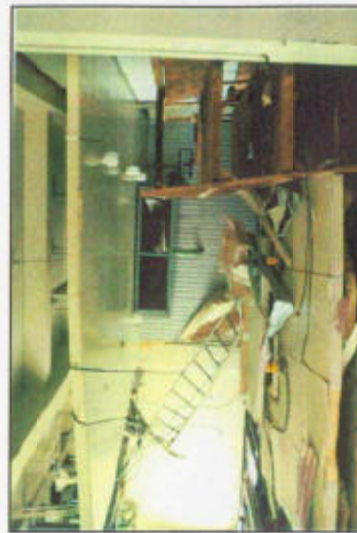
Photo-23 Damages Door and Insulation Panel

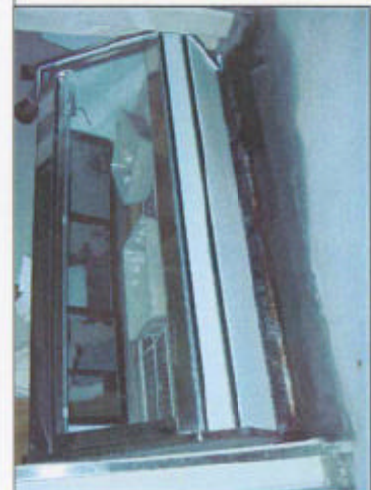
Photo-24 Damages Cold Display Case Soaking with Sea Water

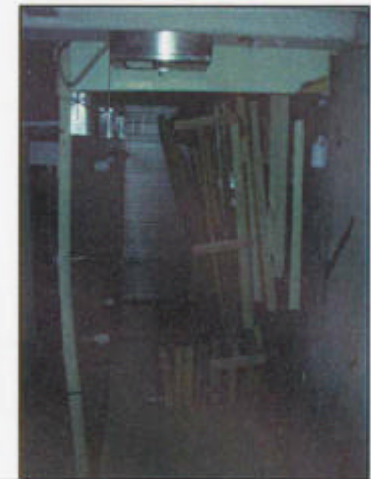
Photo-25 Damages Insulation Panel of Chilled Room

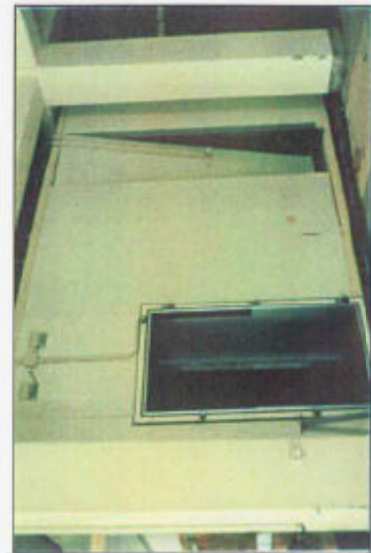
Photo-26 Damages Door and Panel at Cold Storage
