**THE STUDY  
ON  
CRITICAL LAND  
AND  
PROTECTION FOREST REHABILITATION  
AT TONDANO WATERSHED  
IN  
THE REPUBLIC OF INDONESIA**

**APPENDIX-H**

**SOIL EROSION AND SEDIMENTATION**

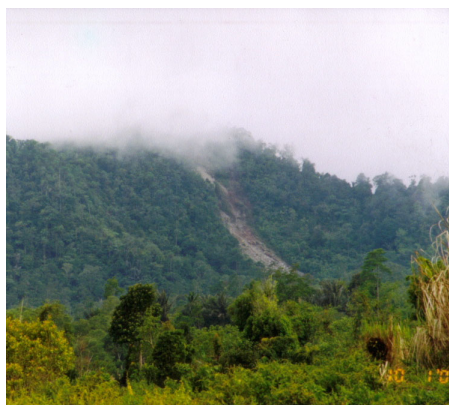
In the Intensive Area, the JICA Study Team observed 5 hillside slope failures (See Table H.3.1, Figure H.3.8 and H.3.9 to H.3.13 for the detail). Among the 5 hillside slope failures, site Mt. Maimberg shown in the picture was classified as a critical land regarding slope failure on hillside taking following criteria into

**Hillside Slope Failure at Mt. Maimberg**

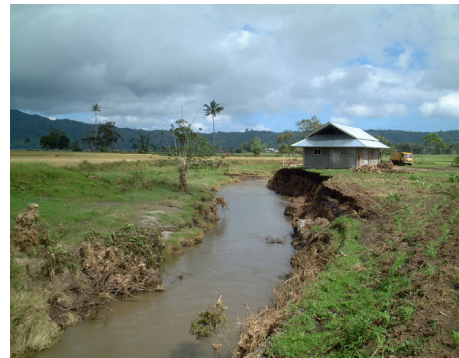
**Severe River Bank Erosion along the River Panasen**

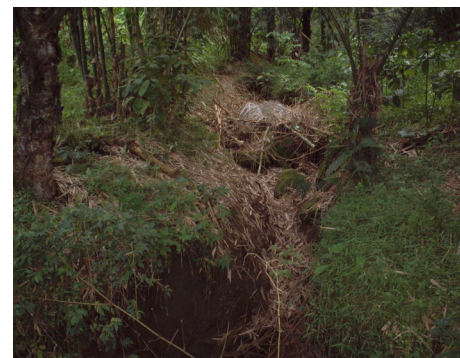
Through the site survey, the JICA Study Team identified the hazard on debris flow at the main torrent of sub-watershed 4 using following criteria (See Figure H.3.25 for the location).

**Devastated Torrent at Sub-watershed No. 4**

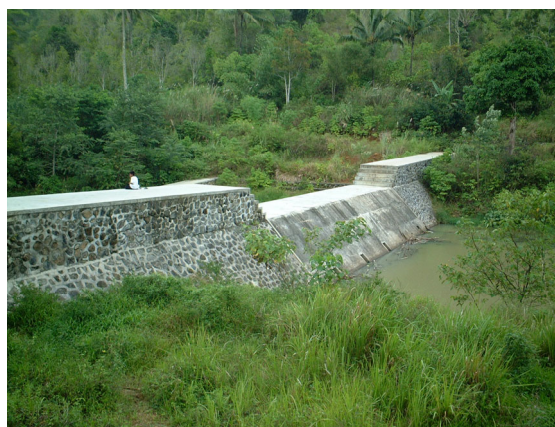
**Wet Masonry Gravity Check Dam at Touliang Oki**

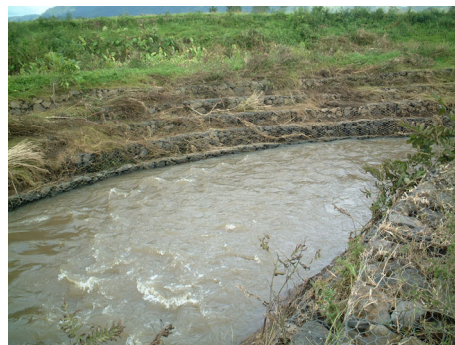
**Effective Torrent Revetment Works at the River Panasen, H=2.5 m**

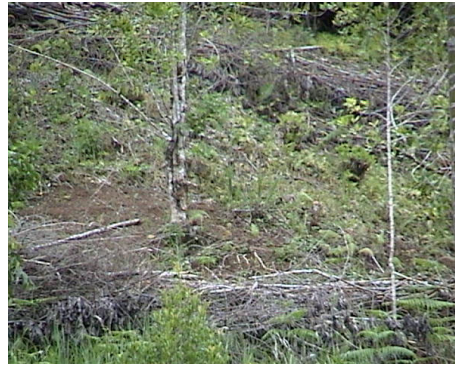
No problem is found for the existing slope protection works for hillside.

**Brushwood Fence Works at Eris**

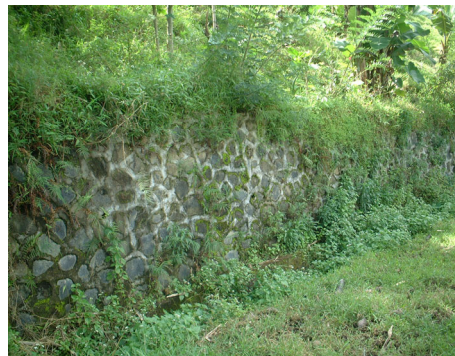
No problem was observed for the existing slope protection works for road.

**Slope Protection Works for Road at Kakas,  
H=2.0 m**

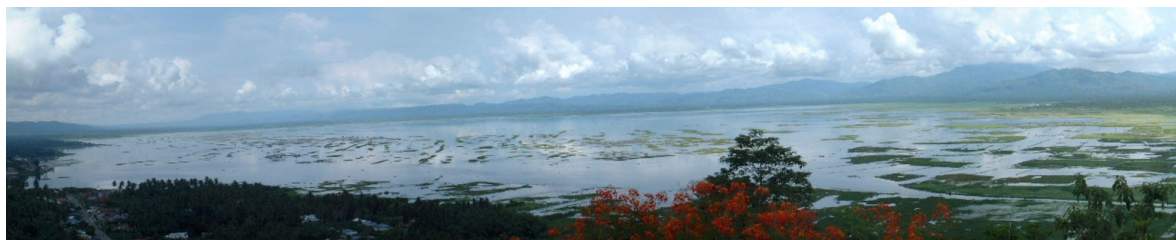
The catchment area of Lake Limboto has been extensively deforested by slash and burn cultivation, and now is characterized by significant degradation of upland area. It has brought about severe sedimentation in the lake. According to the “Limboto-Bolango-Bone Basin Water Management Master Plan, March 1999”, Lake Limboto is the remnant of a lagoon connecting with the sea through the Bolongo-Bone estuary called presently. The lagoon was disconnected from the sea by tectonic activity and became fresh lake. The sedimentation process in the lake was accelerated by deforestation since 1940s. Records showed that the maximum water depth of the lake would be 14 m in 1934, but had reduced to 2.5 m by 1972. The lake seems to be lifeless, which is further worse than Lake Tondano.

**General View of Lake Limboto**

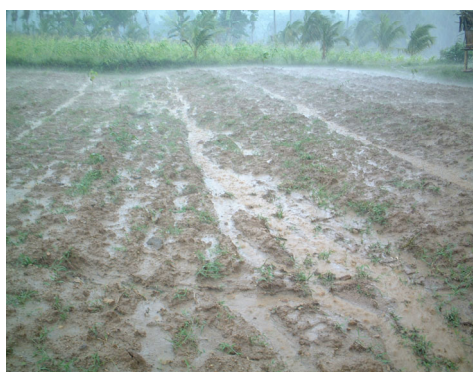
**Severe Soil Erosion with Surface Runoff  
in Limboto Watershed**

Soil is a key factor for soil erosion. Silty clay is observed at the sites inspected. As silty clay has low infiltration rate, runoff flows over soil surface. In fact, it has been observed that runoff has brought about severe sheet soil erosion when heavy rains has occurred during site inspection.
