**The Study on Critical Land And Protection Forest  
Rehabilitation at Tondano Watershed  
in the Republic of Indonesia**

Japan International Cooperation Agency

# Inventory Survey of Major Hillside Slope Failures in the Intensive Area

Name of the Slope Failure

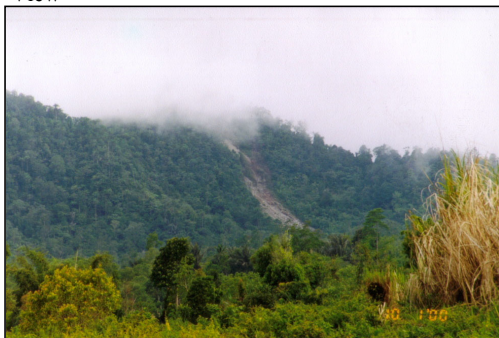
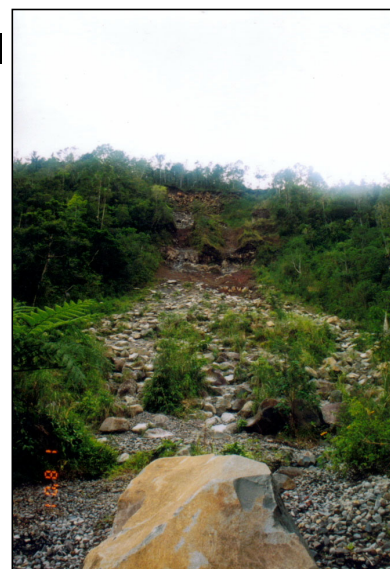
Figure H.3.9

Unsuitable Quarrying

Possibility of slope failure expansion

Middle

Possibility of natural rehabilitation

Low

Condition of Slope Failure on Hillside  
(Mt. Maimberg)
