(4) Ifegh

(6) Chitam

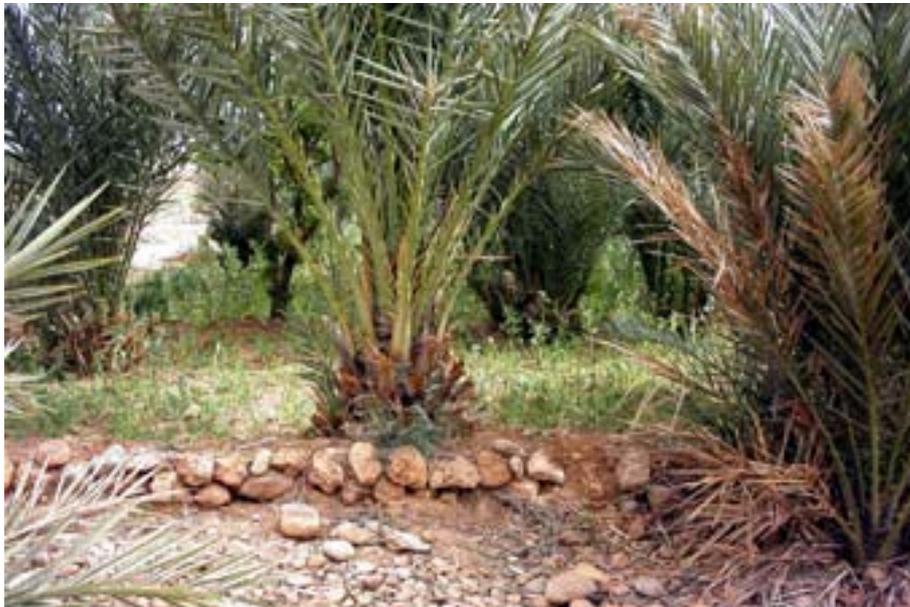
Photo No.29
Dates Palm Trees in
Traditional farm

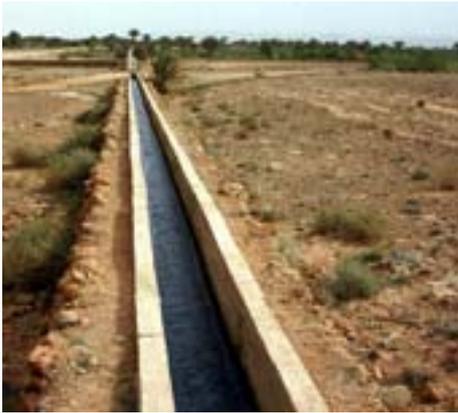
Photo No.30
Irrigation Canal Line to
Extension Area

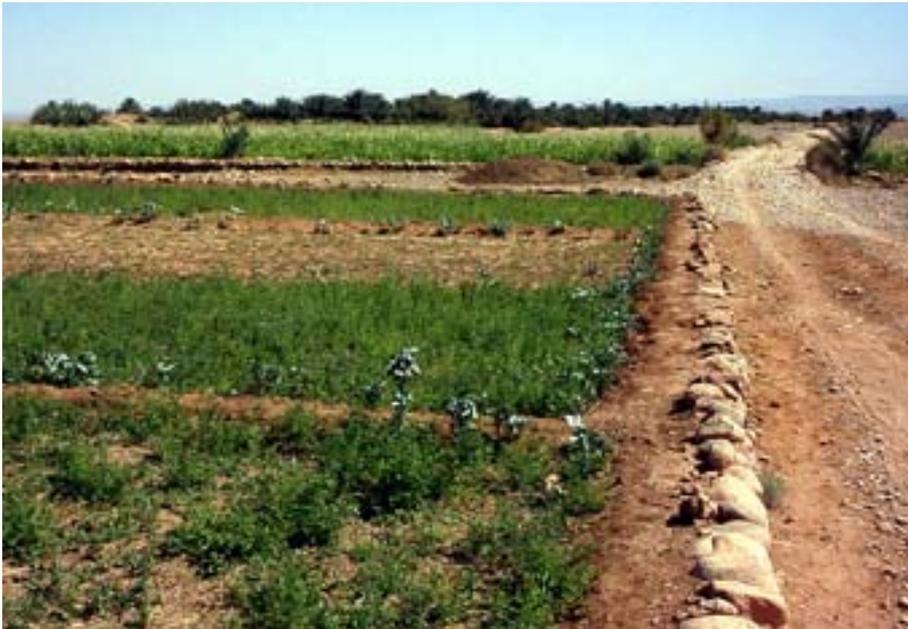
Photo No.31
Agricultural land of
Extended Area

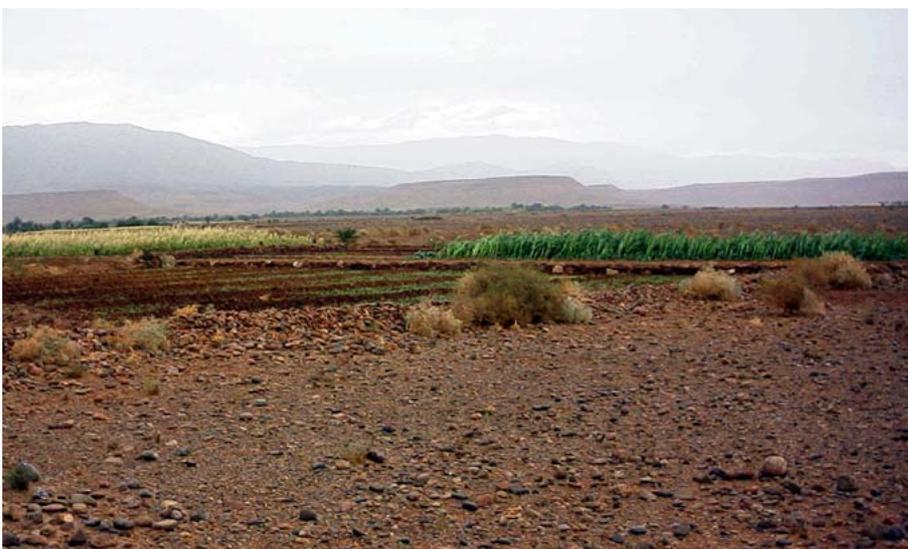
Photo No.32
South End of the
Extension Farmland

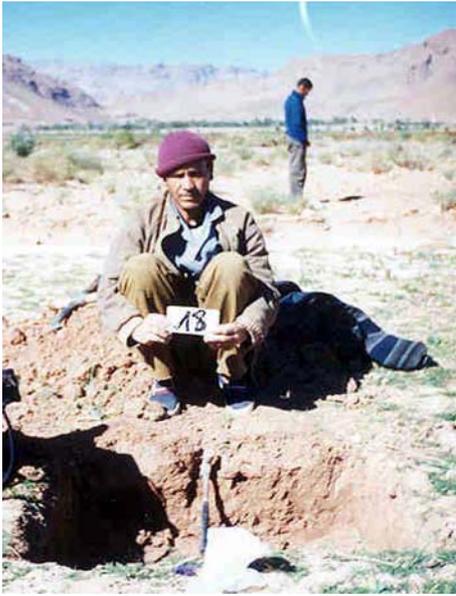
Photo No.33
Class III
Extension Area

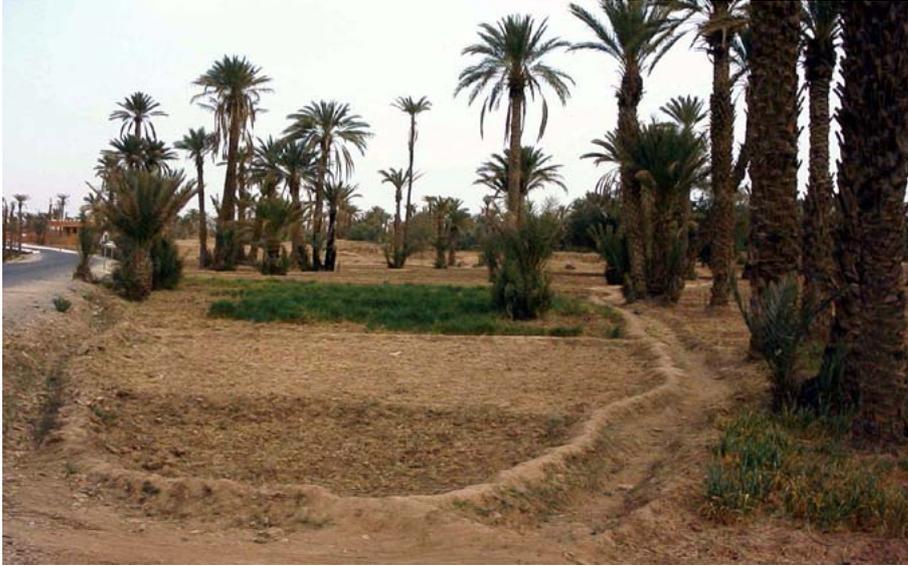
Photo No.38
Agricultural land in
Tinejeda
(Dates and Alfalfa)

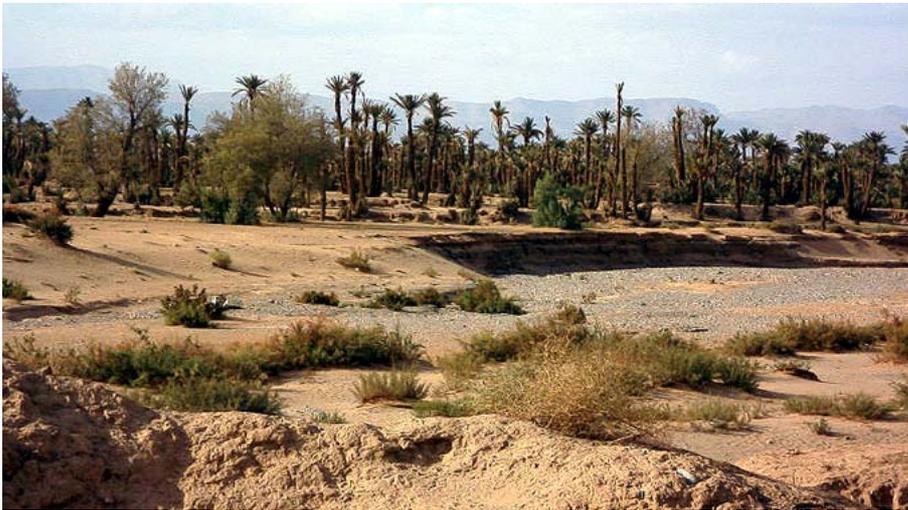
Photo No.39
Damaged Agricultural
land by Drought
(Dates Palm Trees)

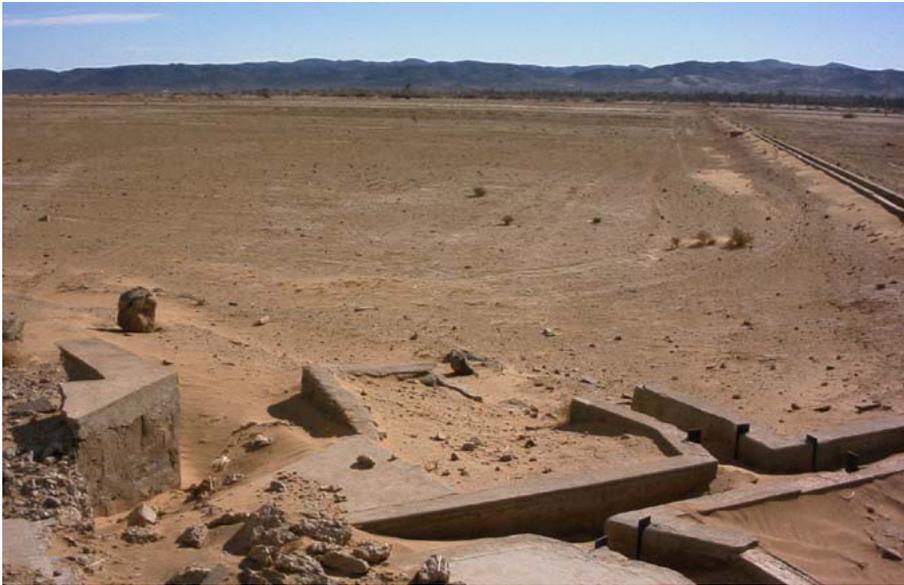
Photo No.40
Abandon Farmland
with Irrigation Canal
Line

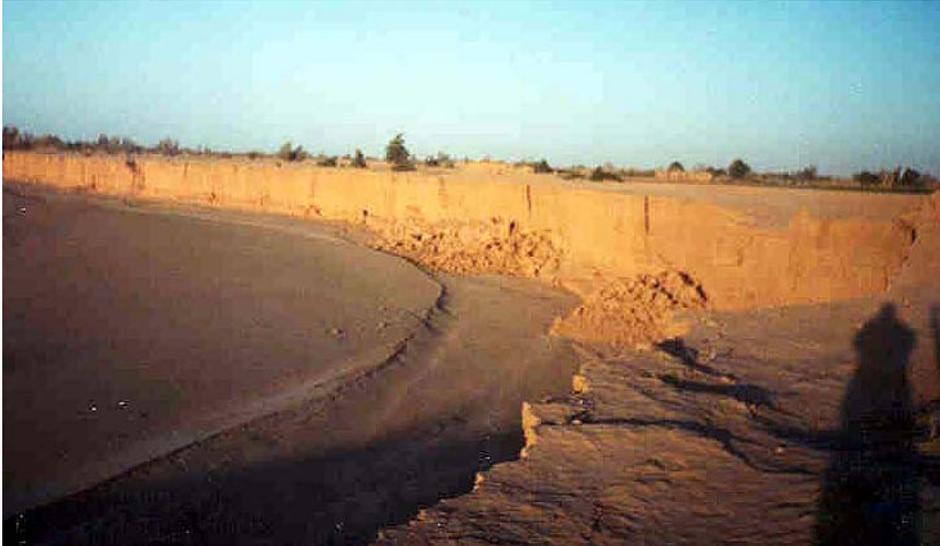
Photo No.41
River Bank
Soil Erosion
Northern Edge of the
Soil Survey Area

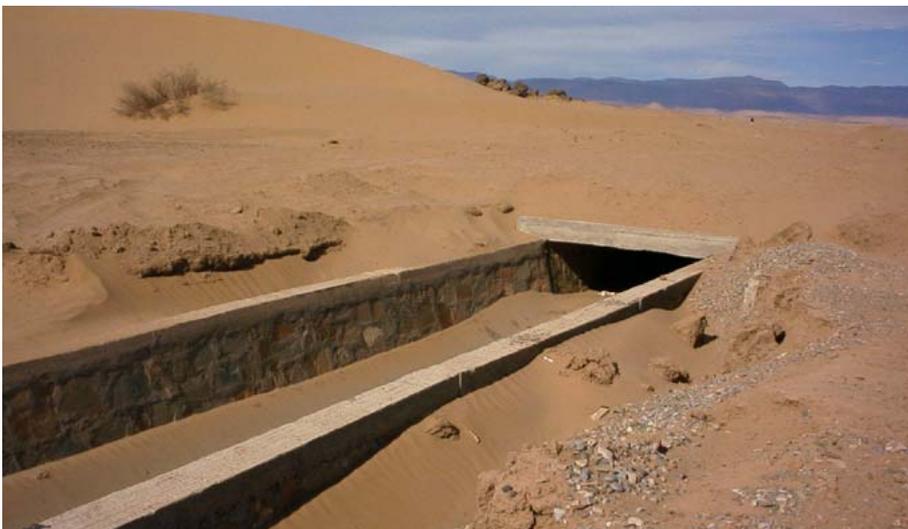
Photo No.42
Buried Canal Line
Sandy Soil

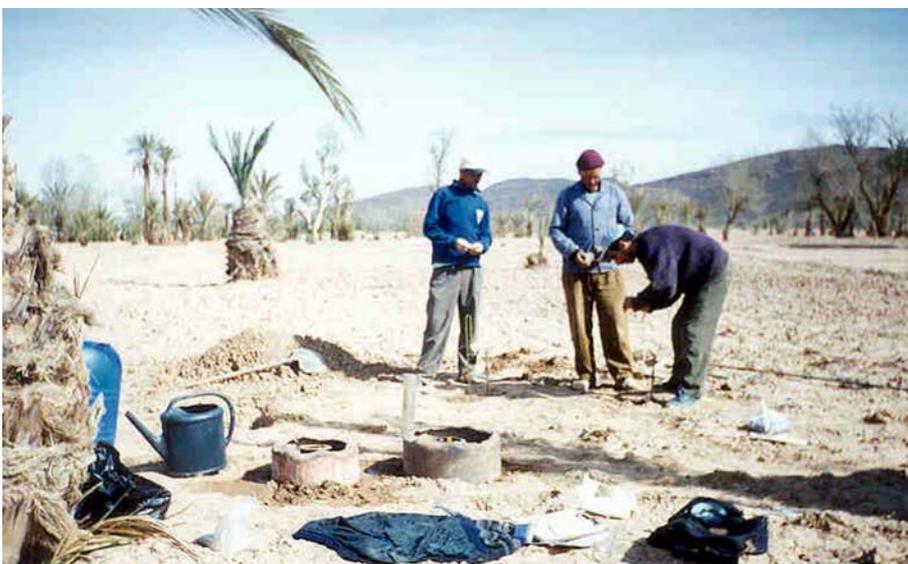
Photo No.43
Soil Permeability Test
on Farmland
