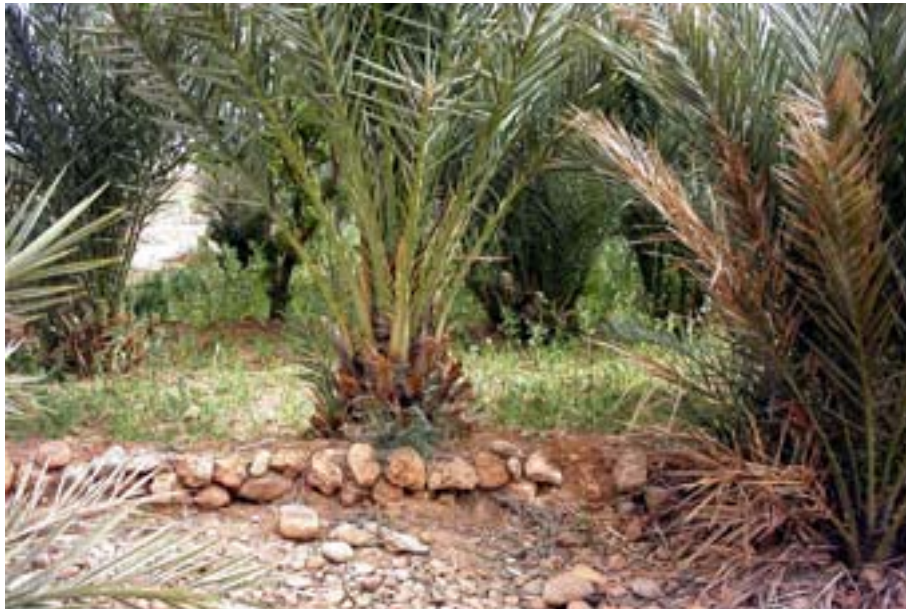
Photo No.29
Dates Palm Trees in
Traditional farm

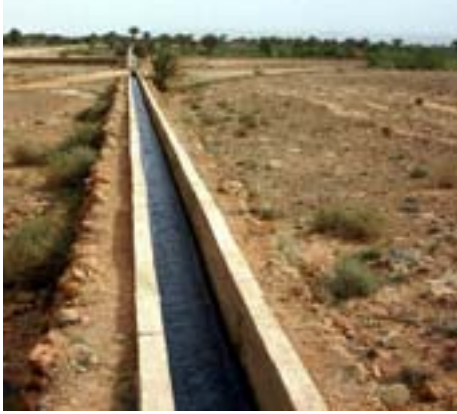
Photo No.30
Irrigation Canal Line to
Extension Area

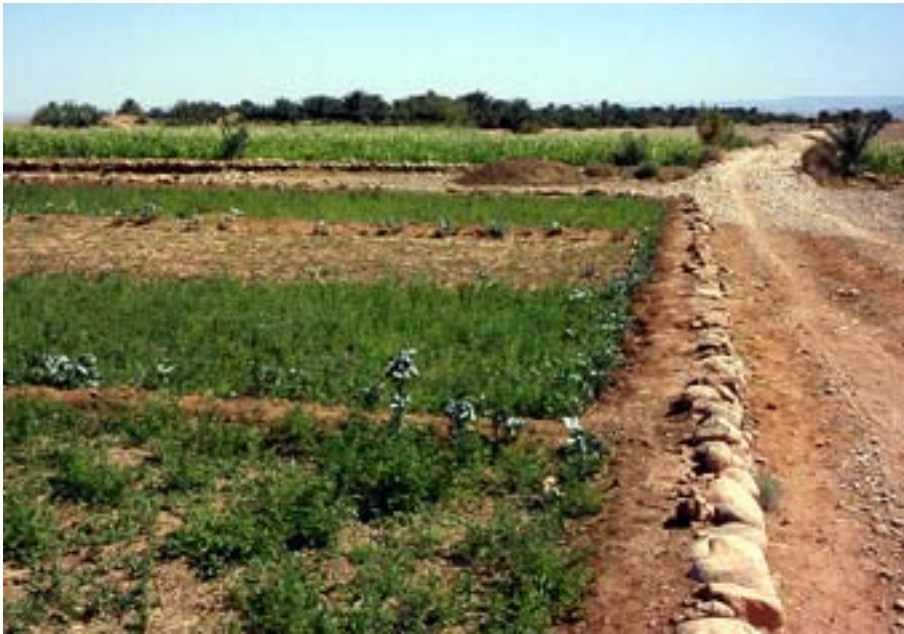
Photo No.31
Agricultural land of
Extended Area

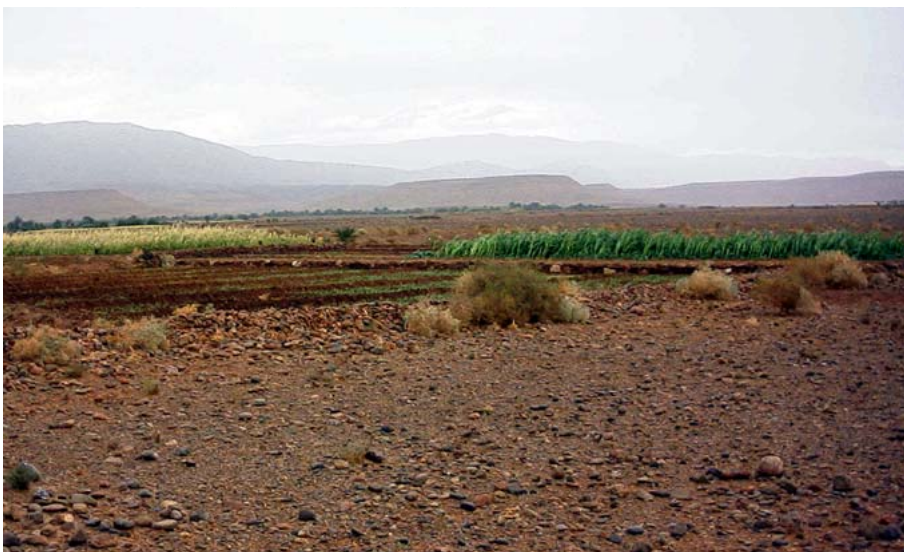
Photo No.32
South End of the
Extension Farmland

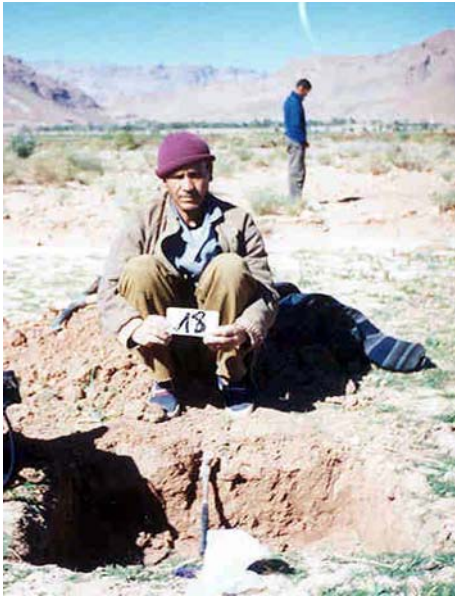
Photo No.33
Class III
Extension Area

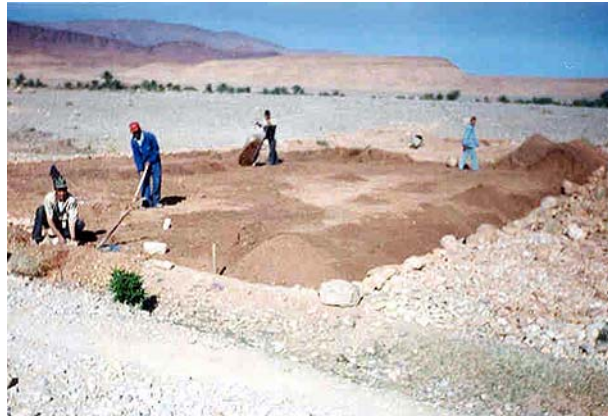
Photo No.34
Soil Dressing

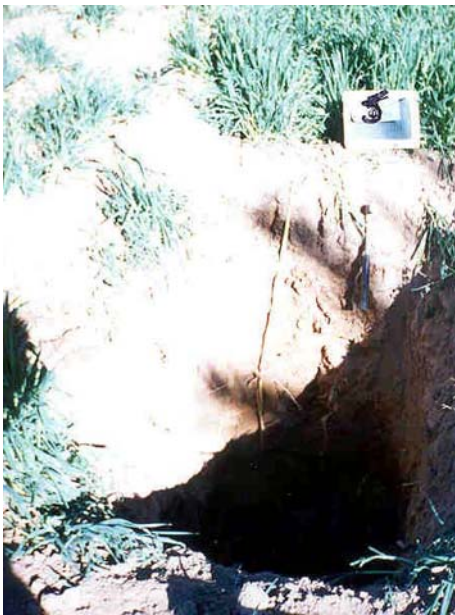
Photo No.35
Class II
Traditional Farmland

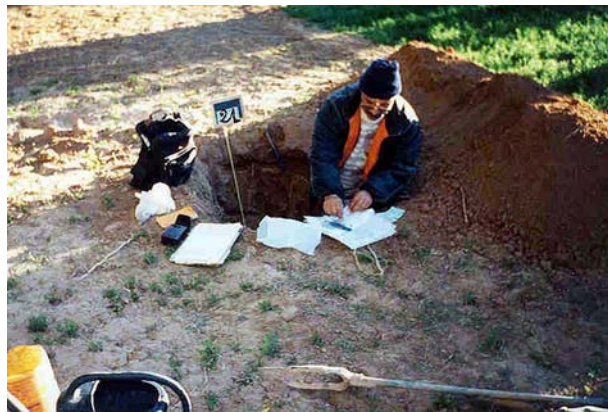
Photo No.36
Profile Observation

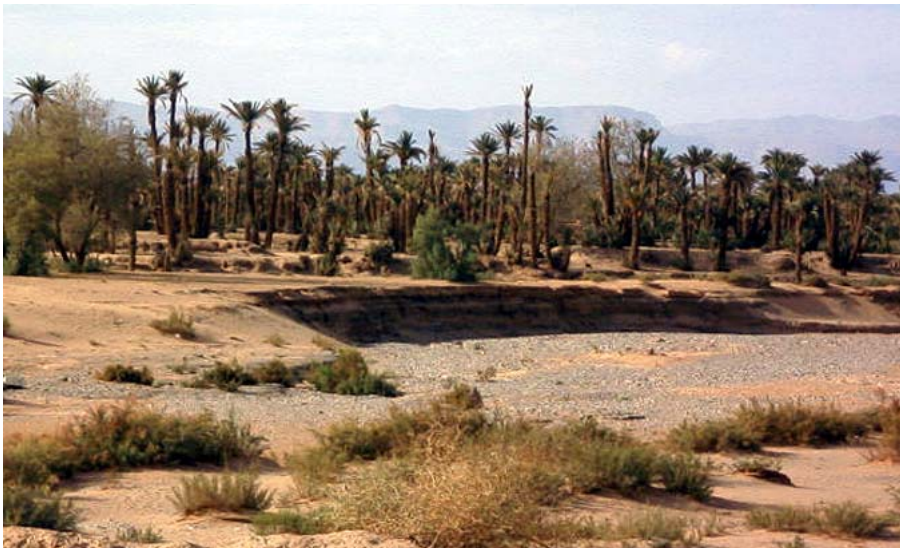
Photo No.37
Riverbed and Dates palm
trees in Tinejdad

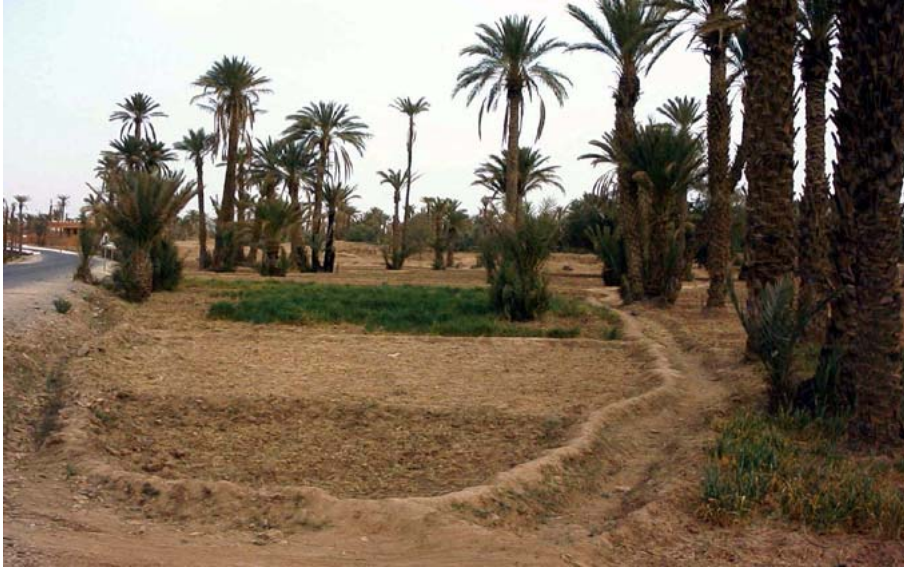
Photo No.38
Agricultural land in
Tinejda
(Dates and Alfalfa)

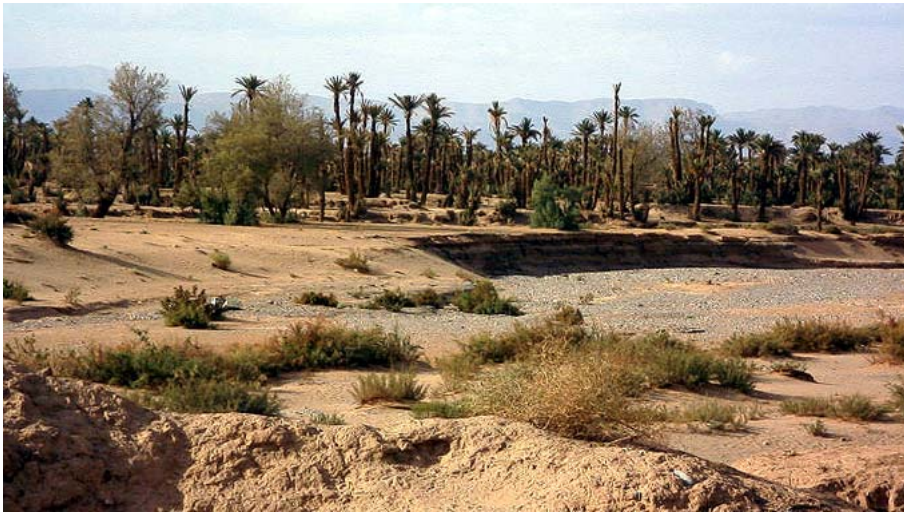
Photo No.39
Damaged Agricultural
land by Drought
(Dates Palm Trees)

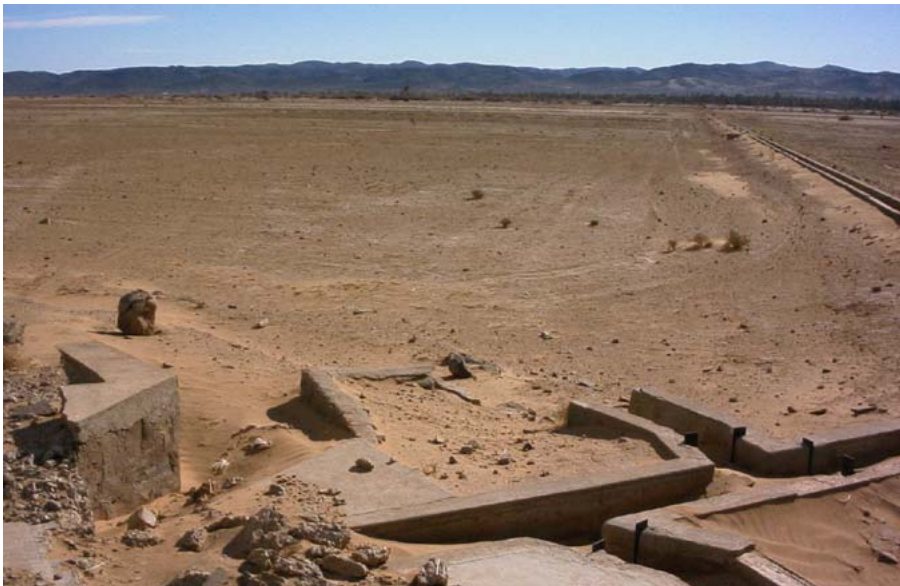
Photo No.40
Abandon Farmland
with Irrigation Canal
Line

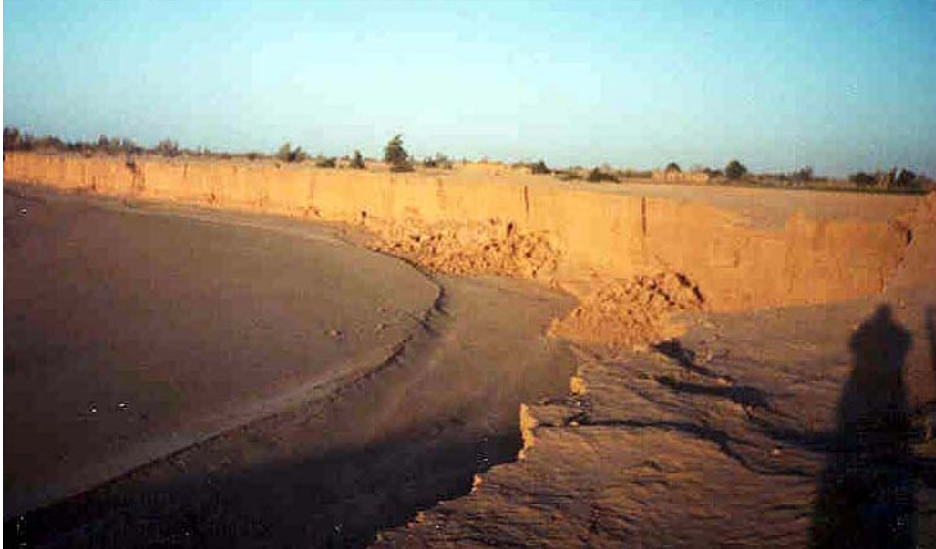
Photo No.41
River Bank
Soil Erosion
Northern Edge of the
Soil Survey Area

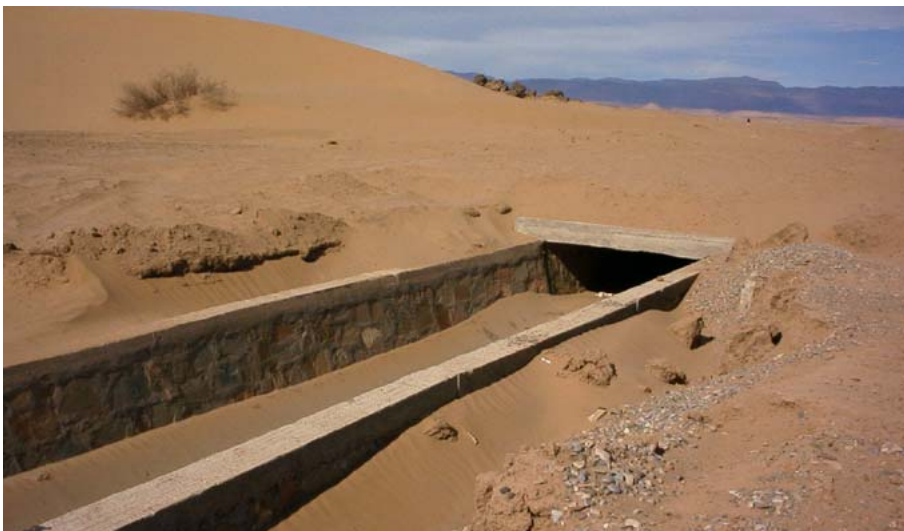
Photo No.42
Buried Canal Line
Sandy Soil

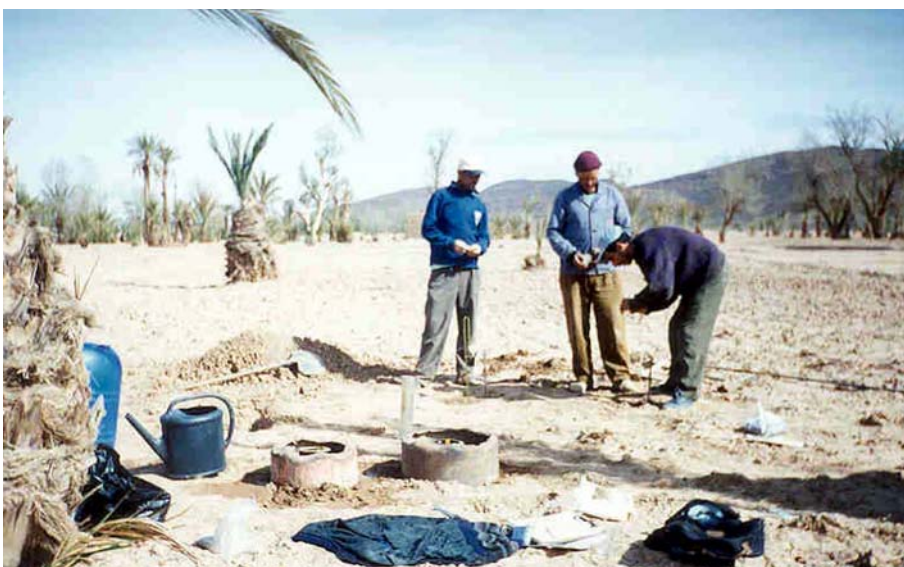
Photo No.43
Soil Permeability Test
on Farmland

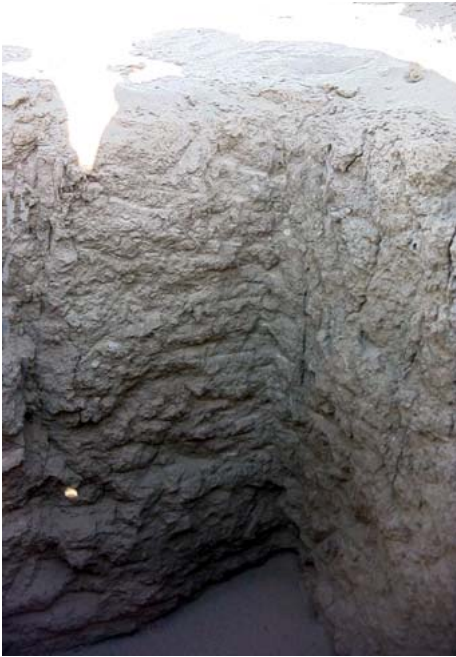
Photo No. 44
Point①、 Class I

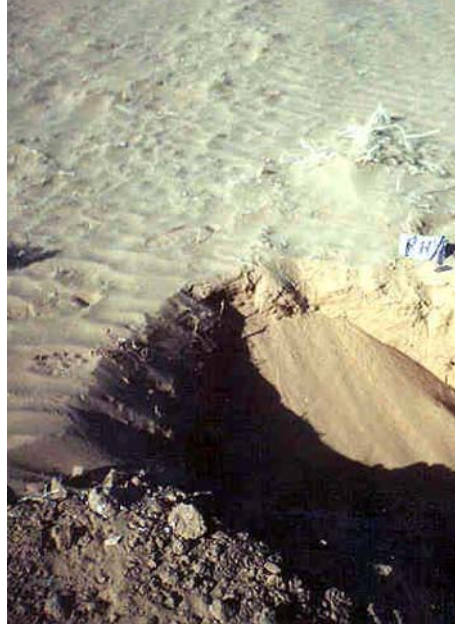
Photo No.45
Point②、 Class IV

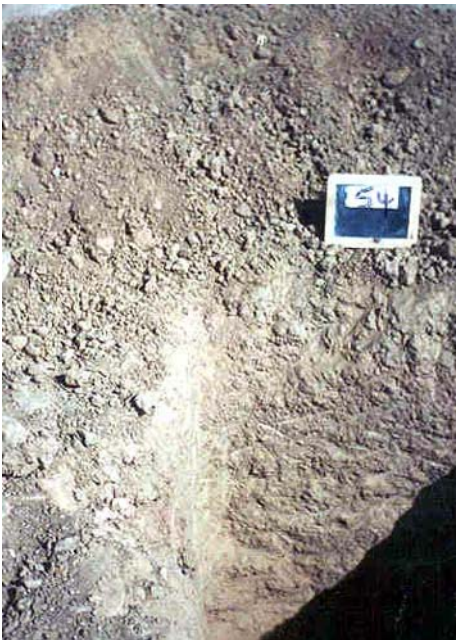
Photo No.46
Class II
