Valenzuela

Individual Information Sheets for the Traffic Bottleneck Points

- VL-01 Karuhatan / A Pablo / MacArthur Hwy
- VL-02 MacArthur Hwy / A Fernando St
- VL-03 MacArthur Hwy / P Valenzuela St
- VL-04 MacArthur Hwy / Tamaraw Hills
- VL-05 Fatima Ave / Serrano St
- VL-06 MacArthur Hwy / Poblacion Road

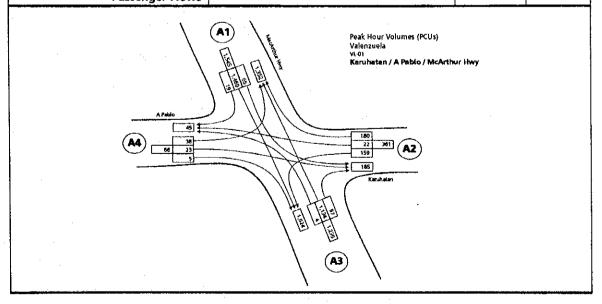
Name	Karuhatan / A. Pablo / MacArthur Hwy	Code	VL-01
Sheet	Analysis	LGU	Valenzuela

- 1) Pedestrians along the Karuhatan approach are sometimes forced to use the road because of the narrowness of the sidewalks.
- 2) Current construction activity for the improvement of drainage is constricting the entry to Karuhatan. Flooding has been a problem during heavy rains due to poor drainage.
- 3) Unpaved shoulder does not allow jeepneys to leave the travel-way or at least allow following vehicles to easily overtake.
- 4) Some shin-high walls slightly restrict the easy movement of pedestrians from the market who are crossing MacArthur Highway.
- 5) Cycle times being used exceed 3 minutes (based on observations) and would need to be shortened.
- 6) Cycle allocations should be based on traffic volumes. Between 50% and 60% of all green times should be given to the north-south and south-north traffic flow on MacArthur Highway.

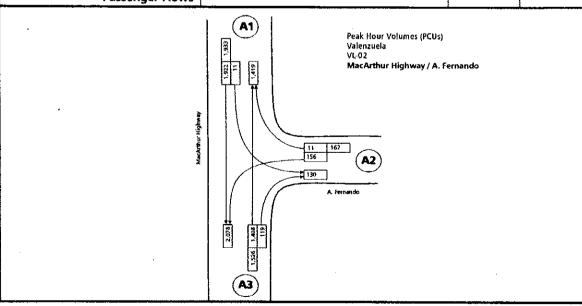
Name	MacArthur Hwy /A Fernando St	Code	VL-02
Sheet	Analysis	LGU	Valenzuela

- 1) The open canal forces pedestrians on to the road and constricts vehicular movement on A. Fernando. Although pedestrian traffic is light, this situation is unsafe.

- 2) Damaged pavement (due to narrow excavation across A. Fernando) causes unnecessary slowing of vehicles, and risk to vehicles.
- 3) Present location and orientation of tricycles exposes passengers to the traffic, their loading and unloading into and from the sidecar being immediately facing the carriageway. This is unsafe for the passengers and presents an opportunity for numerous instances of tricycle passengers obstructing traffic on the carriageway.

- 4) Tricycles reduce the capacity of A. Fernando, but there are presently no viable alternative locations to take them off the road.
- 5) Tricycles, being located at the intersection inadvertently cause exiting traffic to take all or part of the opposing lane on Tamaraw Hills road. This would further limit the capacity of the entering lane and cause tie-ups in traffic.

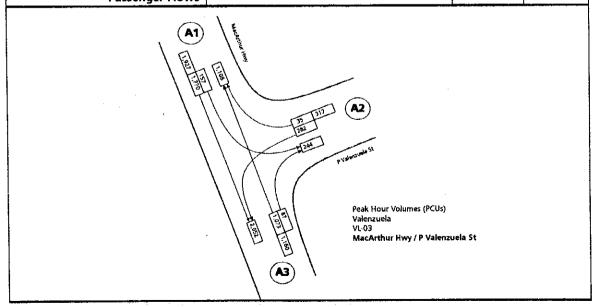
Name	MacArthur Hwy /P Valenzuela St	Code	VL-03
Sheet	Analysis	LGU	Valenzuela

- 1) Existing practice of keeping tricycles off Pio Valenzuela should be maintained.
- 2) Vendors on sidewalks obstruct pedestrian flows, causing pedestrians to use the carriageway.
- 3) Main traffic is along MacArthur Highway, accounting for 90% of 2-way volumes. Problem arises when "green" for Pio Valenzuela traffic gets more than proportionate allocation, or when cycle time become too long (more than 2 minutes).

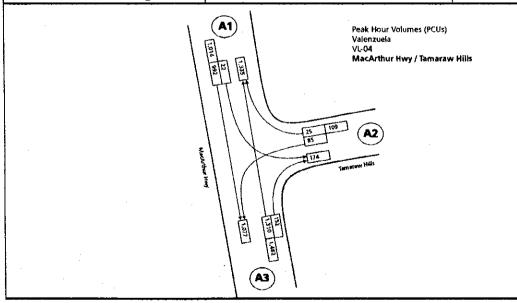
Name	MacArthur Hwy / Tamaraw Hills	Code	VL-04
Sheet	Analysis	LGU	Valenzuela

- 1) Volume on Tamaraw Hills constitute less than 5% of junction traffic, but eats up more than proportionate time. Partly caused by pavement damage.
- 2) Present location and orientation of tricycles exposes passengers to the traffic, their loading and unloading into and from the sidecar being immediately facing the carriageway. This is unsafe for the passengers and presents an opportunity for numerous instances of tricycle passengers obstructing traffic on the carriageway.
- 3) Tricycles reduce the capacity of Tamaraw Hills Rd but there are presently no viable alternative locations to take them off the road. Tricycles, being located at the intersection inadvertently cause exiting traffic to take all or part of the opposing lane on Tamaraw Hills Rd.

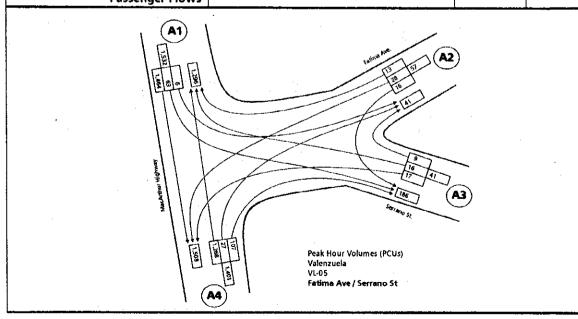
Name	Fatima Ave / Serrano St	Code	VL-05
Sheet	Analysis	LGU	Valenzuela

- 1) The crossing of vehicles from Serrano St to Fatima Ave, before reaching MacArthur Highway, creates conflict with vehicles coming from MacArthur. Length of Fatima (from MacArthur Higway/to Serrano St) is too short and capacity reduced by tricycles and roadside friction.
- 2) Present location and orientation of tricycles exposes passengers to the traffic, their loading and unloading into and from the sidecar being immediately facing the carriageway. This is unsafe for the passengers and presents an opportunity for numerous instances of tricycle passengers obstructing traffic on the carriageway.

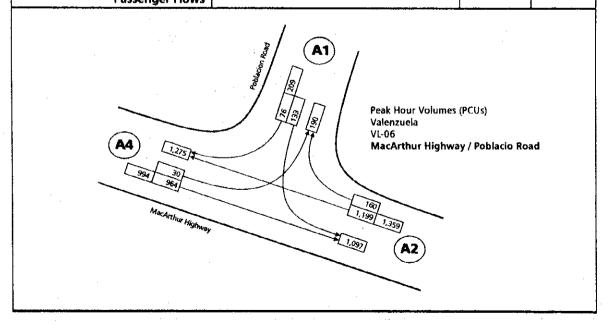
Name	McArthur Highway / Poblacion Road	Code	VL-06
Sheet	Analysis	LGU	Valenzuela

- 1) Poblacion II is an important access to the Valenzuela City Hall. Uncontrolled crossing of pedestrians. Hamper smooth entry / exit from MacArthur. Turning radii at corners also not convenient.
- 2) Traffic on MacArthur comprised about 92% of vehicles passing through the junction, but maybe getting less than proportionate green time from the enforcers controlling the signal.
