Table S.2.4.1.3 General Characteristics of Proposed Dam and Intake Site (2/18)

Table S.2.4.1.3 General Characteristics of Proposed Dam and Intake Site (3/18)

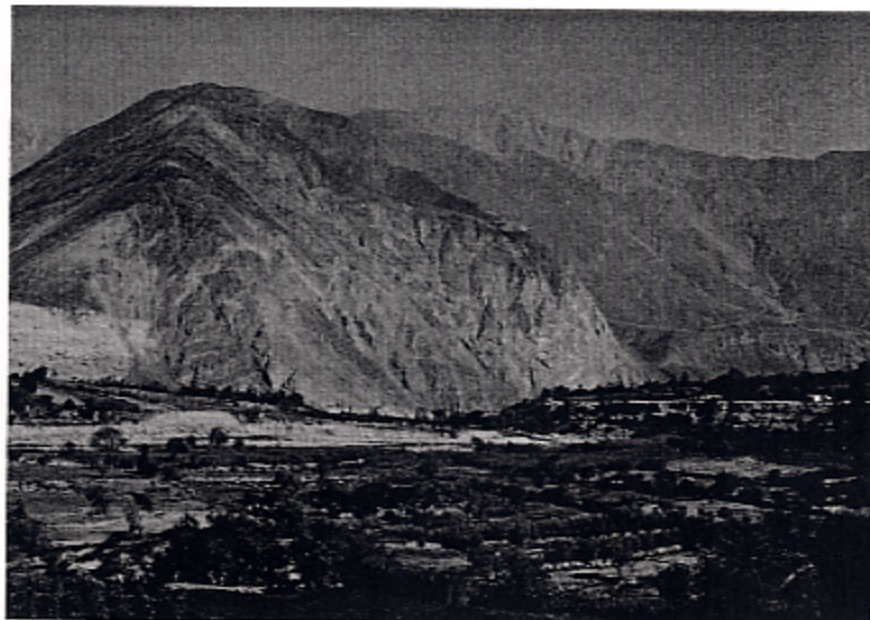
Negative No. I-21

Site	Zuñiga I	Department : Lima	Province : Cañete	District : Zuñiga	River : Cañete					
Topography	Riverbed width	Approximately 20 meters				Dam site	Hard bedrocks in the left bank and soft de sediments in the right bank.			
	Characters	Steep rocky slope in the left bank and gentle slope of terrace, fluvial and alluvial deposits in the right margin.								
Schematic section	EL

Reservoir	Wide valley with extended terrace and alluvial deposits.			
		Qh-pf: Present fluvial deposit Ti-t: Tantarà Formation Ki-g: Goyllarisquiza Group								
Geology	Geology of Basement	Left bank		River bed		Right bank		Issues	Grasping of thickness and properties of the soft subsurface deposit in the right slope.

Fracture	Fractures in parallel with bedding. Strongly folded.		No present		Many irregular fraciures			
		Alteration	No present		No present		Crystallization of calcite and epidote along the fractures.			
		Weathering	Slight rusty-weathering along the fracture.		No detected		Superficial weathering			
	Overlying Sediment	Little amount of colluvial fragments on the steep slope.		Present fluvial deposit		Talus deposit composing of andesitic fragments.				
	Landslide and/or Failure	No present		No present		No present

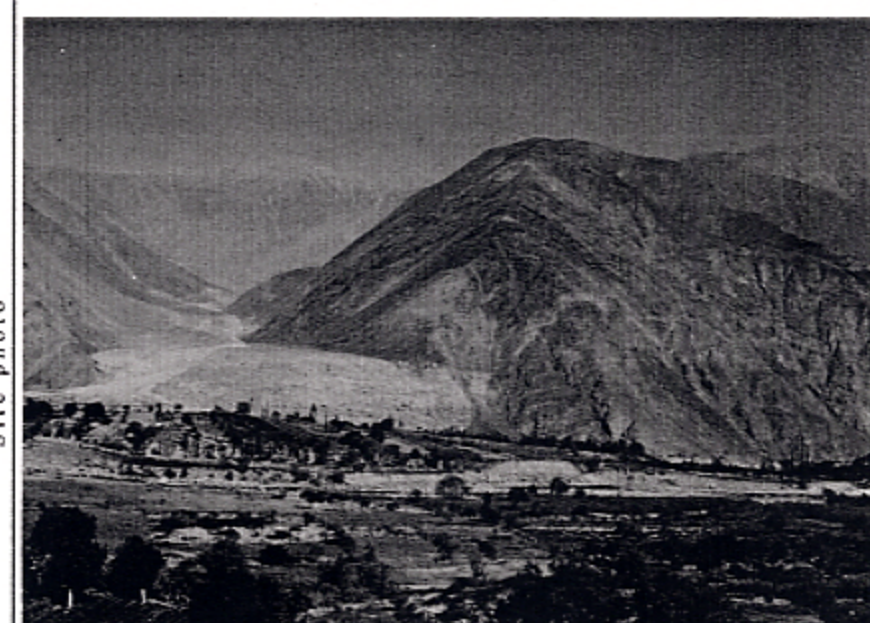
Negative No. 1-20

Site		Zuñiga II	Department : Lima	Province : Cañete	District : Zuñiga	River : Cañete			
Topography	Riverbed width	Approximately 20 meters					Dam site	Alluvial cones located immediately upstream from the proposed intake dam may damage the structure and reduce the storage capacity.	
	Characters	Wide valley deposited by soft deposits. Steep rocky slope in the left bank and alluvial terrace 2-3 meters high from riverbed in the right bank. Alluvial cone is located in the left upper stream from the proposed dam site.							
Schematic section	EL

Reservoir	The river valley shows wide between both steep slopes.	
		Qh-pf: Present fluvial deposit Qh-ac: Alluvial cone Ti-t: Tantarà Formation Ki-g: Goyllarisquiza Group							
Geology	Geology of Basement	Left bank		River bed		Right bank	Issues		
		Lower Cretaceous		Lower Cretaceous		Lower Tertiary			
		Goyllarisquiza Group		Goyllarisquiza Group		Tantarà Formation

Fracture	Fractures in parallel with beddings. Sometimes open crack dips to 20- 40°. Strongly folded.		No present		Fragmental structure		
		Alteration	No present		No present		Crystallization of calcite and epidote along the fracture.		
		Weathering	Slight rusty-weathering along the fracture.		No present		Superficial weathering		
	Overlying Sediment	Little amount of colluvial fragments on the steep slope.		Present fluvial deposit		Talus deposit composing of andesitic fragments.			
	Landslide and/or Failure	No present		No present		No present			
	Remarks	Three tributaries are located nearly upstream from the proposed intake structure; two in the right bank and one in the left, which transport large amount of materials by debris flows.
